MINERALS PROGRAM INSPECTION REPORT
PHONE: (303) 866-3567

MINE NAME: Keenesburg Project	MINE/PROSPECTING ID#: M-2019-027	MINERAL: Sand	COUNTY: Weld
INSPECTION TYPE: Pre-Operation Inspection	INSPECTOR(S): Peter S. Hays	INSP. DATE: June 28, 2019	INSP. TIME: 10:00
OPERATOR: Colorado Sand Company LLC	OPERATOR REPRESENTATIVE: Marv Brown	TYPE OF OPERATION: 110c - Construction Limited Impact	
REASON FOR INSPECTION: Pre-Operation Inspection	BOND CALCULATION TYPE: Complete Bond	BOND AMOUNT: No Bond Held	
DATE OF COMPLAINT: NA	POST INSP. CONTACTS: None	JOINT INSP. AGENCY: None	
WEATHER: Clear	INSPECTOR'S SIGNATURE:

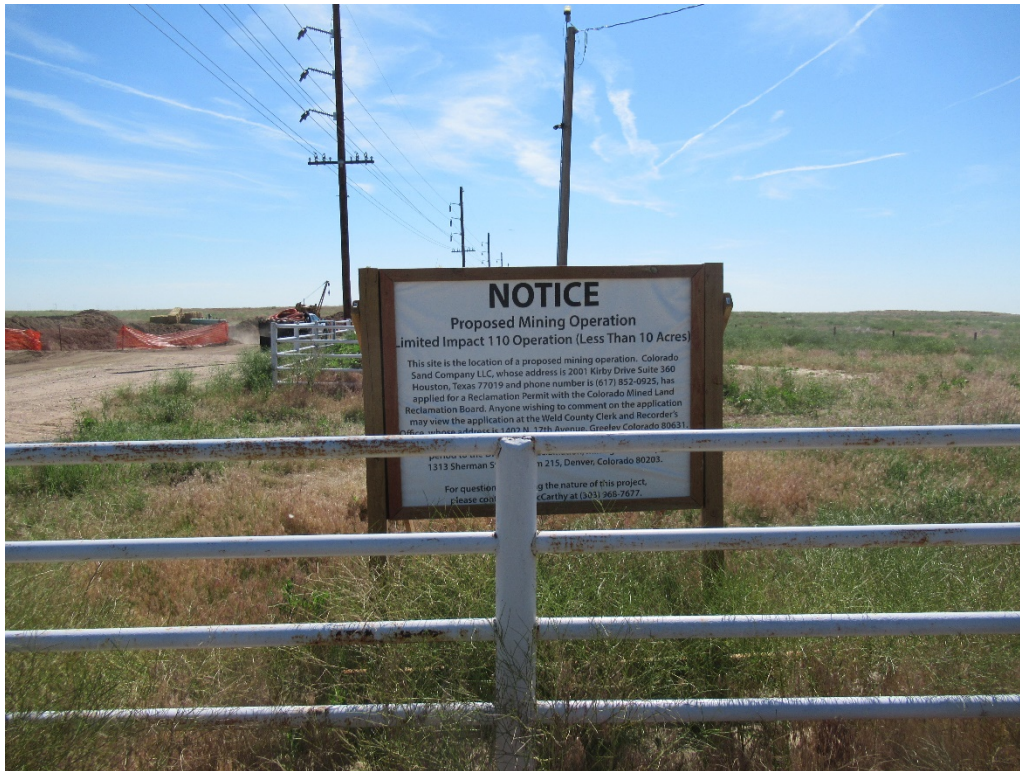
The required notice sign was posted at the entrance to the site. The Operator will be required to install a mine sign and boundary markers as required by Rule 3.1.12 prior to initiating the mining operation. The site consisted of undisturbed rangeland as described by the Applicant in the permit application. An overhead powerline and underground gas pipelines were observed south and west of the proposed permit boundary during the inspection, which were not identified by the Applicant in the permit application. The presence of the unidentified structures will be address by the Division in the adequacy review letter. The existing ranch access road appeared capable of support the mining operation in the current condition. Photographs taken during the inspection are attached.

Keenesburg Project notice sign

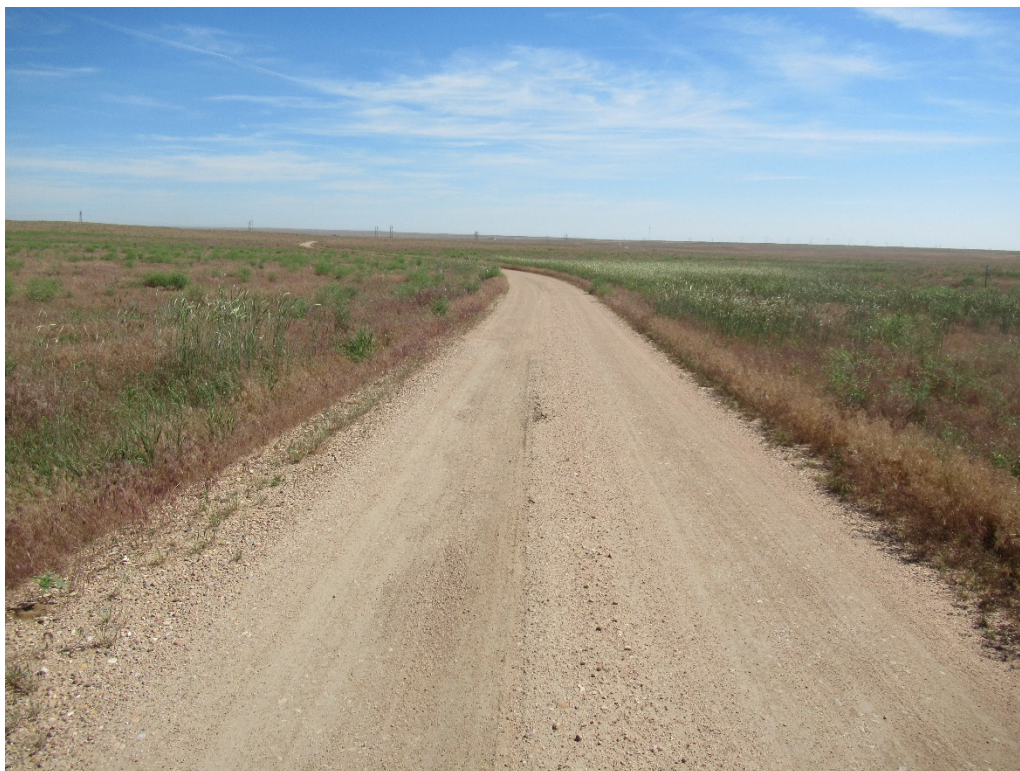
Existing ranch access road

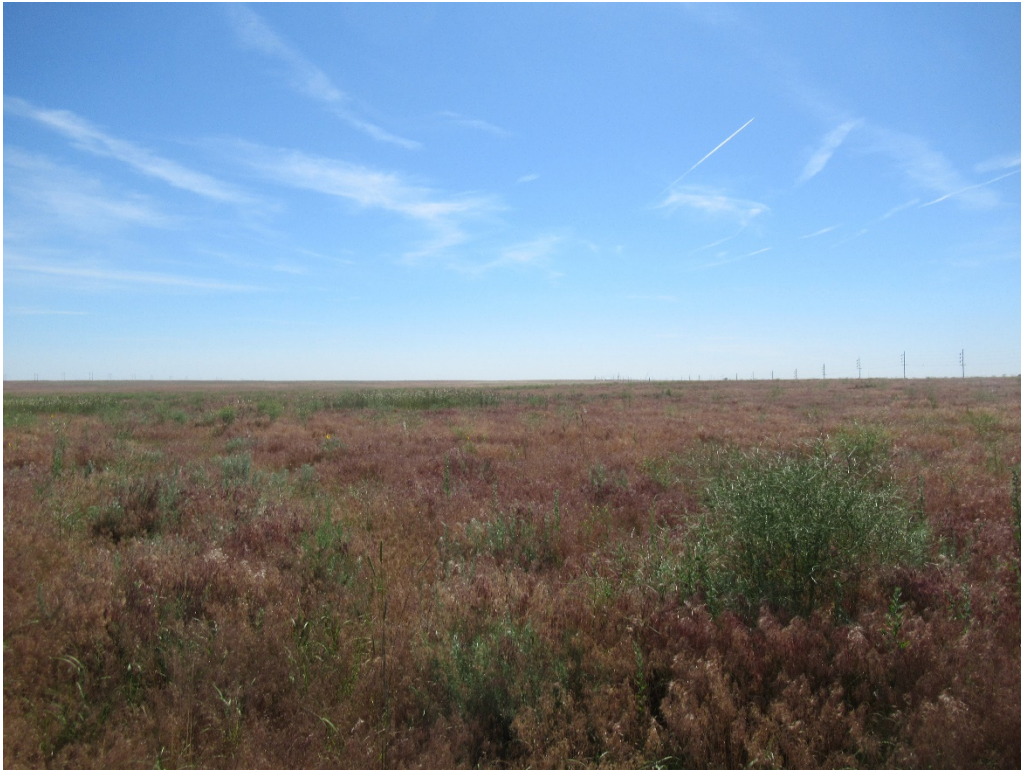
View of the site from the southwest corner looking east

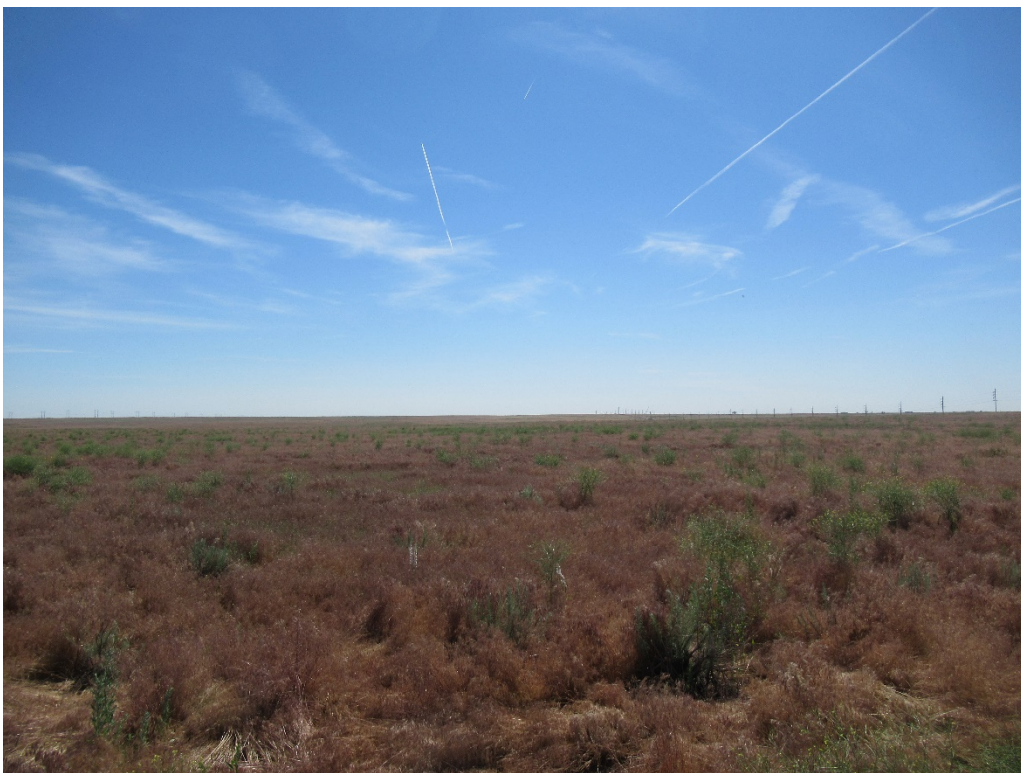
View of the site from the northwest corner looking east

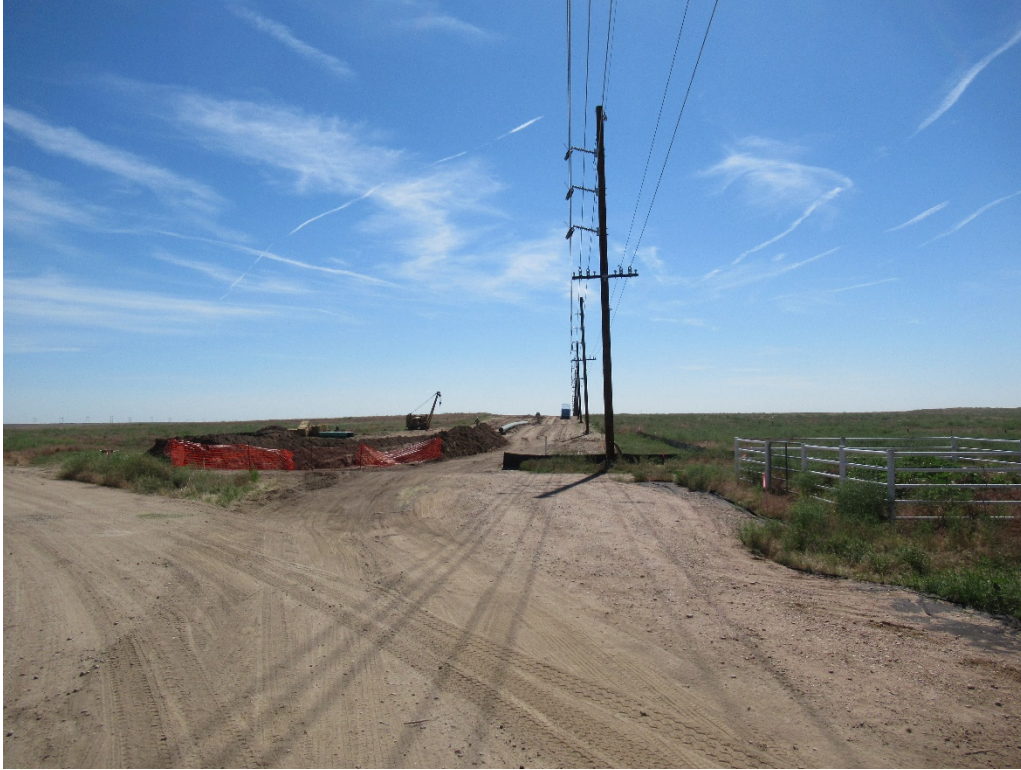
View of unidentified utilities in the permit application south of the permit boundary
