**COLORADO**Division of Reclamation,
Mining and Safety

MINERALS PROGRAM INSPECTION REPORT**PHONE: (303) 866-3567**

MINE NAME: North Clear Creek Construction Materials Mi	MINE/PROSPECTING ID#: M-2006-039	MINERAL: Sand and gravel	COUNTY: Garfield
INSPECTION TYPE: Monitoring	INSPECTOR(S): Amy C. Yeldell	INSP. DATE: June 24, 2019	INSP. TIME: 13:15
OPERATOR: Chevron Shale Oil Company	OPERATOR REPRESENTATIVE: Chris Patterson	TYPE OF OPERATION: 110c - Construction Limited Impact	
REASON FOR INSPECTION: Normal I&E Program	BOND CALCULATION TYPE: Complete Bond	BOND AMOUNT: \$36,939.00	
DATE OF COMPLAINT: NA	POST INSP. CONTACTS: None	JOINT INSP. AGENCY: None	
WEATHER: Clear	INSPECTOR'S SIGNATURE:

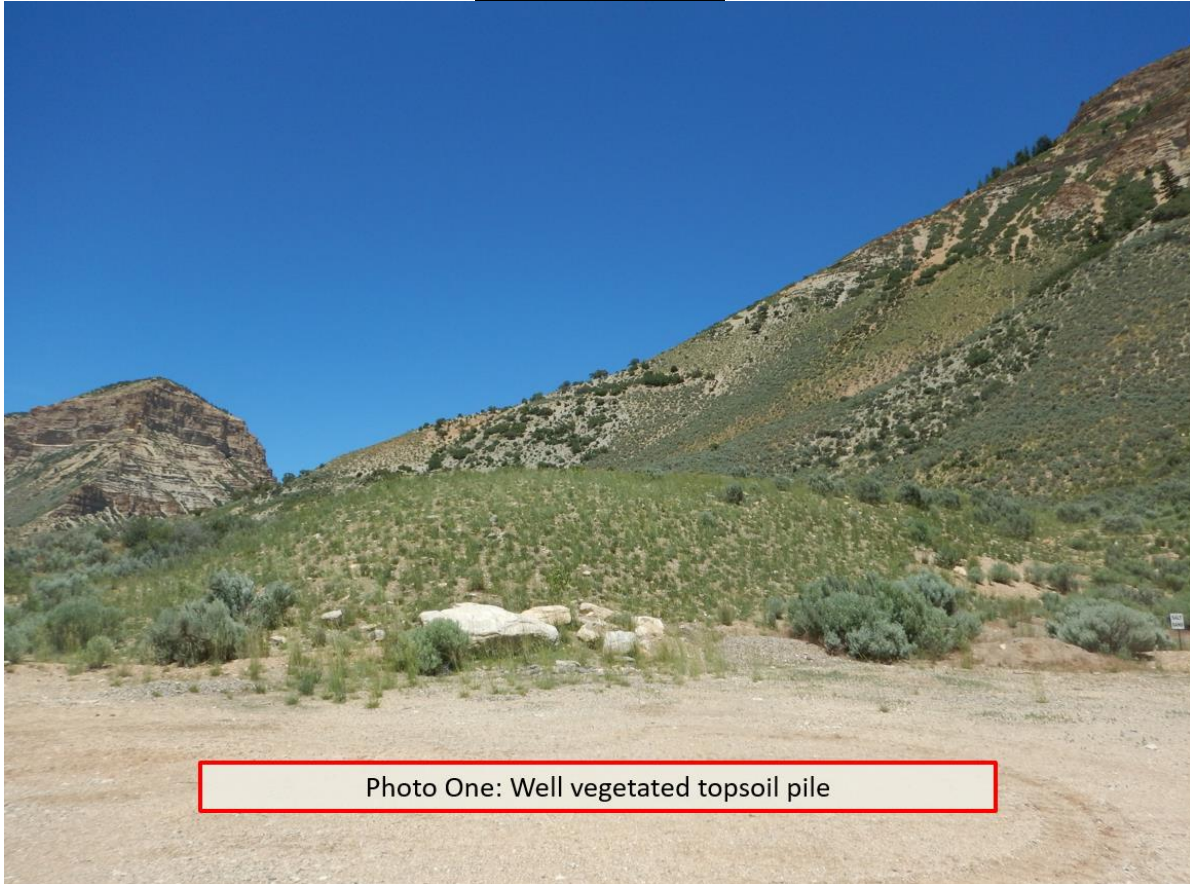
The site was inactive at the time of the inspection. This Operator is approved for Intermittent Status. No new excavations within the hillside were observed. The pit appears to be utilized for storage of inert materials rather than mining of borrow material. The hillside appears to be at a 2H:1V or less in most areas. A few minor slopes occur at the bottom of the hill near the storage piles. The topsoil pile remains to the north and is well vegetated.

Photo One: Well vegetated topsoil pile

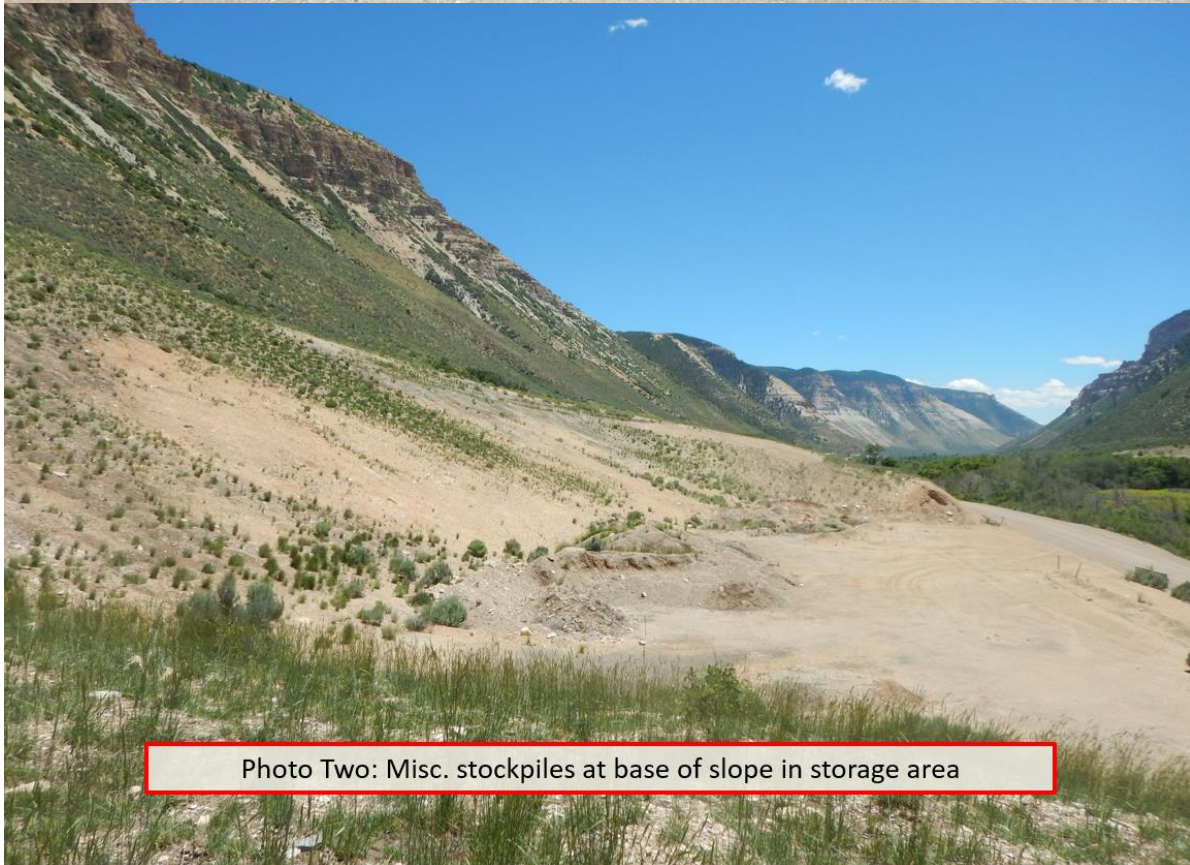
Photo Two: Misc. stockpiles at base of slope in storage area

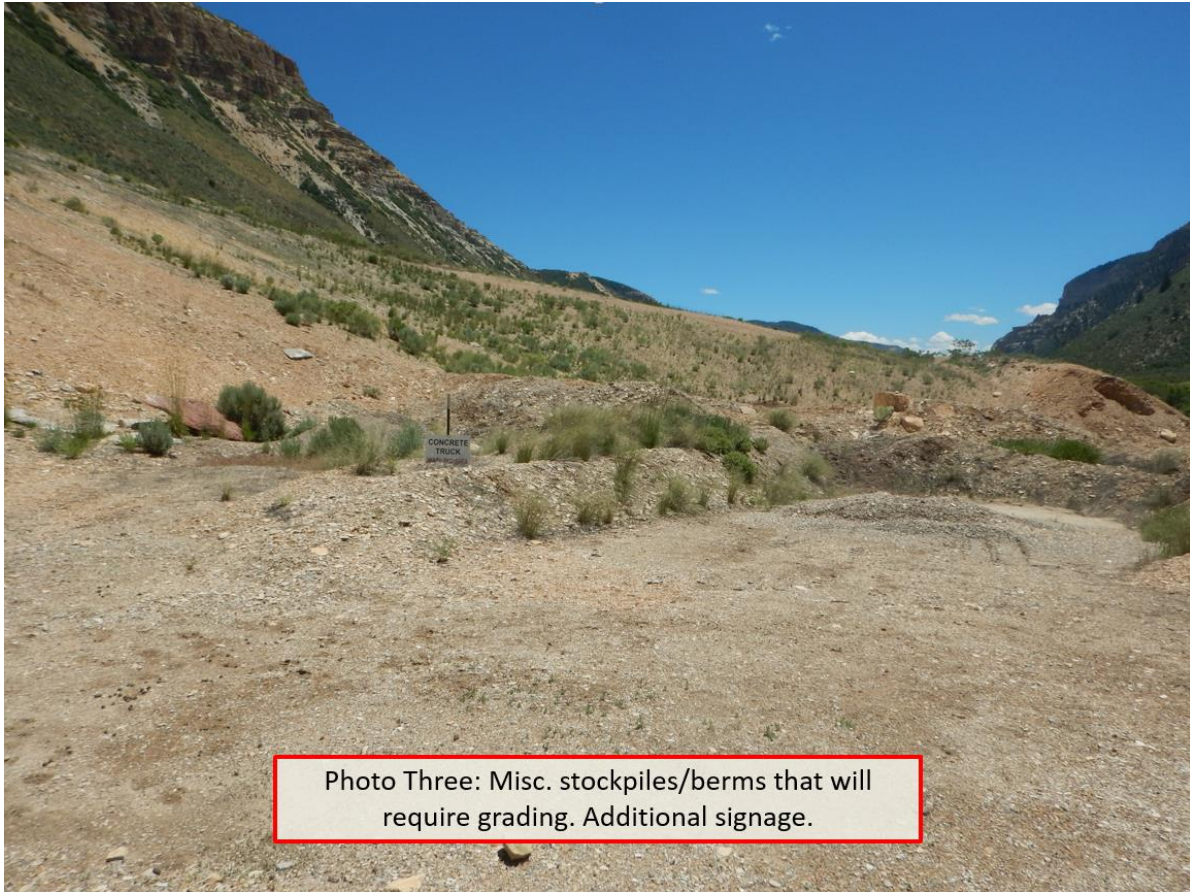
Photo Three: Misc. stockpiles/berms that will require grading. Additional signage.
