MINERALS PROGRAM INSPECTION REPORT
PHONE: (303) 866-3567

MINE NAME: Cresson Project	MINE/PROSPECTING ID#: M-1980-244	MINERAL: Gold	COUNTY: Teller
INSPECTION TYPE: Monitoring	INSPECTOR(S): Timothy A. Cazier	INSP. DATE: May 21, 2019	INSP. TIME: 09:45
OPERATOR: Cripple Creek & Victor Gold Mining Company	OPERATOR REPRESENTATIVE: Justin Bills & Katie Blake	TYPE OF OPERATION: 112d-3 - Designated Mining Operation	
REASON FOR INSPECTION: Normal I&E Program	BOND CALCULATION TYPE: None	BOND AMOUNT: \$209,491,188.00	
DATE OF COMPLAINT: NA	POST INSP. CONTACTS: None	JOINT INSP. AGENCY: None	
WEATHER: Cloudy	INSPECTOR'S SIGNATURE:

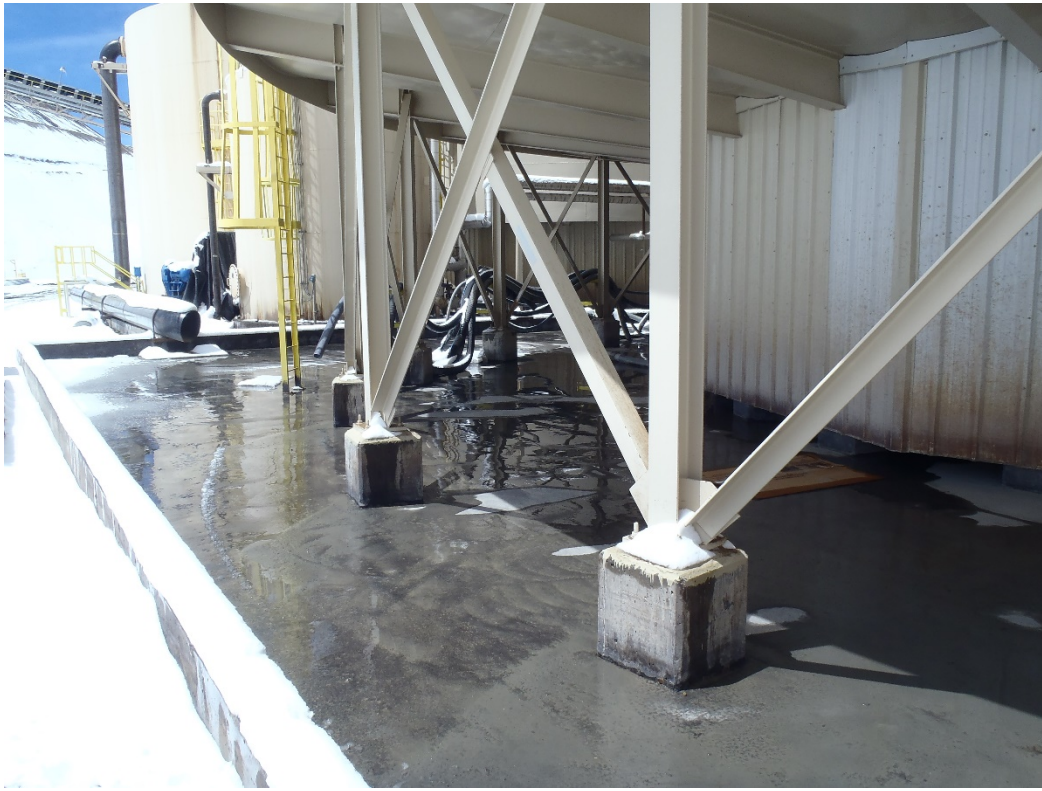
Photo 1. Secondary containment of Process Ore Thickener Tank.

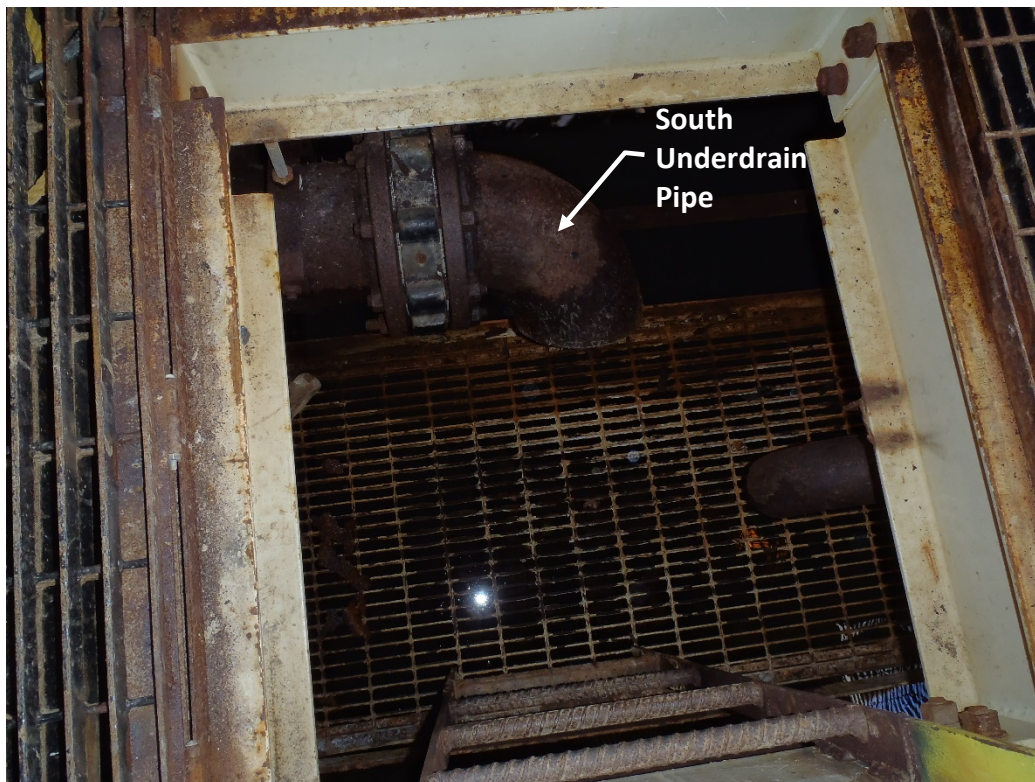
No discharge was observed from the VLF 1 south underdrain (See **Photo 2**).

Photo 2. No discharge from South Underdrain pipe.

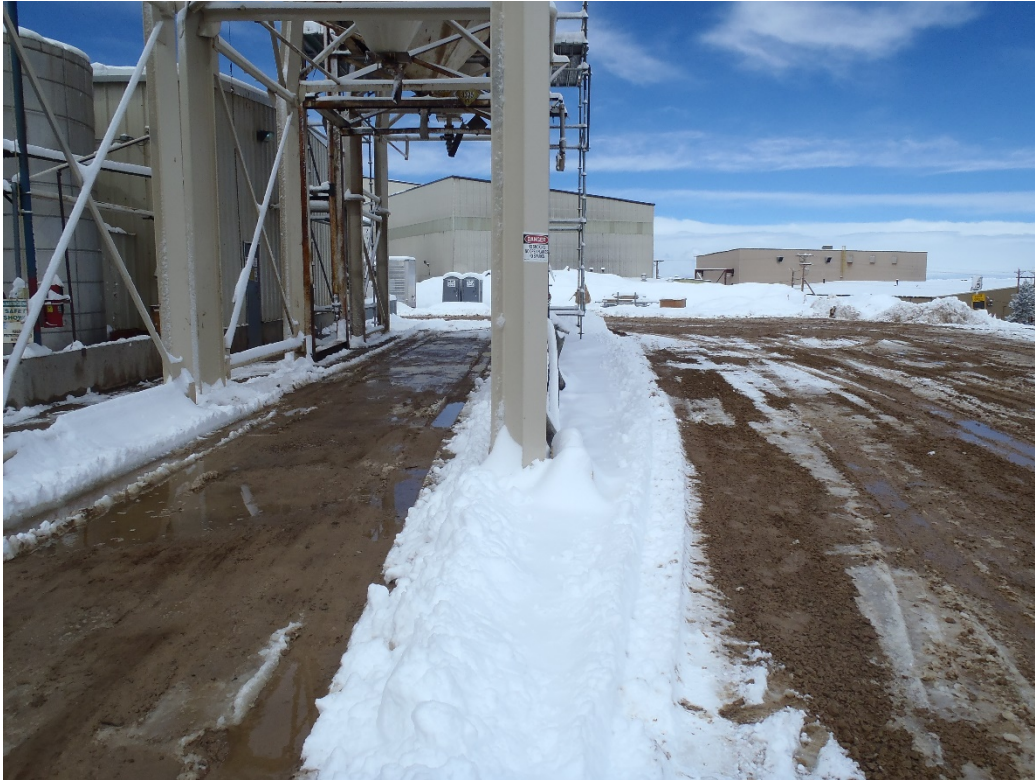
Recent Spill Areas: The overnight snow prevented observations of spill cleanup efforts. However, CC&V personnel explained the circumstances, extents of the spill area and corrective measures taken at the Buckley Emulsion Facility (See **Photo 3**), ADR 2 and VLF 2 (See **Photo 4**).

Photo 3. Buckley Emulsion Facility spill location (looking WNW).

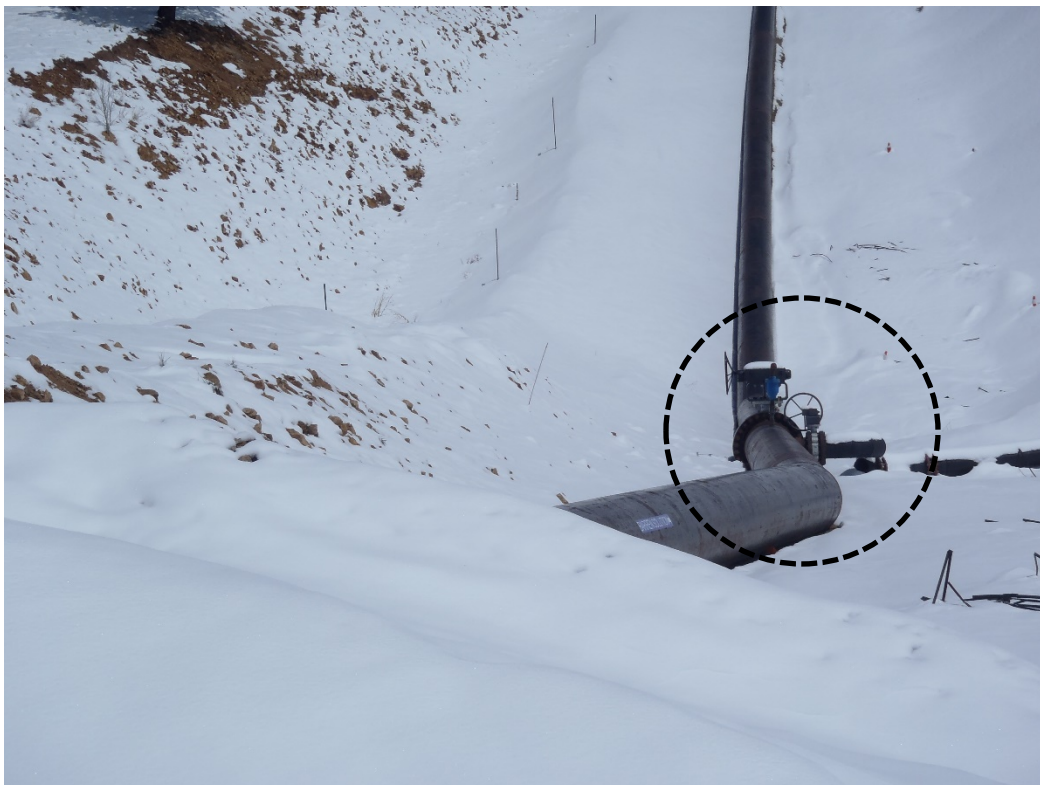
Photo 4. VLF 2 pipe valve failure/spill location (looking NNE).
