COLORADO
Division of Reclamation,
Mining and Safety
Department of Natural Resources

Permit Number: C-1981-014 Mine Name: Southfield Mine Operator: Energy Fuels Coal, Inc. Operator Address: Mr John Adams P.O. Box 773457 Steamboat Springs, CO 80477	County: Fremont Operation Type: Underground Permit Status: Revoked Ownership: Private
	Operator Representative Present: None
Operator Representative Signature: (Field Issuance Only)

Inspection Start Date: June 21, 2019 Inspection Start Time: 10:00 Inspection End Date: June 21, 2019 Inspection End Time: 10:30		Inspection Type: Coal Complete Inspection Inspection Reason: Normal I&E Program Weather: Clear	
Joint Inspection Agency: None		Joint Inspection Contacts: None	
Post Inspection Agency: None		Post Inspection Contacts: None	
Inspector(s): Zach T. Trujillo	Inspector's Signature:

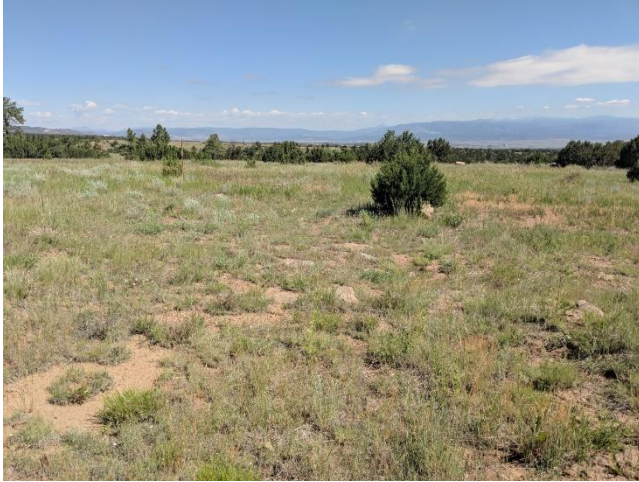
MW-NW Pad

The road spur remains heavily vegetated with no issues. The two-track road to the MW-NW off of County Road 15 has not been reclaimed however due to lack of use, the road has begun to "self-heal". Vegetation has begun to establish itself to the point where it blends in with the adjacent undisturbed land at certain areas. The MW-NW pad itself continues to establish itself with more vegetation as well. Overall, this area is stable with no erosion.
