MINERALS PROGRAM INSPECTION REPORT
PHONE: (303) 866-3567

MINE NAME: Sievers Pit	MINE/PROSPECTING ID#: M-1977-098	MINERAL: Sand and gravel	COUNTY: Garfield
INSPECTION TYPE: Monitoring	INSPECTOR(S): Amy C. Yeldell	INSP. DATE: June 25, 2019	INSP. TIME: 10:00
OPERATOR: Oldcastle SW Group, Inc. dba United Compai County	OPERATOR REPRESENTATIVE: Jason Burkey	TYPE OF OPERATION: 112c - Construction Regular Operation	
REASON FOR INSPECTION: Normal I&E Program	BOND CALCULATION TYPE: Complete Bond	BOND AMOUNT: \$432,580.00	
DATE OF COMPLAINT: NA	POST INSP. CONTACTS: None	JOINT INSP. AGENCY: None	
WEATHER: Clear	INSPECTOR'S SIGNATURE:

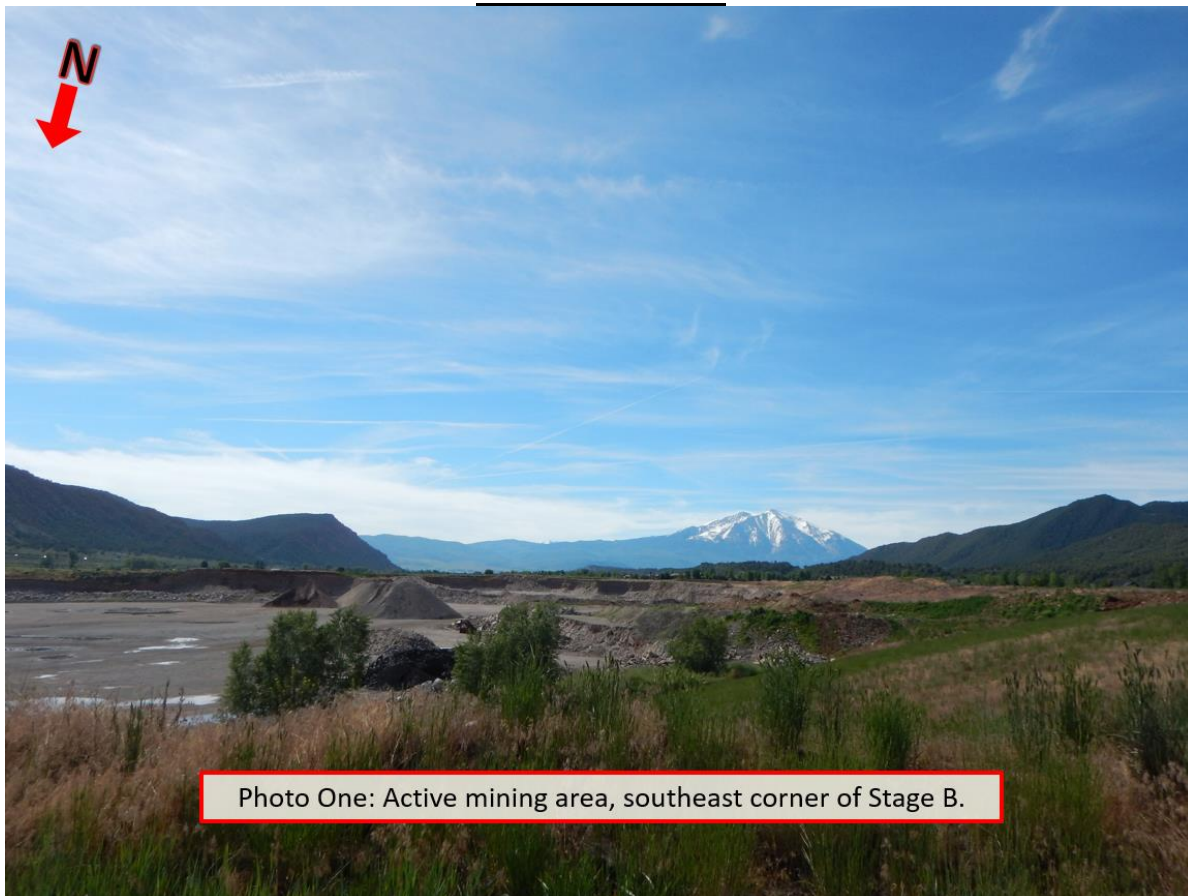
The pit was active at the time of the inspection. Mining is progressing southeast and is approaching Stage C. Under TR-1 the maximum disturbance was set at 65.23 ac of unreclaimed lands. The last annual report indicated that approximate 85 acres have been affected to date, of which only 8 acres have been reclaimed (77 ac affected). This is cited as a problem for failure to follow the approved mining plan. The Operator shall revise the mining plan to increase the total maximum disturbance. Or the operator may demonstrate that areas in Stage A & B have been reclaimed and that less than 65.23 acres requires reclamation.

Photo One: Active mining area, southeast corner of Stage B.

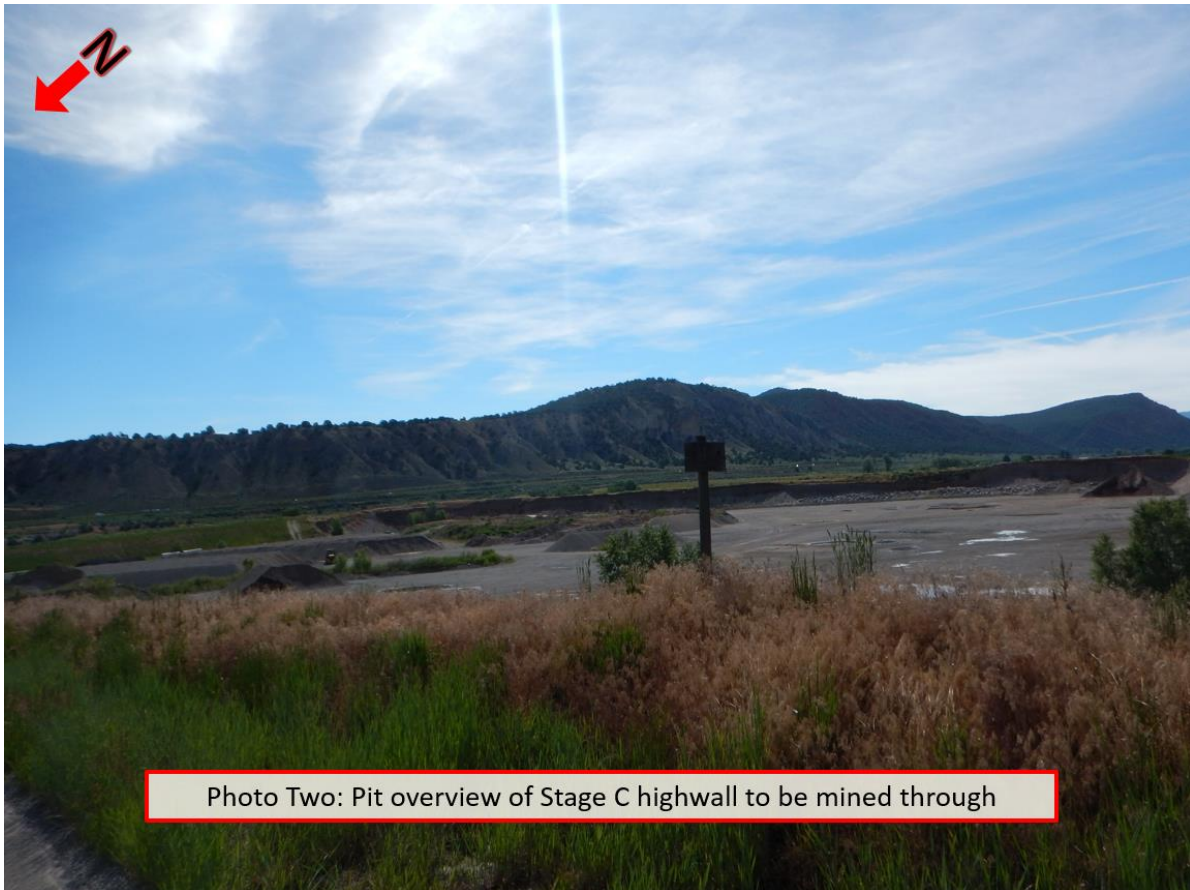
Several pieces of equipment were observed excavating and hauling material. Currently a highwall exists to screen in the pit. The next phase (Stage C) will be to daylight out the remaining highwall. Most highwall excavations are near vertical. Upon final reclamation very little highwall grading will be required due to daylighting. There are several large piles of stockpiled material located throughout the pit floor.

Photo Two: Pit overview of Stage C highwall to be mined through

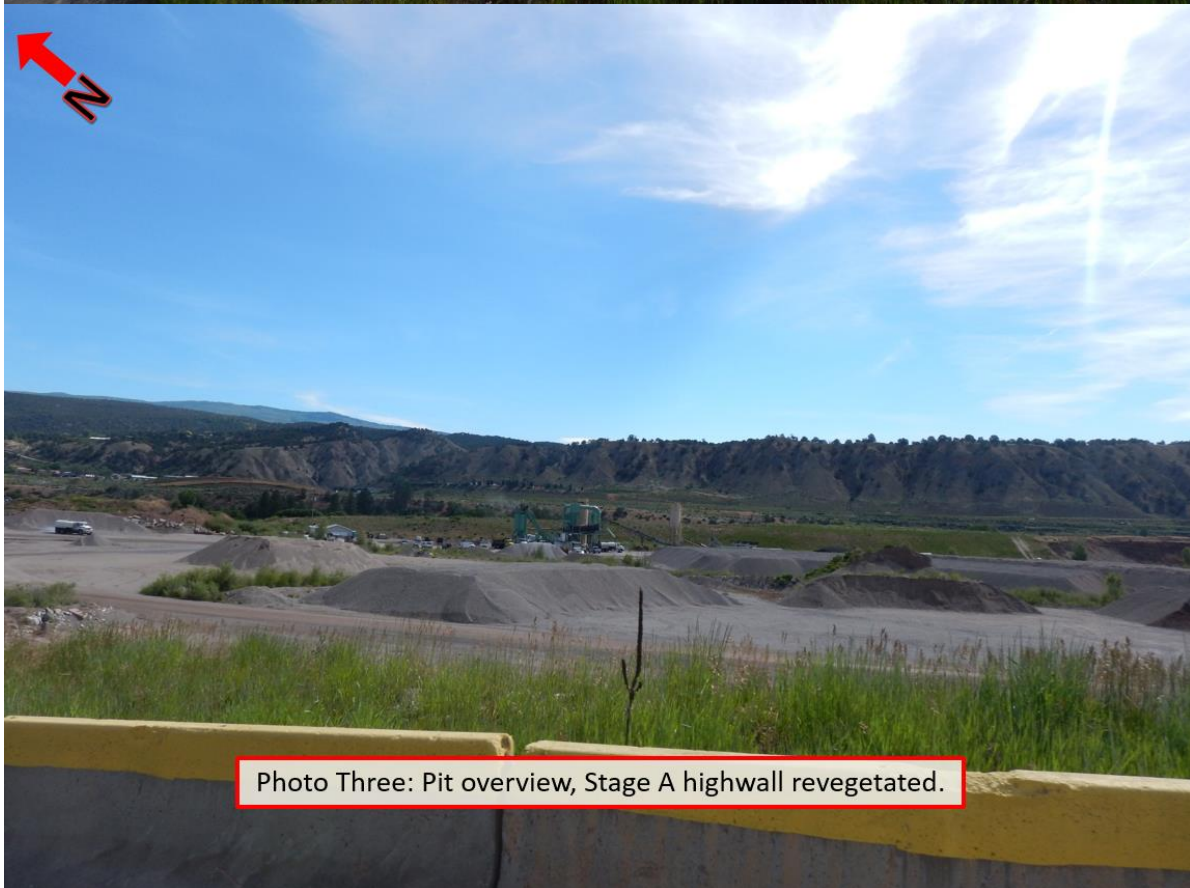
Photo Three: Pit overview, Stage A highwall revegetated.
