**COLORADO**Division of Reclamation,
Mining and Safety

MINERALS PROGRAM INSPECTION REPORT**PHONE: (303) 866-3567**

MINE NAME: Henderson Mine	MINE/PROSPECTING ID#: M-1977-342	MINERAL: Molybdenum	COUNTY: Clear Creek, Grand
INSPECTION TYPE: Monitoring	INSPECTOR(S): Stephanie J. Mitchell	INSP. DATE: May 14, 2019	INSP. TIME: 09:00
OPERATOR: Climax Molybdenum Company	OPERATOR REPRESENTATIVE: Alex Ungers and Aaron Hilshorst	TYPE OF OPERATION: 112d-3 - Designated Mining Operation	
REASON FOR INSPECTION: Normal I&E Program	BOND CALCULATION TYPE: None	BOND AMOUNT: \$37,993,785.00	
DATE OF COMPLAINT: NA	POST INSP. CONTACTS: None	JOINT INSP. AGENCY: None	
WEATHER: Clear	INSPECTOR'S SIGNATURE:

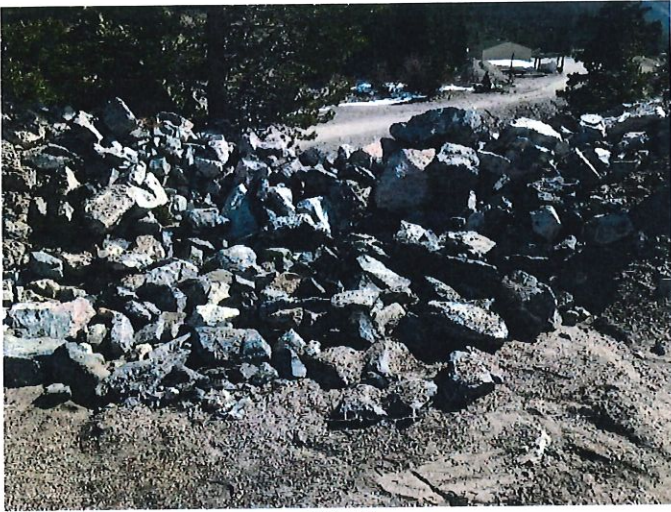
OF-13

The Henderson Mine includes a diversion ditch south of the mine office which diverts water around industrial activities and the primary parking area to the east end of the affected area. Water which flows onto the affected area from the south is captured by a diversion ditch which either routes water to the west and into Butler Gulch or to the east and into the West Fork of Clear Creek. The Diversion ditches were under snow at the time of the inspection. The BMPs used to prevent erosion within the ditches include minimizing impacts to existing vegetation as well as rock check dams. Water channels which are designed for flows in excess of 2 feet per second contain a suitable bedding 6" in depth. All surface and stormwater diversions were free of obstructions and the BMPs were functioning as designed. In addition, the Division and Henderson staff also visited the fourteen outfalls at the mine. All of the outfalls were free of obstructions.

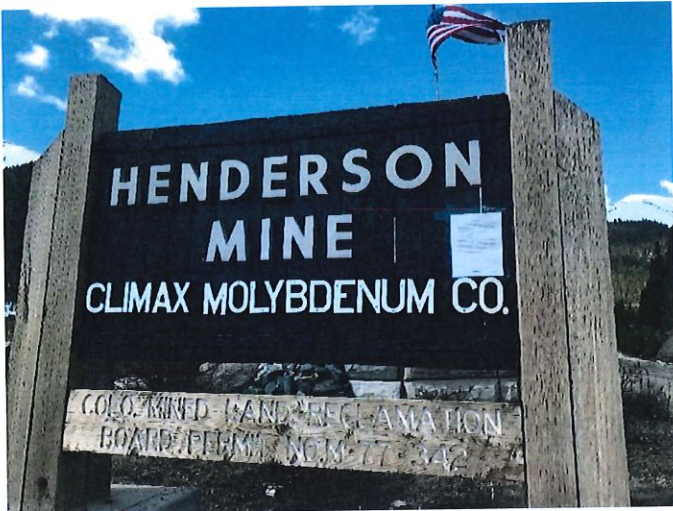
The inspection commenced with a meeting to during which the following topics were discussed: the surface and stormwater control features at the Henderson Mine and Amendment 07, which the Division received on May 9, 2019. The AM07 Public Notice Sign was posted at the entrance to the mine site.

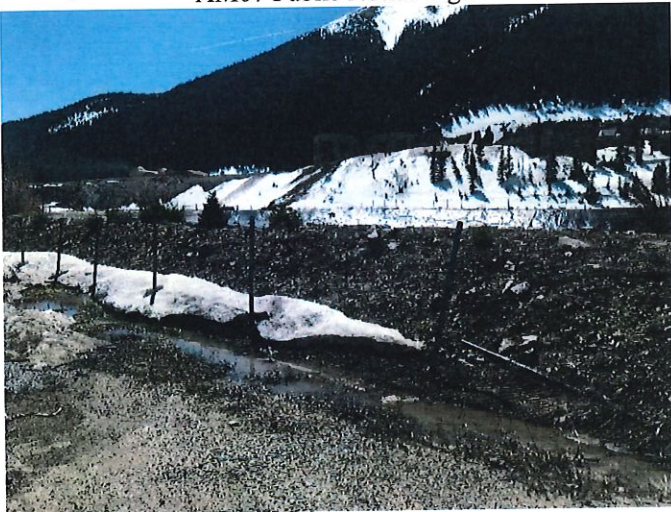
Fencing at 1.2 Pond

The fence around 1.2 pond is going to be fixed in the near future according to Henderson Staff. It has been in need of repair for some time. Division staff will inspect the fencing at the next scheduled inspection in late July.

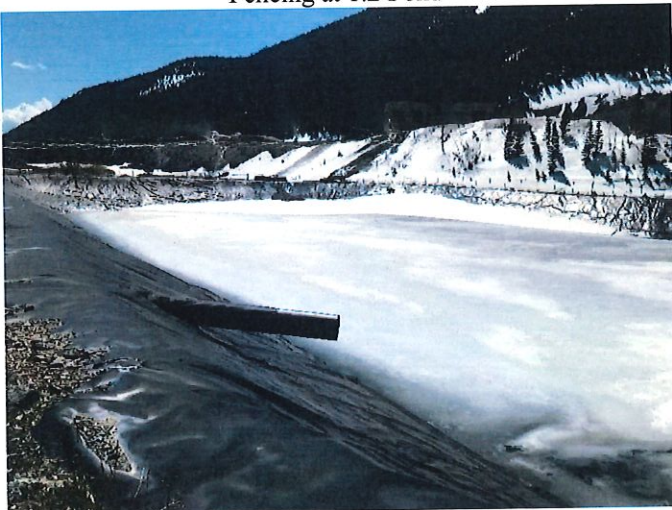
Liner in good condition at 1.2 pond
