**MINERALS PROGRAM INSPECTION REPORT**  
**PHONE: (303) 866-3567**

<b>MINE NAME:</b> Deer Trail Pit	<b>MINE/PROSPECTING ID#:</b> M-1988-090	<b>MINERAL:</b> Sand and gravel	<b>COUNTY:</b> Arapahoe
<b>INSPECTION TYPE:</b> Monitoring	<b>INSPECTOR(S):</b> Patrick Lennberg	<b>INSP. DATE:</b> July 2, 2019	<b>INSP. TIME:</b> 12:00
<b>OPERATOR:</b> 5A Aggregate LLC	<b>OPERATOR REPRESENTATIVE:</b> Chad Hrbek and Don Fort	<b>TYPE OF OPERATION:</b> 112c - Construction Regular Operation	
<b>REASON FOR INSPECTION:</b> Normal I&E Program	<b>BOND CALCULATION TYPE:</b> None	<b>BOND AMOUNT:</b> \$32,702.00	
<b>DATE OF COMPLAINT:</b> NA	<b>POST INSP. CONTACTS:</b> None	<b>JOINT INSP. AGENCY:</b> None	
<b>WEATHER:</b> Clear	<b>INSPECTOR'S SIGNATURE:</b>

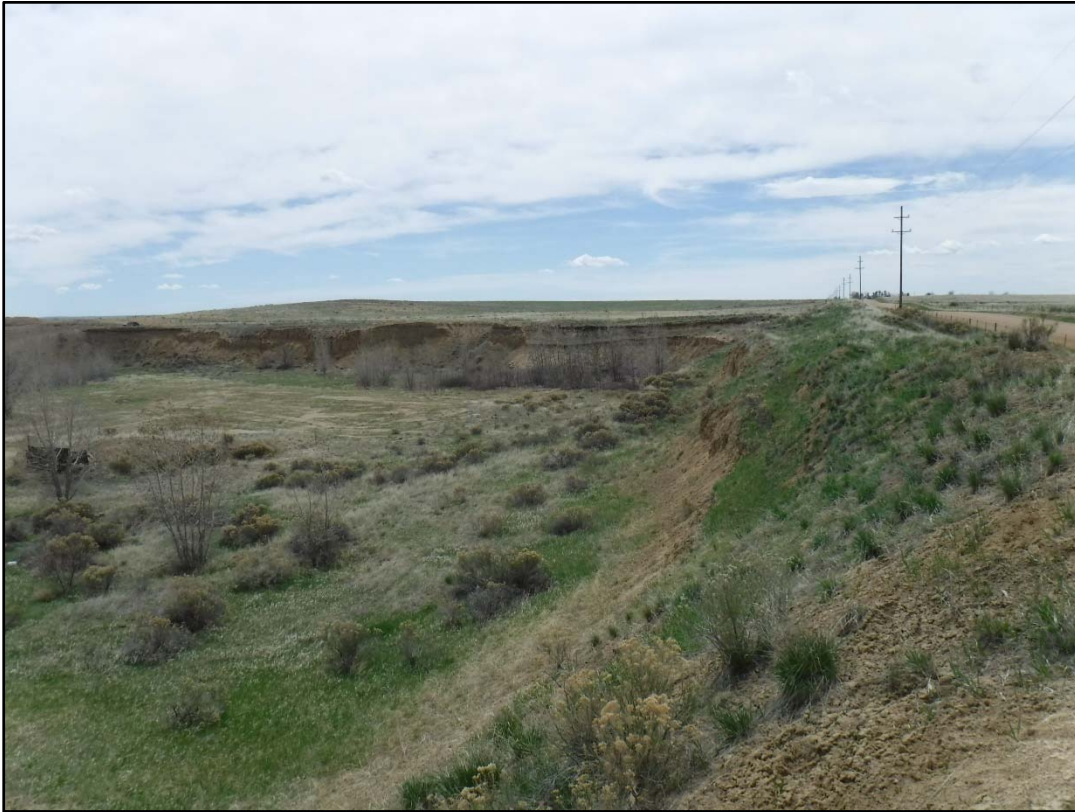
**Photo 1:** Highwall along County Road 213 looking south (April 29, 2019)

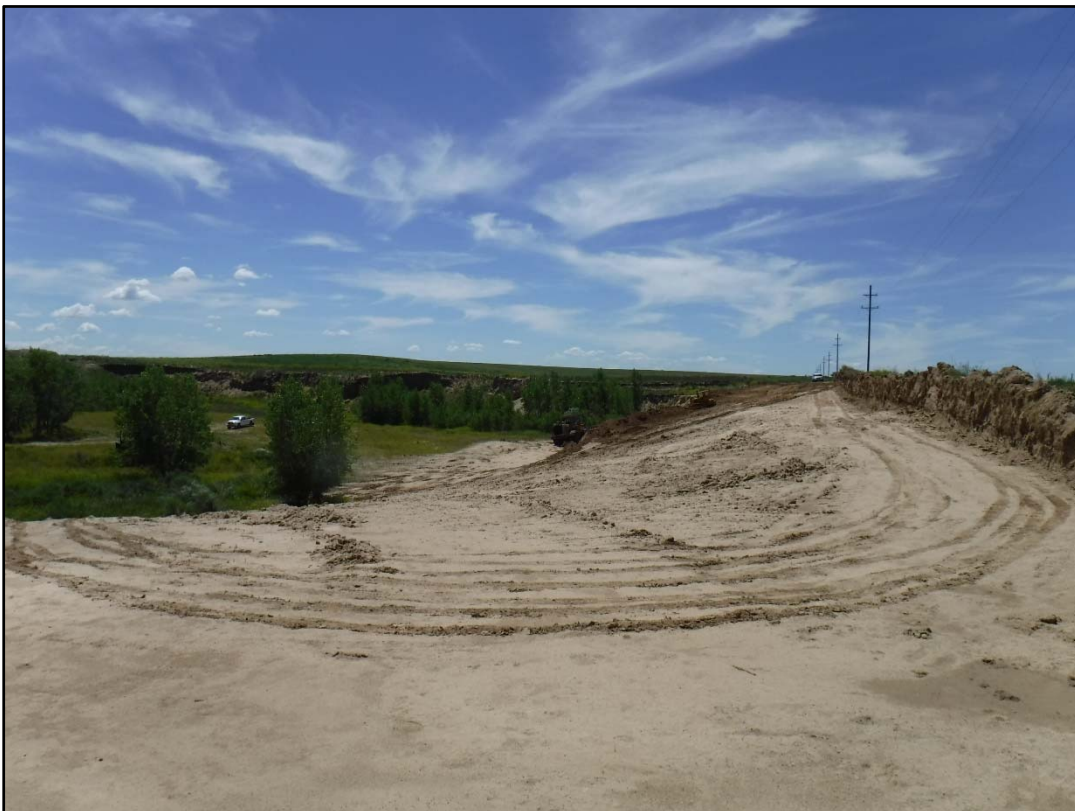
As mentioned earlier this inspection was performed to determine the progress of the backfilling and reclamation. The Operator has backfilled the highwall along the County Road 213 to a 3H:1V slope or shallower. During the backfilling they were able to maintain a run on/off control berm at the top of what was the highwall. They plan on installing a swale or two along the slope to help mitigate any erosion that might begin before vegetation can be established. Once the highwall grading is complete they will move to an area in the southeast corner of the pit to grade out another area that has exposed highwalls that are not part of the mining face.

**Photo 2:** Highwall along County Road 213 looking south (July 2, 2019)

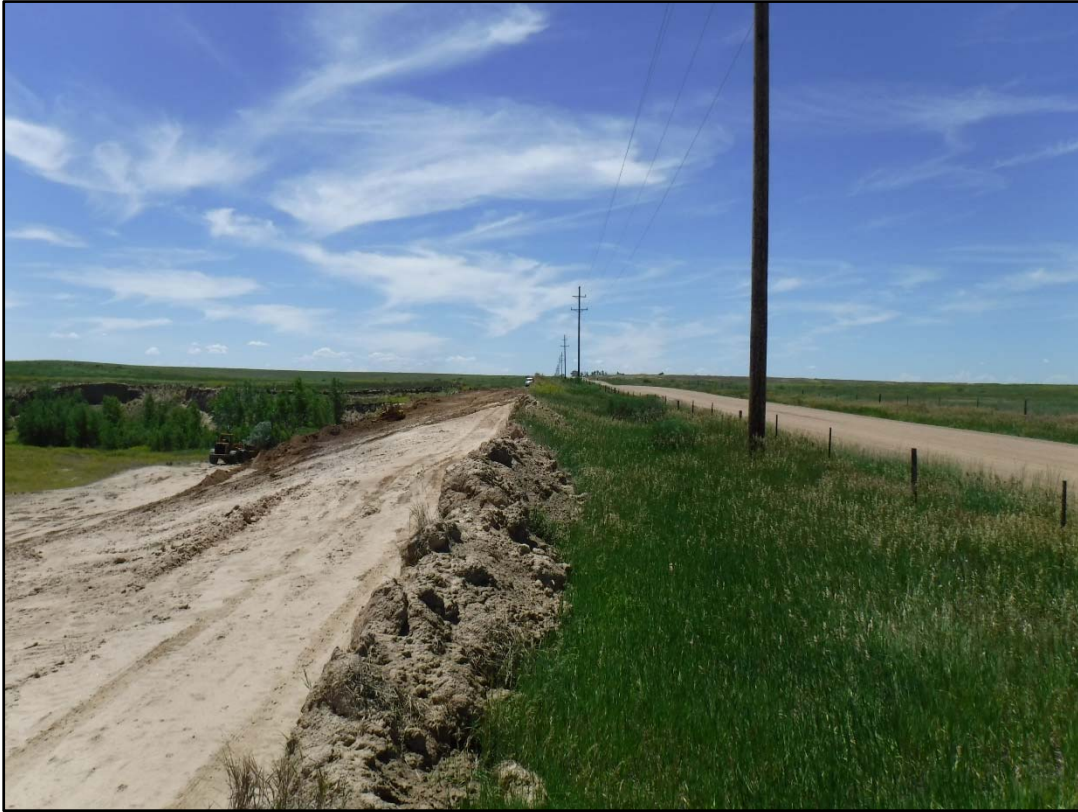
**Photo 3:** Highwall along County Road 213 looking south (July 2, 2019)

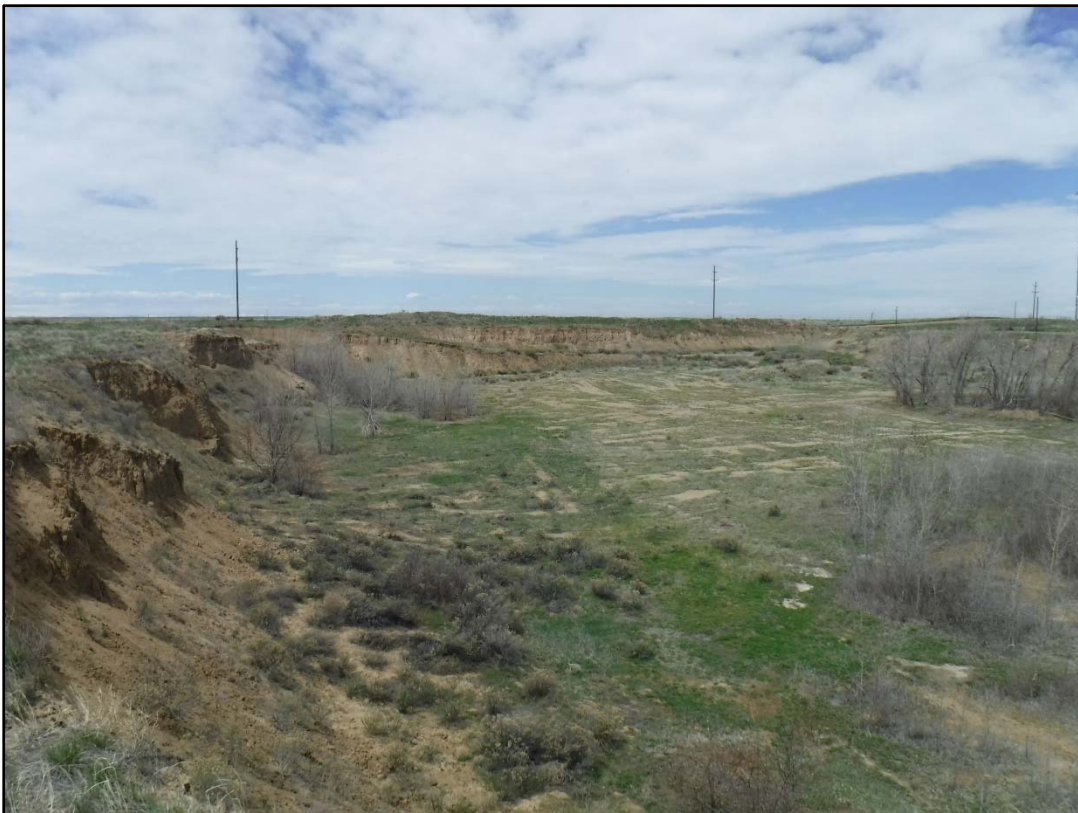
**Photo 4:** Looking west across the pit at the highwall along the county road (April 29, 2019)

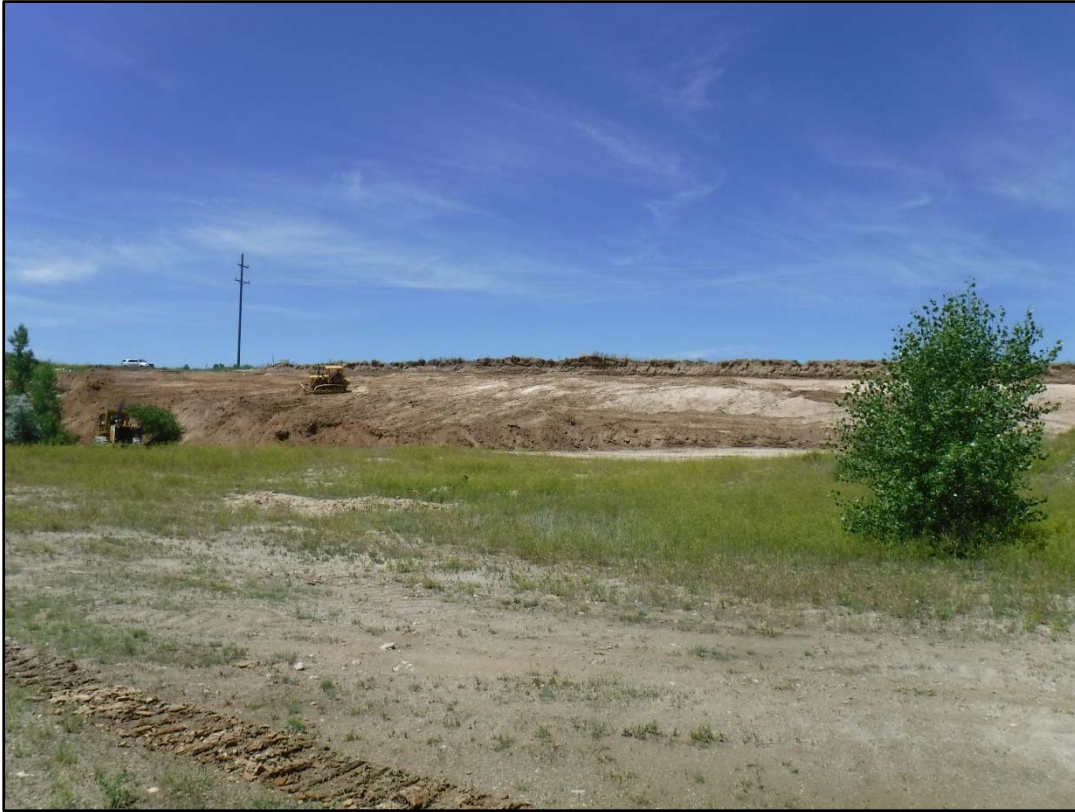
**Photo 5:** Looking west, mid-pit area, at the highwall along the county road (July 2, 2019)

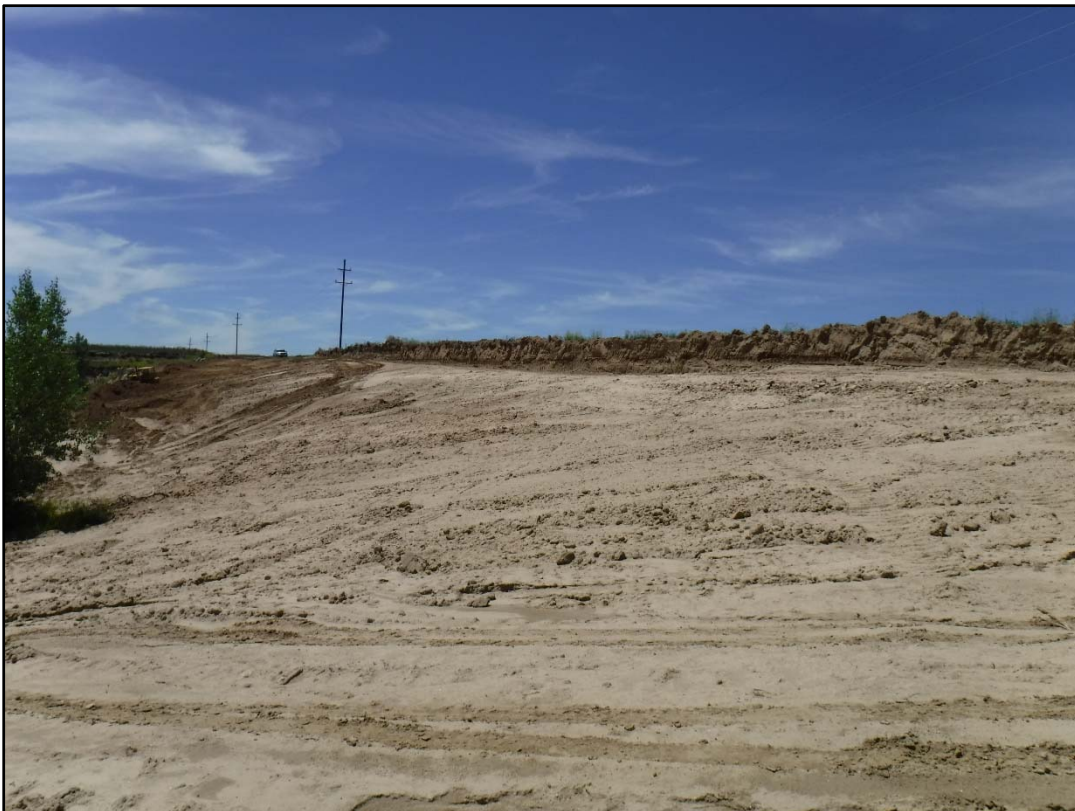
**Photo 6:** Looking south along the backfilled area from the northeast toe of slope
