**MINERALS PROGRAM INSPECTION REPORT**  
**PHONE: (303) 866-3567**

<b>MINE NAME:</b> South Fork Gravel Pit (aka Williams Fork)	<b>MINE/PROSPECTING ID#:</b> M-2006-029	<b>MINERAL:</b> Sand and gravel	<b>COUNTY:</b> Grand
<b>INSPECTION TYPE:</b> Monitoring	<b>INSPECTOR(S):</b> Peter S. Hays	<b>INSP. DATE:</b> July 9, 2019	<b>INSP. TIME:</b> 13:30
<b>OPERATOR:</b> Grand County	<b>OPERATOR REPRESENTATIVE:</b> Chris Baer, Micah Benson	<b>TYPE OF OPERATION:</b> 110c - Construction Limited Impact	
<b>REASON FOR INSPECTION:</b> Normal I&E Program	<b>BOND CALCULATION TYPE:</b> None	<b>BOND AMOUNT:</b> No Bond Held	
<b>DATE OF COMPLAINT:</b> NA	<b>POST INSP. CONTACTS:</b> None	<b>JOINT INSP. AGENCY:</b> None	
<b>WEATHER:</b> Clear	<b>INSPECTOR'S SIGNATURE:</b>

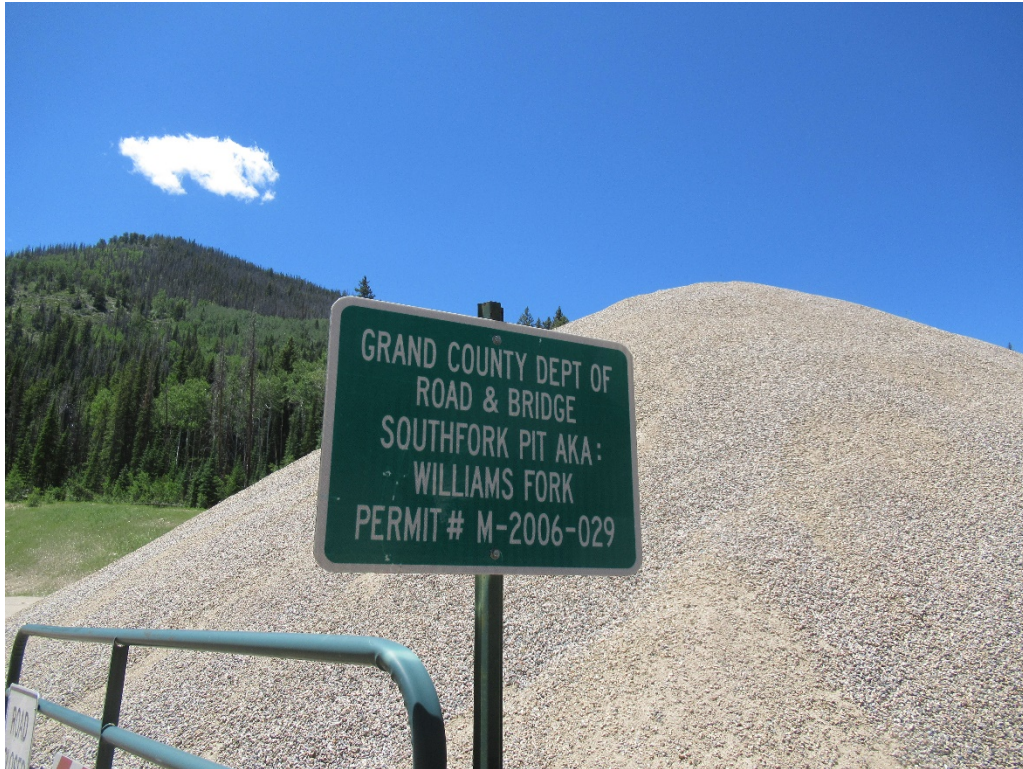
South Fork Pit mine sign

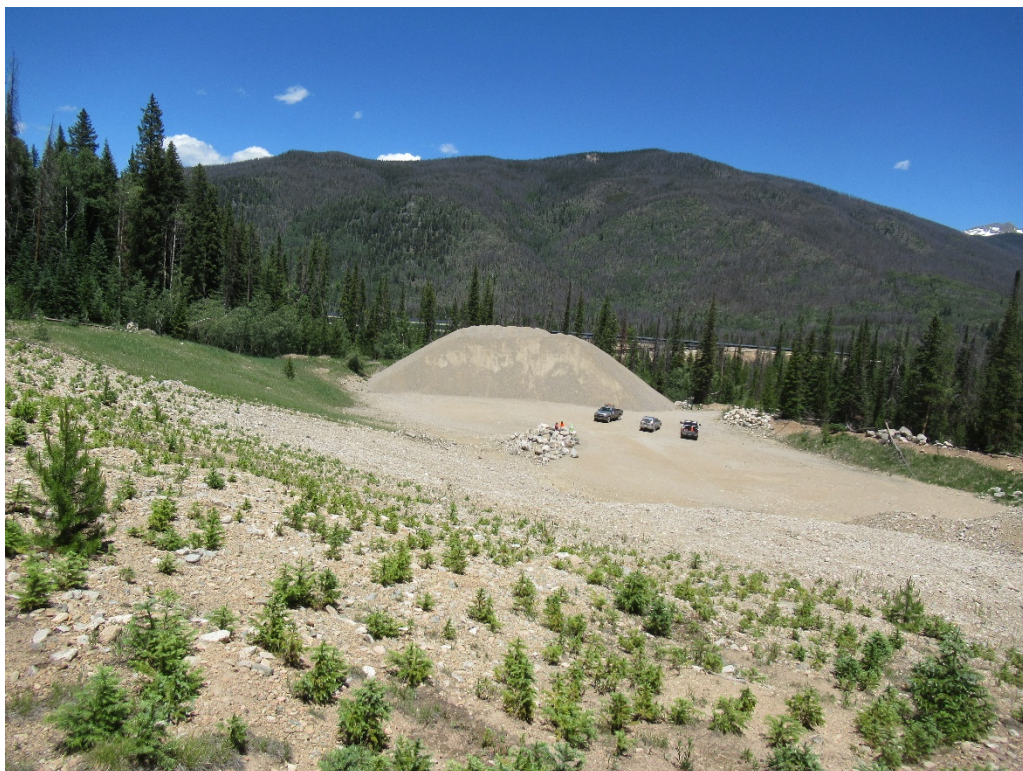
View of site from the southwest corner looking north

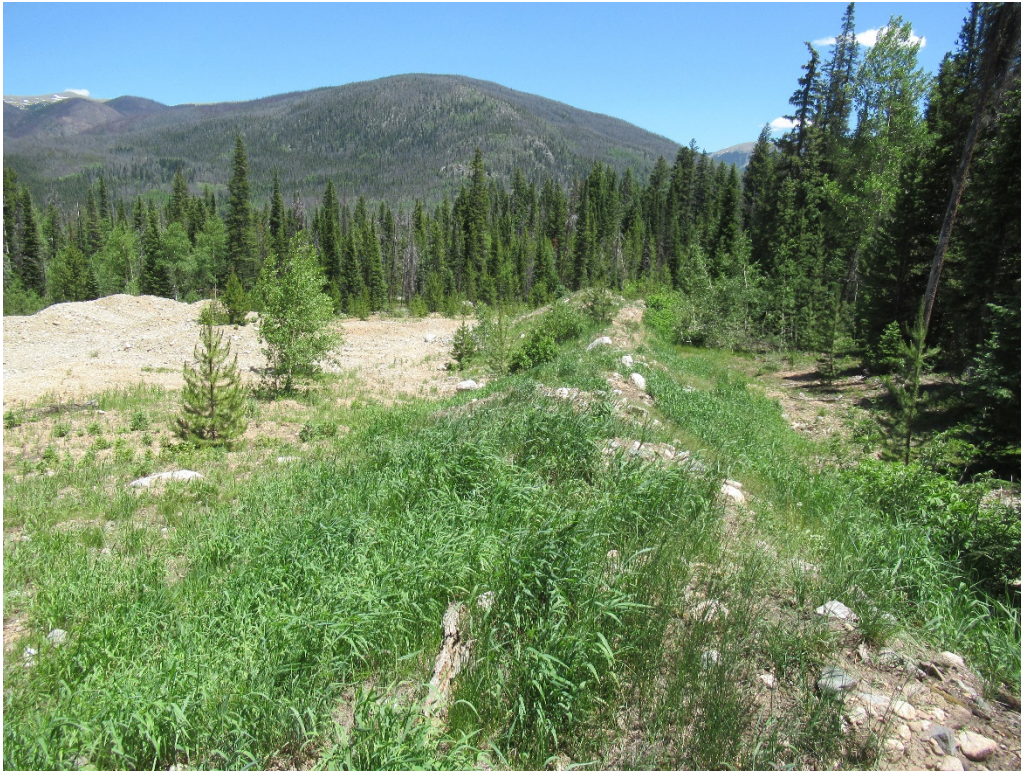
Topsoil berm located along the south boundary

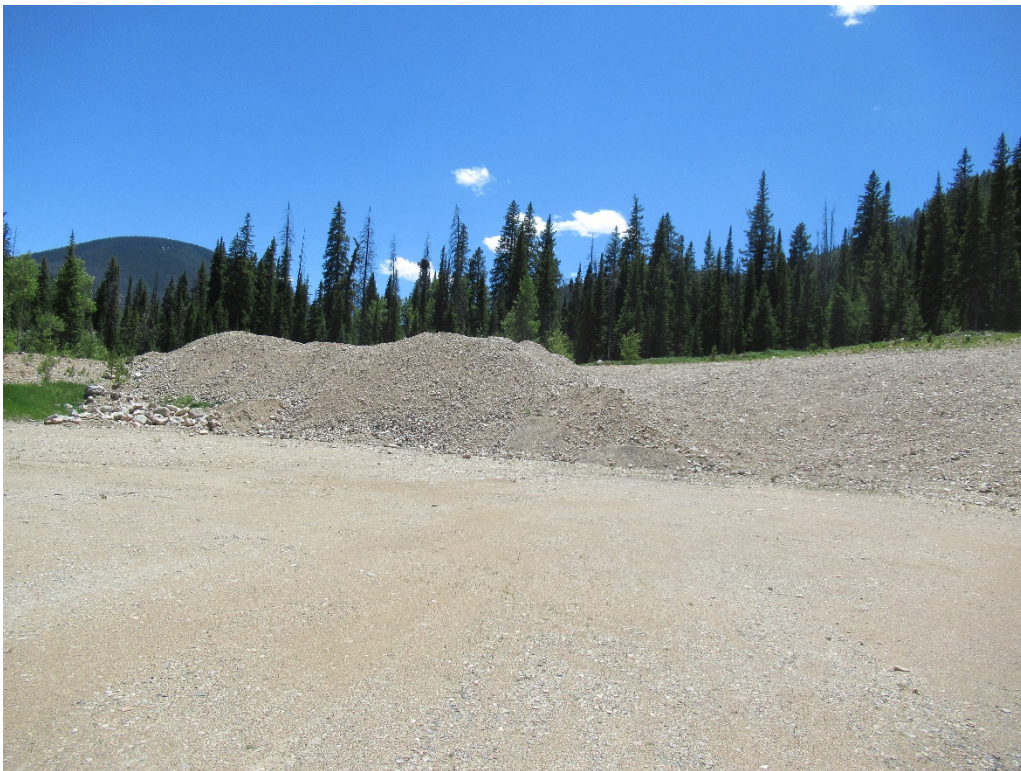
View of the remaining area to be mined from the pit floor looking south

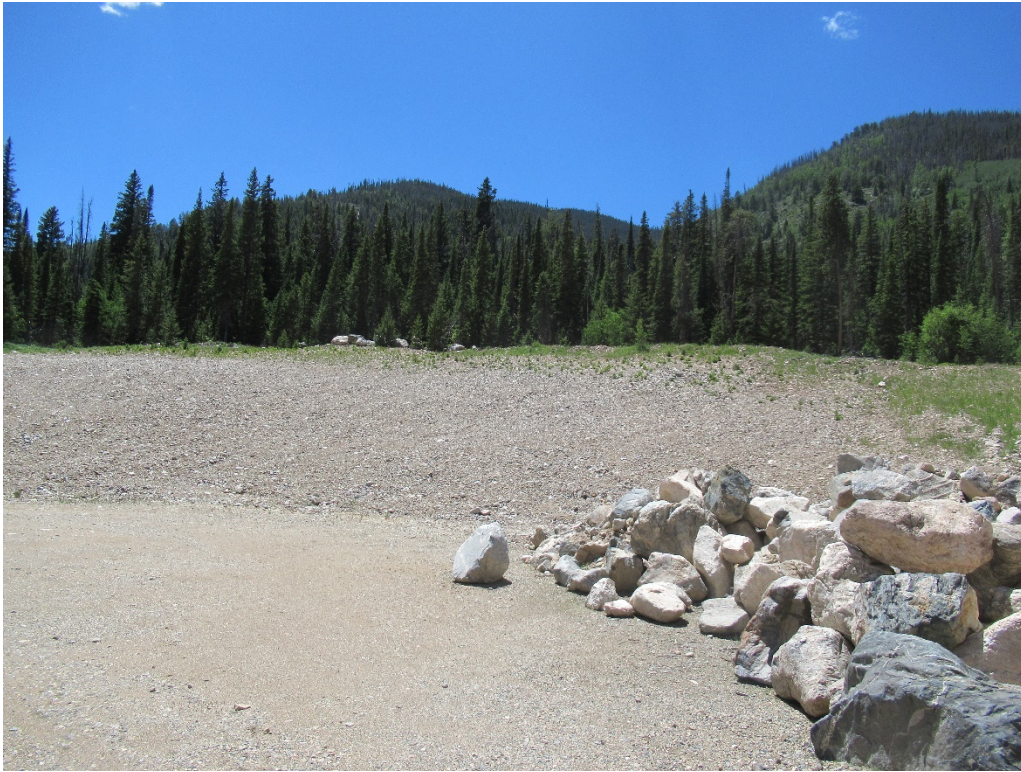
The approved post-mining land use for the site is recreation. The western slope has been regraded to the final 3H:1V slope. The site is approved for a maximum reclamation slope of 2H:1V. The northern portion of the slope is revegetated with grasses. Topsoil stockpiles were located along the perimeter of the site adjacent to the permit boundary. The approved Reclamation Plan states 3 to 6 inches of topsoil will be replaced during final reclamation. The Operator stated topsoil may need to be imported to complete reclamation of the site in the future.

View of regraded western slope

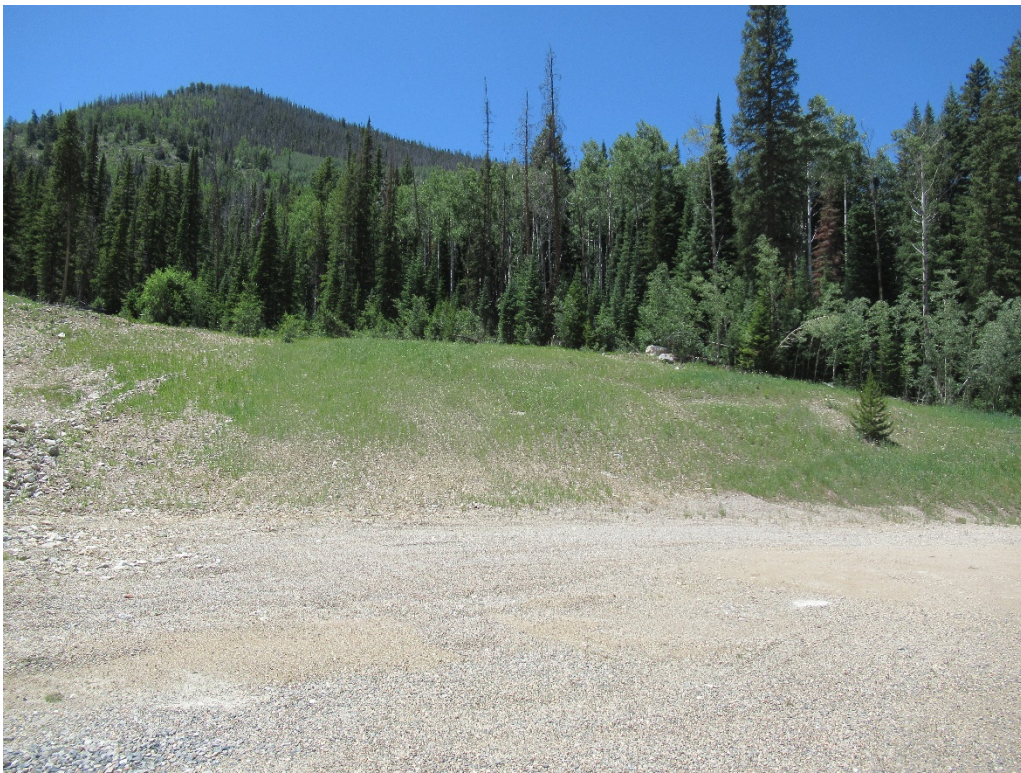
View of the regraded and vegetated slope in the northwest corner of the site
