MINERALS PROGRAM INSPECTION REPORT

MINE NAME: CR #3 Pit	MINE/PROSPECTING ID#: M-2009-064	MINERAL: Gravel and sand	COUNTY: Grand
INSPECTION TYPE: Monitoring	INSPECTOR(S): Peter S. Hays	INSP. DATE: July 9, 2019	INSP. TIME: 12:30
OPERATOR: Grand County	OPERATOR REPRESENTATIVE: Chris Baer, Micah Benson	TYPE OF OPERATION: 112c - Construction Regular Operation

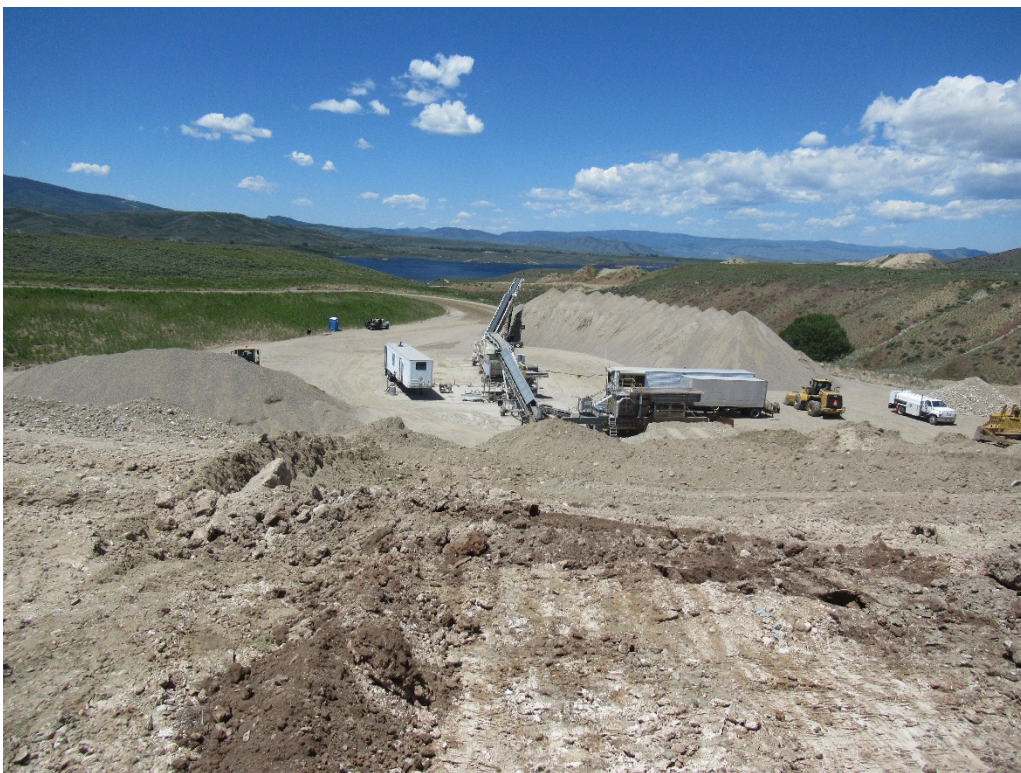
View of processing activity from the active highwall looking northwest

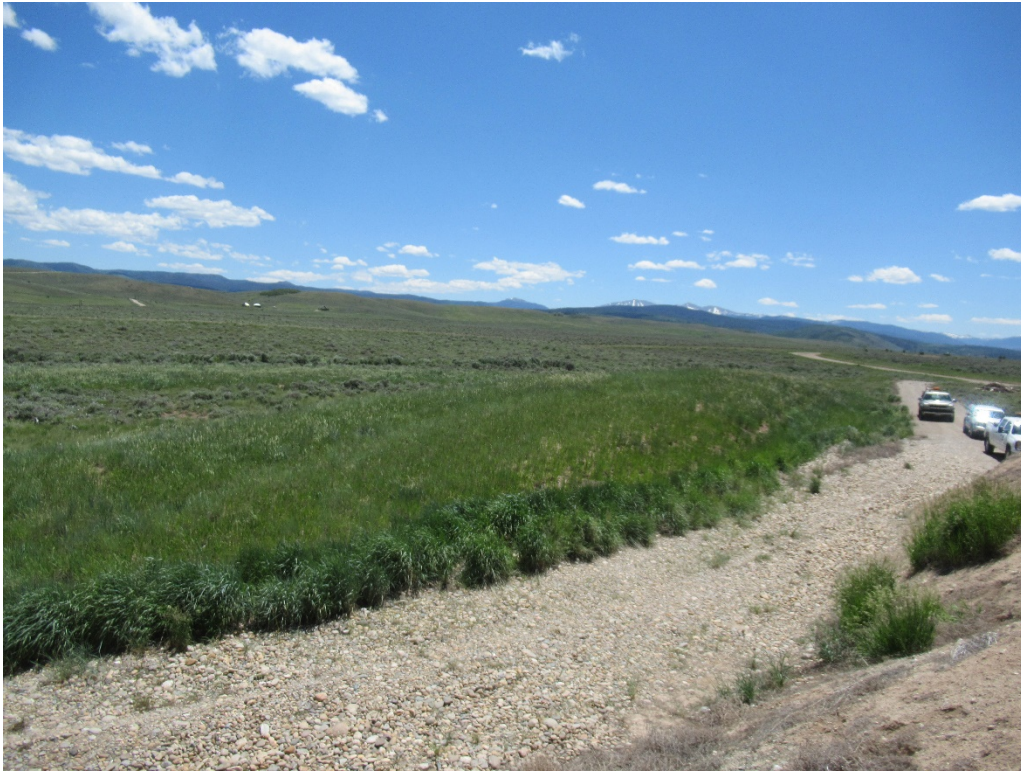
The approved post-mining land use for the site is rangeland. The topsoil stockpiles located southwest and east of the pit were well-vegetated and stable. The overburden (clay) stockpiles observed during the last inspection were used by the Operator to mix into the mined sand and gravel to produce road base. The Operator stated the topsoil stockpile located east of the current highwall would be moved to the east fence line to allow the highwall excavation to proceed to the east. The Operator stated the site was sprayed for noxious weeds the prior week. Evidence of weed control methods were observed during the inspection.

View of well-vegetated topsoil stockpile located east of the pit,
to be moved to the fence line

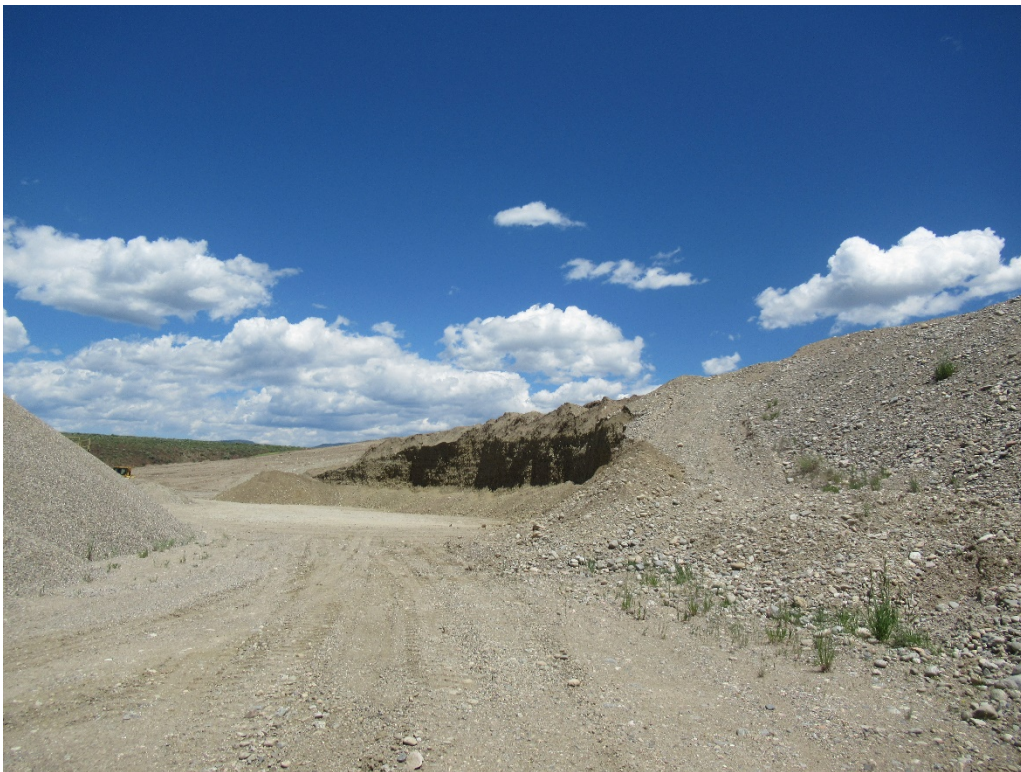
View of temporarily sloped, active and future highwall from the south end looking north

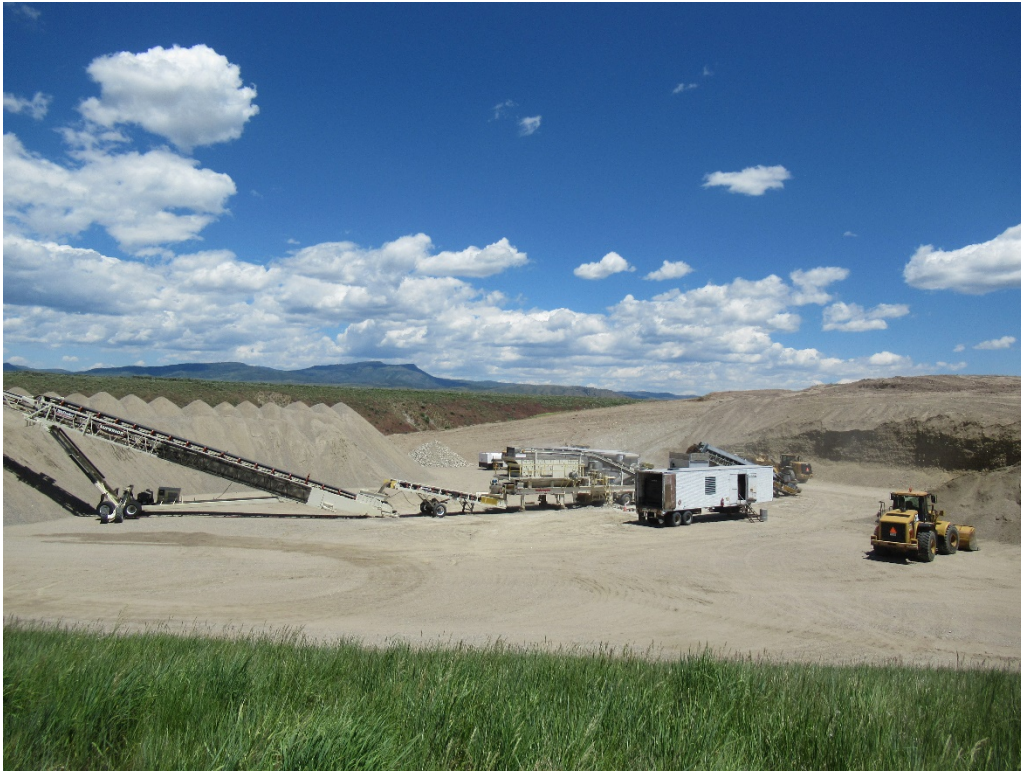
View of the mining activity from the west side looking east

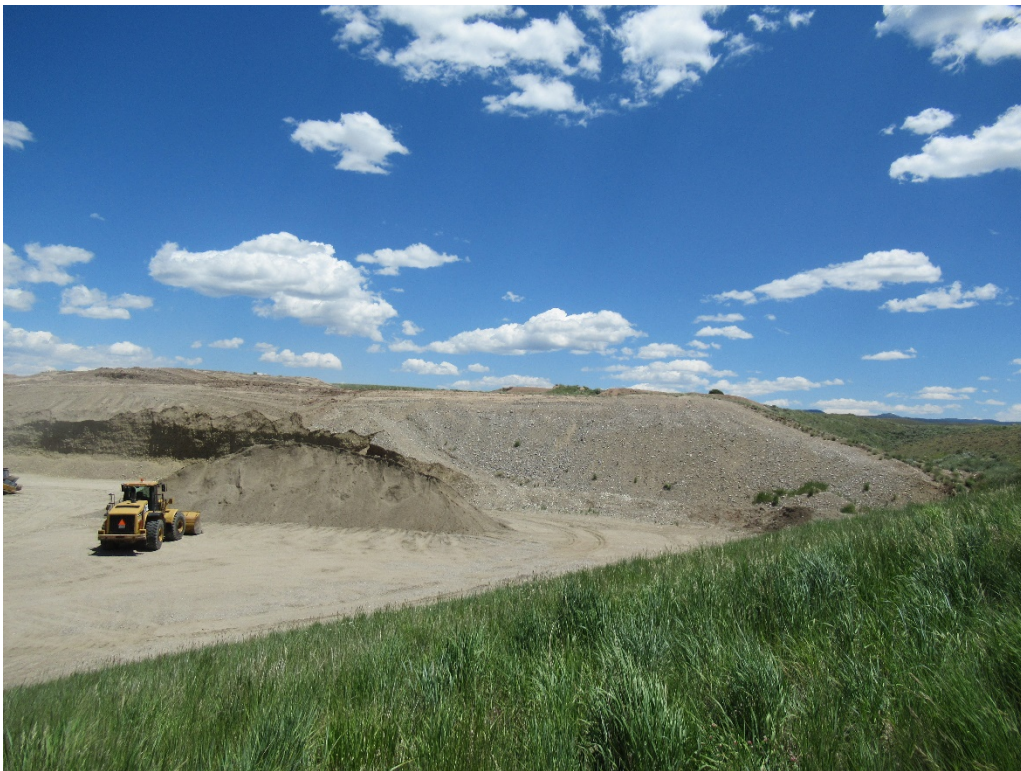
View of the mining activity from the west side looking southeast

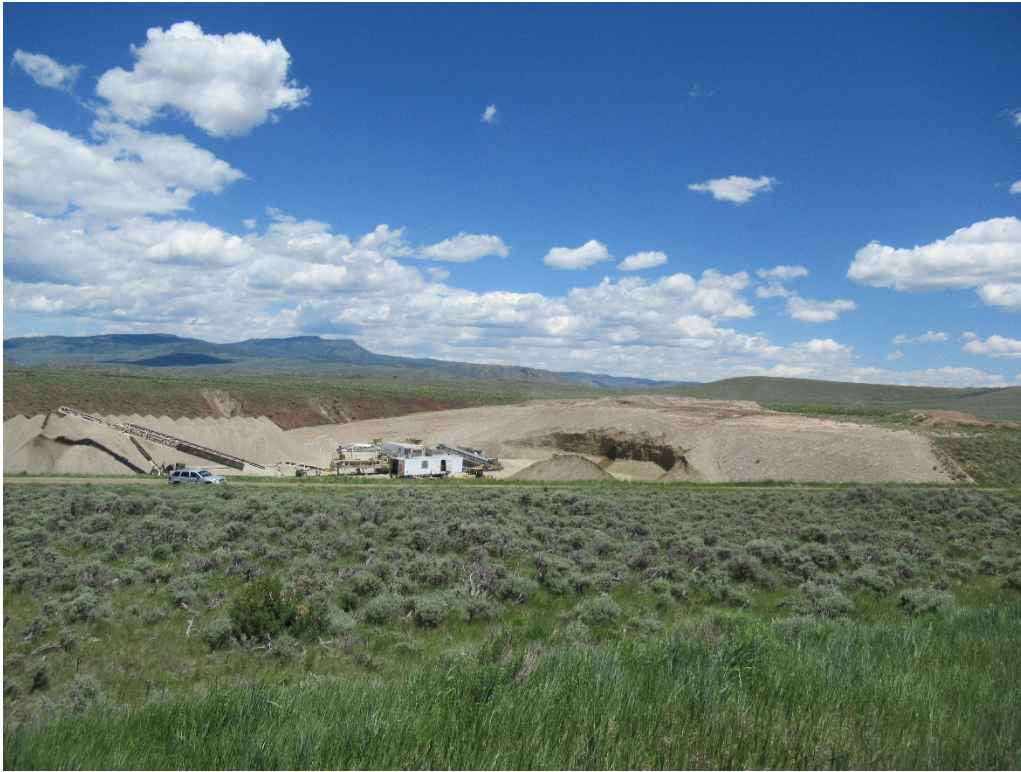
View of the site from the southwest topsoil stockpile looking east
