**MINERALS PROGRAM INSPECTION REPORT**  
**PHONE: (303) 866-3567**

<b>MINE NAME:</b> Western Slope Flagstone Quarry No. 2	<b>MINE/PROSPECTING ID#:</b> M-1996-076	<b>MINERAL:</b> Gravel	<b>COUNTY:</b> Mesa
<b>INSPECTION TYPE:</b> Monitoring	<b>INSPECTOR(S):</b> Amy C. Yeldell	<b>INSP. DATE:</b> July 9, 2019	<b>INSP. TIME:</b> 18:00
<b>OPERATOR:</b> Rudolph Fontanari	<b>OPERATOR REPRESENTATIVE:</b> None	<b>TYPE OF OPERATION:</b> 112c - Construction Regular Operation	
<b>REASON FOR INSPECTION:</b> High Priority	<b>BOND CALCULATION TYPE:</b> None	<b>BOND AMOUNT:</b> \$88,251.00	
<b>DATE OF COMPLAINT:</b> NA	<b>POST INSP. CONTACTS:</b> None	<b>JOINT INSP. AGENCY:</b> State Engr. (Water Resources)	
<b>WEATHER:</b> Clear	<b>INSPECTOR'S SIGNATURE:</b>

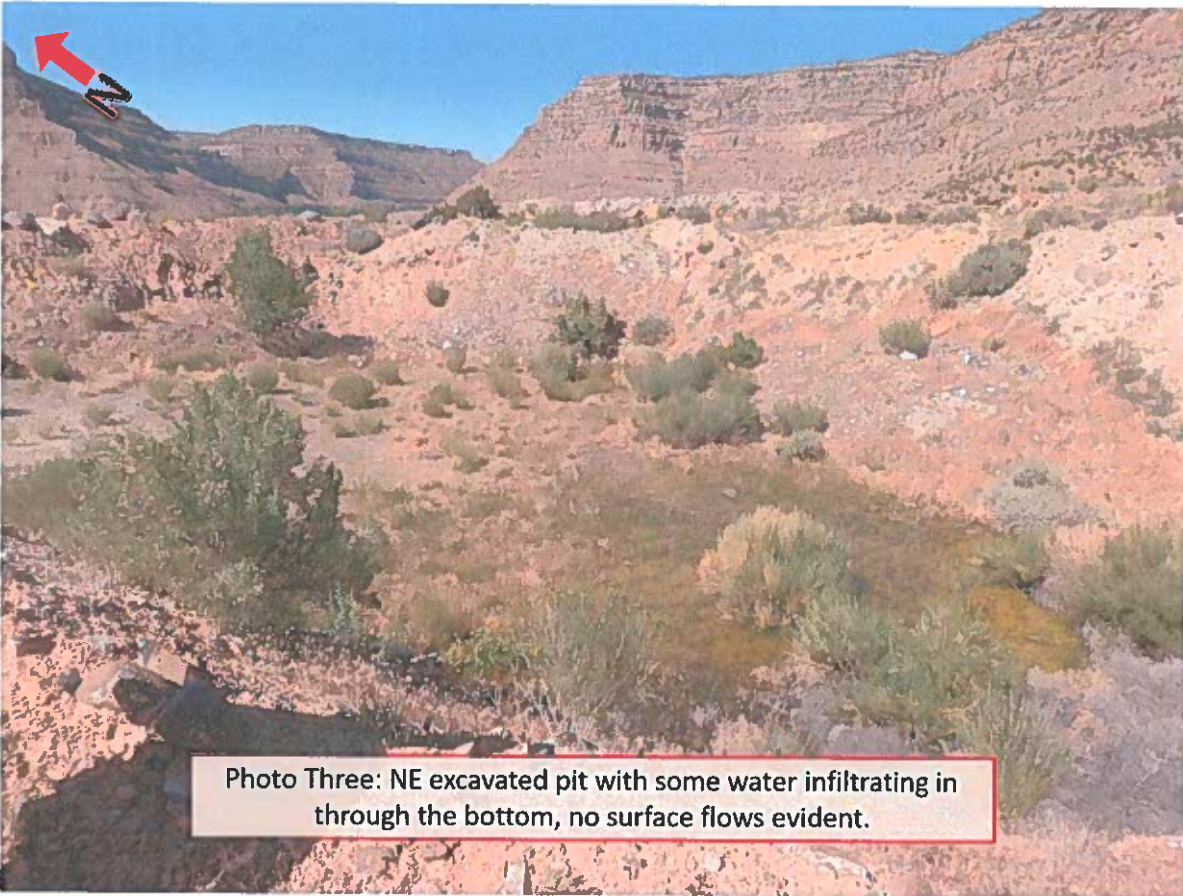
The second pit is located on the east side of the northern permit area. Historically this pit has also been dry. This pit too had water in the bottom. Water levels in the east pit were estimated to be only a few feet in depth. Due to the high porosity of the soils, connectivity between the two pits rather than direct surface flows is highly probable.

Photo Three: NE excavated pit with some water infiltrating in through the bottom, no surface flows evident.

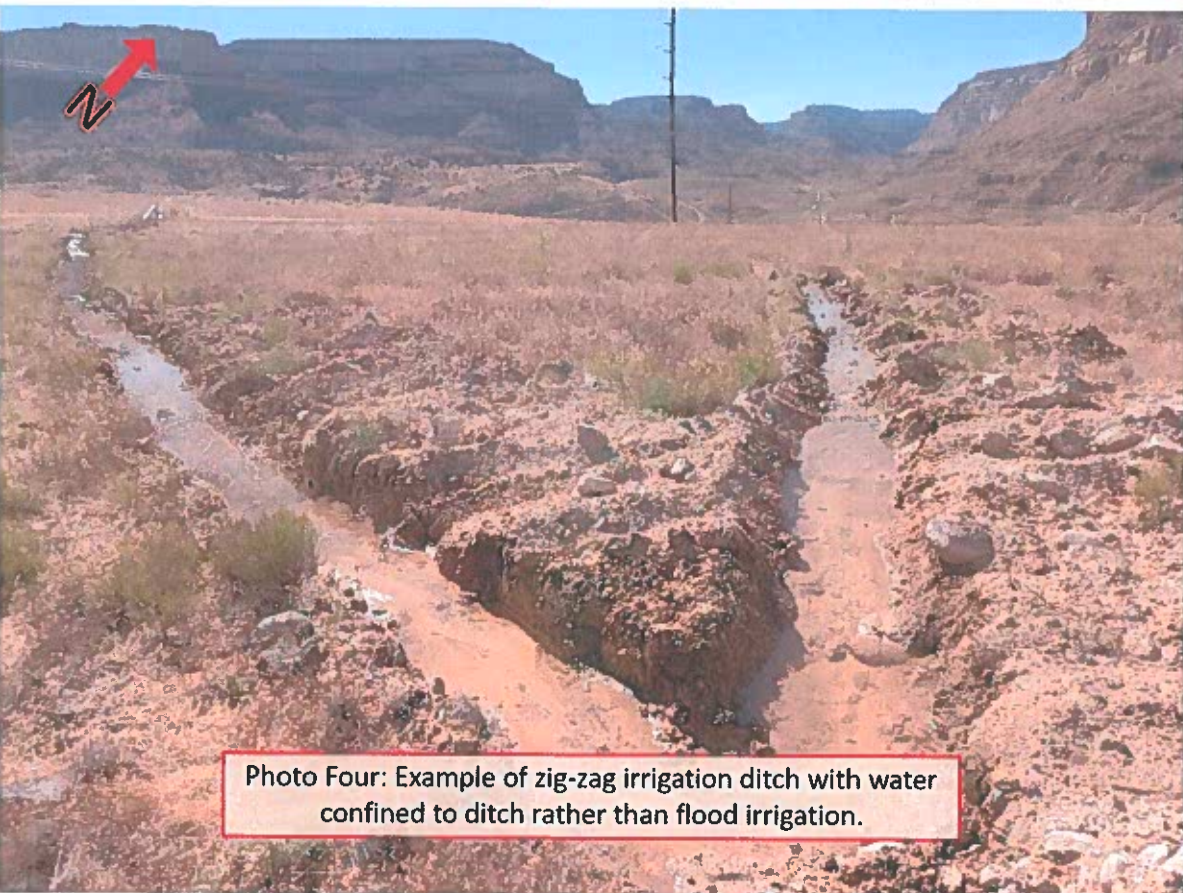
West of the affected lands within the permit boundary the Division observed several alleged "irrigation" ditches being utilized. Water was supplied via a buried pipe where it was then brought to surface and allowed to flow in a zig-zag pattern along the surface. In most areas water appeared to be confined to the ditches rather than flood irrigating the surface. In several instances water 'disappeared' subsurface leaving holes of varying sized. In other areas soil sloughing or collapses were observed with the saturated soils visible by a distinct dark patches. This activity does not appear to be in support of the mining operation and is contrary to the conditions of a permit. The approved mine and reclamation plans are conditions of the approved permit. Neither plan is approved for water storage retention either for irrigation or stormwater. Reclamation plans do not cite irrigation as a method to establish reclamation.

Photo Four: Example of zig-zag irrigation ditch with water confined to ditch rather than flood irrigation.

**CORRECTIVE ACTIONS:** A Cease and Desist Order is attached. The Operator shall immediately cease irrigation activities within the approved permit boundaries upon receipt of this report.
