**COLORADO**Division of Reclamation,
Mining and Safety

MINERALS PROGRAM INSPECTION REPORT**PHONE: (303) 866-3567**

MINE NAME: Walker Pit North	MINE/PROSPECTING ID#: M-1984-140	MINERAL: Sand and gravel	COUNTY: Prowers
INSPECTION TYPE: Monitoring	INSPECTOR(S): Amy Eschberger	INSP. DATE: March 26, 2019	INSP. TIME: 16:00
OPERATOR: Prowers County	OPERATOR REPRESENTATIVE: Mark Dorenkamp	TYPE OF OPERATION: 110c - Construction Limited Impact	
REASON FOR INSPECTION: Normal I&E Program	BOND CALCULATION TYPE: None	BOND AMOUNT: \$0.00	
DATE OF COMPLAINT: NA	POST INSP. CONTACTS: None	JOINT INSP. AGENCY: None	
WEATHER: Clear	INSPECTOR'S SIGNATURE:

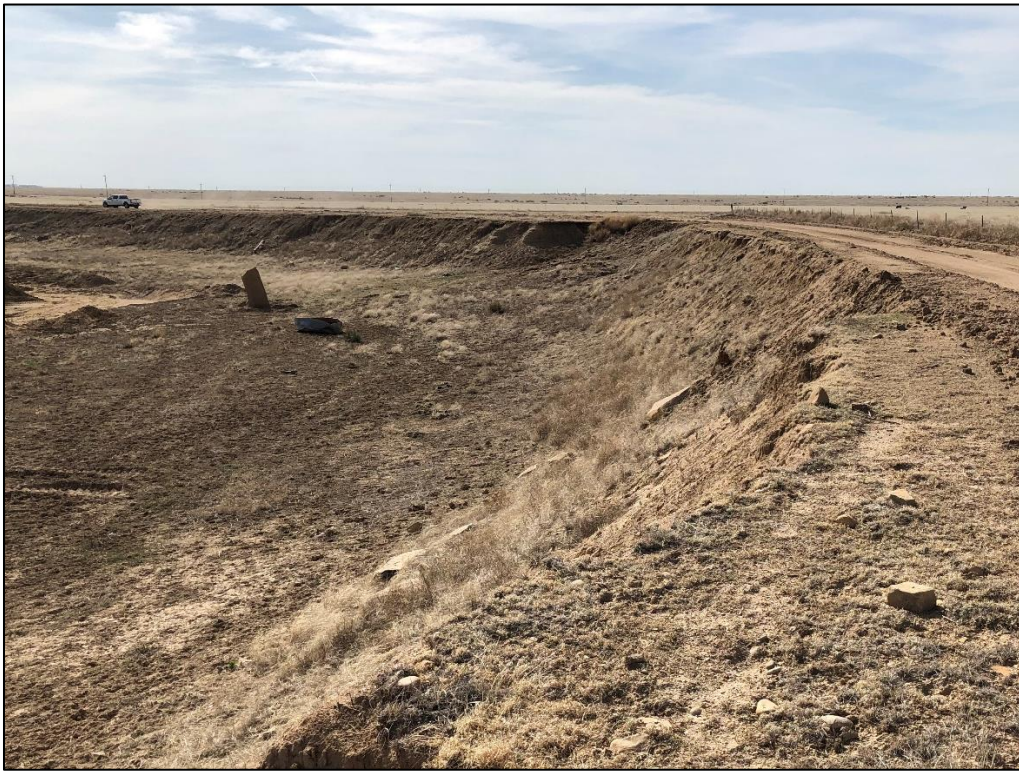
Photo 1. View looking southwest across old meander bank, not included in approved permit area (pit disturbance at far left).

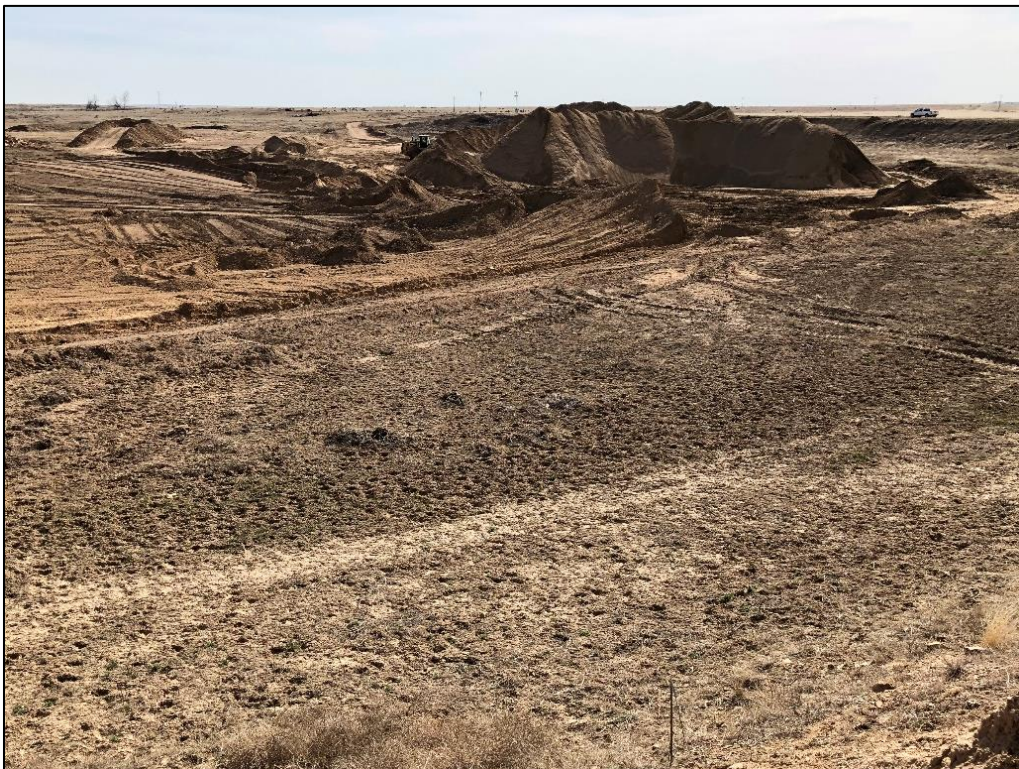
Photo 2. View looking south across pit from top of meander bank, showing several material stockpiles stored on pit floor.

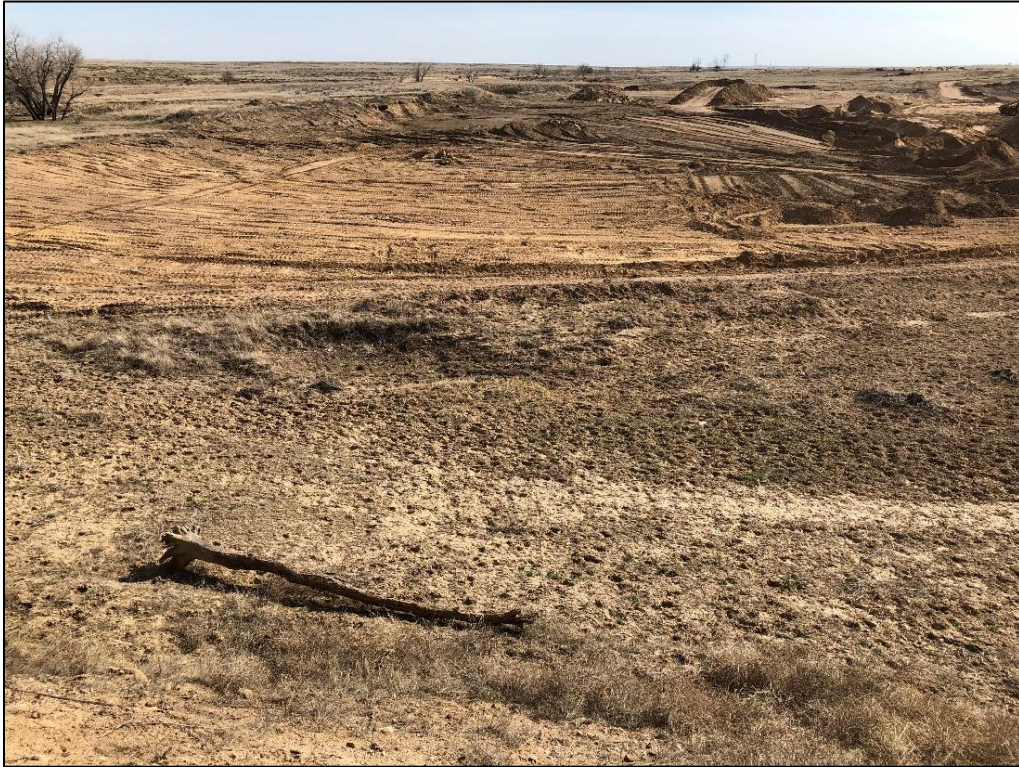
Photo 3. View looking southeast across excavated area at northeastern edge of pit (in background), with slopes graded nearly flat.

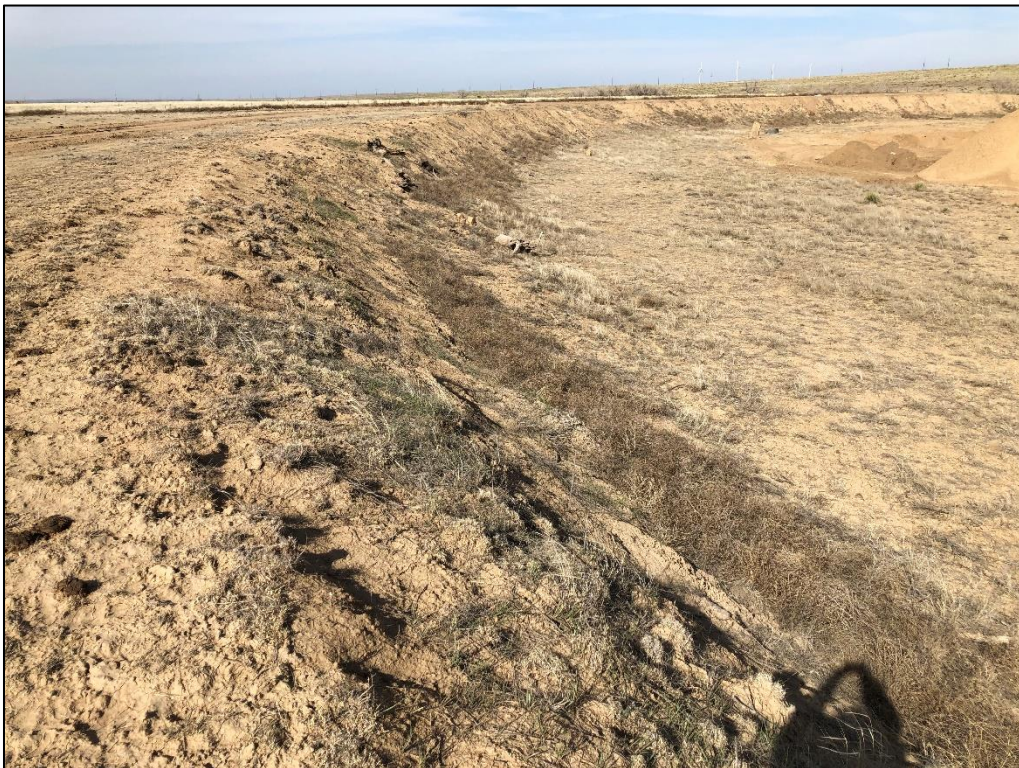
Photo 4. View looking north across old meander bank, not included in approved permit area (pit disturbance at far right).

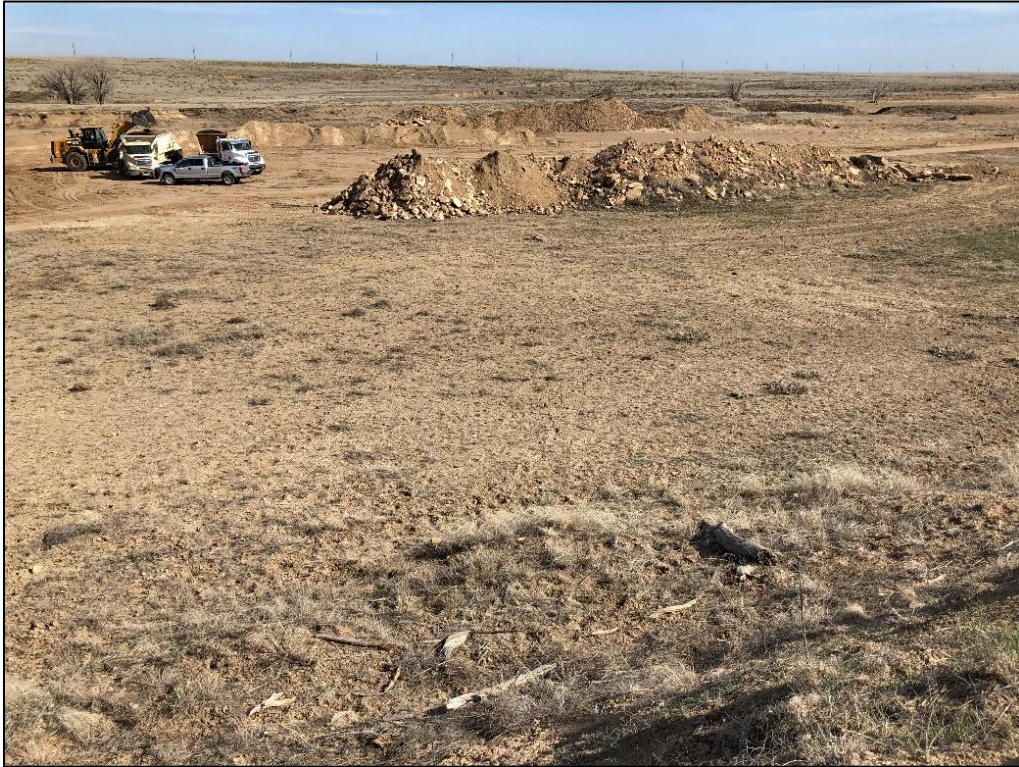
Photo 5. View looking east across southern edge of pit from top of meander bank.

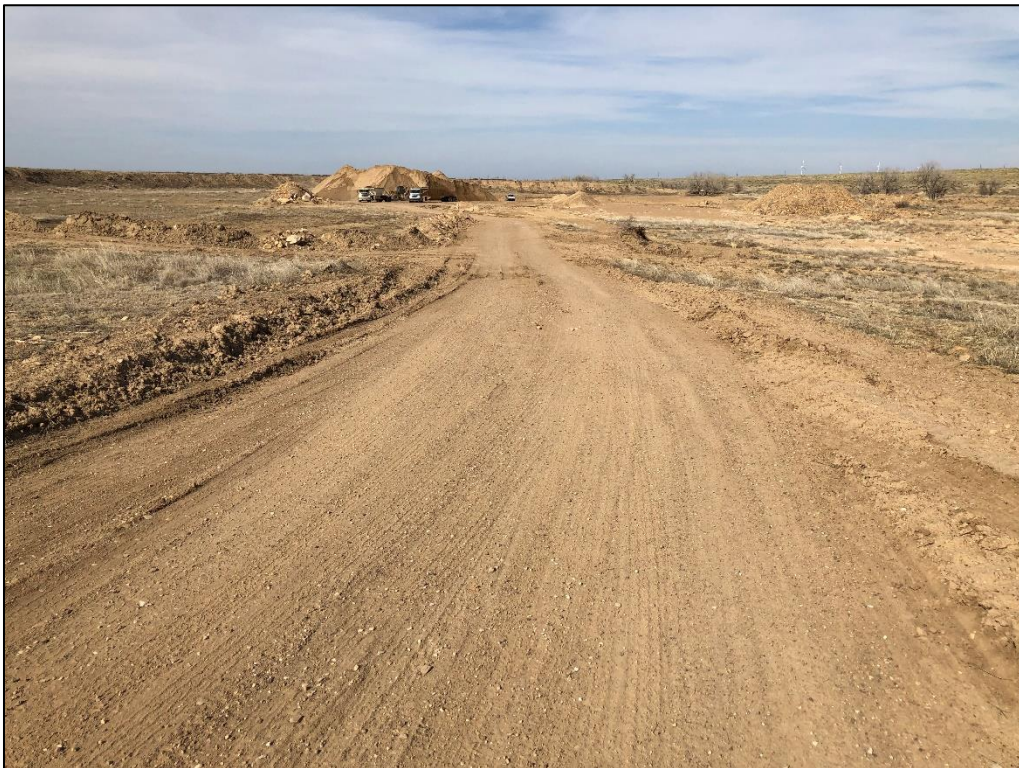
Photo 6. View looking northeast toward pit area from pit access road which will be reclaimed.

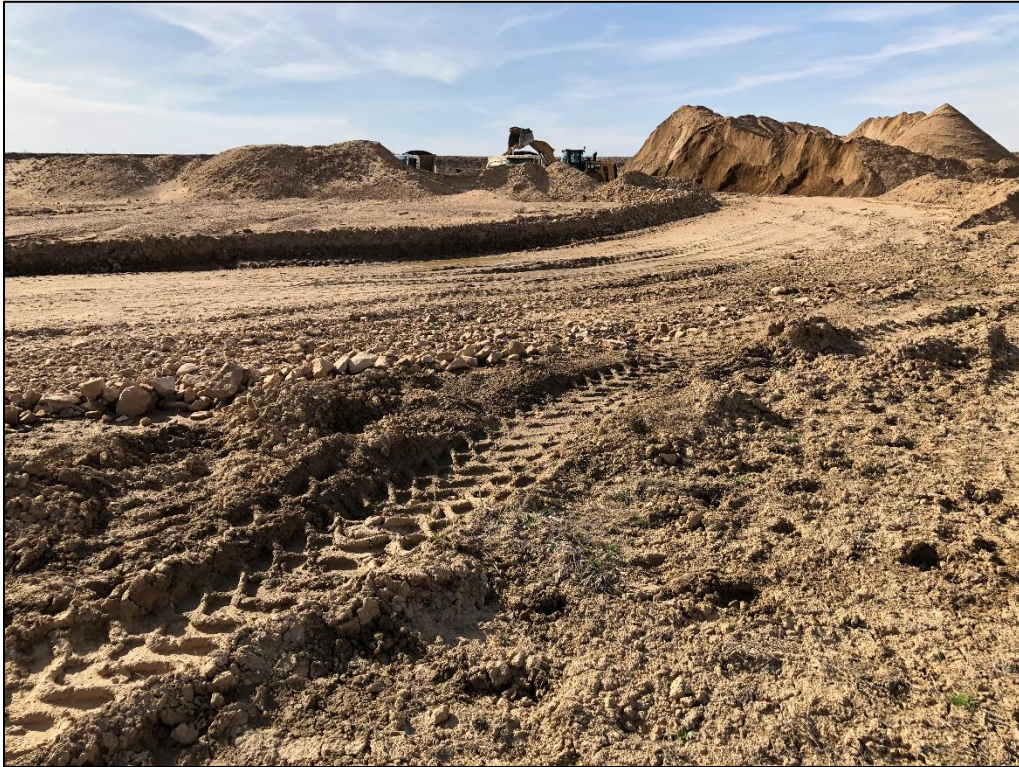
Photo 7. View looking west across pit area from its eastern edge.

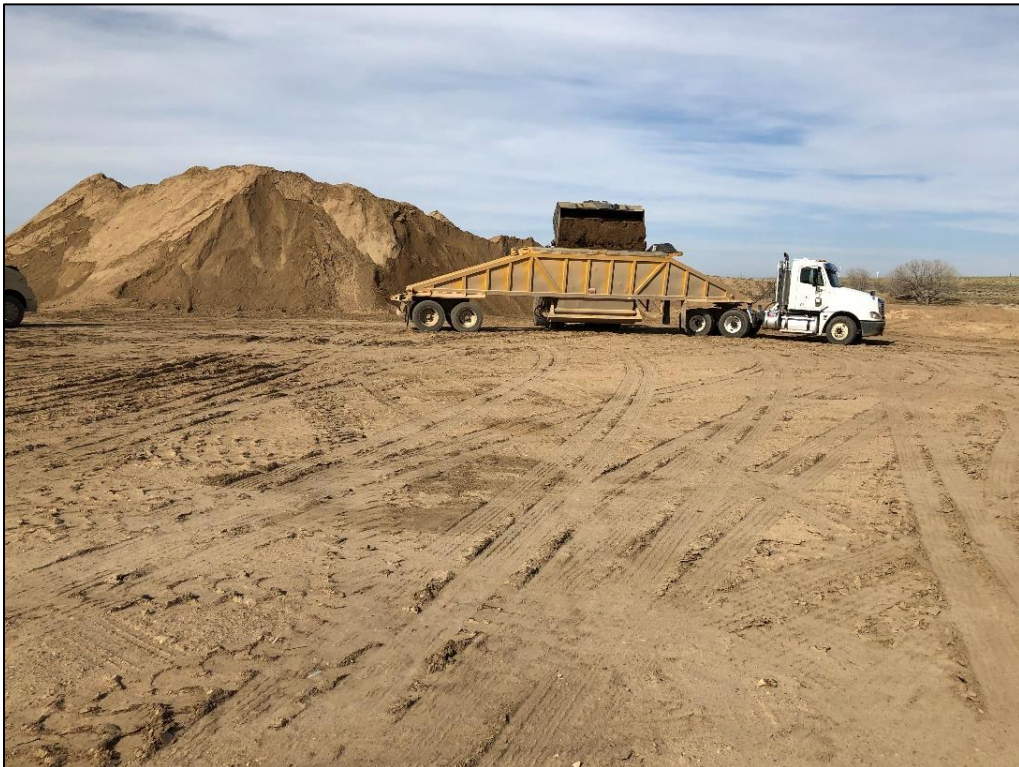
Photo 8. View looking north across pit area, showing operation hauling off from large sand stockpile during inspection.

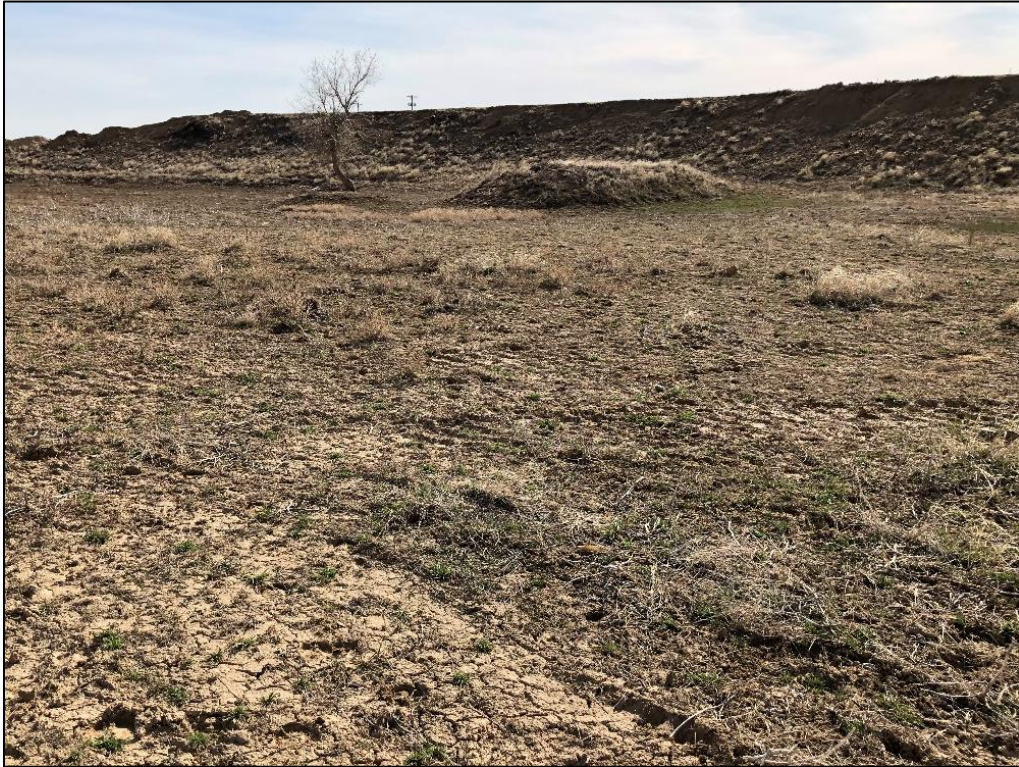
Photo 9. View looking southwest at pre-law disturbed area located southwest of permit area. Note the small grassed over stockpile that remains in this area.

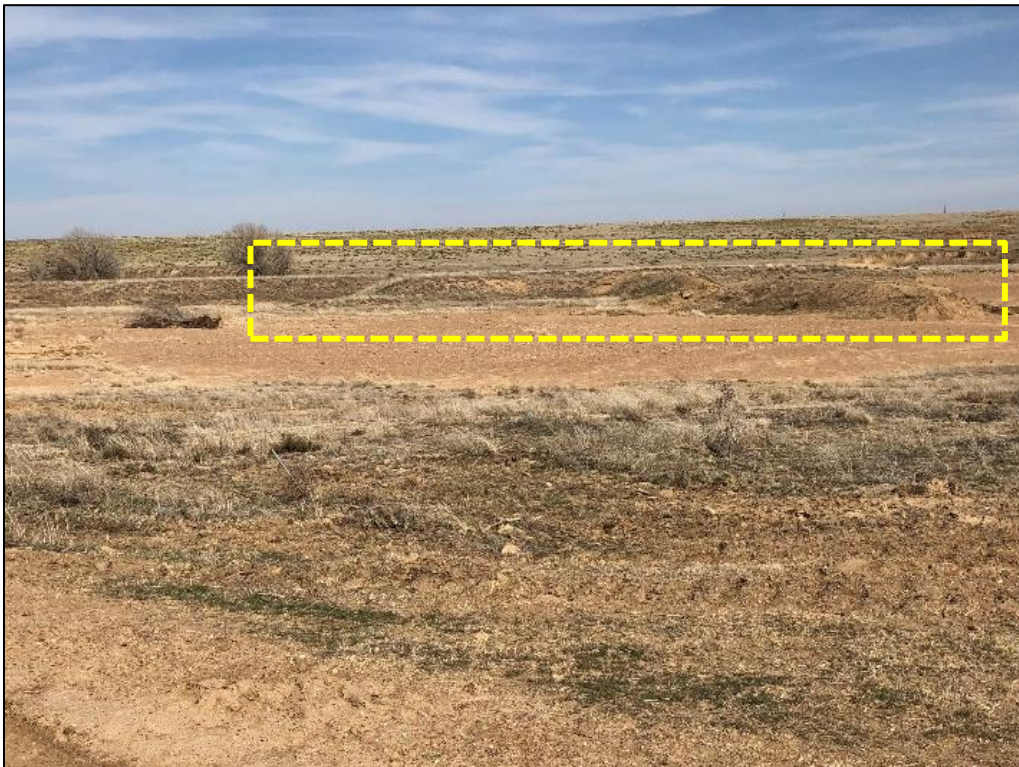
Photo 10. View looking southeast at pre-law disturbed area located south of permit area. Note the low-lying grassed over stockpile that remains in this area (indicated).
