MINERALS PROGRAM INSPECTION REPORT
PHONE: (303) 866-3567

MINE NAME: Lamar Park Grav Pit	MINE/PROSPECTING ID#: M-1987-078	MINERAL: Sand and gravel	COUNTY: Prowers
INSPECTION TYPE: Monitoring	INSPECTOR(S): Amy Eschberger	INSP. DATE: March 27, 2019	INSP. TIME: 08:30
OPERATOR: City of Lamar	OPERATOR REPRESENTATIVE: Patrick Mason, Martin Montoya	TYPE OF OPERATION: 110c - Construction Limited Impact	
REASON FOR INSPECTION: Normal I&E Program	BOND CALCULATION TYPE: None	BOND AMOUNT: \$0.00	
DATE OF COMPLAINT: NA	POST INSP. CONTACTS: None	JOINT INSP. AGENCY: None	
WEATHER: Clear	INSPECTOR'S SIGNATURE:

M-1987-078 / Lamar Park Grav Pit / City of Lamar

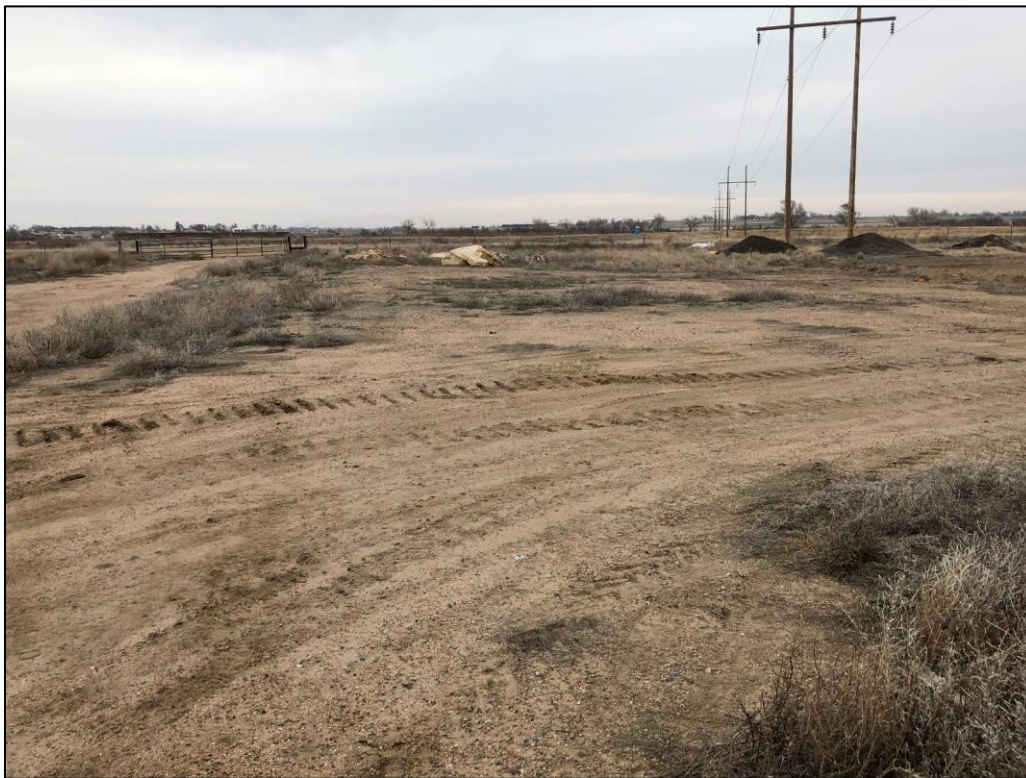
Photo 1. View looking north along western permit boundary from southwestern boundary corner.

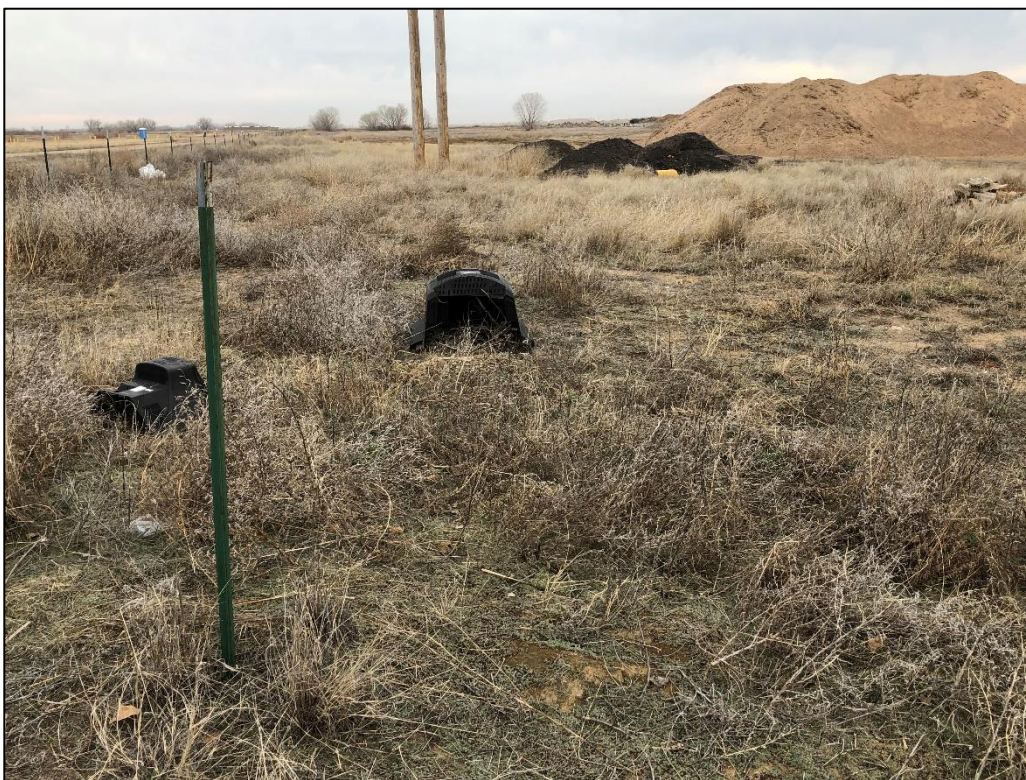
Photo 2. View looking east along northern permit boundary from northwestern boundary corner (marked by T-post).

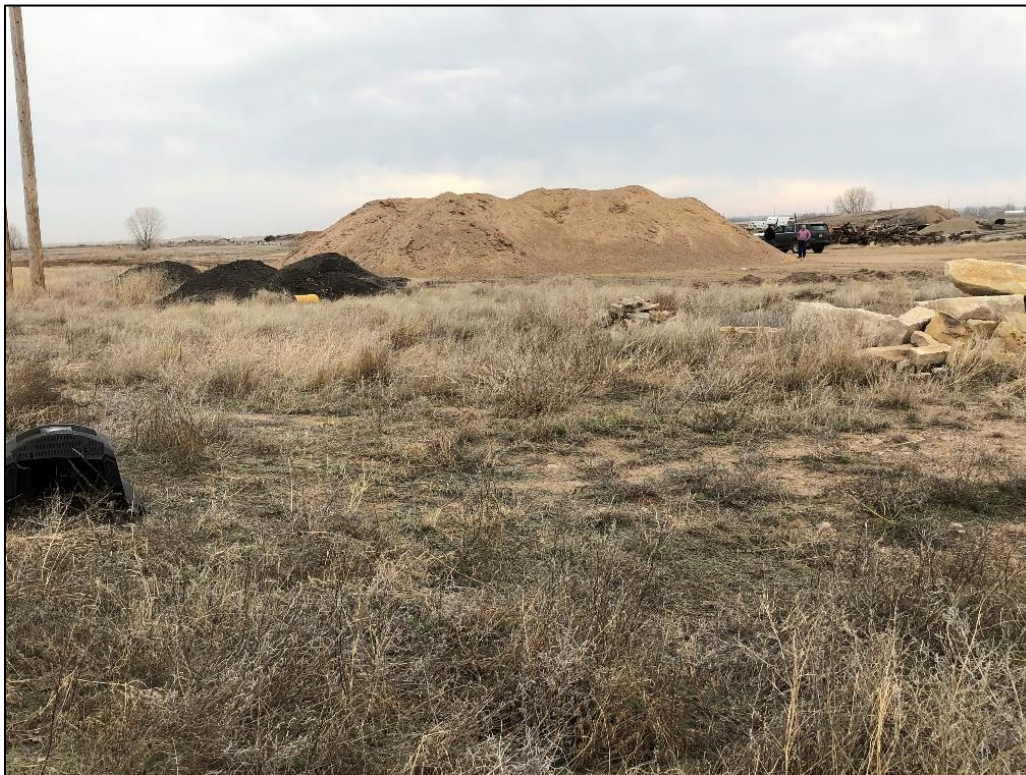
Photo 3. View looking east from western permit boundary, showing material stockpiles stored in western portion of permit area.

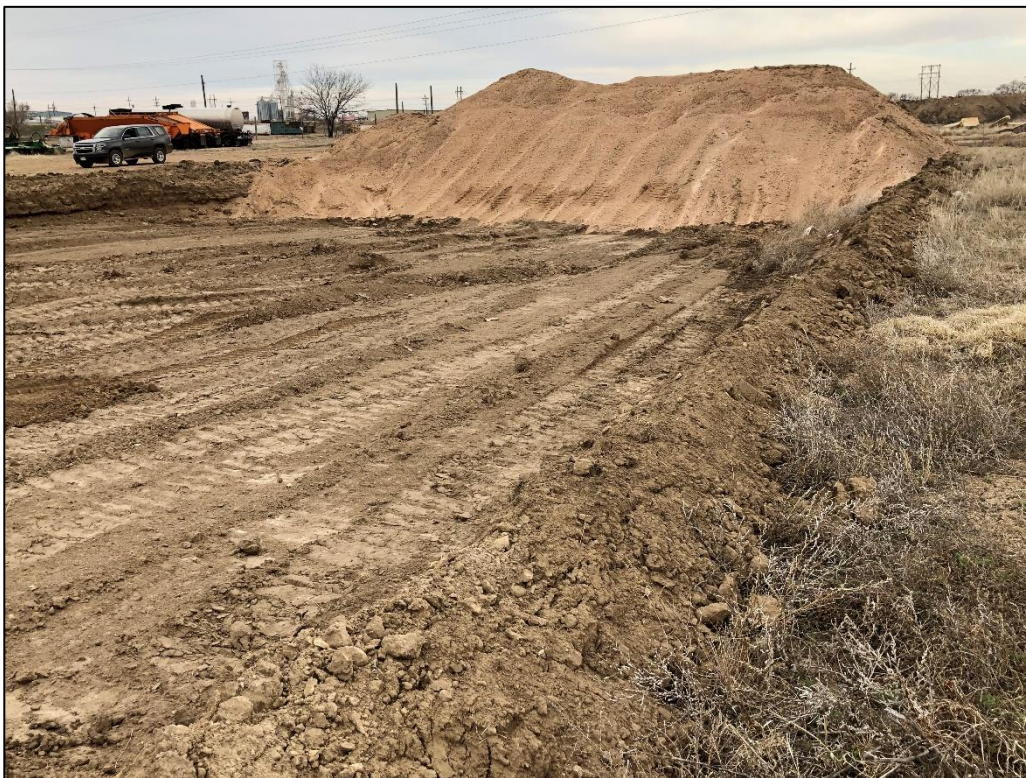
Photo 4. View looking southwest, showing small excavation, approximately 3 feet in depth, present in western portion of permit area. Note sand stockpile stored adjacent to excavation.

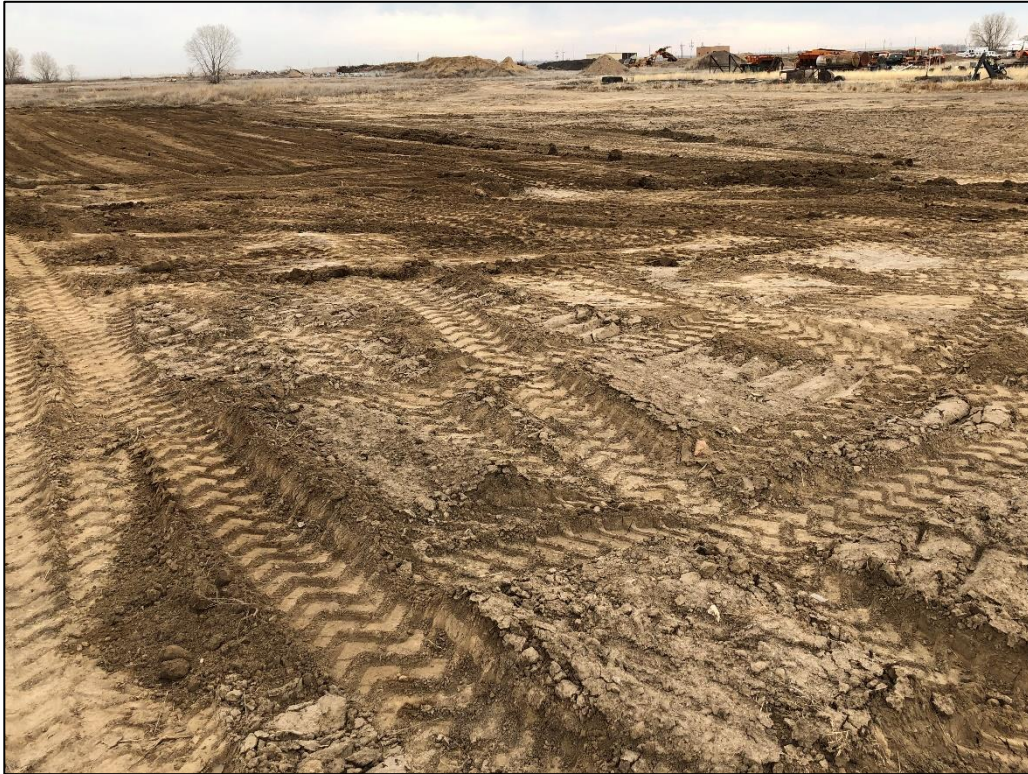
Photo 5. View looking southeast across graded area located just east of excavation. This area just needs to be retopsoiled and revegetated for reclamation.

At the time of the inspection, the weather was partly cloudy, cool, and dry. A permit sign was posted at the western entrance to the site. The rectangular-shaped permit area was delineated by T-posts. The site was not active during the inspection. However, according to the operator, the site is active every year in accordance with its intermittent status. A few material stockpiles were stored at the western edge of the permit area, including a larger sand stockpile. A small, rectangular-shaped excavation approximately 3 feet in depth was present in the western portion of the permit area, adjacent to the sand stockpile. The mined area just east of the current excavation has been backfilled and graded nearly flat. This area just needs to be retopsoiled and seeded for reclamation.

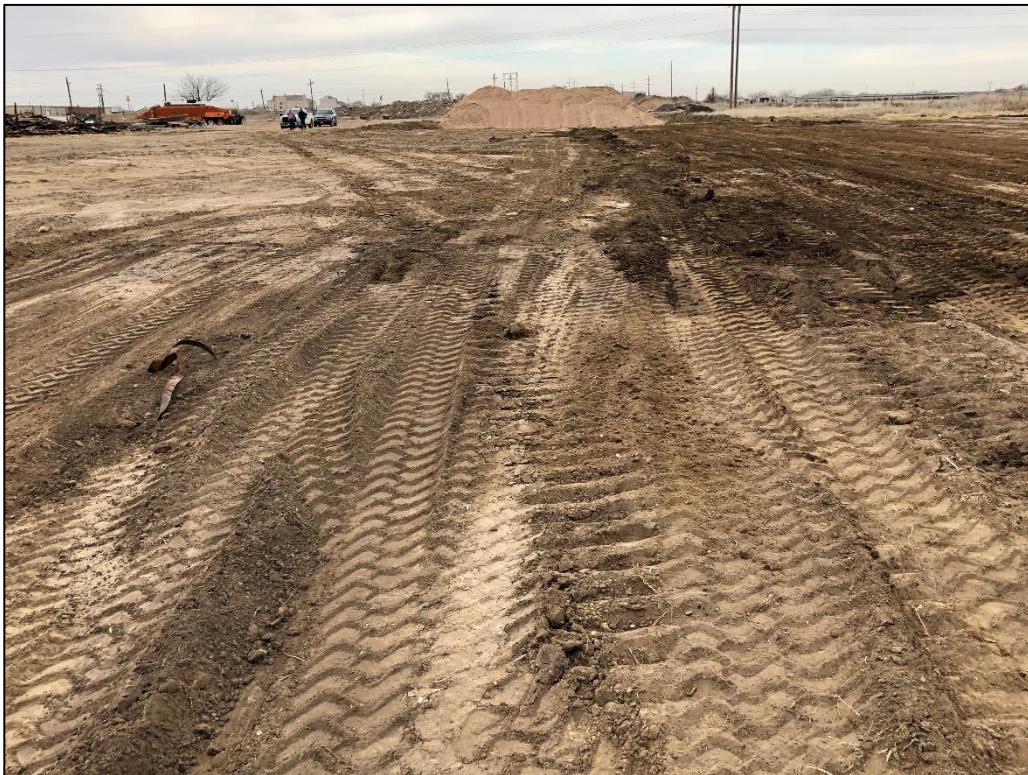
Photo 6. View looking west across graded area located just east of excavation. This area just needs to be retopsoiled and revegetated for reclamation.

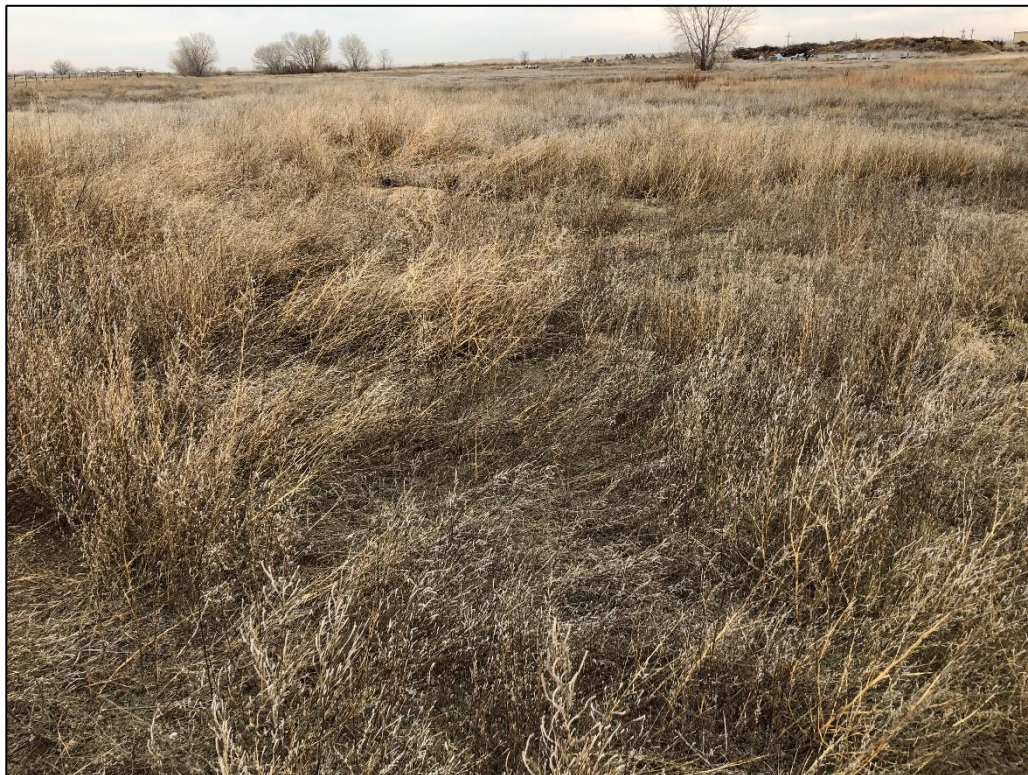
The earlier mined eastern half of the permit area has been in reclamation for many years. The western portion of this reclaimed area has good vegetative cover consisting of grasses, forbs, and some weeds (primarily Kochia). During the last inspection of the site, conducted on August 14, 2014, the Division informed the operator the small gravel stockpiles stored in this area would need to be removed in order for the area to be released from the permit. The stockpiles have been removed from this area since the last inspection.

Photo 7. View looking east across reclaimed eastern half of permit area with good vegetative cover consisting of grasses, forbs, and some annual weeds (primarily Kochia).

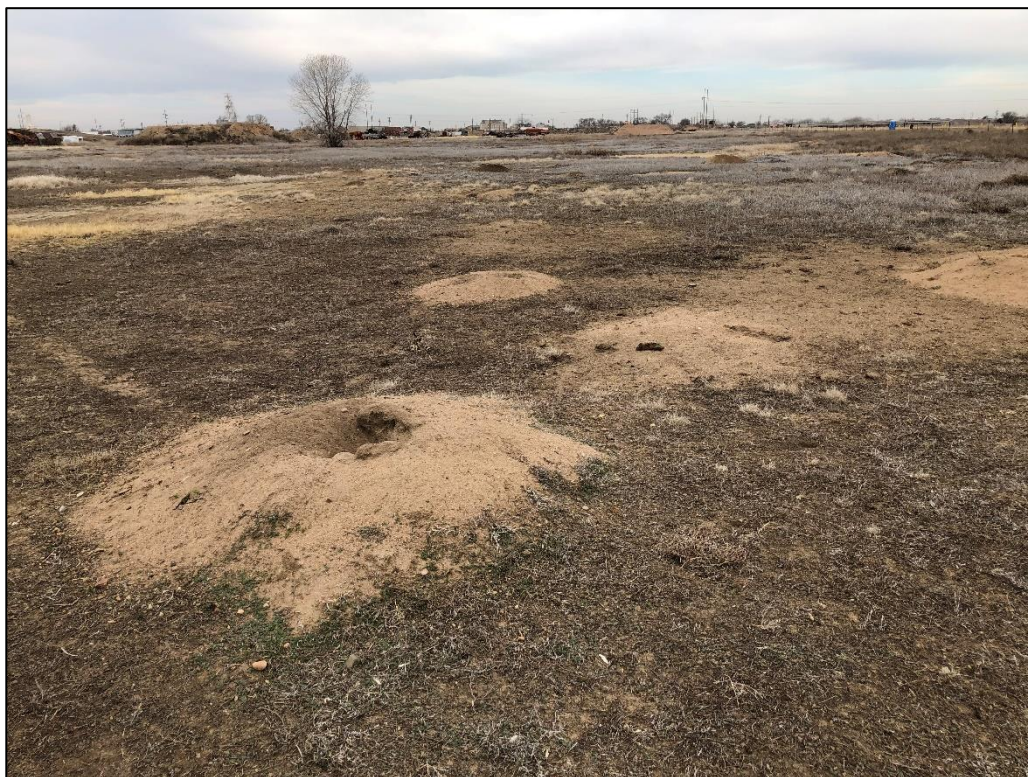
The far eastern portion of the permit area was reclaimed during the last inspection. However, since that time, the area has been invaded by prairie dogs, which have torn up most of the reclamation grass cover. The operator is currently working with CPW to figure out how to manage the prairie dog population. To complete the approved reclamation plan for this area, the operator would need to grade out the mounds, backfill the holes, and revegetate the area. However, considering the post-mining land use for the site is wildlife habitat, an argument could be made this area is meeting the approved beneficial use. If the operator has a desire to release the eastern portion of the permit area as-is, the Division recommends the operator provide a letter from CPW

Photo 8. View looking west across eastern portion of permit area that was reclaimed, but then disturbed in recent years by prairie dog colonization of the area.

supporting its current use as wildlife habitat.
