MINERALS PROGRAM INSPECTION REPORT
PHONE: (303) 866-3567

MINE NAME: Benson Pit	MINE/PROSPECTING ID#: M-1977-256	MINERAL: Sand and gravel	COUNTY: Grand
INSPECTION TYPE: Monitoring	INSPECTOR(S): Peter S. Hays	INSP. DATE: July 9, 2019	INSP. TIME: 10:00
OPERATOR: Grand County	OPERATOR REPRESENTATIVE: Chris Baer, Micah Benson	TYPE OF OPERATION: 112c - Construction Regular Operation	
REASON FOR INSPECTION: Normal I&E Program	BOND CALCULATION TYPE: None	BOND AMOUNT: No Bond Held	
DATE OF COMPLAINT: NA	POST INSP. CONTACTS: None	JOINT INSP. AGENCY: None	
WEATHER: Clear	INSPECTOR'S SIGNATURE:

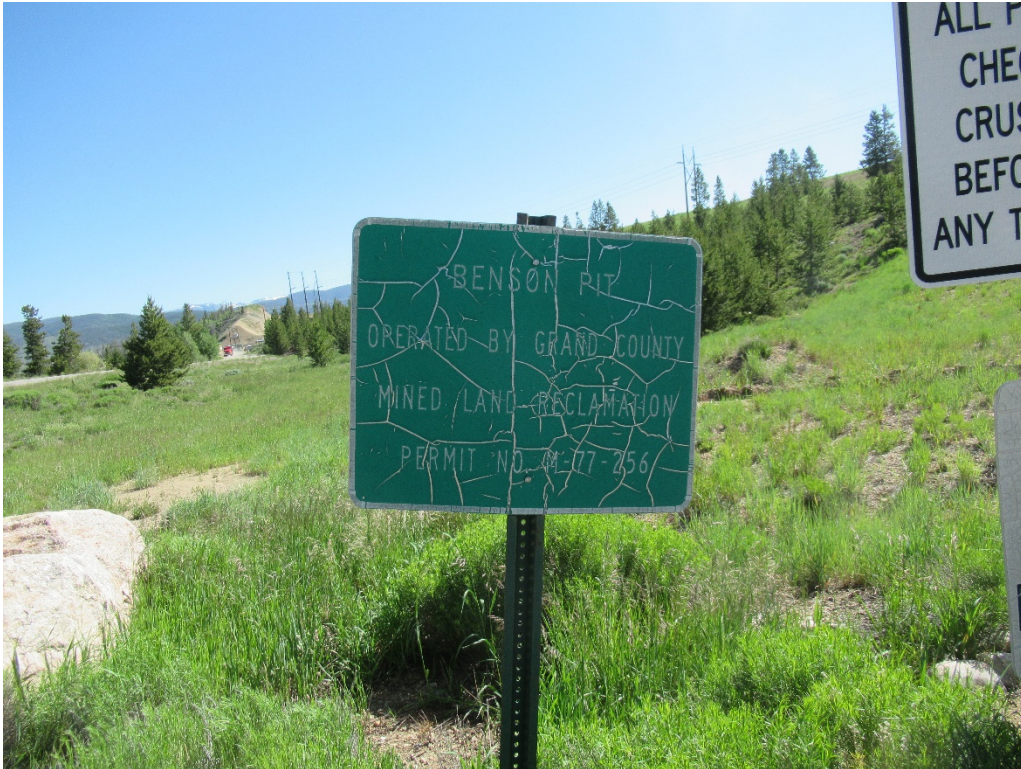
Benson Pit mine sign

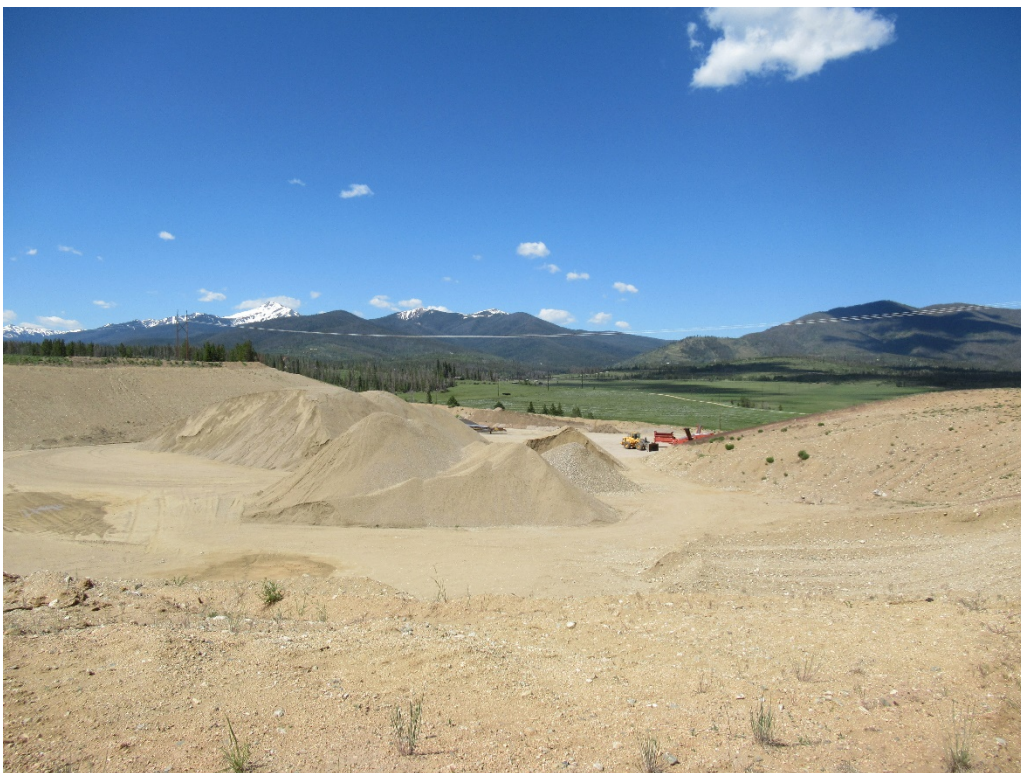
View of the pit floor from the northeast corner of the highwall looking southwest

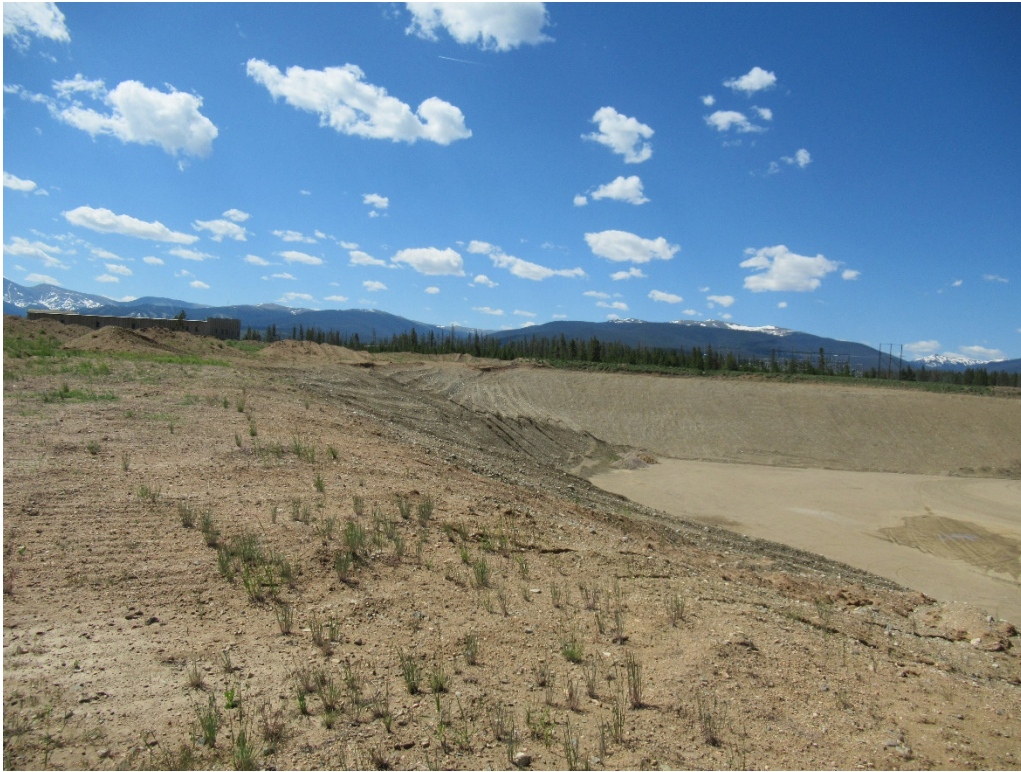
View of the eastern highwall and regraded southern highwall from the northwest corner of the highwall looking south

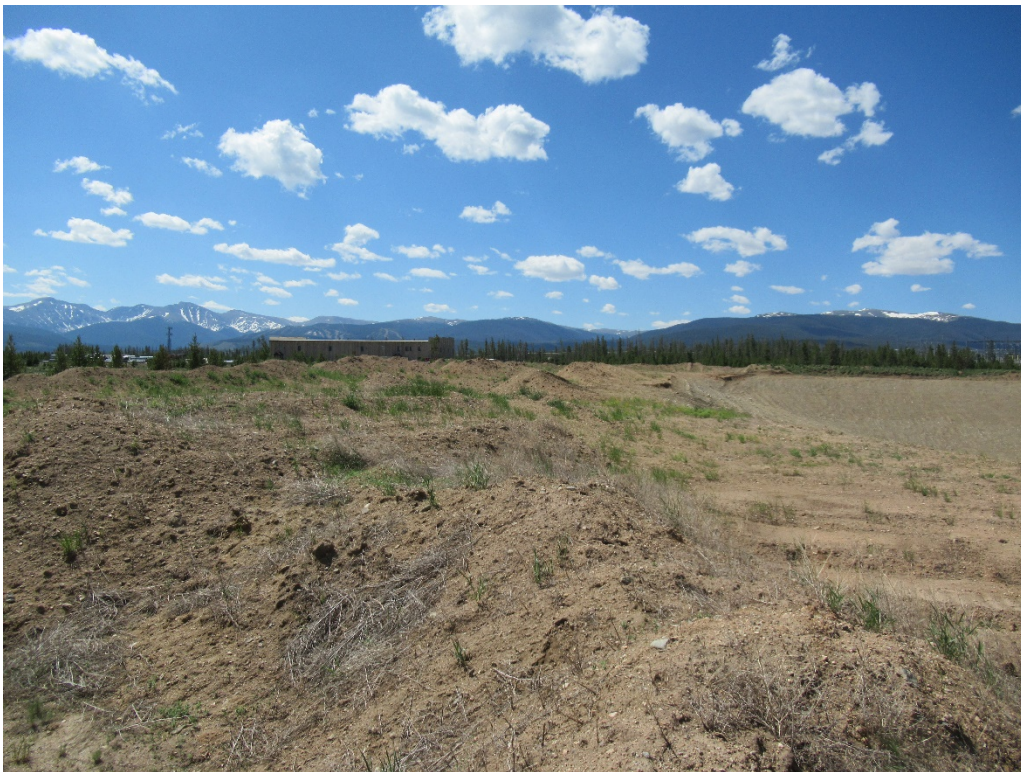
View of topsoil stockpiles stripped ahead of the highwall looking south

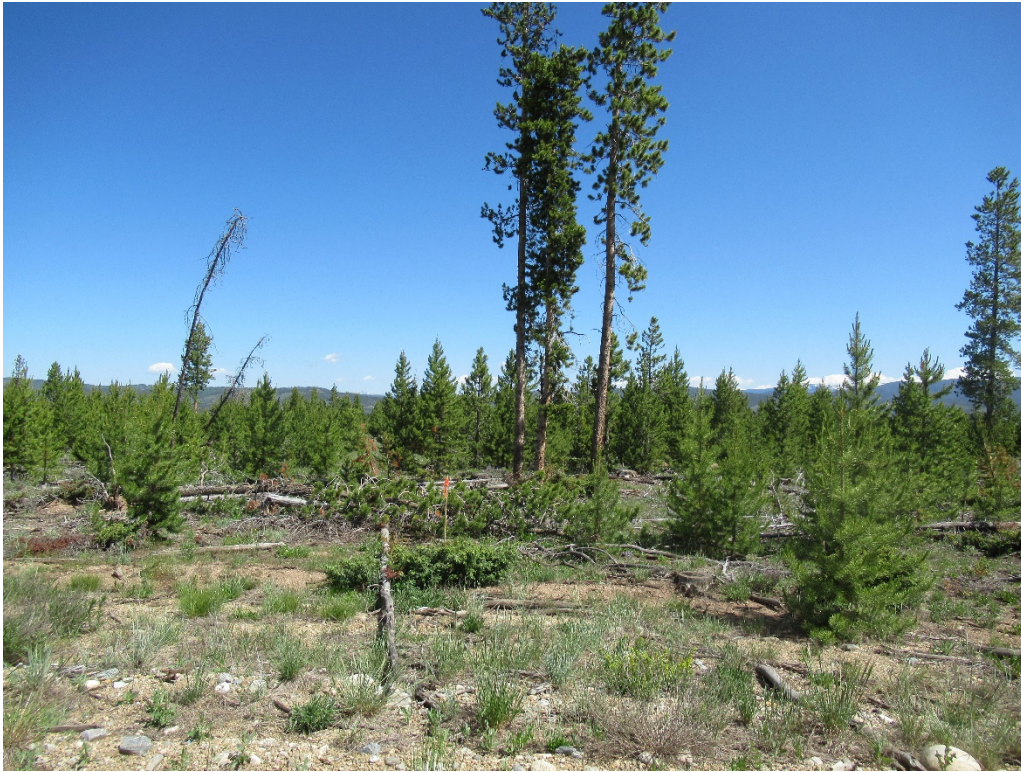
A technical revision (TR-01) to the permit was submitted by the Operator on March 29, 2019. The revision allows the construction of a solar facility on 11.54 acres on the undisturbed southwestern portion of the permit boundary. The technical revision was approved by the Division on April 5, 2019. Construction of the facility had not started as of this inspection. Survey stakes indicating the boundaries of the solar facility and utility locate markings were observed during the inspection.

View of the solar facility lease area from the south side looking north

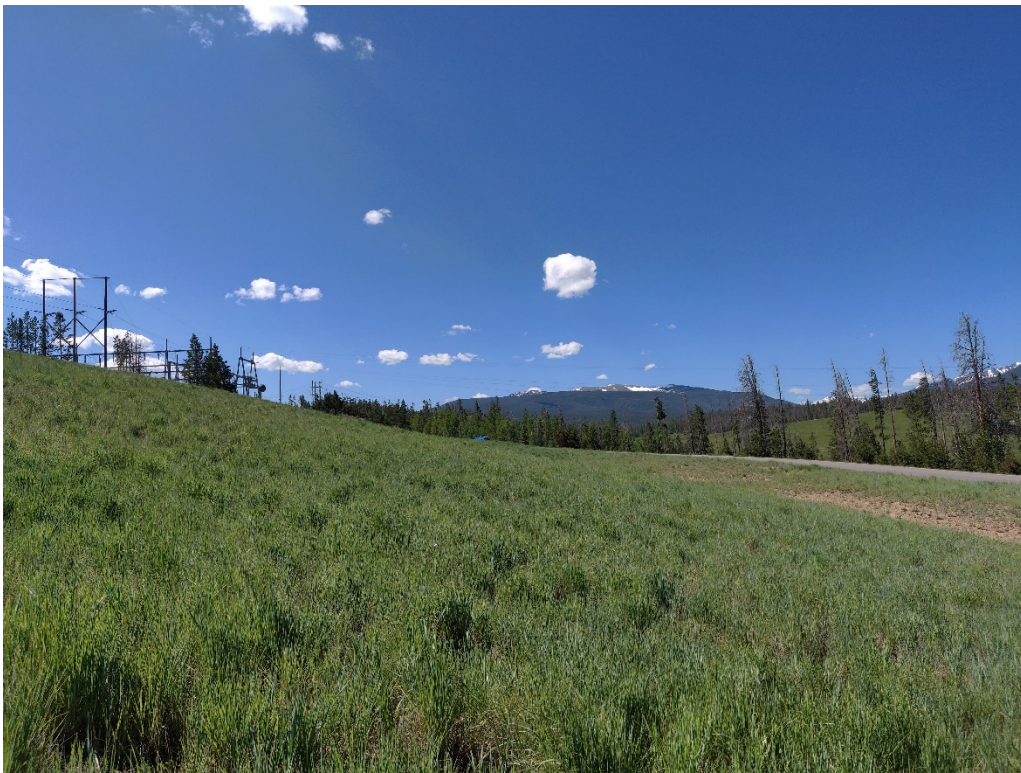
View of the well-vegetated southern portion of the south powerline peninsula looking south

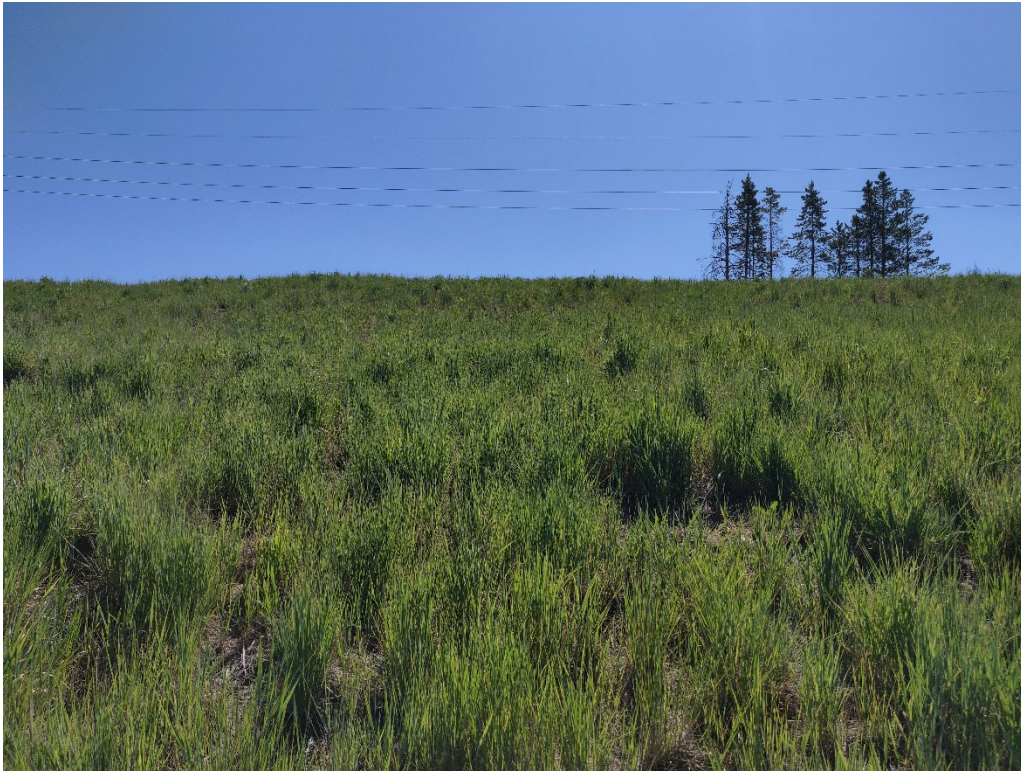
View of the well-vegetated southern portion of the south powerline peninsula looking east

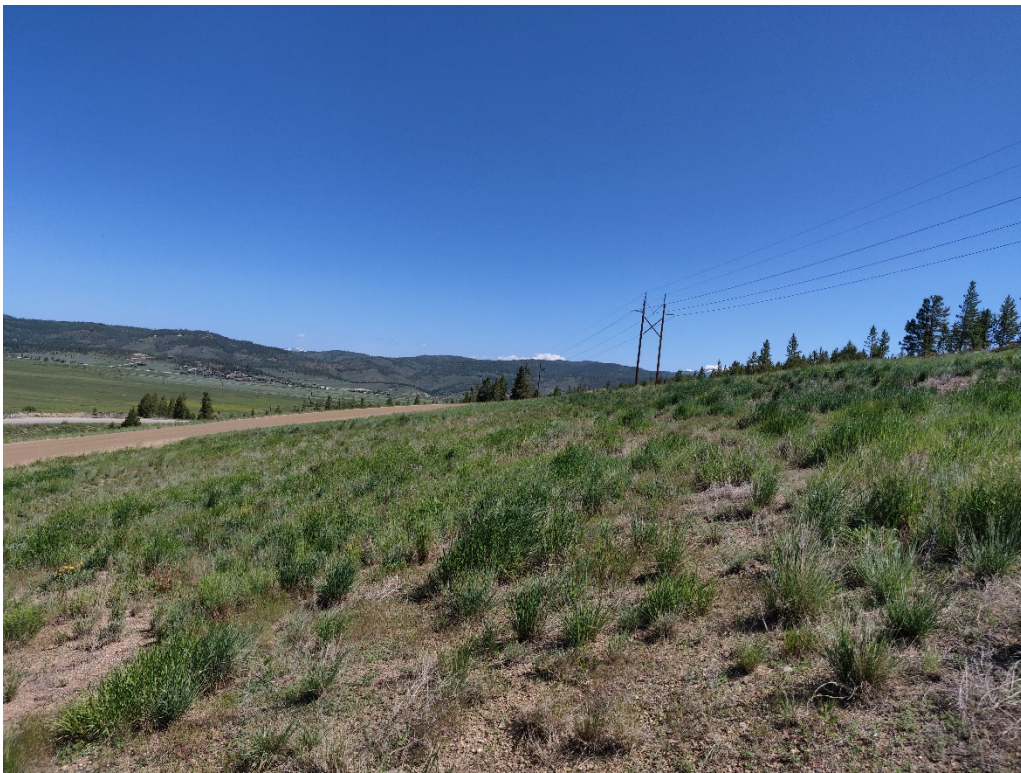
View of the vegetated northern portion of the north powerline peninsula looking north
