MINERALS PROGRAM INSPECTION REPORT**PHONE: (303) 866-3567**

MINE NAME: Cresson Project	MINE/PROSPECTING ID#: M-1980-244	MINERAL: Gold	COUNTY: Teller
INSPECTION TYPE: Monitoring	INSPECTOR(S): Patrick Lennberg	INSP. DATE: June 24, 2019	INSP. TIME: 08:30
OPERATOR: Cripple Creek & Victor Gold Mining Company	OPERATOR REPRESENTATIVE: Justin Bills	TYPE OF OPERATION: 112d-3 - Designated Mining Operation

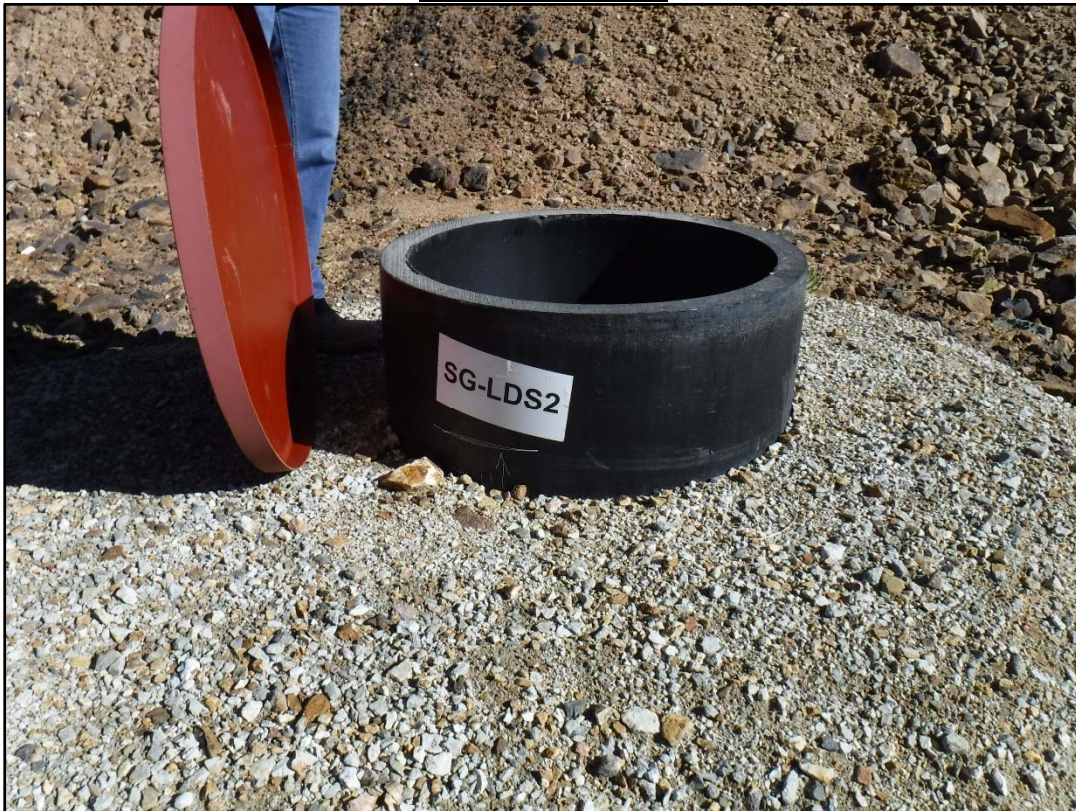
One of the three of the SGVLF Leak Detection System (LDS) sumps was inspected, SG-LDS-2. The sump was found to be dry. The operator must inspect all sumps weekly, and sample and characterize any water present. Any water should be removed after sampling so it can be determined if water continues to enter the sump.

Photo 1: Leak Detection System Sump, SG-LDS2 (dry)

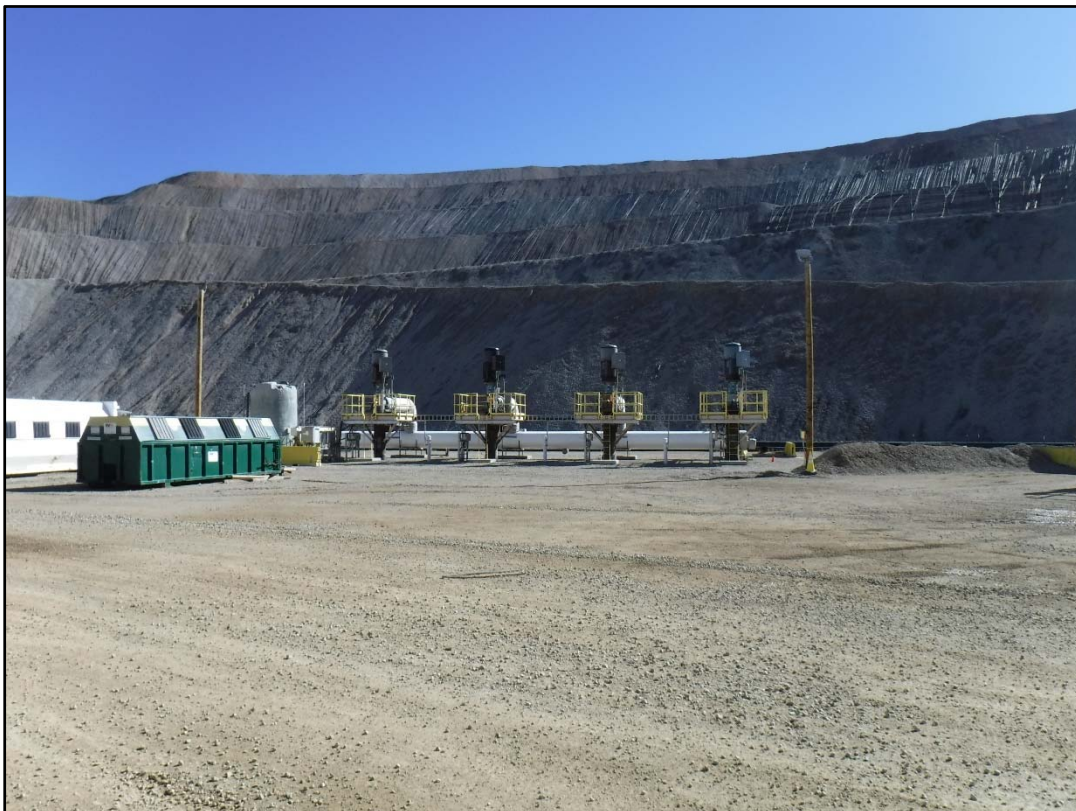
Photo 2: Squaw Gulch high volume extraction pumps

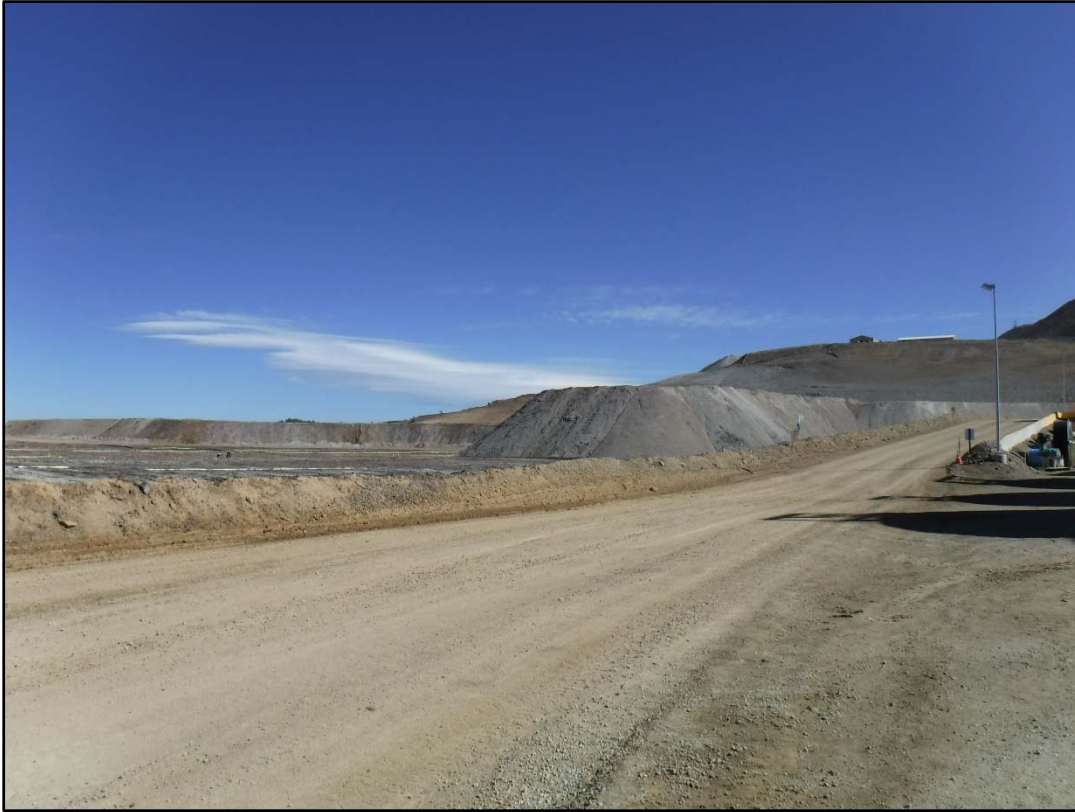
The operation is currently advancing the 9,950 foot lift, which is very close to the top elevation of the mill platform. The Division inspected active leaching surfaces on the SGVLF. The operation is required to minimize ponding of leaching solution to less than 3 feet by 3 feet in area. This is to prevent the ponds from being a wildlife attractant. Active leaching areas appeared to be well-ripped to minimize ponding. No ponding was observed. The elongated sump present at the southwestern toe of the SGVLF (near the ADR-2 Facility) that was filled with bird balls has received an abundant amount of storm water run-off that has scattered the balls. However, no ponded stormwater was observed.

Photo 3: The 9950' level (VLF2) being built out adjacent to the Mill

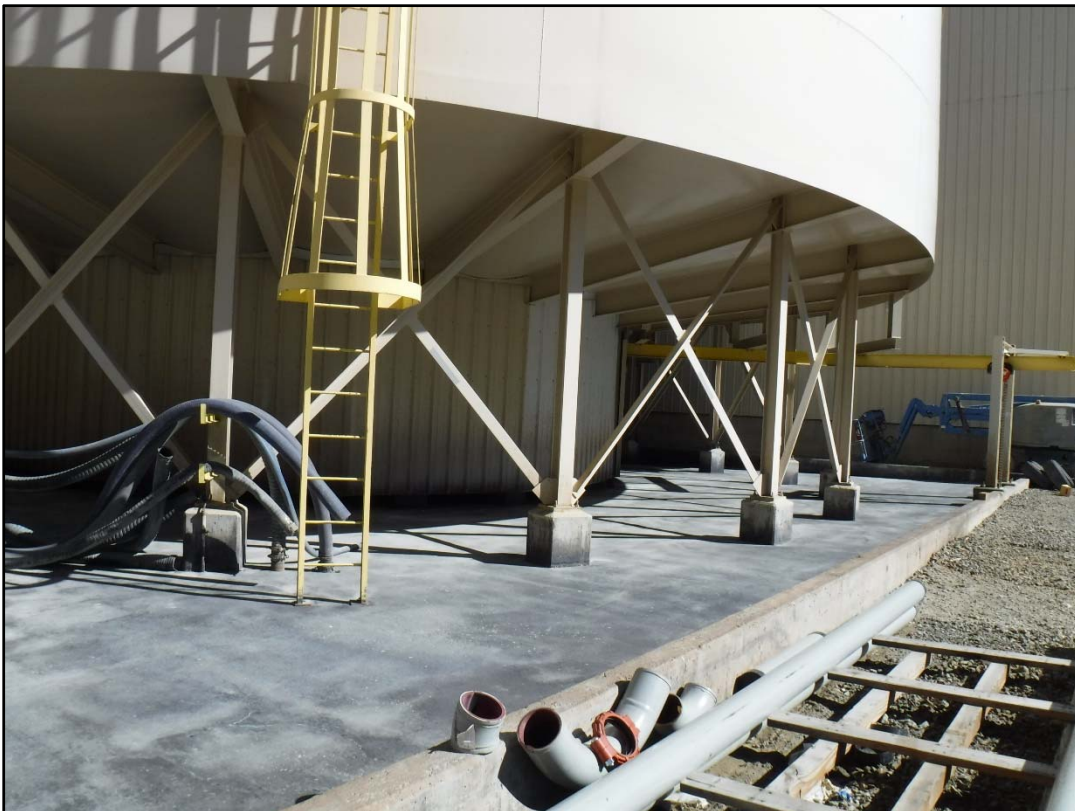
Photo 4: East side of the Mill (Processed Ore Thickener – east side), typical conditions

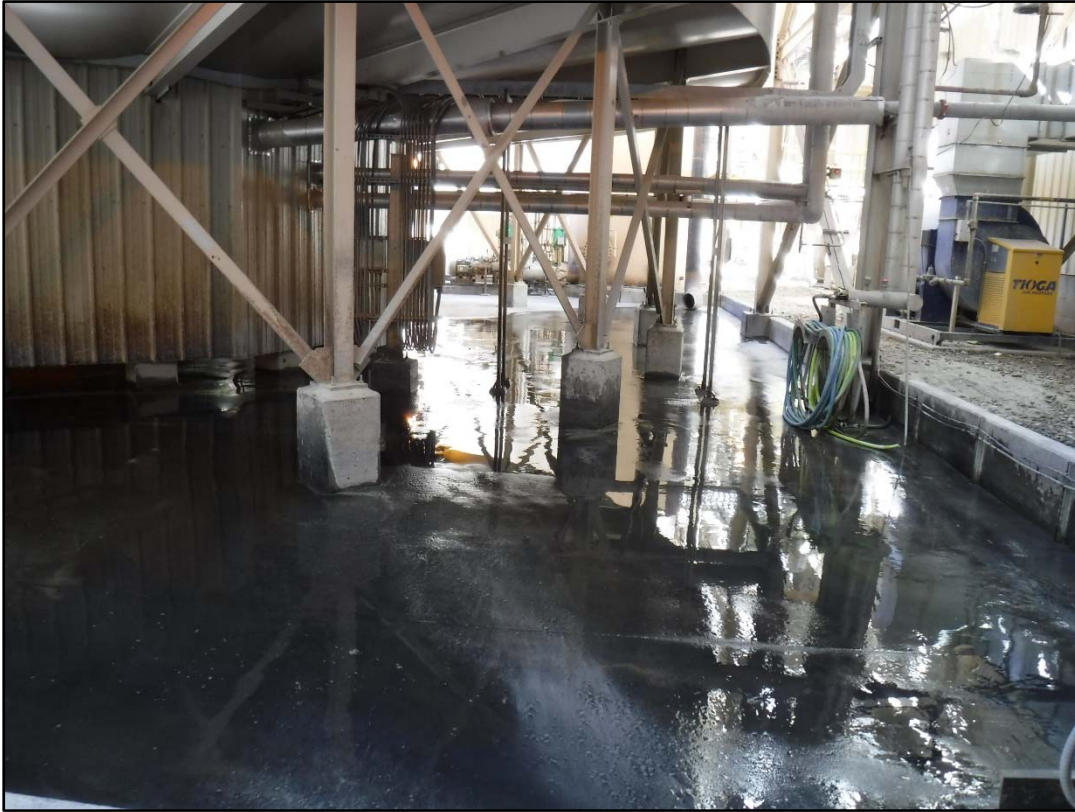
Photo 5: East side of the Mill (Processed Ore Thickener – west side), typical conditions

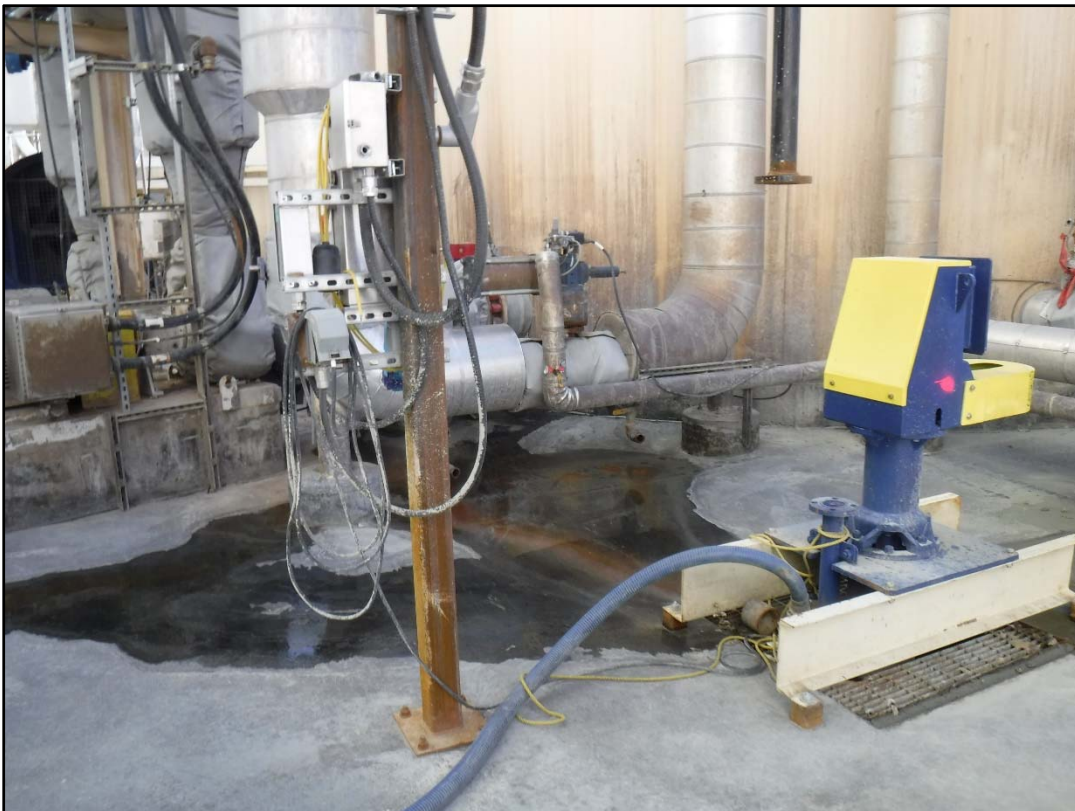
Photo 6: East side of the Mill (Neutral pH Process Water Tank), typical conditions

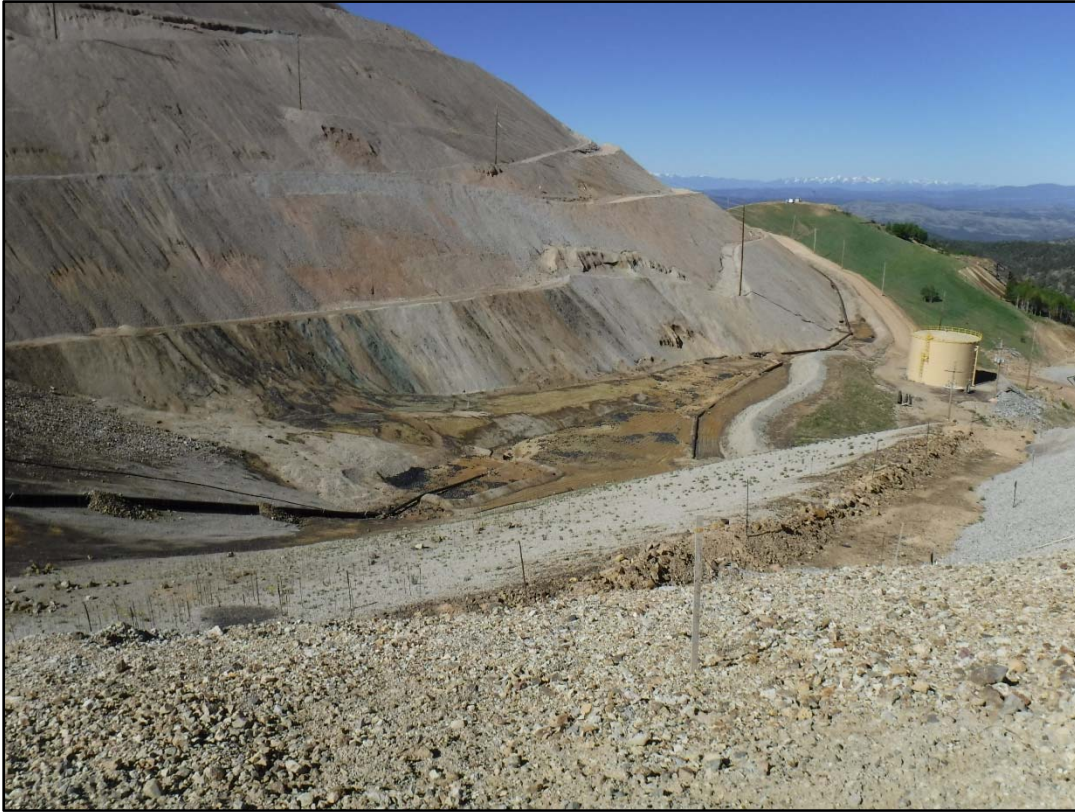
Photo 7: The elongated sump present at VLF1

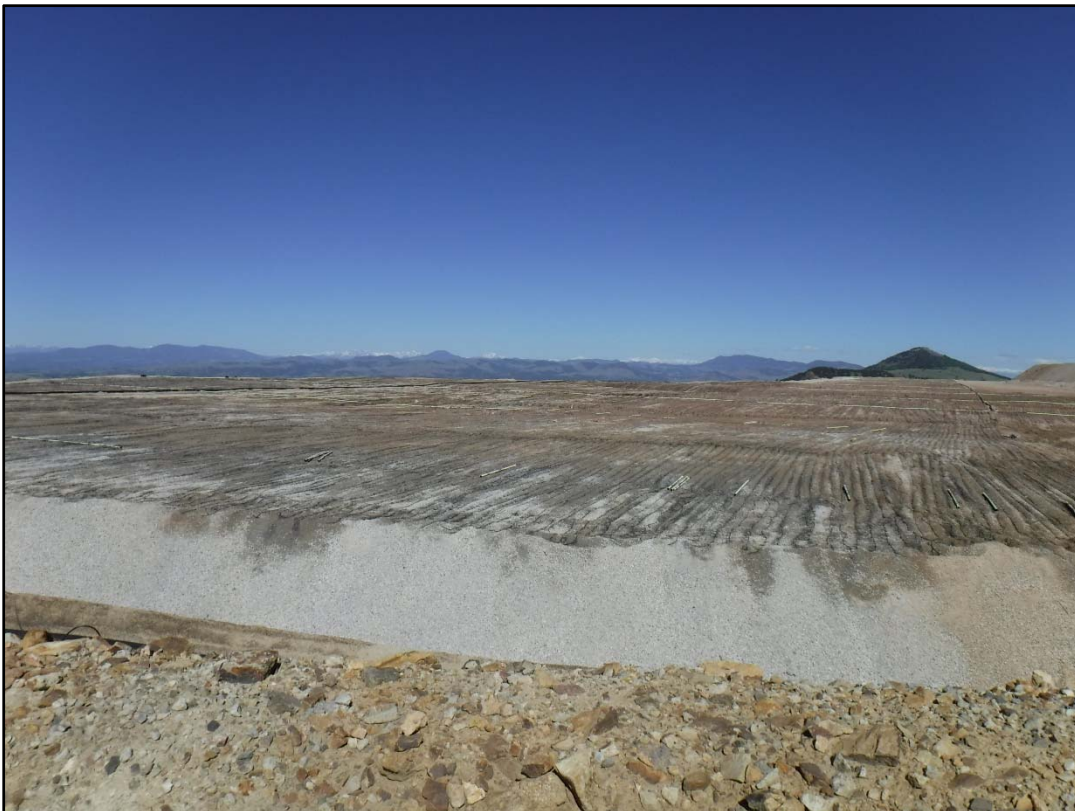
Photo 8: SGVLF active leaching areas appeared to be well-ripped to minimize ponding, 9900' level

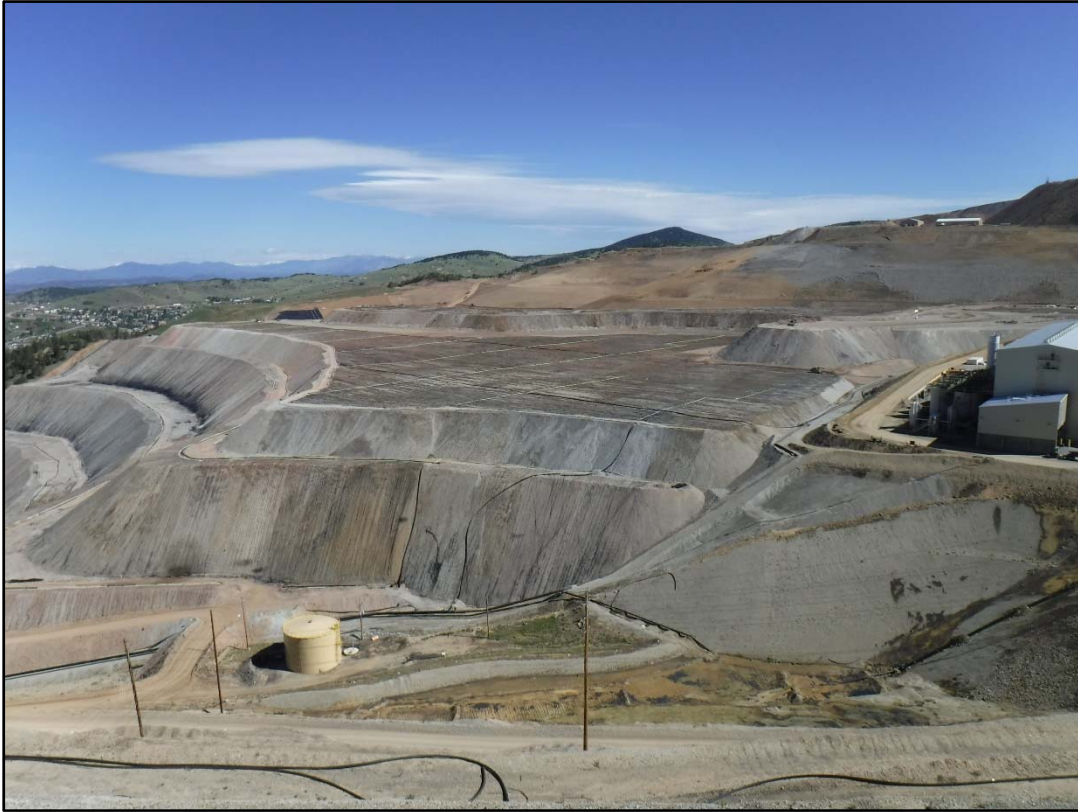
Photo 9: SGVLF overview

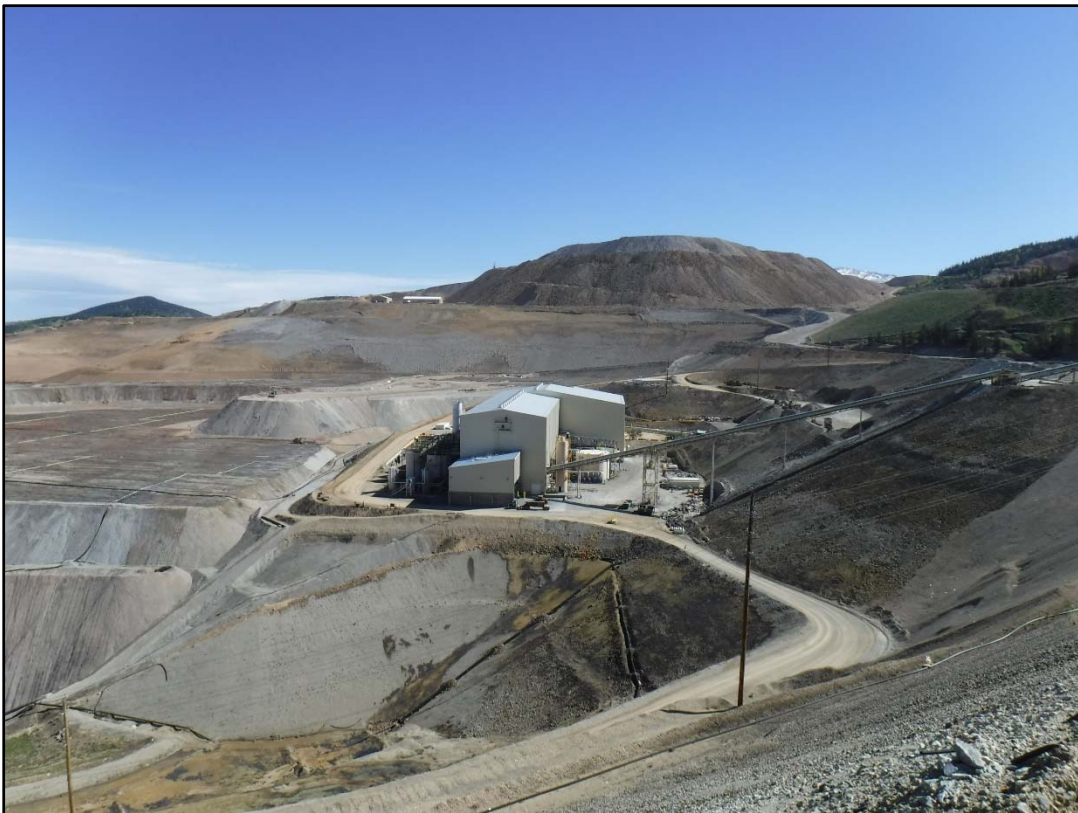
Photo 10: Mill Area overview

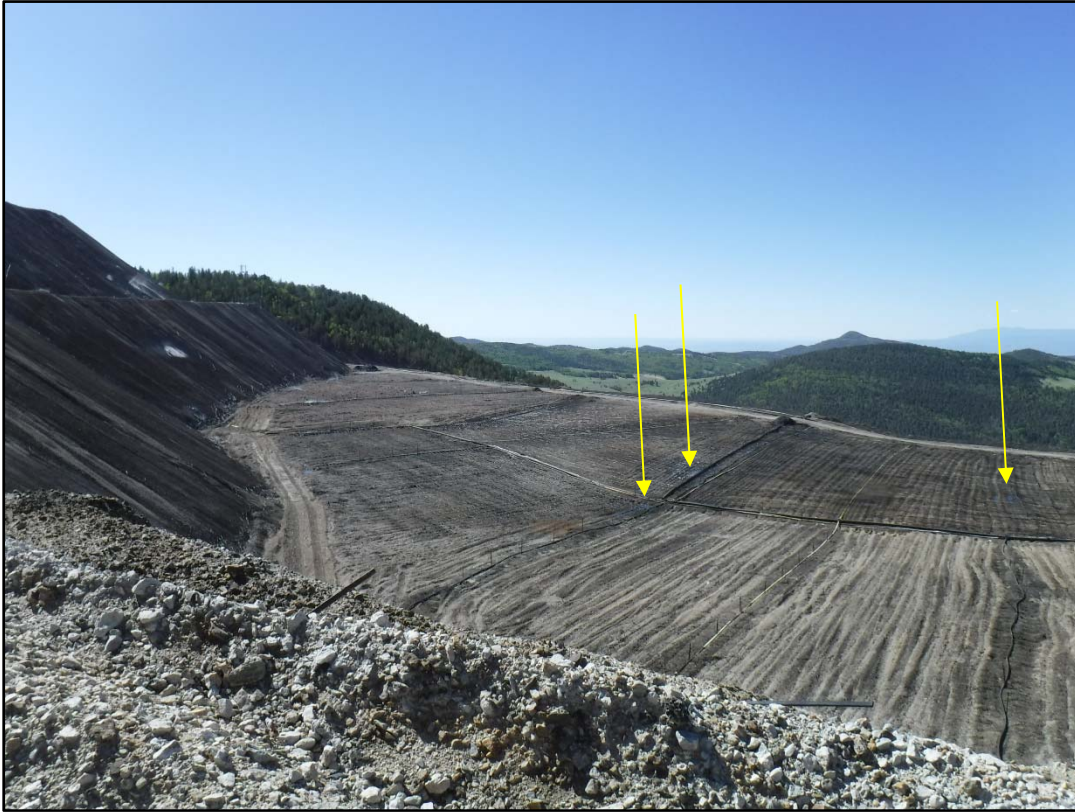
The current and maximum elevation of ore placement in the AGVLF is 10,400 feet (for Phase V). The Division inspected active leaching surfaces on the AGVLF. These surfaces were well saturated and ponding of leachate, greater than 3 feet by 3 feet, was common. In addition, ponding of leachate was observed on the lower 10,200 foot level, although not as common as was observed on the upper level. During the close-out meeting the Operator indicated that the application rate of leachate had been reduced by approximately 120 gpm in these areas. Also, a crew that was observed on the 10,200 foot level was moved to the upper level to begin ripping the material to promote infiltration. While the weather in the recent past had been wet this was not a significant factor in the ponding. Finally, during an aerial inspection in early June there were several areas of ponding noted including the areas observed during this inspection. A problem is being cited in this report due

to the ponding observed in excess of the 3 foot by 3 foot requirement.

Photo 11: AGVLF 10,200' level east area, arrows show ponding

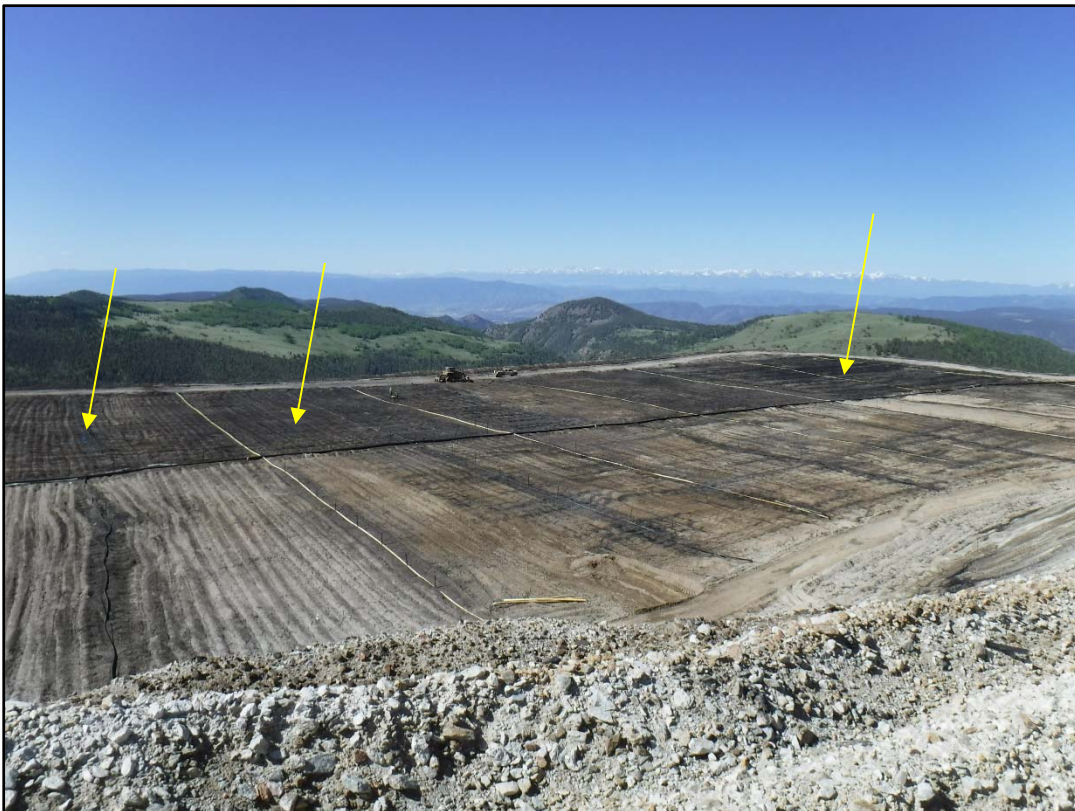
Photo 12: AGVLF 10,200' level west area, arrows show ponding

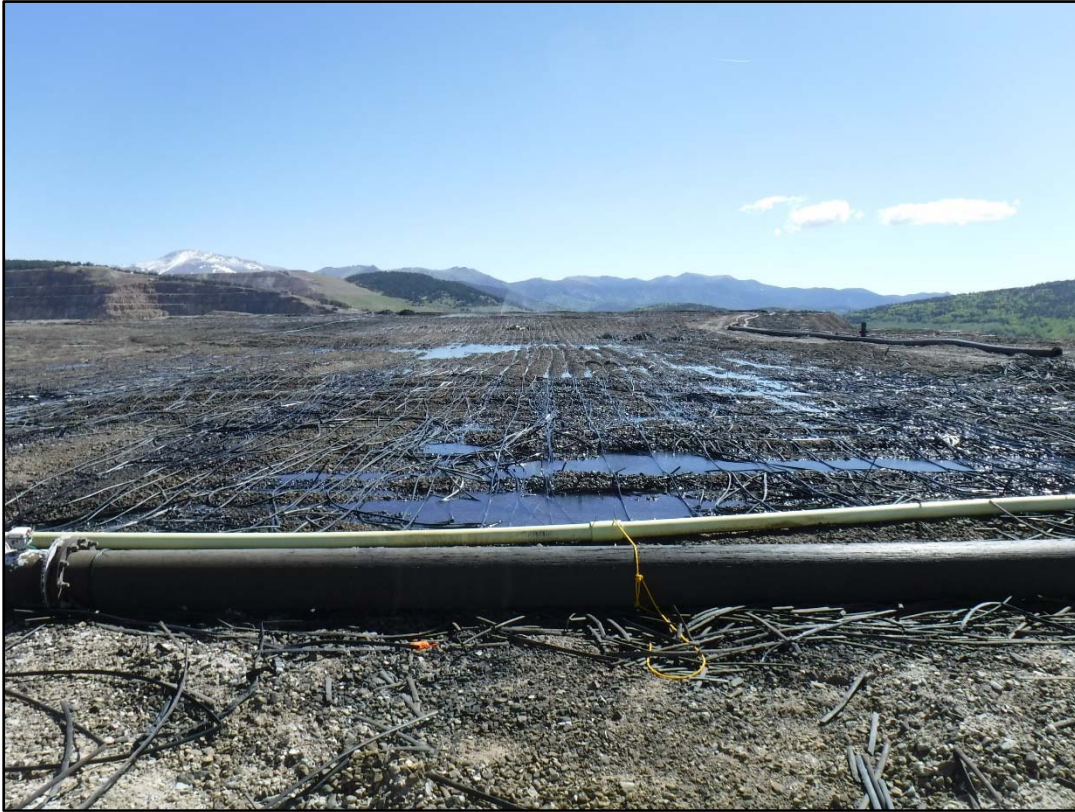
Photo 13: AGVLF 10,400' level, typical ponding observed

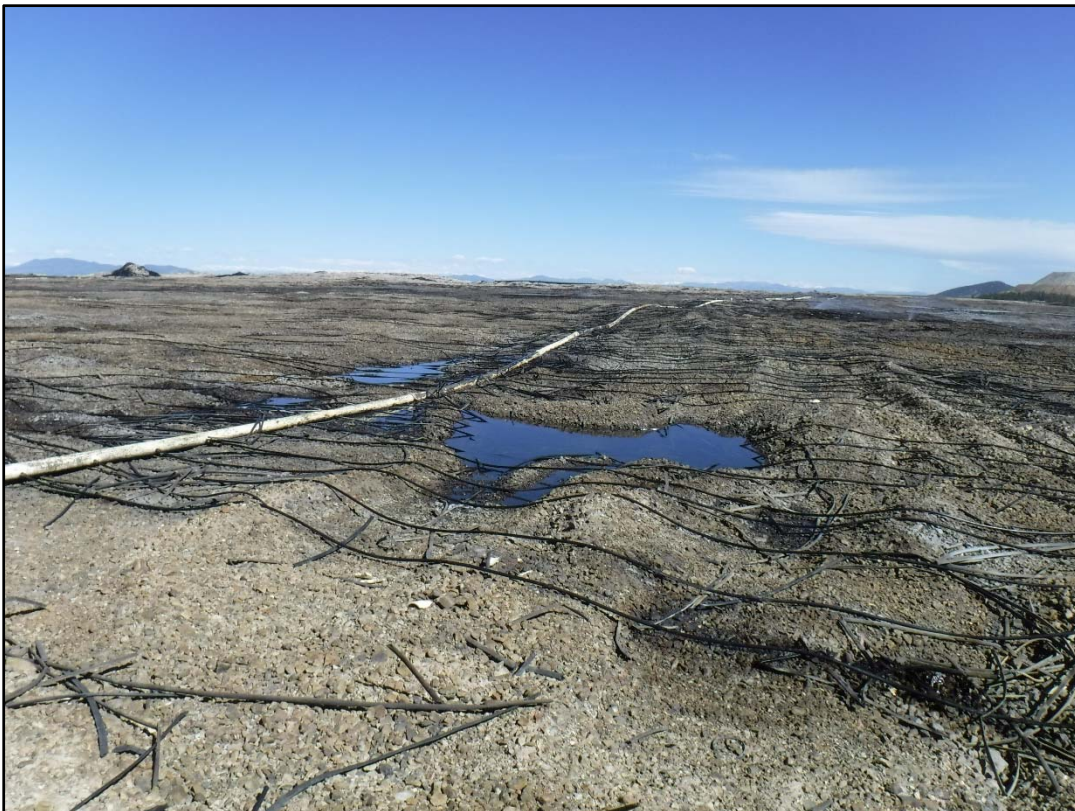
Photo 14: AGVLF 10,400' level, typical ponding observed

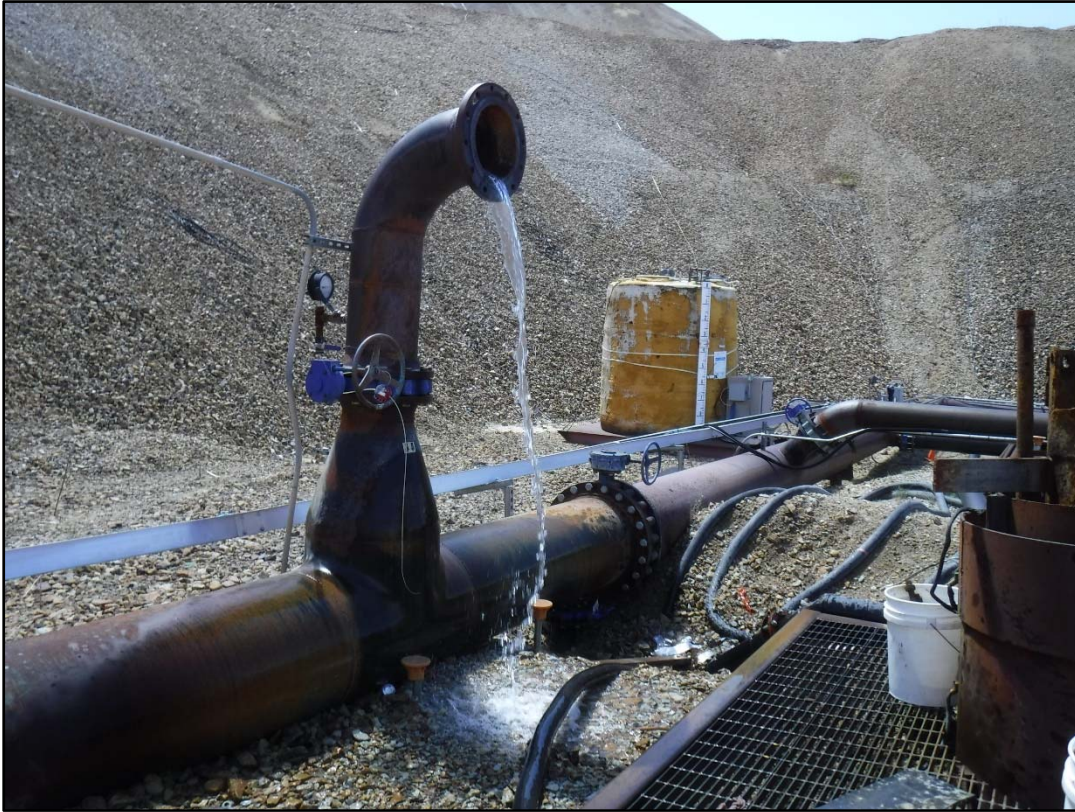
During inspection of the AGVLF Phase I HVSCS the stand pipe for pump #303 that connects the pump flow to the main solution pipe was leaking. The pump has been disconnected from the main pipe for maintenance. The remaining pipe had a valve that was intended to prevent flow from the main solution pipe from flowing back towards the pump. The valve was not working correctly and was allowing solution to discharge at an estimated rate of 10-15 gpm onto the surrounding ground surface. The solution was infiltrating as fast as it was being discharged. The Operator indicated that a maintenance crew had been dispatched to investigate and fix the issue.

Photo 15: Solution bypassing the gate valve at the 303 pump Phase I, AQVLF

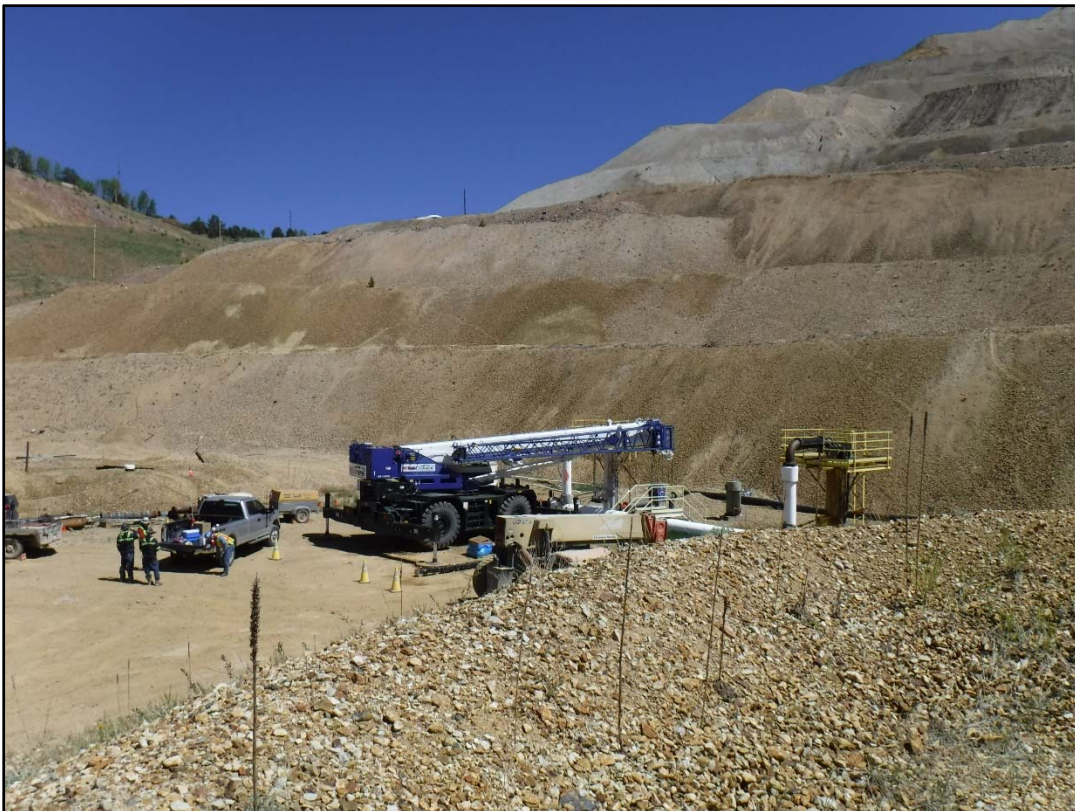
Photo 16: Phase II pump 5 maintenance

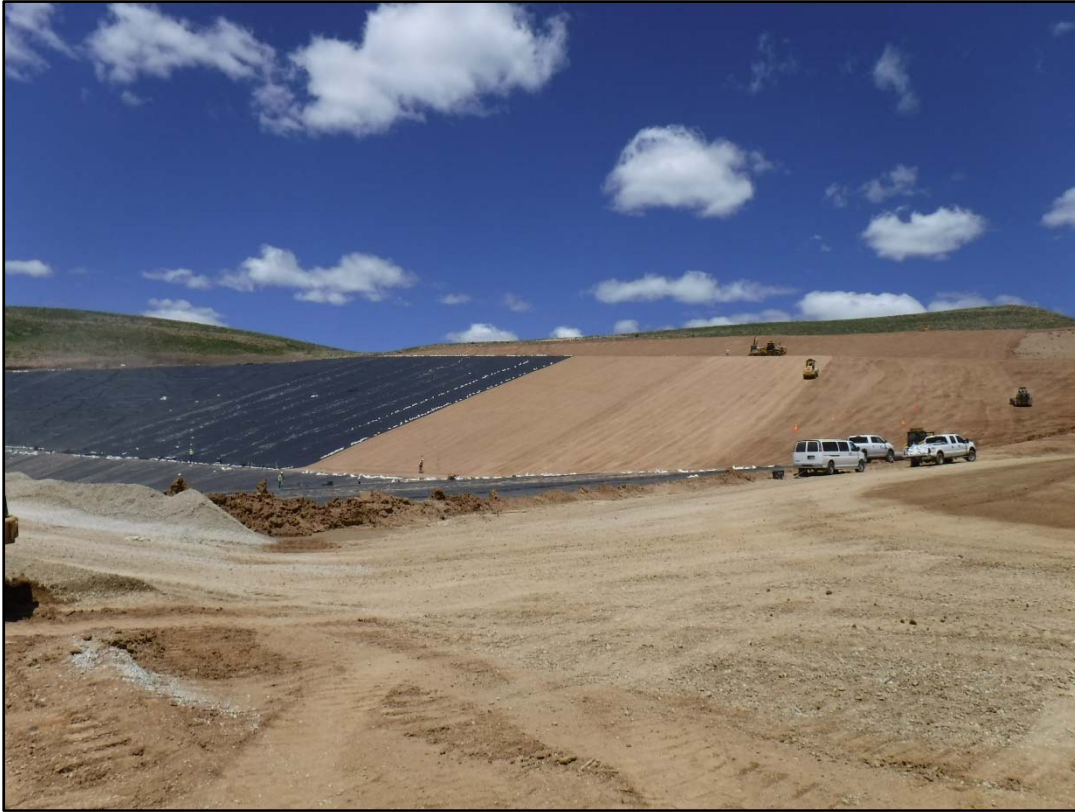
By noon approximately 60,000 square feet of liner had been deployed that day and subgrade was being prepped for additional panels to be deployed. Subgrade preparation includes density testing to confirm proper compaction, final survey of prepared surface, and final inspection by liner contractor to verify that the subgrade is free of any large and/or sharp particles that could damage the liner.

Photo 17: VLF 2 Phase 2 construction, panels deployed in morning and subgrade prep for additional liner placement

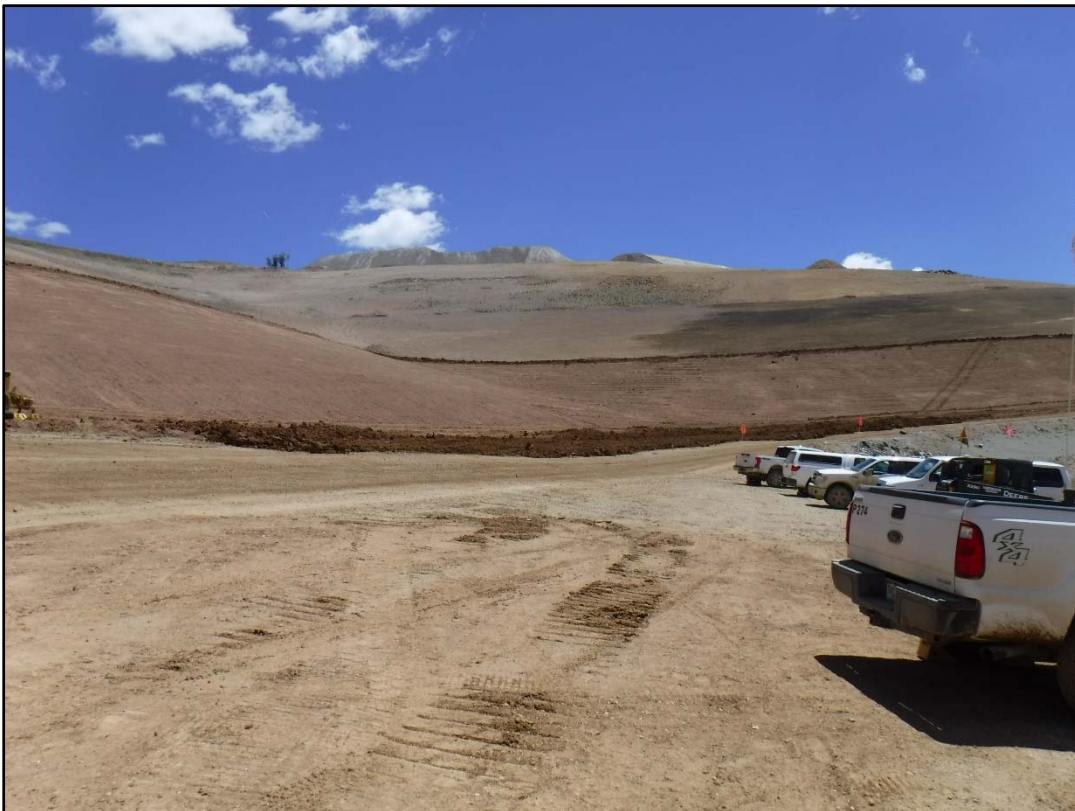
In addition to hauling DCF material other articulating haul trucks were transporting clay material for placement in areas that are planned for liner placement.

Photo 18: VLF 2 Phase 2 construction, clay material staging

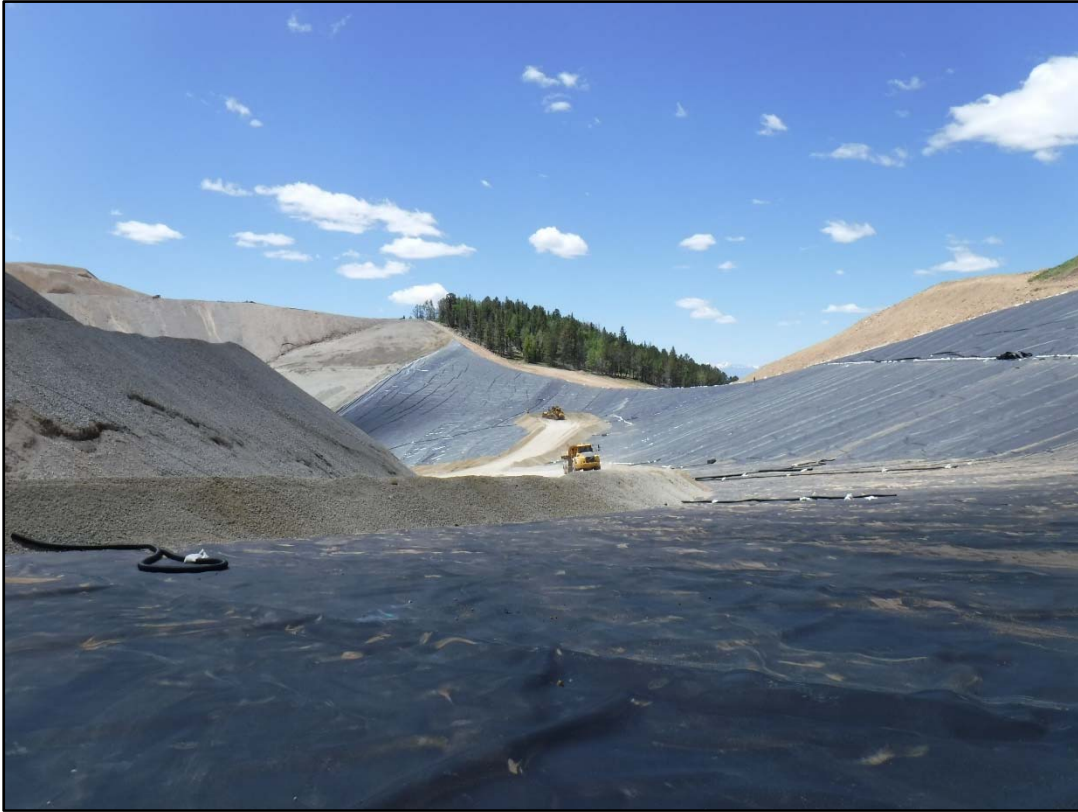
The Division observed the construction activities associated with the new liner construction in the Phase 2 area. The Operator informed the Division that due to weather delays the first volume of the QA/QC Report expected in mid-July has been rescheduled for mid-August. The Division observed hauling and placement of Drain Cover Fill (DCF) using articulating haul trucks. The trucks hauled DCF to LGP dozers that then spread the material out. The trucks travelled on a minimum of 4 foot thick DCF material that had been placed on a geofabric that lied directly on the textured liner. Travelling on thick DCF material is intended to protect the geomembrane liner from damage. As the material was spread by the dozers there were two laborers that watched for material larger than 2-inches and removed any wrinkles in the liner from being buried. The laborers also monitored for DCF thickness. Overseeing the two laborers was a NewFields employee for QA oversight.

Photo 19: VLF 2 Phase 2 construction, DCF hauling and placement

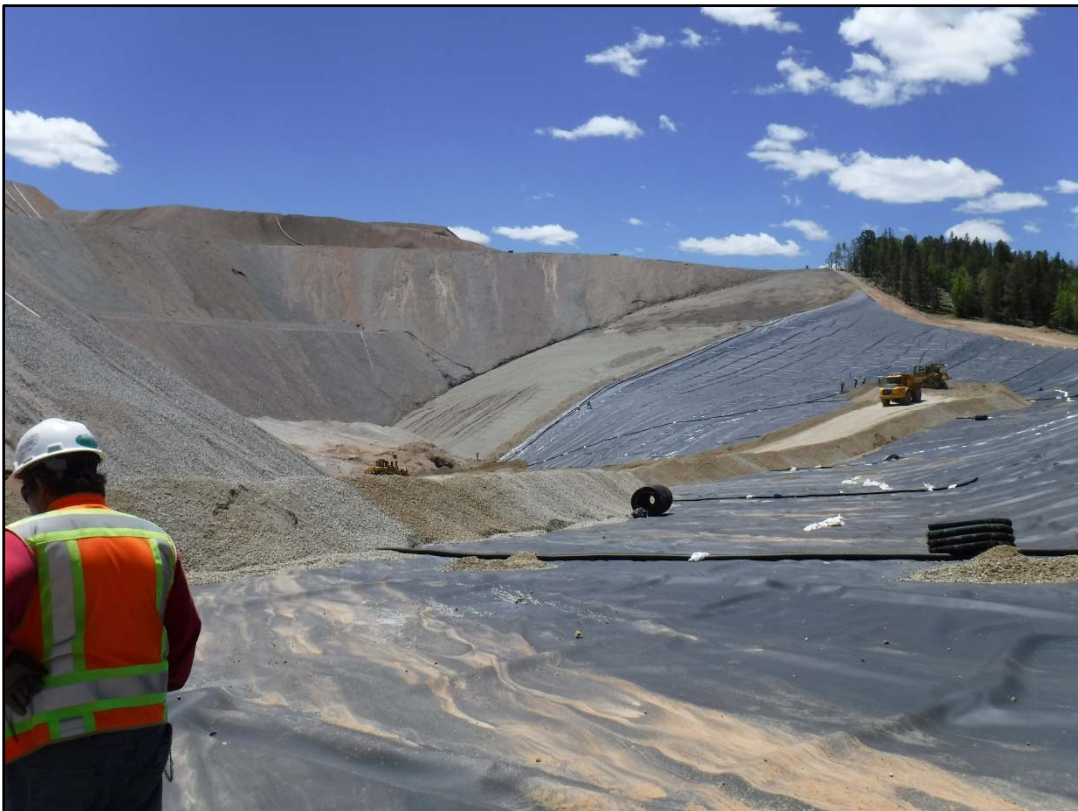
Photo 20: VLF 2 Phase 2 construction, DCF hauling and placement

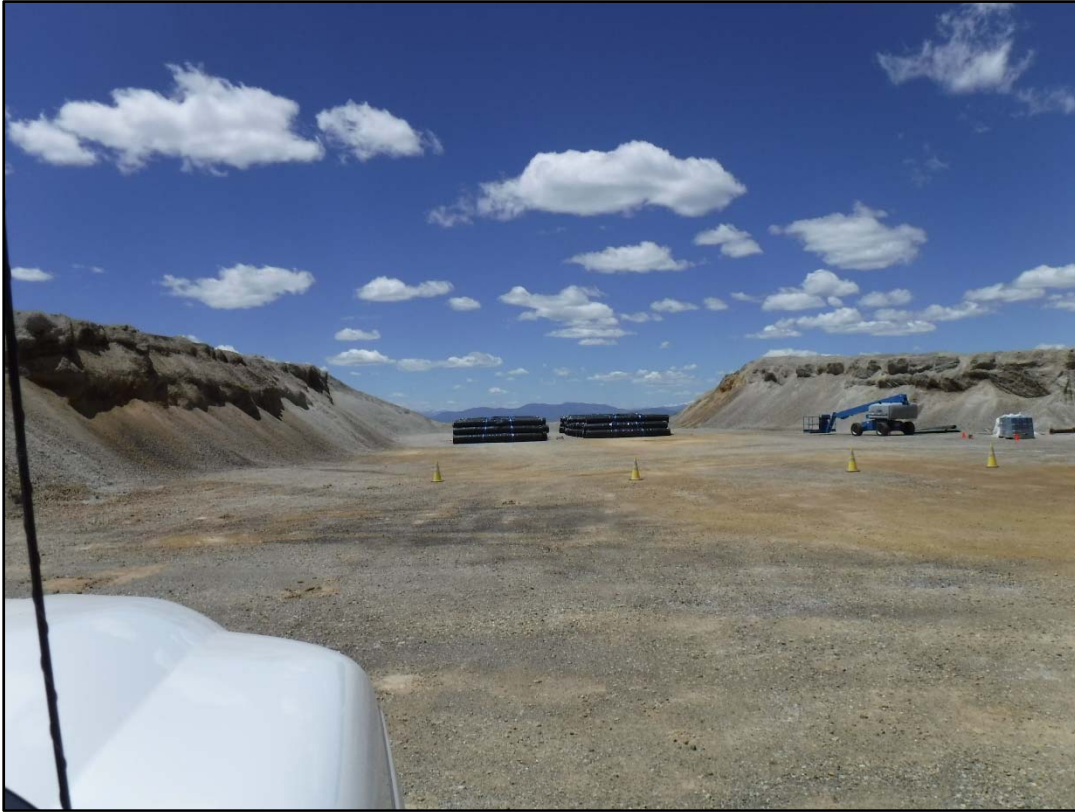
Photo 21: VLF 2 Phase 2 construction, liner storage area

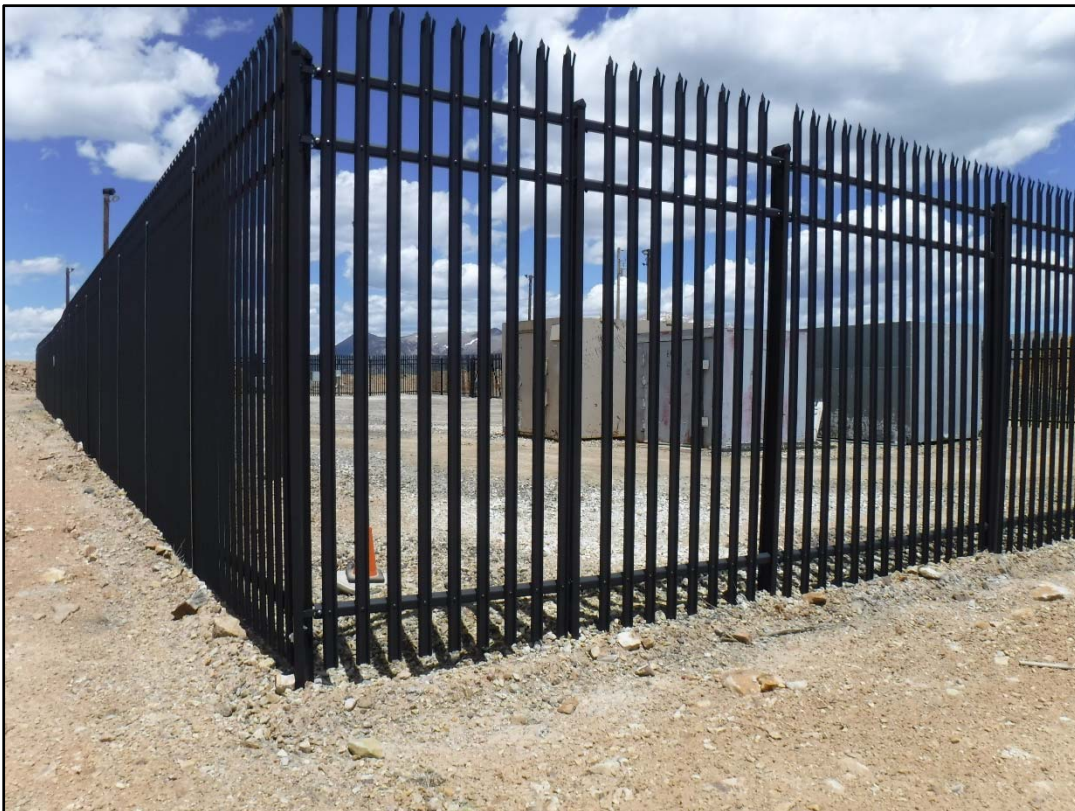
The Division walked the perimeter of the explosives storage area, no problems were observed.

Photo 22: Explosives storage area

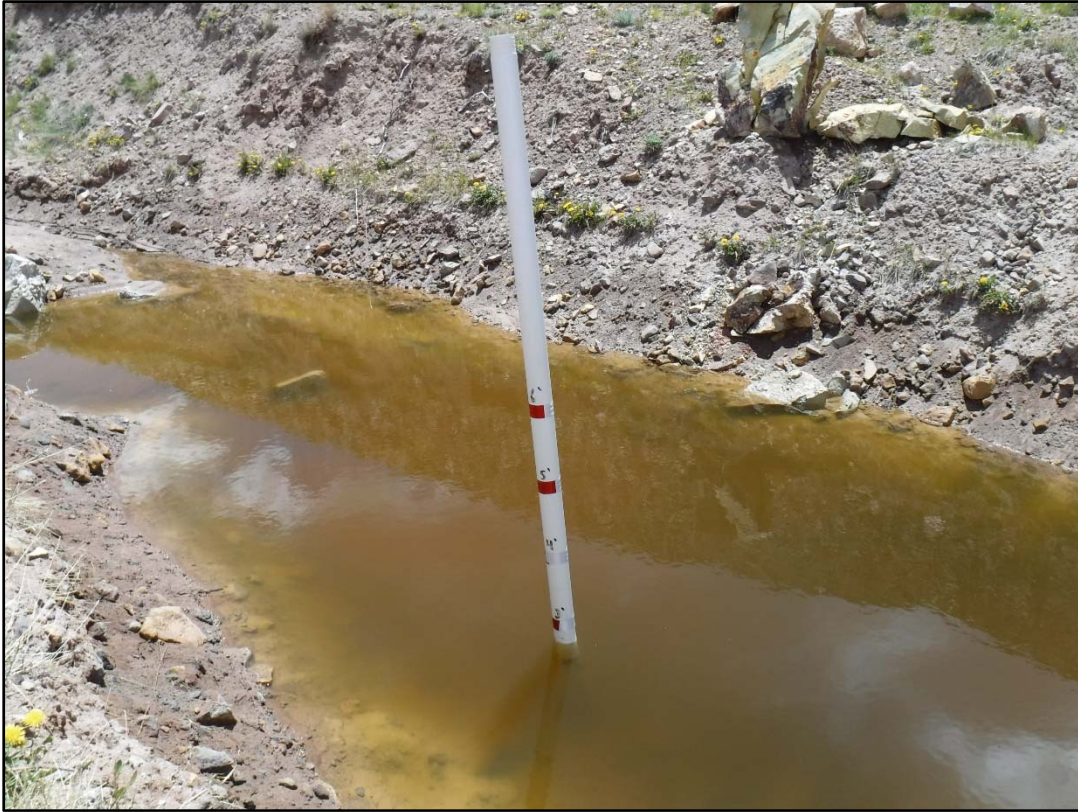
The Division inspected the seep area located at the eastern toe of the ECOSA. The seep accumulation trench was holding water during the inspection. The water was red in color and approximately 2-1/2 feet deep, as measured by a recently installed staff gauge. No water was observed flowing into the trench (within the toe berm of the ECOSA) from the south/southeast. The Operator pumps water out of the trench when they have approximately 5,000 gallons or a full truck volume. They are in the process of investigating the correlation between precipitation and volume seen at the seep and removing full truck volumes at one time aids in the investigation. The Operator removed six truck loads in May and have removed 1-2 truckloads a week during June. Water from the seep is transported and dumped onto a lined facility (one of the valley leach facilities).

Photo 23: Staff gauge installed at ECOSA seep pond

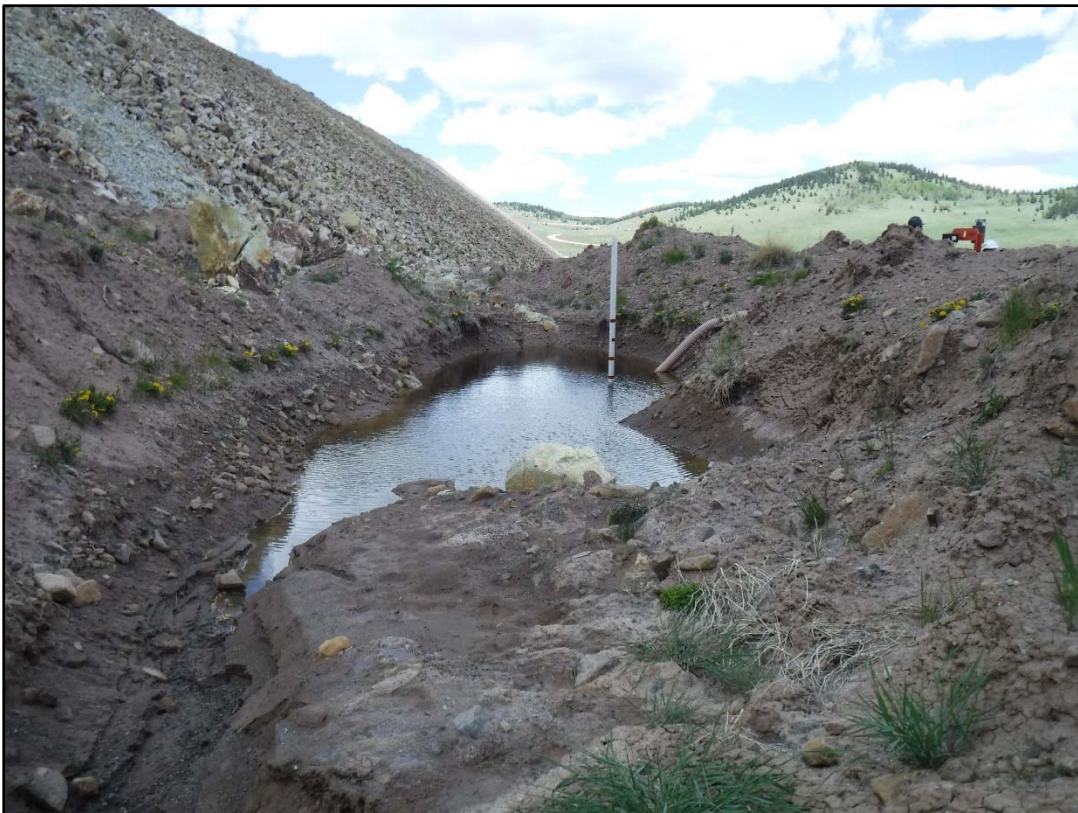
Photo 24: ECOSA seep pond, note no flow coming into pond
