MINERALS PROGRAM INSPECTION REPORT
PHONE: (303) 866-3567

MINE NAME: Well Field Pit	MINE/PROSPECTING ID#: M-1984-154	MINERAL: Sand and gravel	COUNTY: Prowers
INSPECTION TYPE: Monitoring	INSPECTOR(S): Amy Eschberger	INSP. DATE: March 27, 2019	INSP. TIME: 09:15
OPERATOR: City of Lamar	OPERATOR REPRESENTATIVE: Patrick Mason, Martin Montoya	TYPE OF OPERATION: 110c - Construction Limited Impact	
REASON FOR INSPECTION: Normal I&E Program	BOND CALCULATION TYPE: None	BOND AMOUNT: \$0.00	
DATE OF COMPLAINT: NA	POST INSP. CONTACTS: None	JOINT INSP. AGENCY: None	
WEATHER: Clear	INSPECTOR'S SIGNATURE:

M-1984-154 / Well Field Pit / City of Lamar

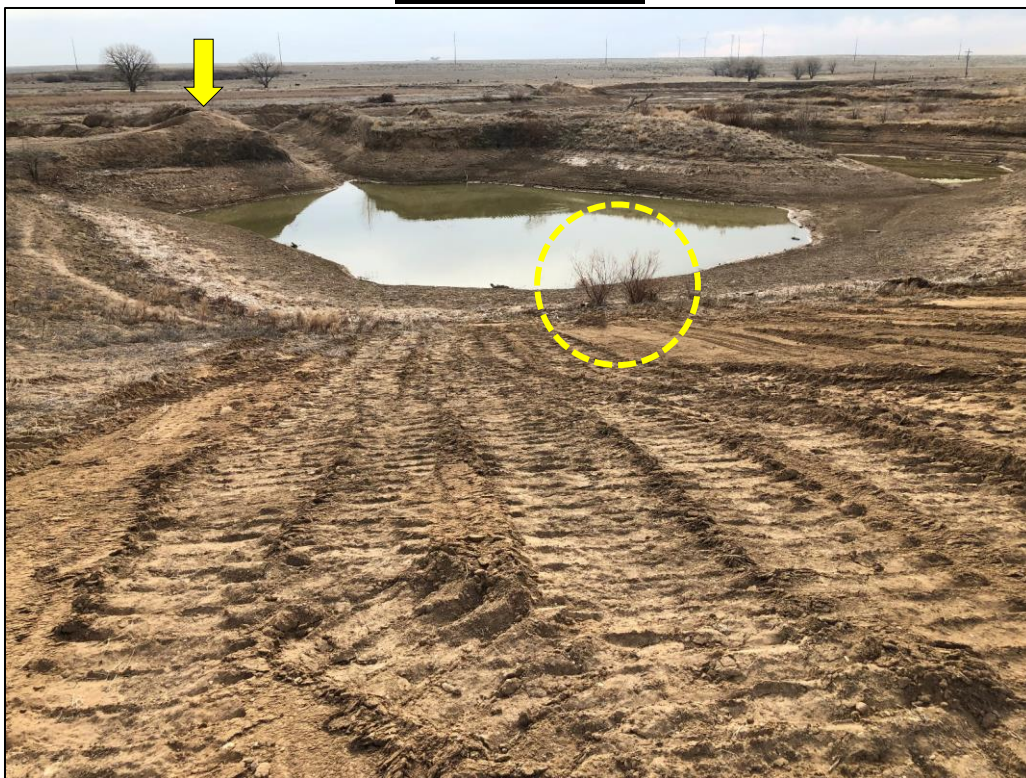
All disturbed land has been graded to the approved final slope configuration of 3H:1V or flatter, except for one knob that protrudes into the recharge pond along the northern shoreline of the expanded pit (at the northeastern

edge of the permit area). The operator will need to level off this portion of the pond shoreline to the required 3H:1V slope gradient and seed the area with the approved seed mixture. The operator expressed concerns about knocking dirt from the steep knob into the recharge pond, and will therefore, work to grade the knob away from the pond (northward) with an excavator. This work was expected to be conducted later this spring.

Photo 1. View looking east across recharge pond in northern portion of permit area. Note section of pond bank in foreground that was redisturbed for erosion repair, and will need to be reseeded. Steep knob requiring grading shown in background (indicated). Early growth Tamarisk trees present near base of pond slope (circled).

In summary, remaining reclamation at the site includes grading off the steep shoreline knob to 3H:1V, and revegetating this area and the two sections of the pond bank that were recently redisturbed. The operator should be aware that Rule 3.1.3 requires all reclamation to be carried to completion by the operator with all reasonable diligence, and each phase of reclamation be completed within 5 years from the date the operator informs the Division that such phase has commenced. The operator informed the Division that mining operations were completed at the site in 2010, which was more than 5 years ago now. Therefore, the Division strongly encourages the operator to complete final reclamation of the site and request full release of the permit once the desired vegetation has established in reseeded areas.

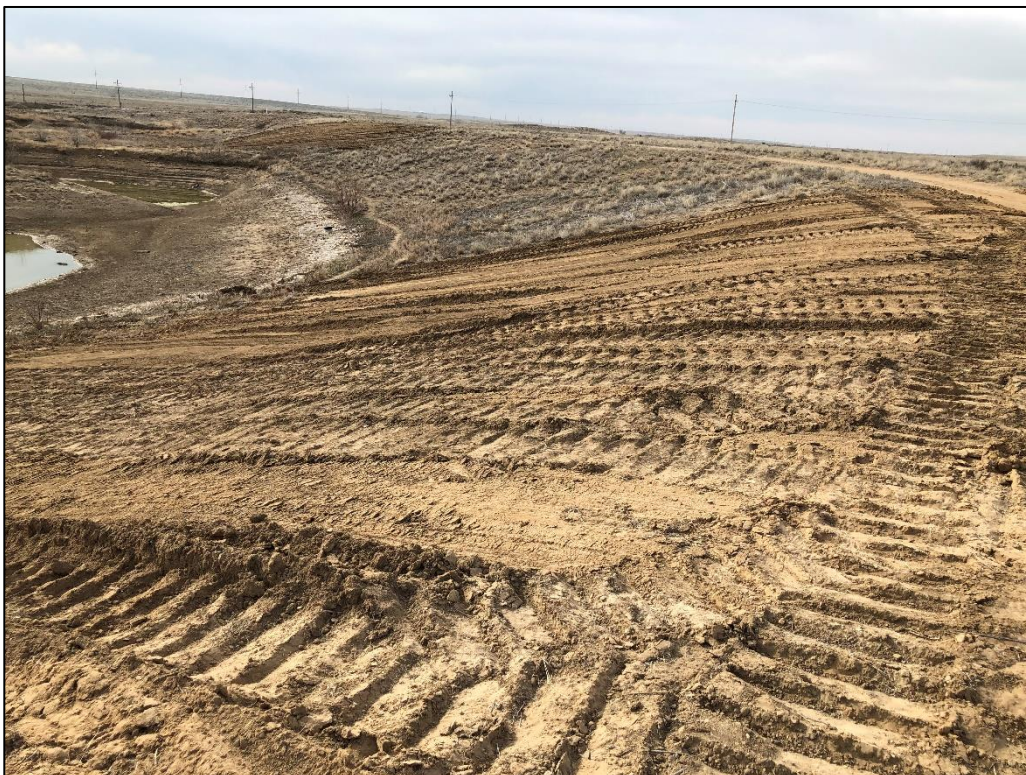
Photo 2. View looking southeast across redisturbed section of pond bank. Note slopes graded 3H:1V or flatter.

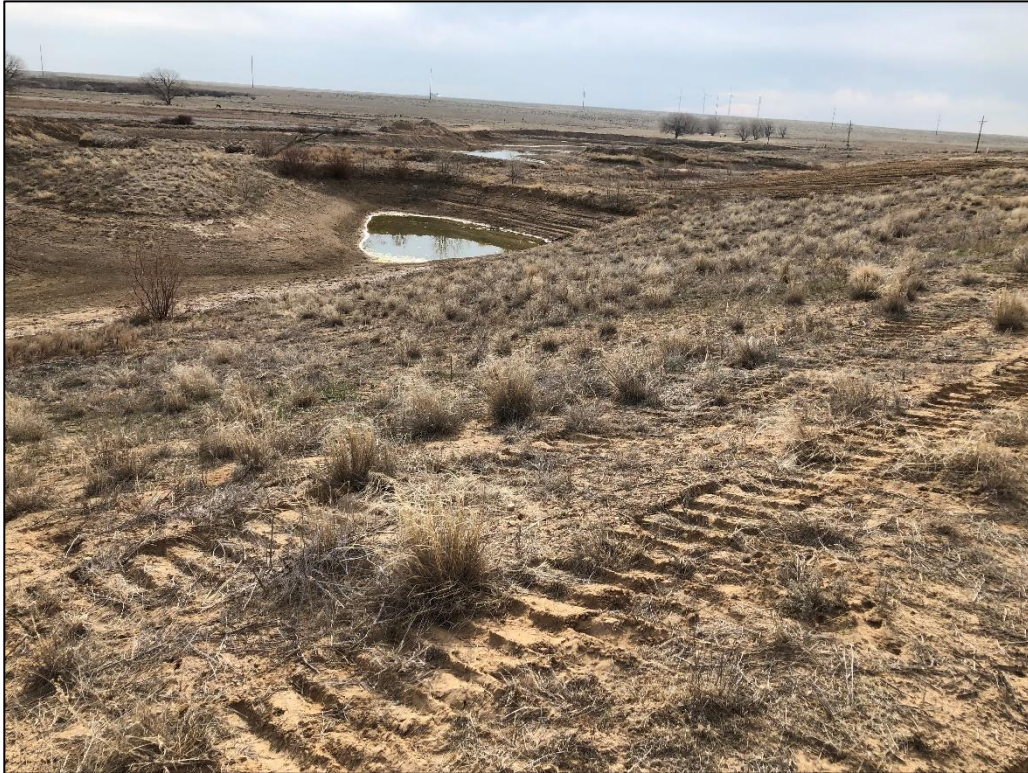
Photo 3. View looking southeast across reclaimed western pond bank. Note top portion of slope somewhat disturbed by dozer tracks.

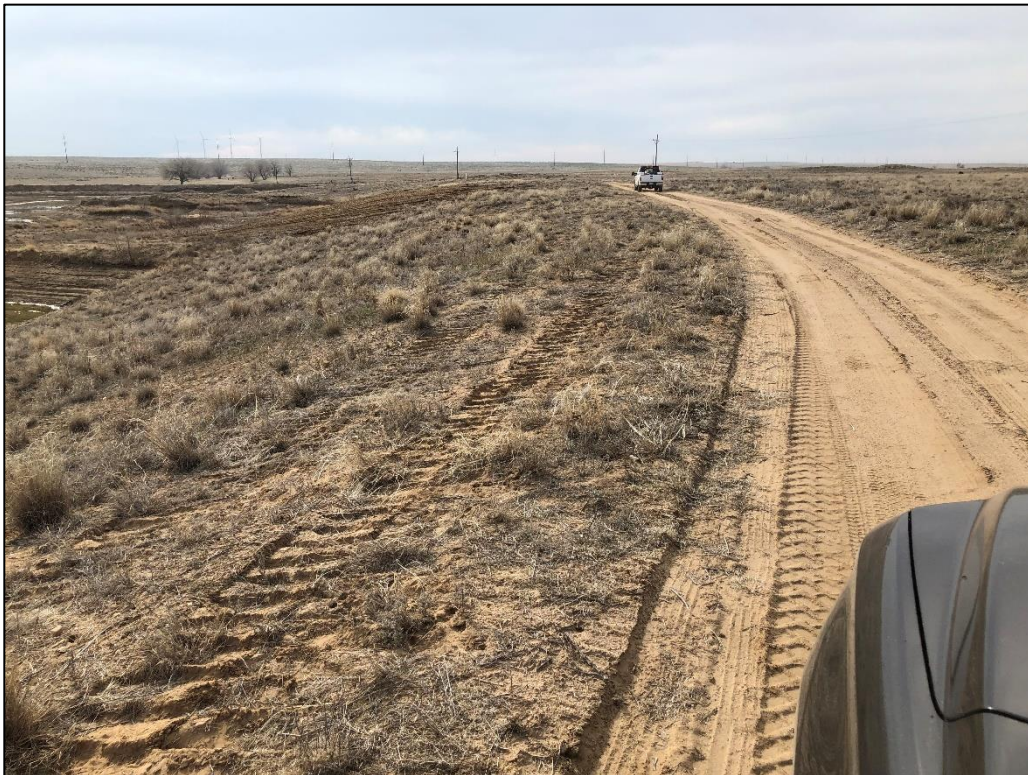
Photo 4. View looking southeast across reclaimed western pond bank. Note pond access road (at right) to remain after reclamation for continued use by the City.

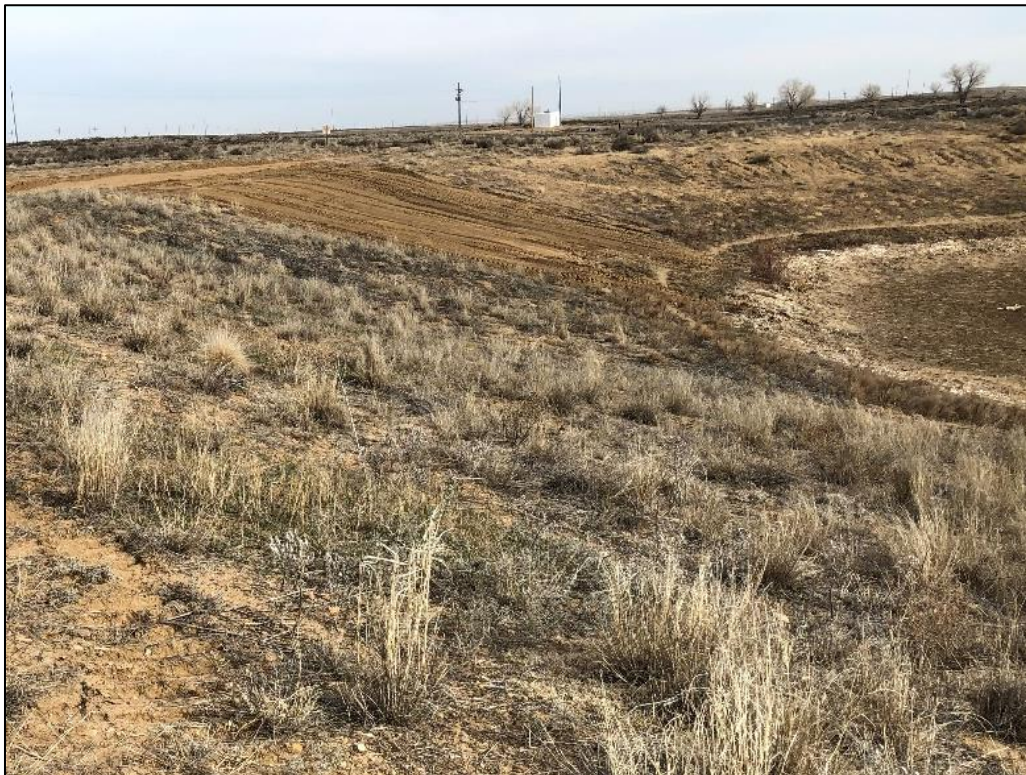
Photo 5. View looking northwest across reclaimed western pond bank. Note redisturbed section of pond bank (in background) which will require reseeding.

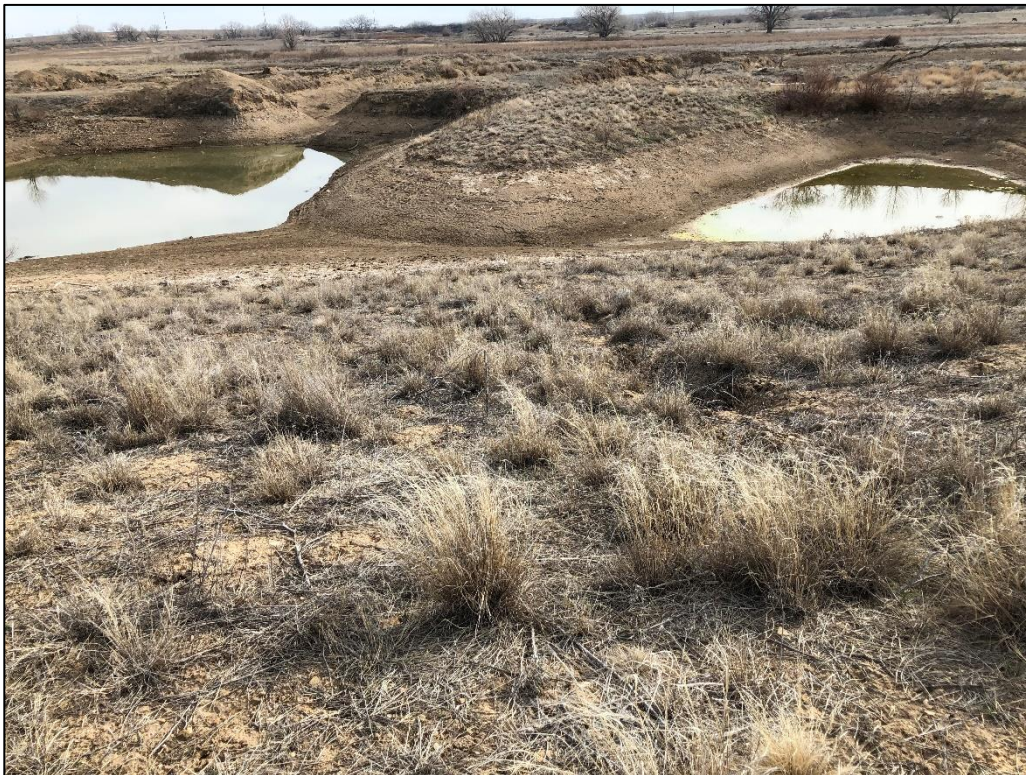
Photo 6. View looking east across recharge pond, showing reclaimed western pond bank (in foreground) and eastern pond bank (in background).

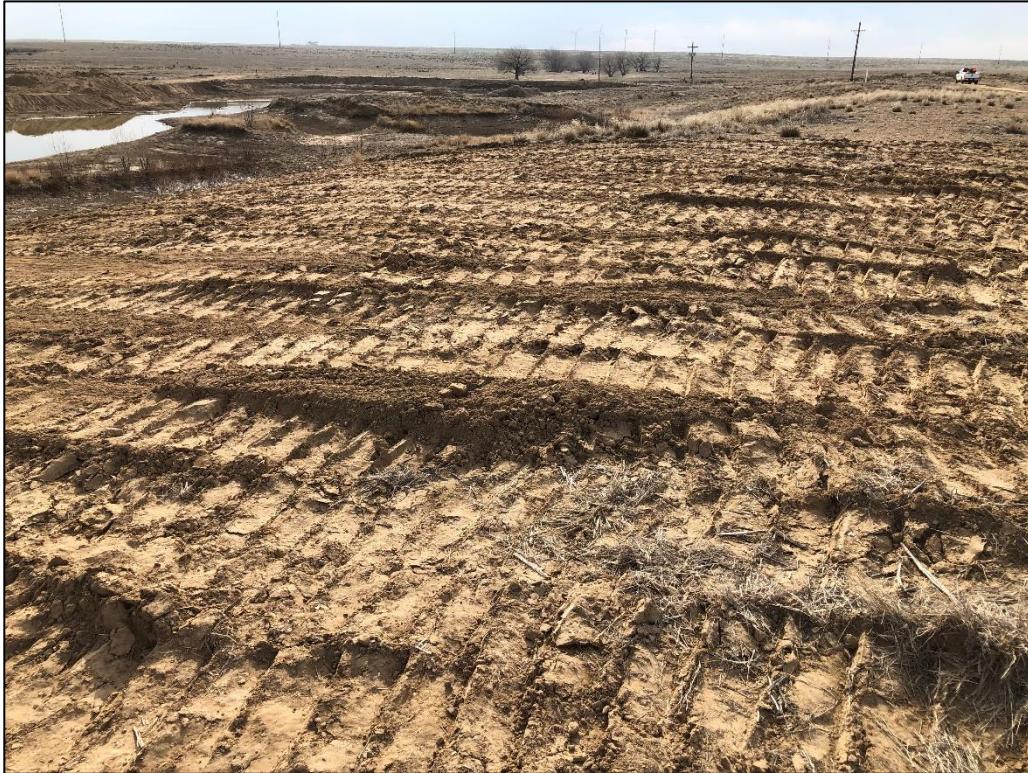
Photo 7. View looking southeast across other section of western pond bank redistributed by operation for erosion repair which will require reseeding.

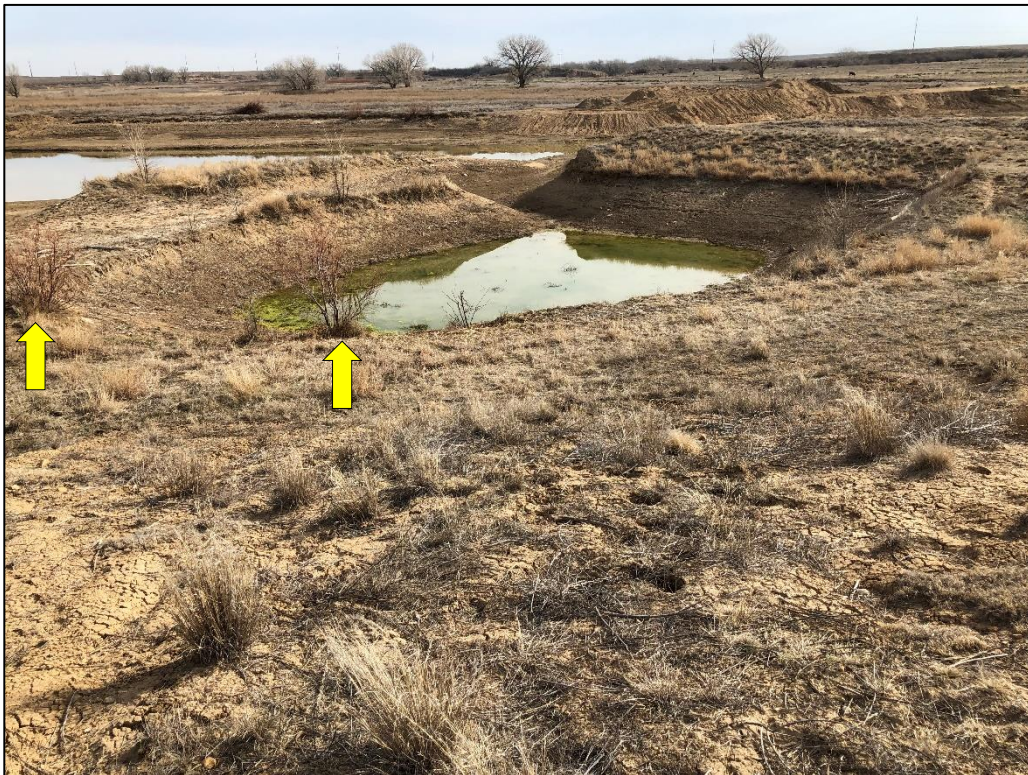
The operator had retopsoiled and seeded all disturbed lands on site prior to the Division's last inspection conducted on August 14, 2014. However, during that inspection, the Division observed primarily weeds growing along the pond slopes, and recommended the operator reseed these areas. During the current inspection, the Division observed the pond slopes to have a good establishment of native grasses. However, two sections of the western pond bank were recently redisturbed by the operation to repair erosion gullies that had developed in these areas. These sections were graded to 3H:1V, but had not yet been reseeded. The operator indicated they intend to seed these areas and the area where the steep knob will be leveled off this spring. It should be noted, a few early growth Tamarisk trees were observed growing near the bottom edge of the reclaimed pond slope. Because Tamarisk is a state-listed noxious weed species, these trees will need to be removed as soon as possible. The Division will not be able to release the site with state-listed noxious weed species present.

Photo 8. View looking northeast across recharge pond in southern portion of permit area. Note early growth Tamarisk trees present at base of pond slope (indicated) which need to be removed.

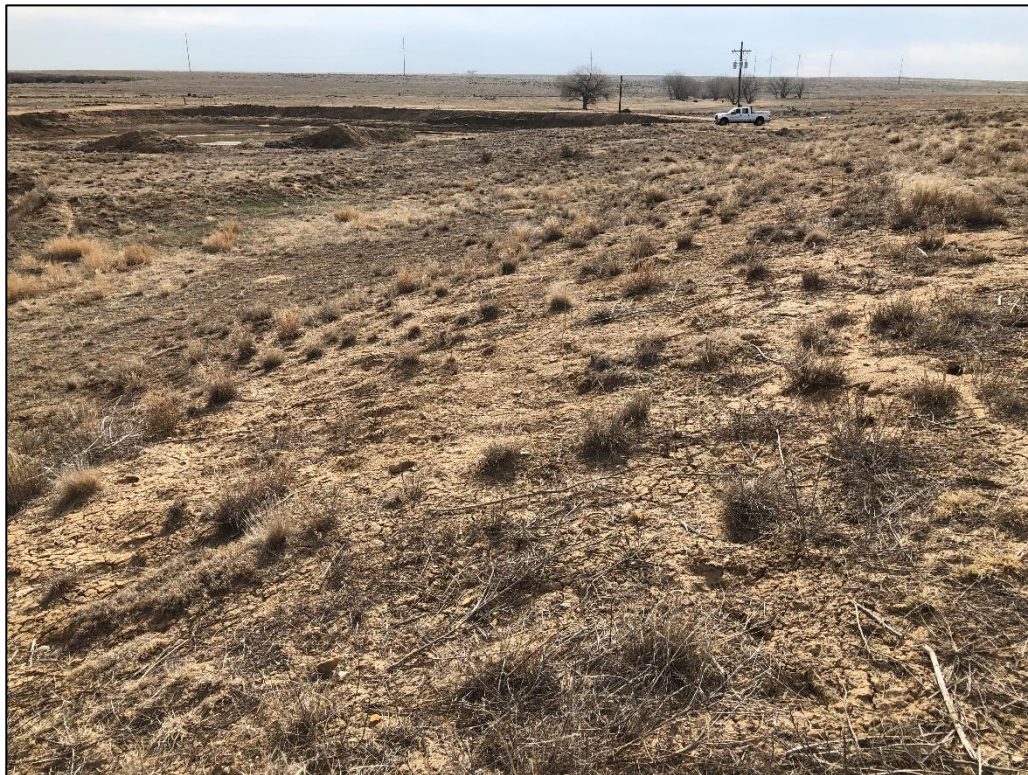
Photo 9. View looking southeast across reclaimed western pond bank in southern portion of permit area.

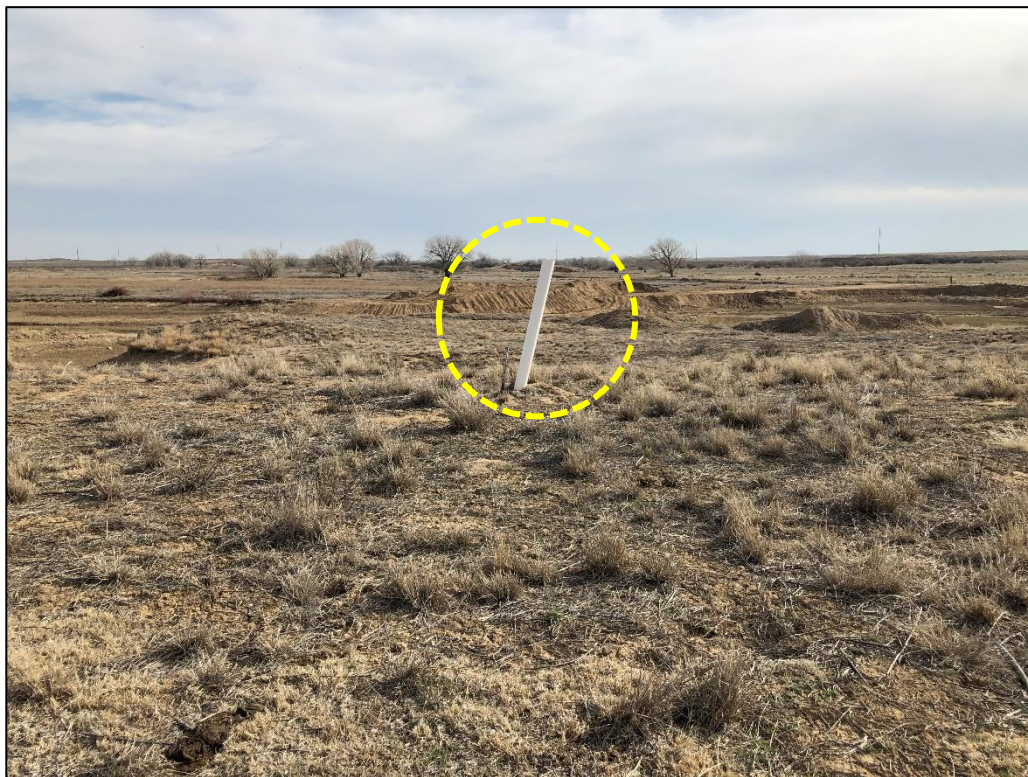
Photo 10. View of large white post (circled) marking southwestern corner of permit boundary.

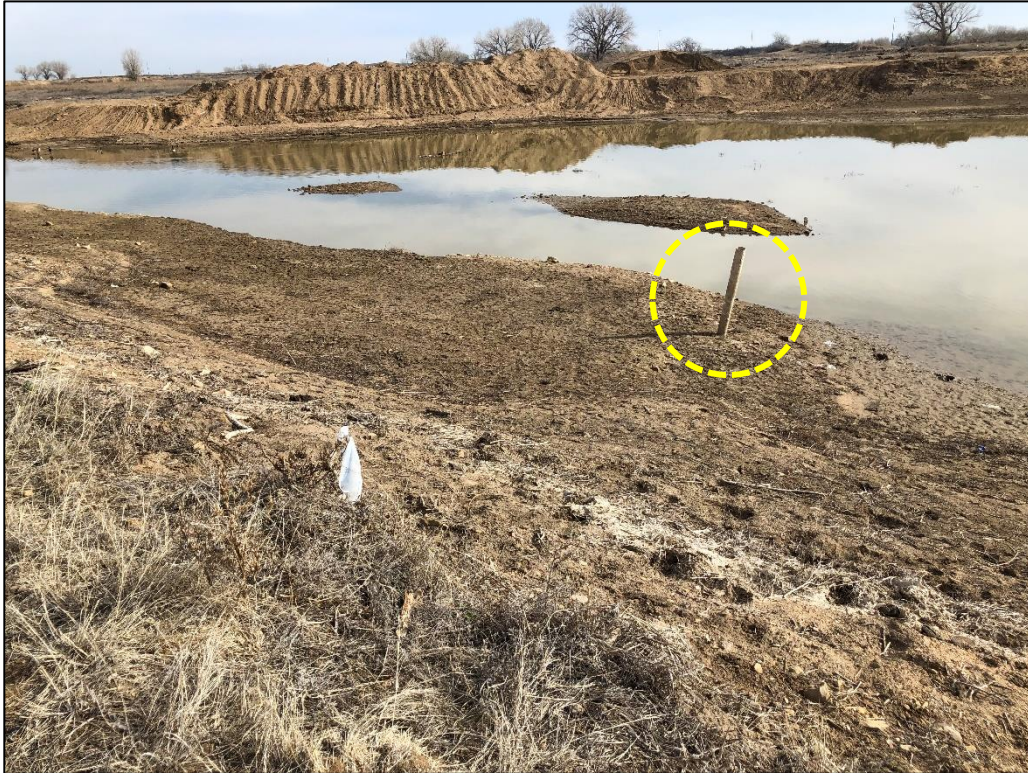
Photo 11. View looking northeast, showing large white post (circled) marking southeastern corner of permit boundary, which is typically submerged when pond is filled with water.

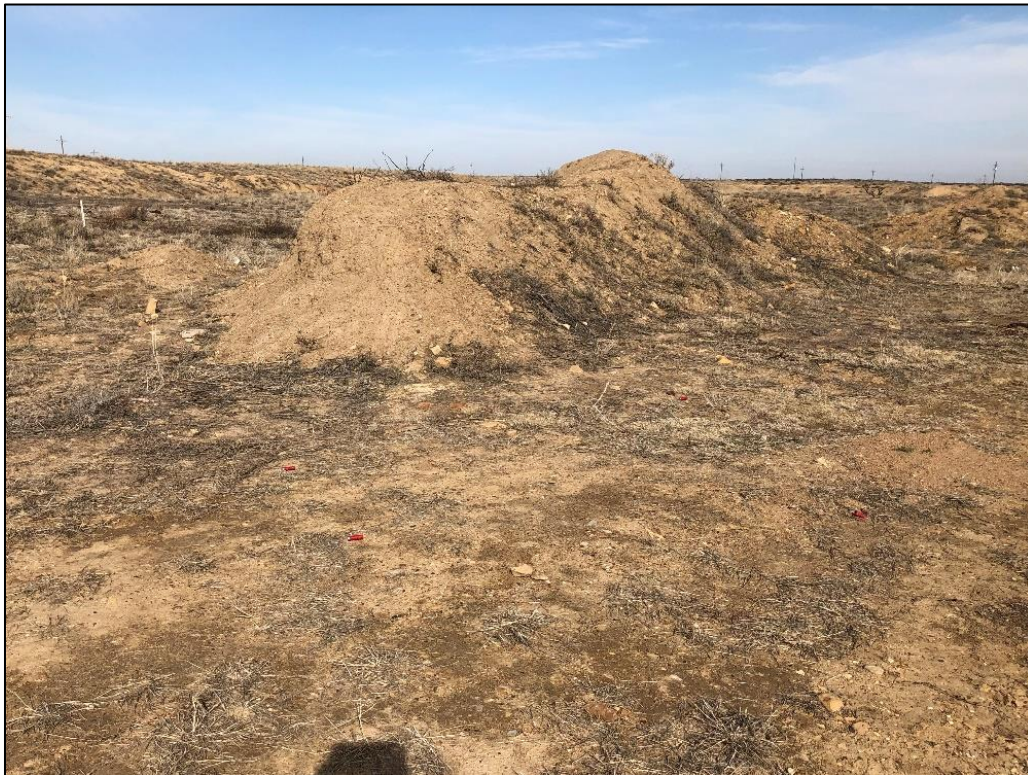
All stockpiles have been removed from the site or used for reclamation of the site, except for a few small, low-lying stockpiles present in the southern portion of the permit area. The operator inquired during the inspection about leaving these small stockpiles for reclamation so the City could use this material to maintain site roads, as needed. Given the small footprint of the stockpiles and proposed use of the material on site for continued maintenance of the City's roads, the Division was not opposed to the stockpiles remaining for reclamation.

Photo 12. View looking west at small material stockpiles left in southern portion of permit area, which could be left for reclamation given their small footprint and proposed use for continued maintenance of site roads.
