**COLORADO**  
Division of Reclamation,  
Mining and Safety  
Department of Natural Resources

<b>Permit Number:</b> C-1981-035 <b>Mine Name:</b> King Coal Mine <b>Operator:</b> GCC Energy, LLC <b>Operator Address:</b> Mr. Tom Bird 6473 County Road 120 Hesperus, CO 81326	<b>County:</b> La Plata <b>Operation Type:</b> Underground <b>Permit Status:</b> Active <b>Ownership:</b> Federal
	<b>Operator Representative Present:</b>  Jordan McCourt
<b>Operator Representative Signature: (Field Issuance Only)</b>

<b>Inspection Start Date:</b> November 8, 2018 <b>Inspection Start Time:</b> 08:00 <b>Inspection End Date:</b> November 8, 2018 <b>Inspection End Time:</b> 15:00		<b>Inspection Type:</b> Coal Complete Inspection <b>Inspection Reason:</b> Normal I&E Program <b>Weather:</b> Clear	
<b>Joint Inspection Agency:</b>  None		<b>Joint Inspection Contacts:</b>	
<b>Post Inspection Agency:</b>  None		<b>Post Inspection Contacts:</b>	
<b>Inspector(s):</b>  Brock F. Bowles	<b>Inspector's Signature:</b>

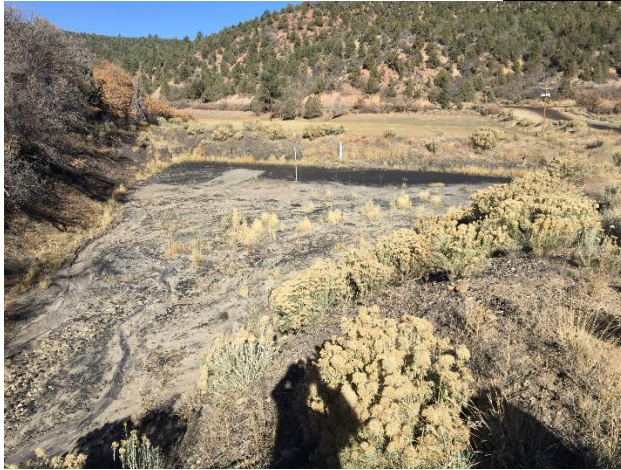
Photo 1 – King I West Pond

The west pond did not contain water and the embankment appeared stable (photo 1).

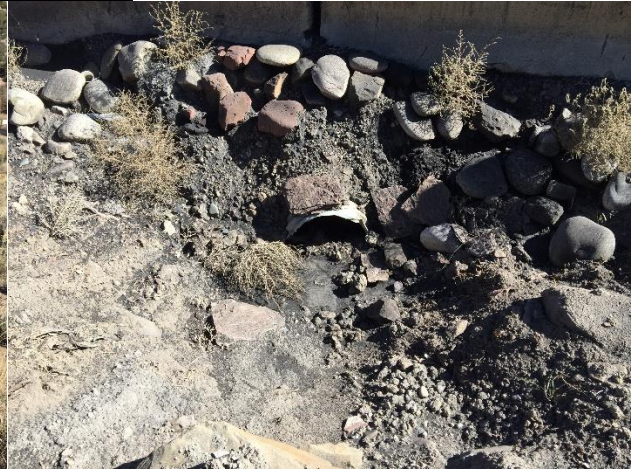
Photo 2 – King II Culvert C5 Inlet

The inlets to C5 (photo 2) and C13 had sediment built up and need to be cleaned.

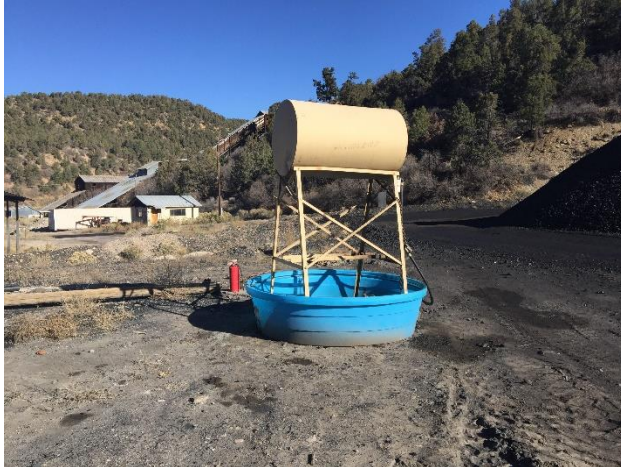
Photo 3 – King I Fuel Tank

The fuel tank was in a spill containment device (photo 3).

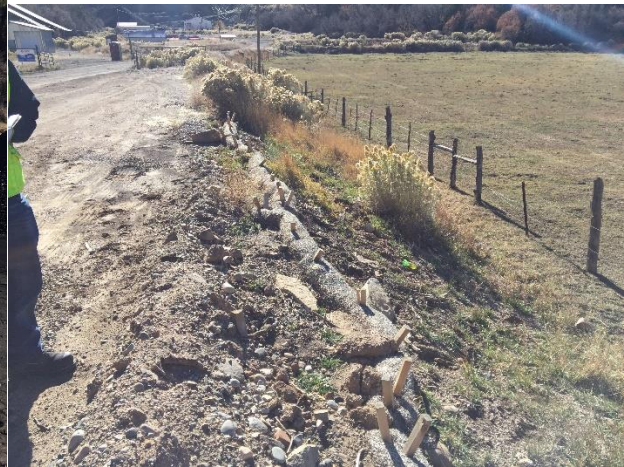
Photo 4 – King I Haul Road Wattles

The haul road was well maintained. The silt fence on the east side was in working order. The wattles on the west side of the road need to be repaired (photo 4).
