MINERALS PROGRAM INSPECTION REPORT

MINE NAME: Parkdale Project	MINE/PROSPECTING ID#: M-1997-054	MINERAL: Sandstone (silica, stone, quartzite), gravel and granite, granite gneiss	COUNTY: Fremont
INSPECTION TYPE: Monitoring	INSPECTOR(S): Timothy A. Cazier	INSP. DATE: June 18, 2019	INSP. TIME: 12:30
OPERATOR: Front Range Aggregates, LLC	OPERATOR REPRESENTATIVE: Josh Esquivel	TYPE OF OPERATION: 112c - Construction Regular Operation

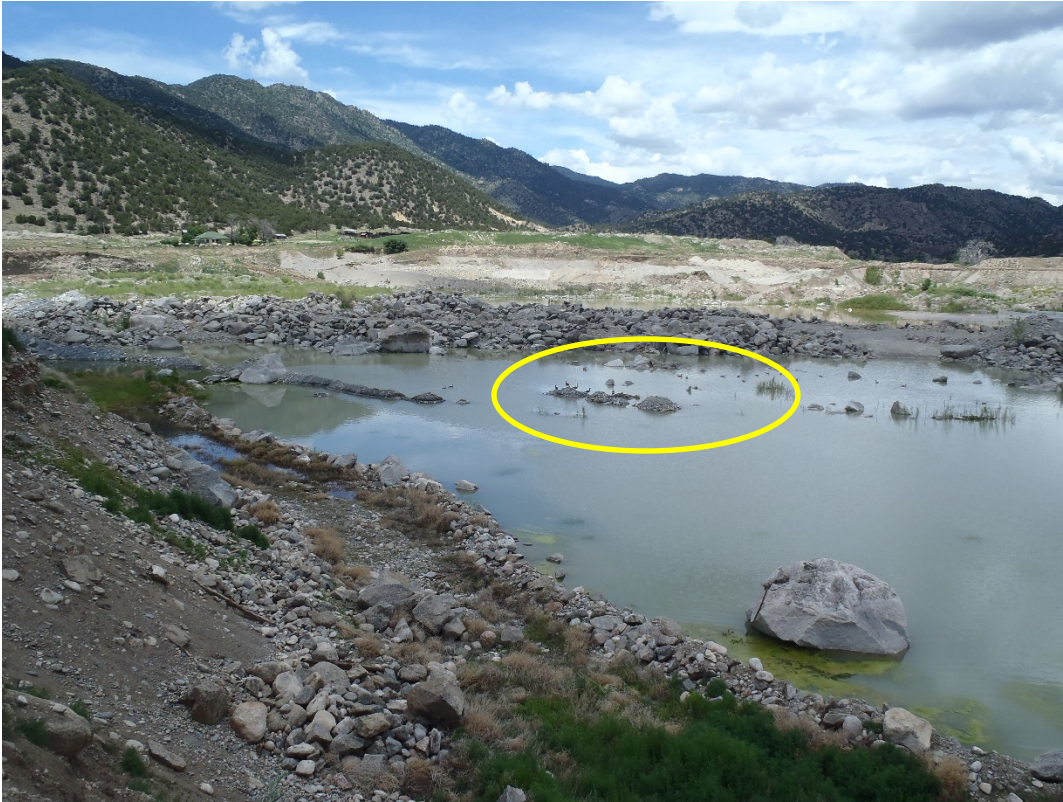
PROBLEM/POSSIBLE VIOLATION: Problem: The Division has no evidence that the operator has a current substitute water supply plan, or approved water augmentation plan for the exposed groundwater at the site. This is a problem related to 34-32.5-116(4)(h) of the Colorado Revised Statutes and 3.1.6(1)(a) of the Construction Materials Rules and Regulations governing injury to existing water rights.

Fish and Wildlife: No impact to wildlife was observed. Canada geese were observed in the water observed in the pit (see **Photo 1**).

Hydrologic Balance: Standing water was observed in the pit and believed to be exposed groundwater (see **Photos 1 and 2**). Mr. Esquivel stated he believed they have an approved substitute water supply plan (SWSP). However, the DRMS has no record of either an approved augmentation plan or a currently approved SWSP. The last SWSP received by the DRMS expired 9/30/2018. **The lack of an approved plan is cited as a problem on page 1 of this report.**

Photo 1. Exposed groundwater in main pit (looking NW, note geese, circled).

CORRECTIVE ACTIONS: The operator shall demonstrate that the operation is in compliance with the Office of the State Engineer, show evidence that the operator is taking measures to bring the site into compliance with the SEO, or backfill the pits to at least two feet above the groundwater surface by the corrective action date specified.

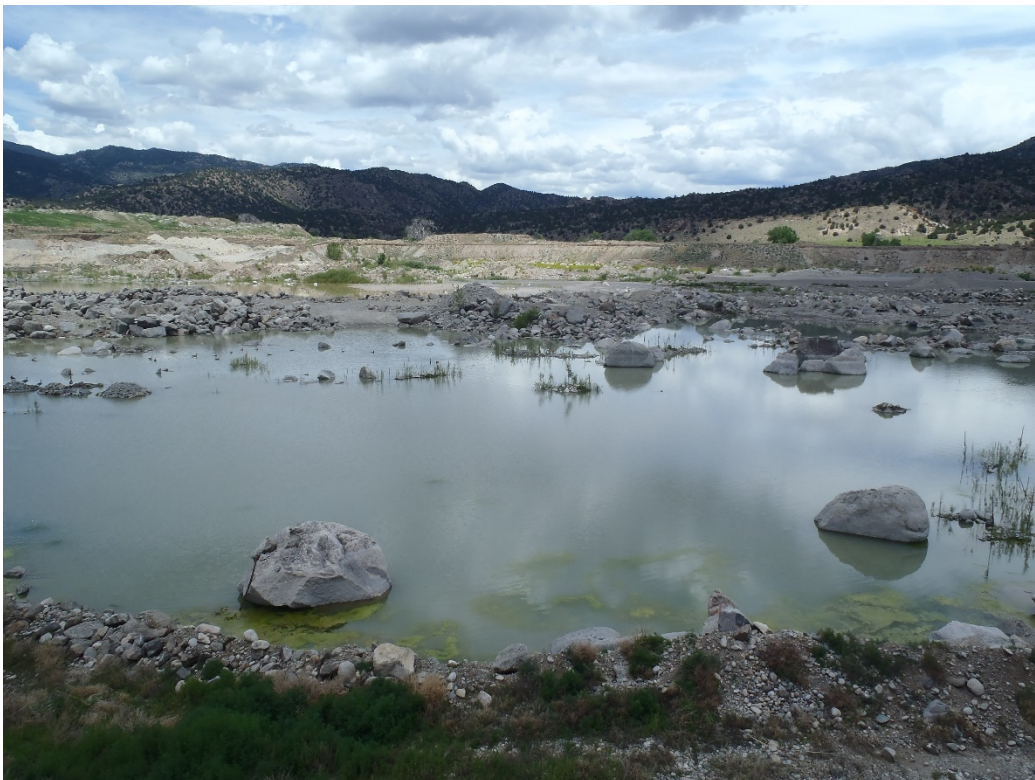
Photo 2. Exposed groundwater in main pit (looking north).

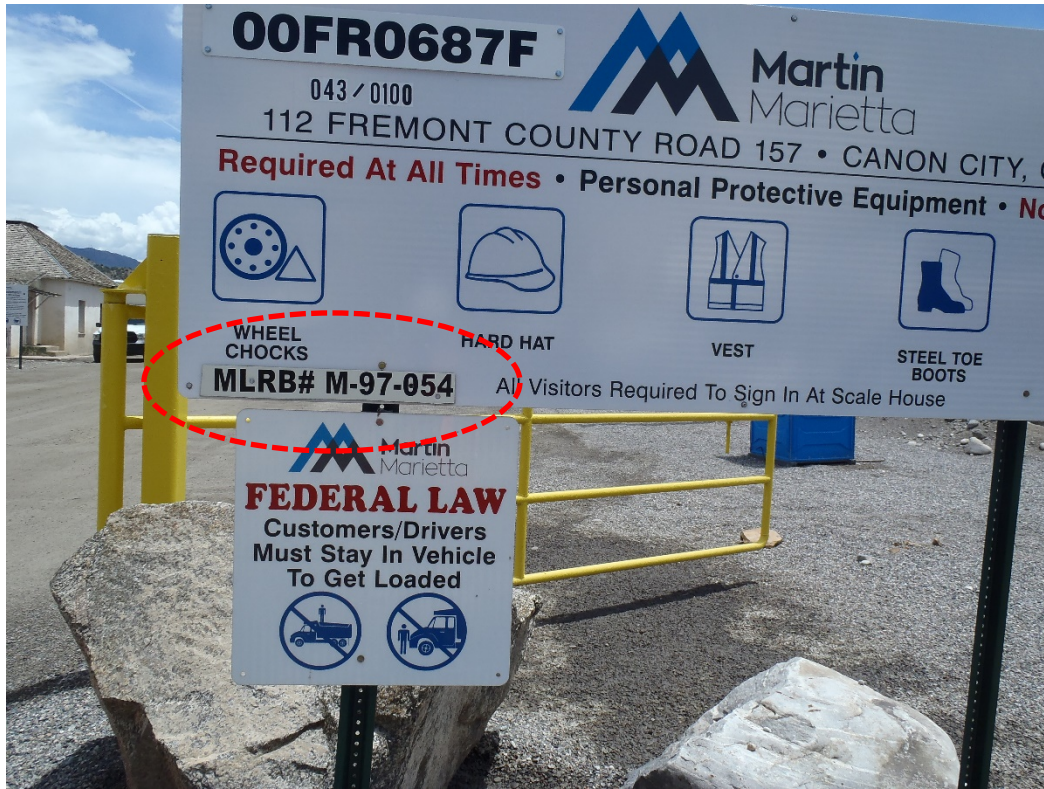
Signs and Markers: The permit sign was properly posted (see **Photo 3**).

Photo 3. Permit sign (near scale house).
