MINERALS PROGRAM INSPECTION REPORT
PHONE: (303) 866-3567

MINE NAME: Lamar East Pit	MINE/PROSPECTING ID#: M-1977-572	MINERAL: Sand and gravel	COUNTY: Prowers
INSPECTION TYPE: Monitoring	INSPECTOR(S): Amy Eschberger	INSP. DATE: March 27, 2019	INSP. TIME: 10:40
OPERATOR: City of Lamar	OPERATOR REPRESENTATIVE: John Sutherland	TYPE OF OPERATION: 112c - Construction Regular Operation	
REASON FOR INSPECTION: Normal I&E Program	BOND CALCULATION TYPE: None	BOND AMOUNT: \$0.00	
DATE OF COMPLAINT: NA	POST INSP. CONTACTS: None	JOINT INSP. AGENCY: None	
WEATHER: Clear	INSPECTOR'S SIGNATURE:

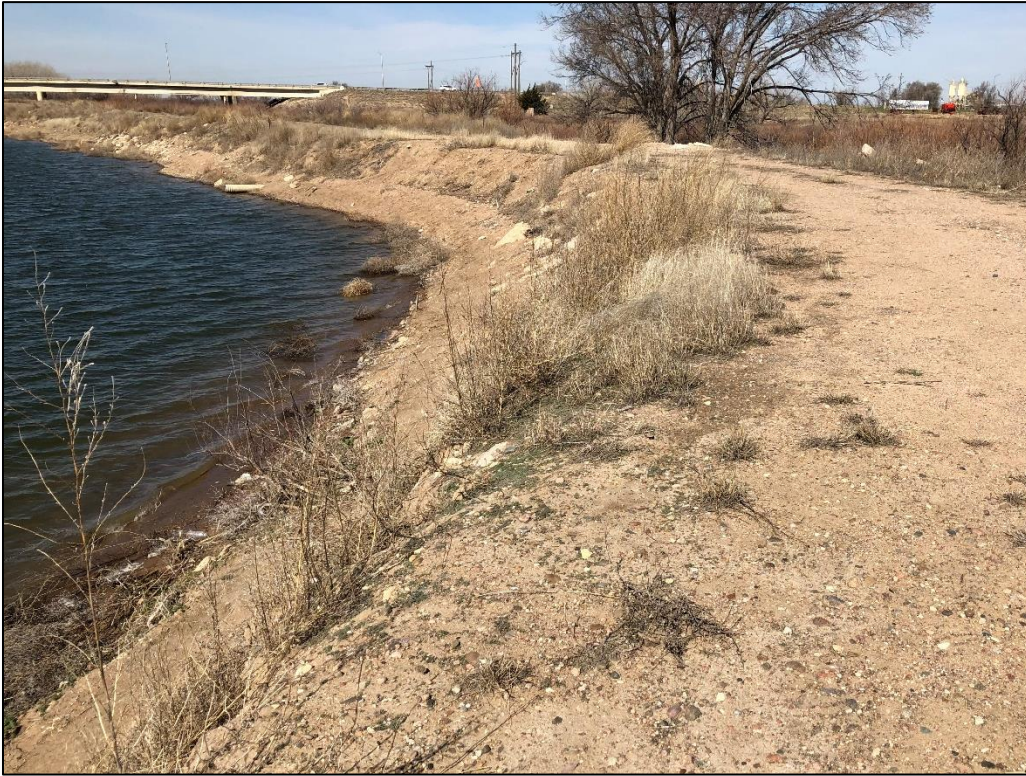
During the current inspection, it appeared that dirt and rock material had been placed in the gullies that were previously observed along the northern shoreline of the western pond. The northern shoreline has slopes of approximately 2.5H:1V for the top 5-6 feet, and flatter slopes for the lower few feet (below the high water line). Because the operator has repaired the erosion damage, a problem will not be cited in this report. However, continued erosion control efforts on this shoreline/berm will be necessary for protecting the stability of this critical flood control feature. The Division recommends the operator review the erosion control/bank stabilization methods provided in Technical Revision No. 2 (approved January 11, 2012) for flood mitigation and reclamation grading at the site. If the operator wishes to propose alternative erosion control measures from what has been approved, this proposal must be submitted in the form of a Technical Revision.

Photo 1. View looking west along northern shoreline of western pond, where erosion damage was repaired since 2017 inspection. Top 5-6 feet of pond slopes at approx.. 2.5H:1V, with flatter slopes along bottom few feet (below high waterline).

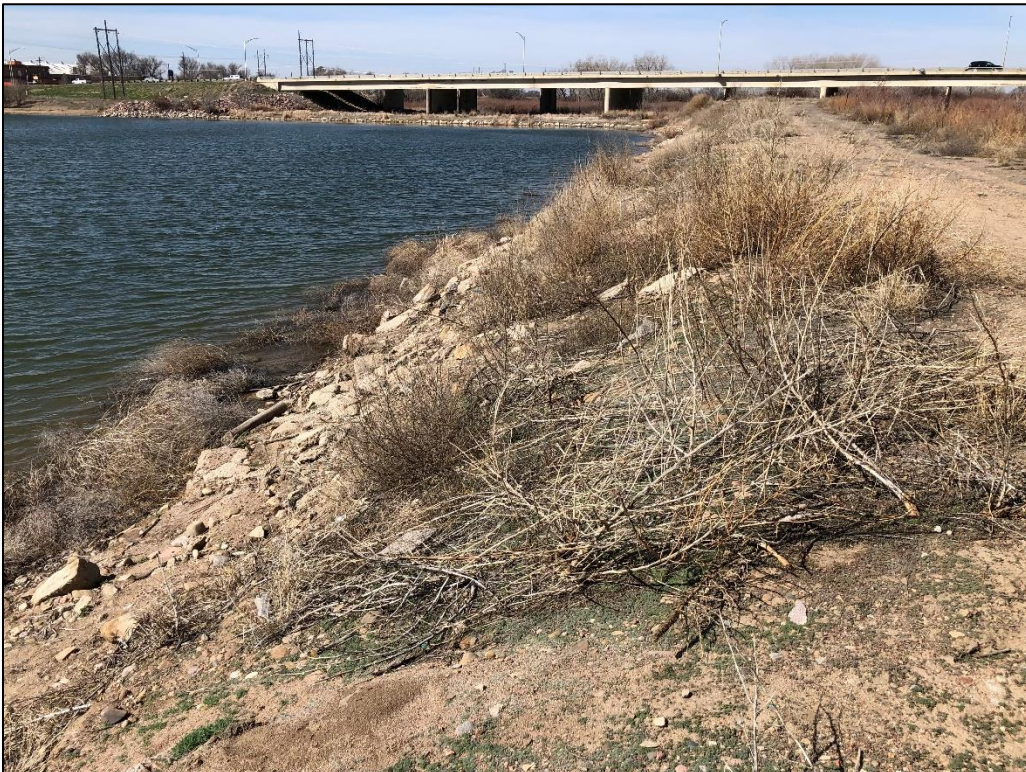
Photo 2. View looking west along northern shoreline of western pond (at a point further west than in Photo 1), where erosion damage was repaired since 2017 inspection.

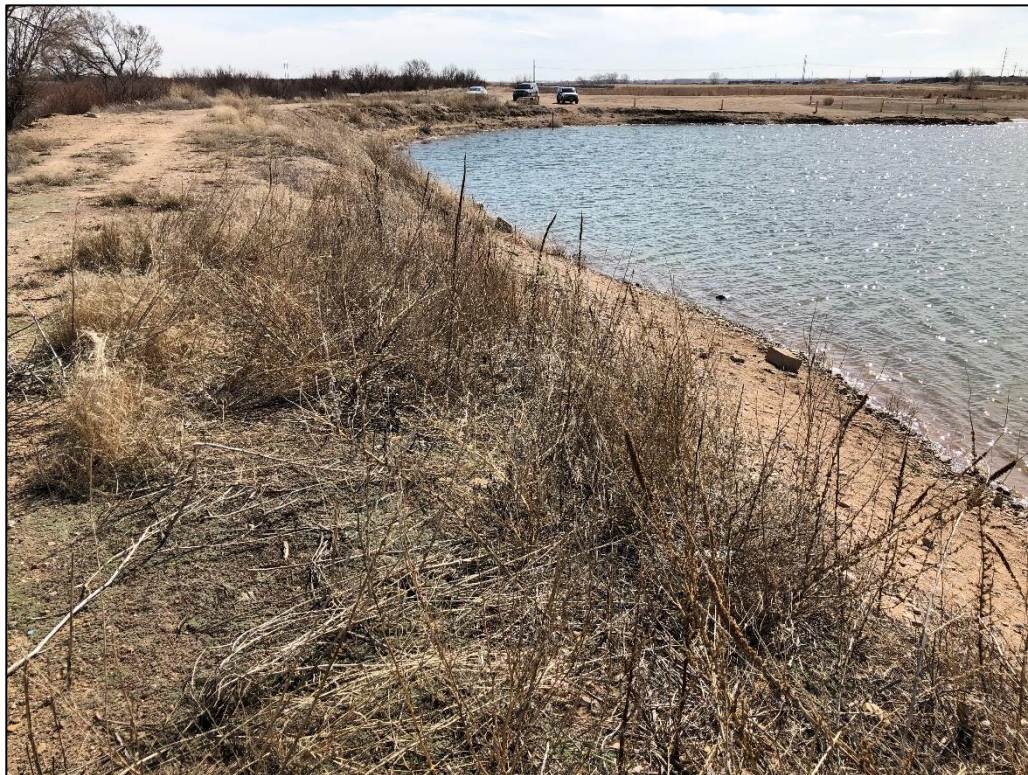
Photo 3. View looking east along northern shoreline of western pond, where erosion damage was repaired since 2017 inspection.

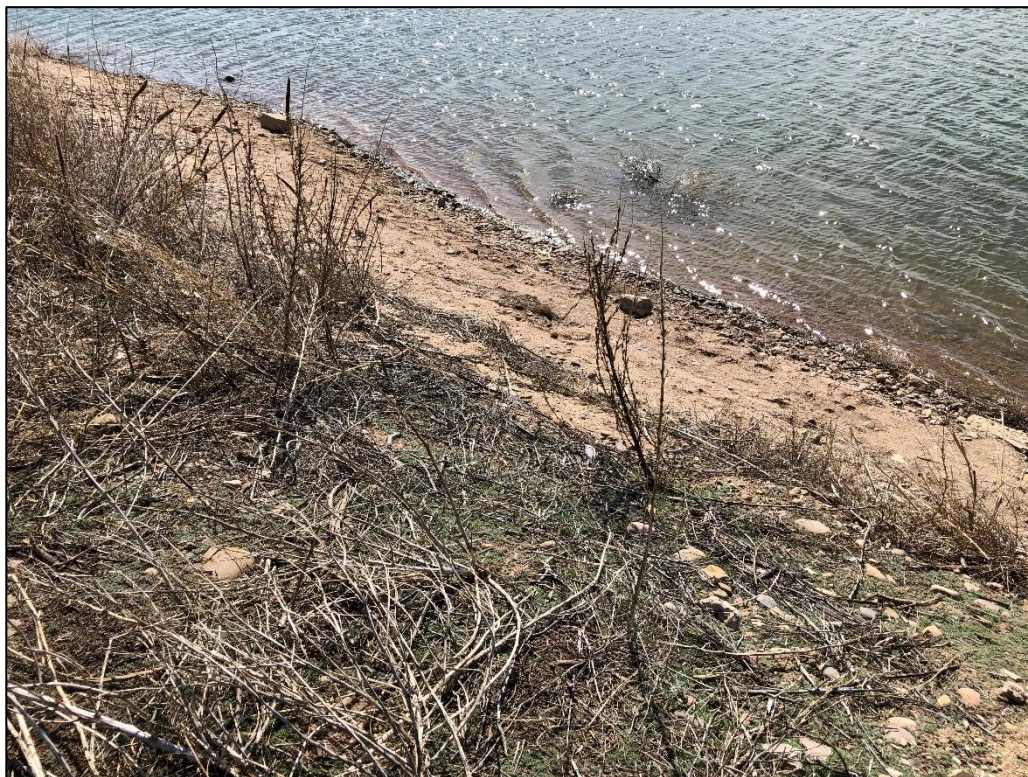
Photo 4. View looking down northern shoreline of western pond. Top 5-6 feet of pond slopes at approx. 2.5H:1V, with flatter slopes along bottom few feet (below high waterline).

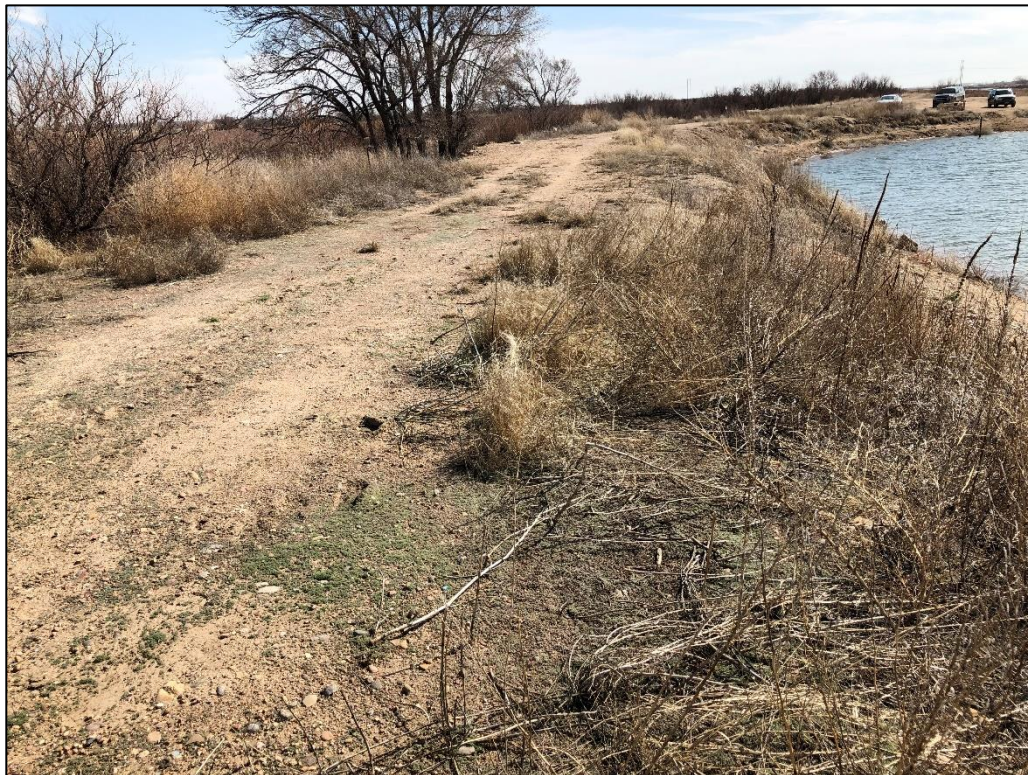
Photo 5. View looking east across top of berm separating western pond (at right) from Arkansas River (at left, not shown). Flattened top of berm is approx. 15 feet wide.

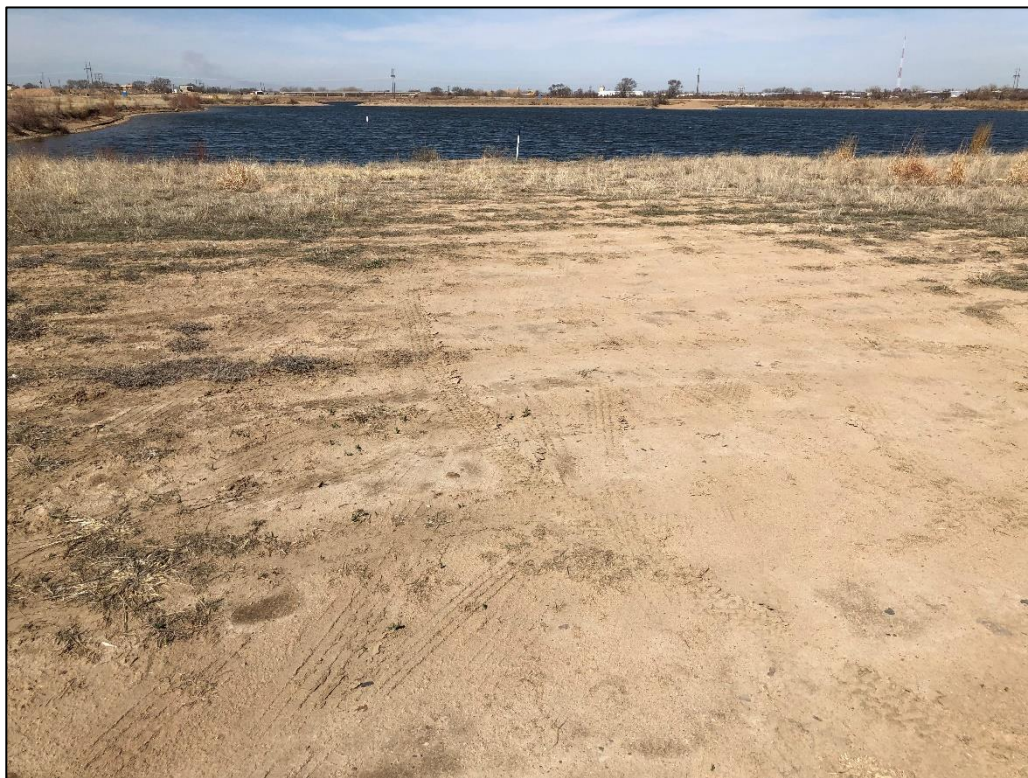
During the current inspection, the Division re-evaluated revegetation success in the areas south and southeast of the eastern ponds. The section of land located west of the small parking lot (south of the middle pond) had a good establishment of grasses with very minimal weed growth. The section of land located east of the parking lot (south of the eastern pond) had good grass growth on the half closest to the pond (approximately 50-60 feet out from the pond). However, grass growth in the half closest to the road was sparse. The section of land located southeast of the eastern pond had very little to no grass growth and more weedy vegetation present. It appears the 2016 reseeding event was not fully successful. During the inspection, the operator indicated they would consult with the City's agronomist to figure out what could be done (other than reseeding) to increase the revegetation success in these areas. Any proposed changes to the approved reclamation plan would need to be submitted in the form of a Technical Revision.

Photo 6. View looking west across land southeast of eastern pond, showing area with little to no vegetative cover.

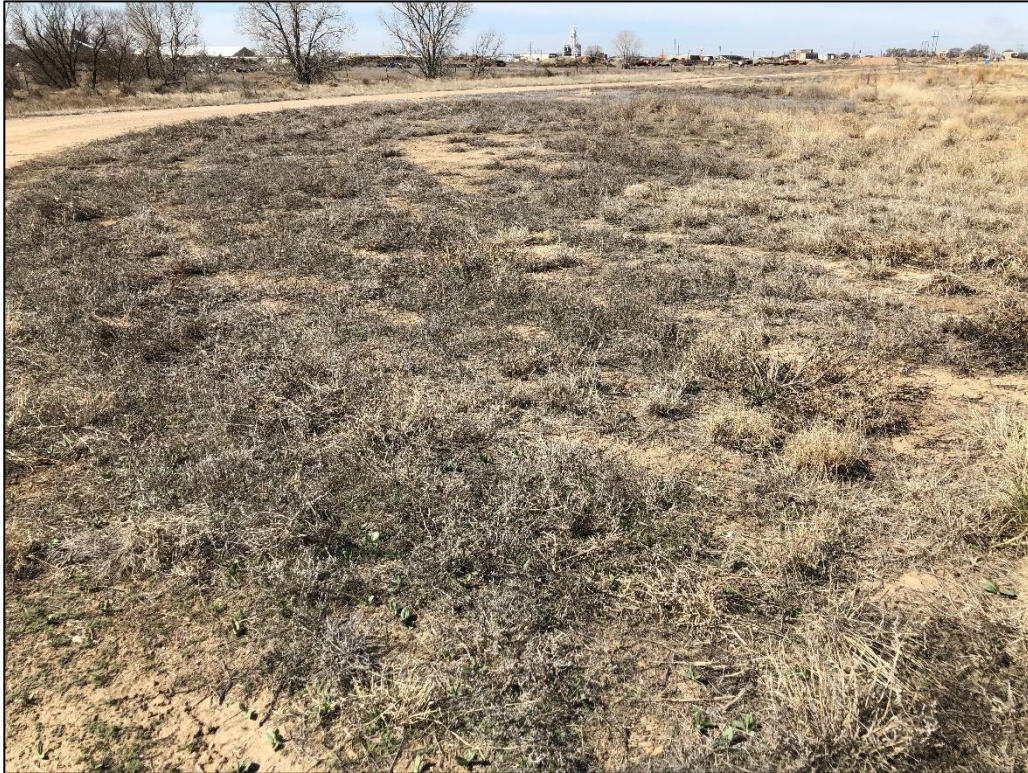
Photo 7. View looking southwest across land southeast of eastern pond, showing area with sparse grass growth.

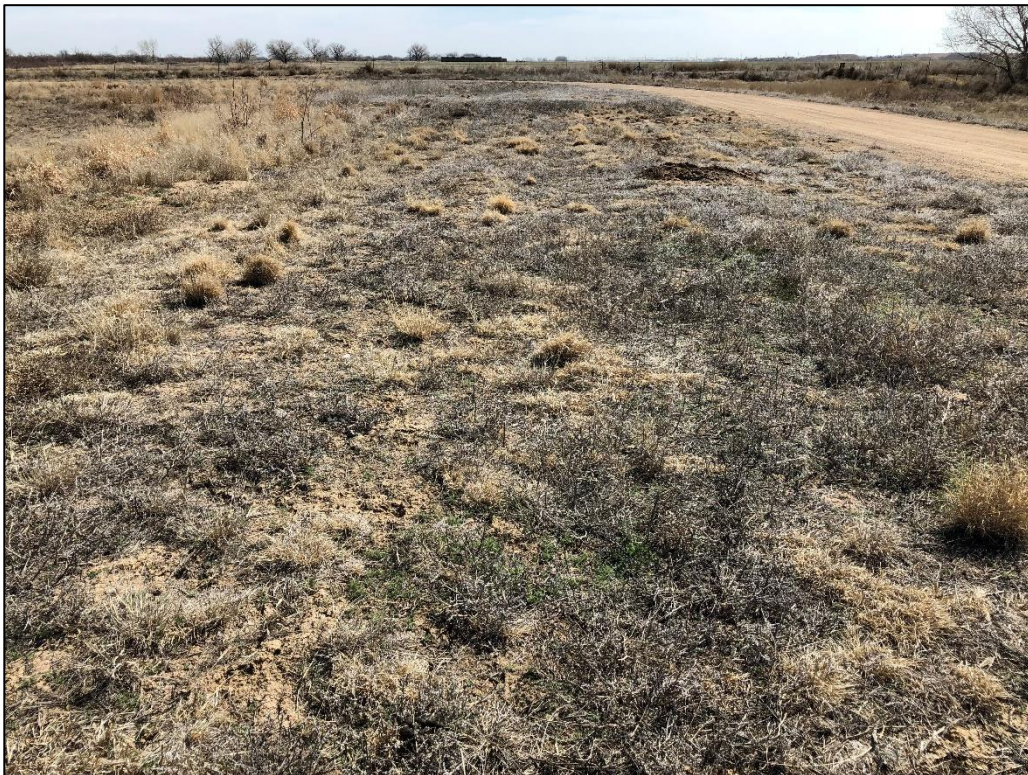
Photo 8. View looking east across land south of eastern pond, showing area closer to road with sparse grass growth.

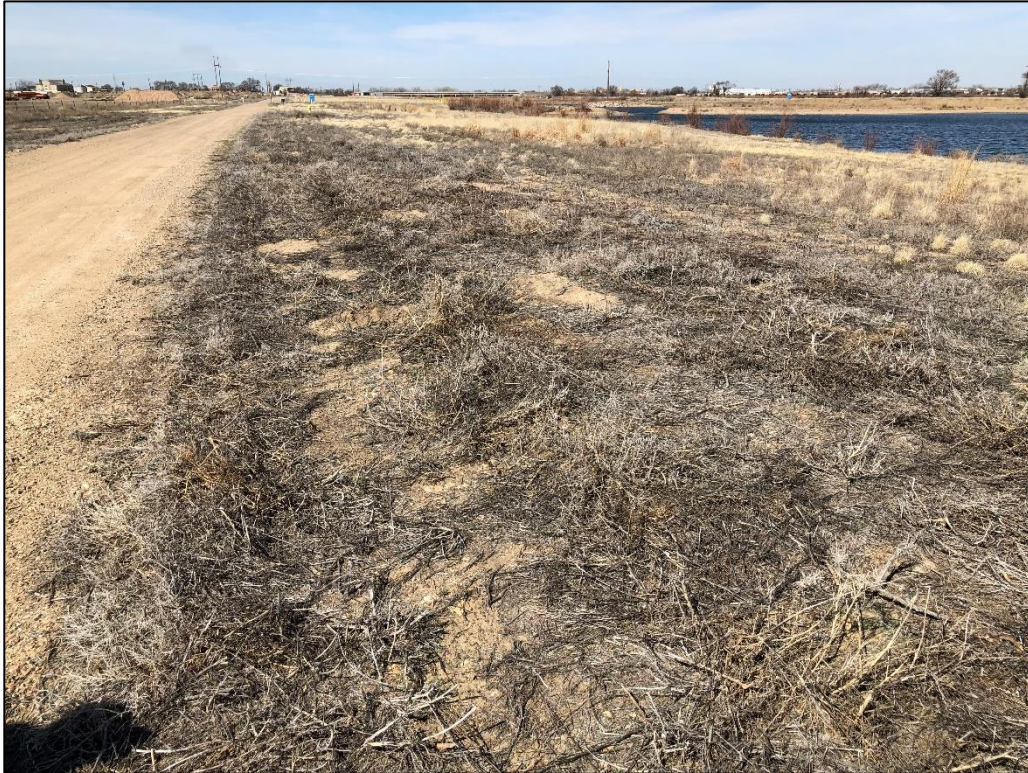
Photo 9. View looking west across land south of eastern pond, showing area closer to road with sparse grass growth.

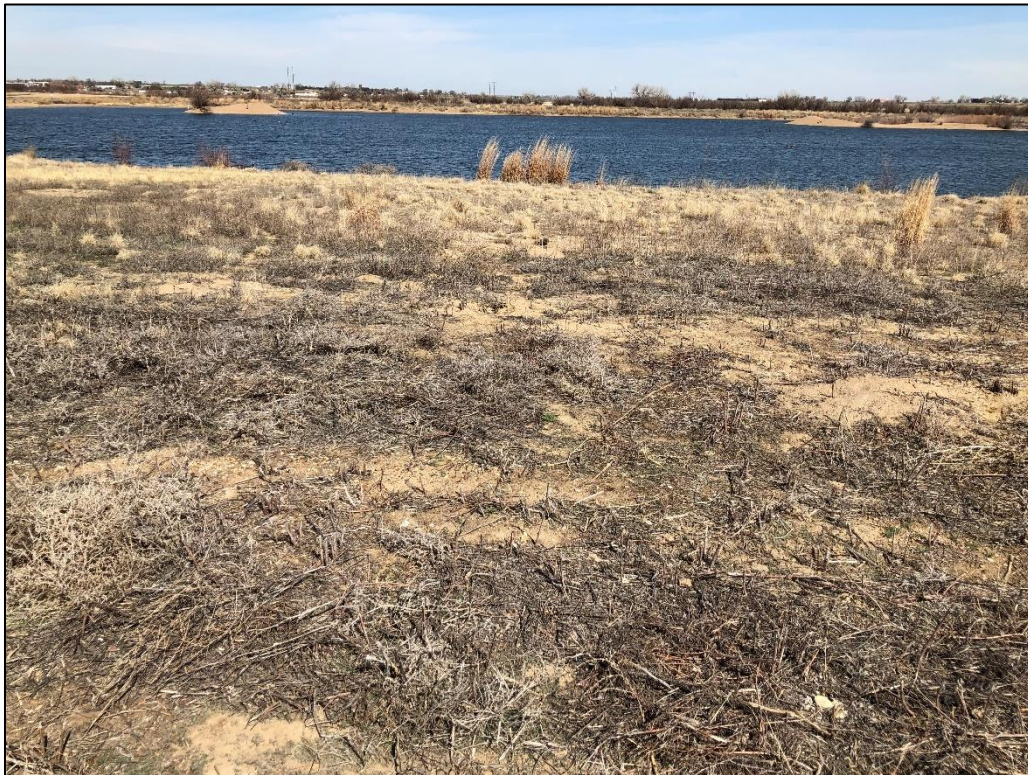
Photo 10. View looking north across land south of eastern pond, showing area closer to road with sparse grass growth.

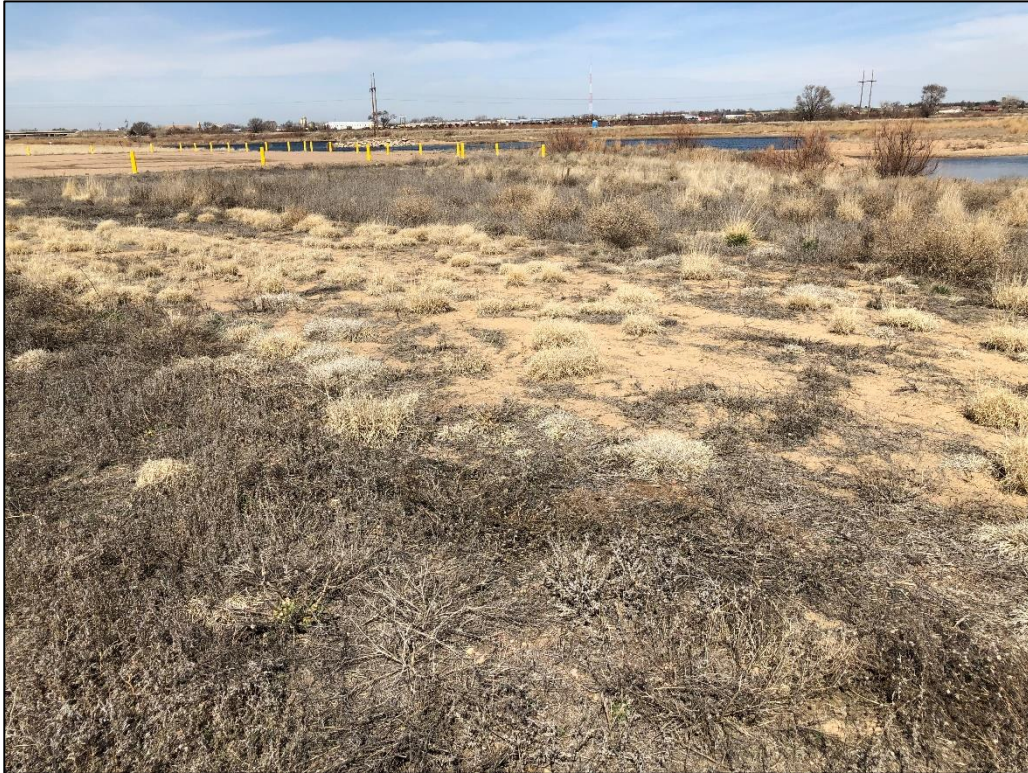
Photo 11. View looking northwest across land south of eastern pond, just east of parking lot, showing sparse grass growth.

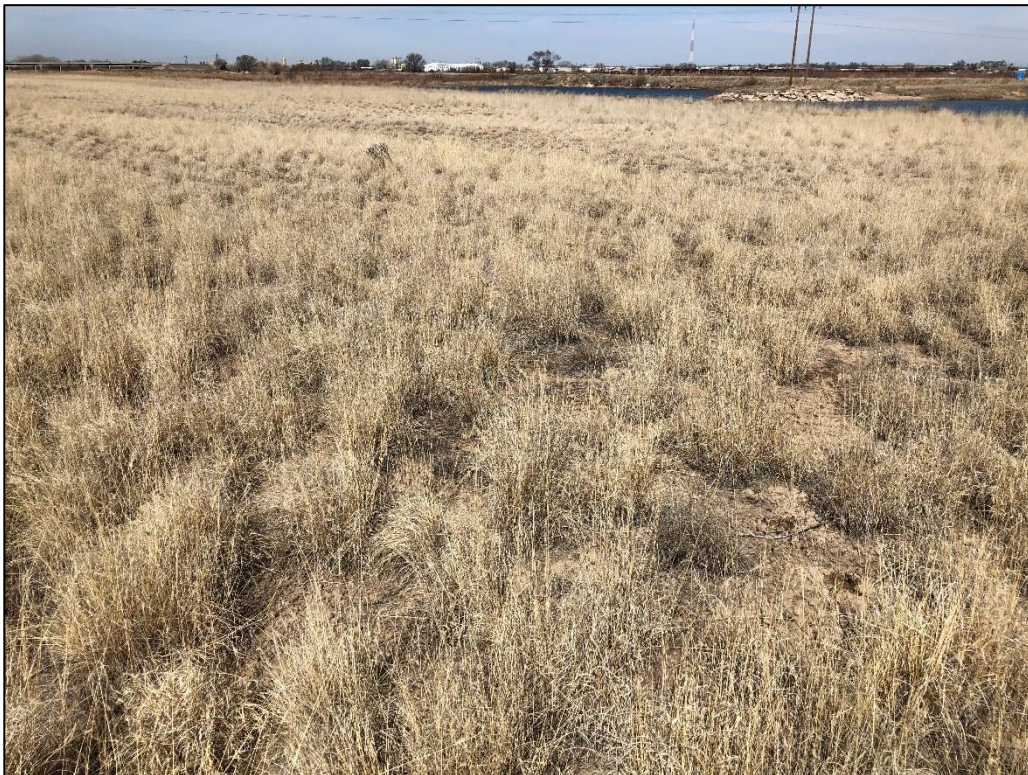
Photo 12. View looking northwest across land south of middle pond, just west of parking lot, showing good grass cover in this area.
