**MINERALS PROGRAM INSPECTION REPORT****PHONE: (303) 866-3567**

<b>MINE NAME:</b> Cresson Project	<b>MINE/PROSPECTING ID#:</b> M-1980-244	<b>MINERAL:</b> Gold	<b>COUNTY:</b> Teller
<b>INSPECTION TYPE:</b> Monitoring	<b>INSPECTOR(S):</b> Patrick Lennberg	<b>INSP. DATE:</b> June 24, 2019	<b>INSP. TIME:</b> 08:30
<b>OPERATOR:</b> Cripple Creek & Victor Gold Mining Company	<b>OPERATOR REPRESENTATIVE:</b> Justin Bills	<b>TYPE OF OPERATION:</b> 112d-3 - Designated Mining Operation

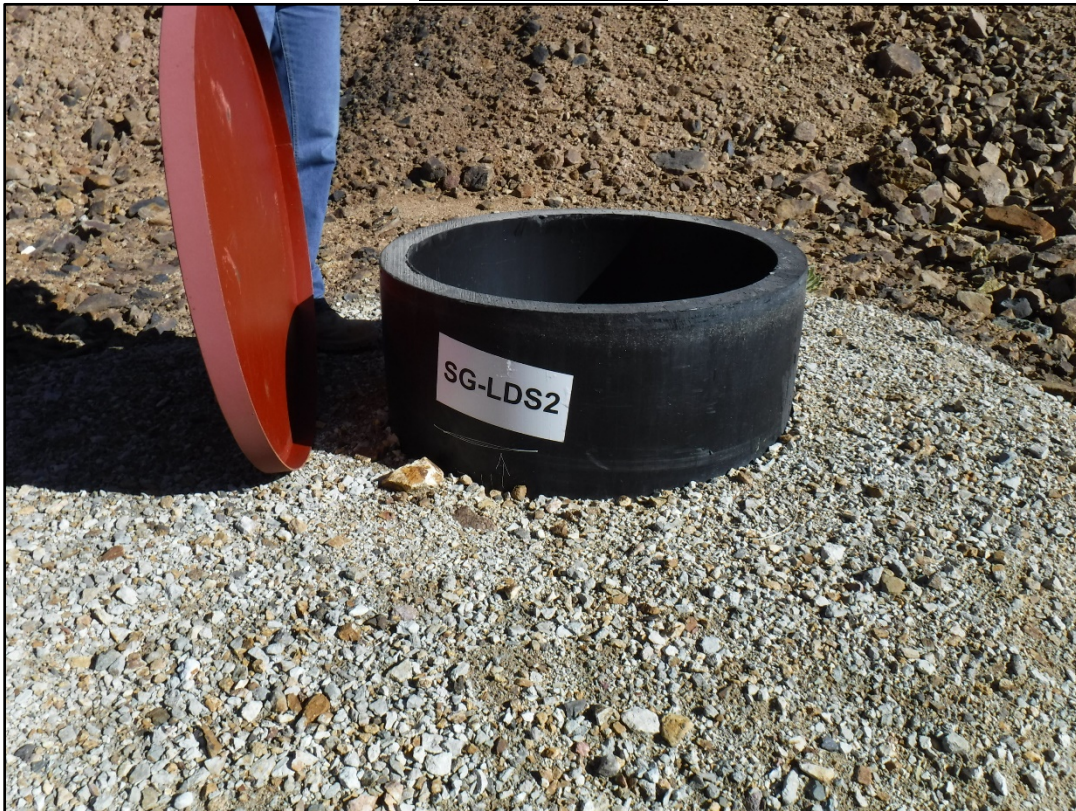
One of the three of the SGVLF Leak Detection System (LDS) sumps was inspected, SG-LDS-2. The sump was found to be dry. The operator must inspect all sumps weekly, and sample and characterize any water present. Any water should be removed after sampling so it can be determined if water continues to enter the sump.

**Photo 1:** Leak Detection System Sump, SG-LDS2 (dry)

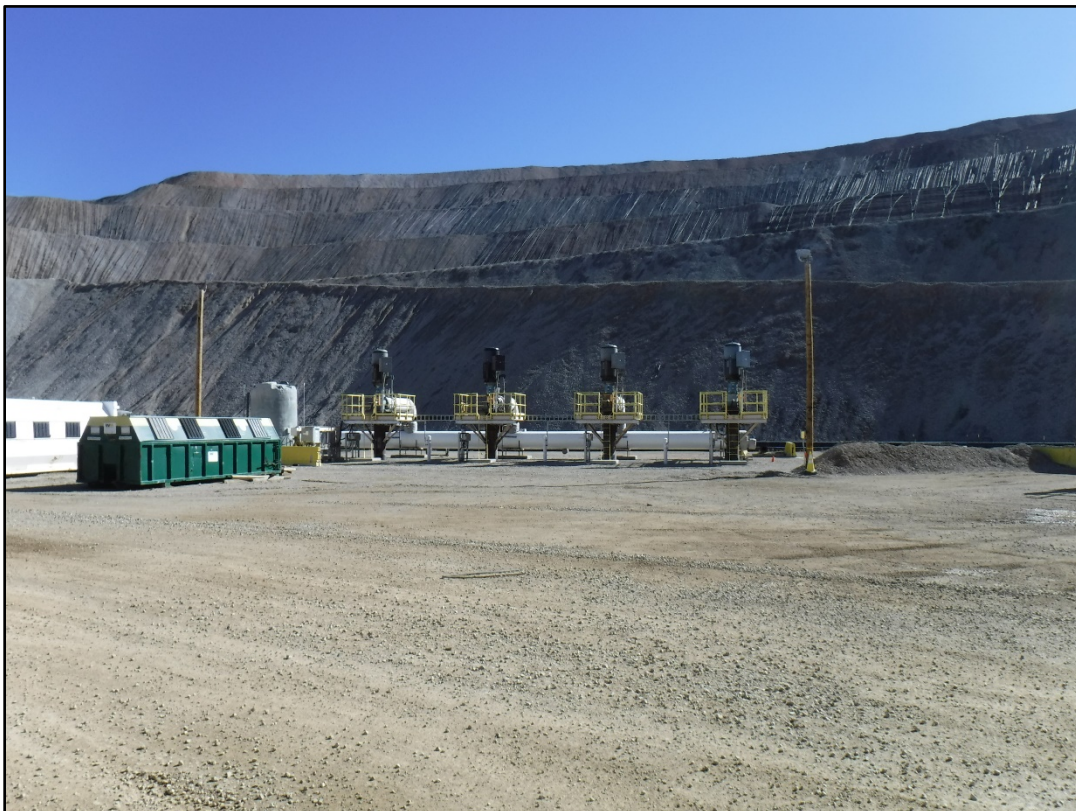
**Photo 2:** Squaw Gulch high volume extraction pumps

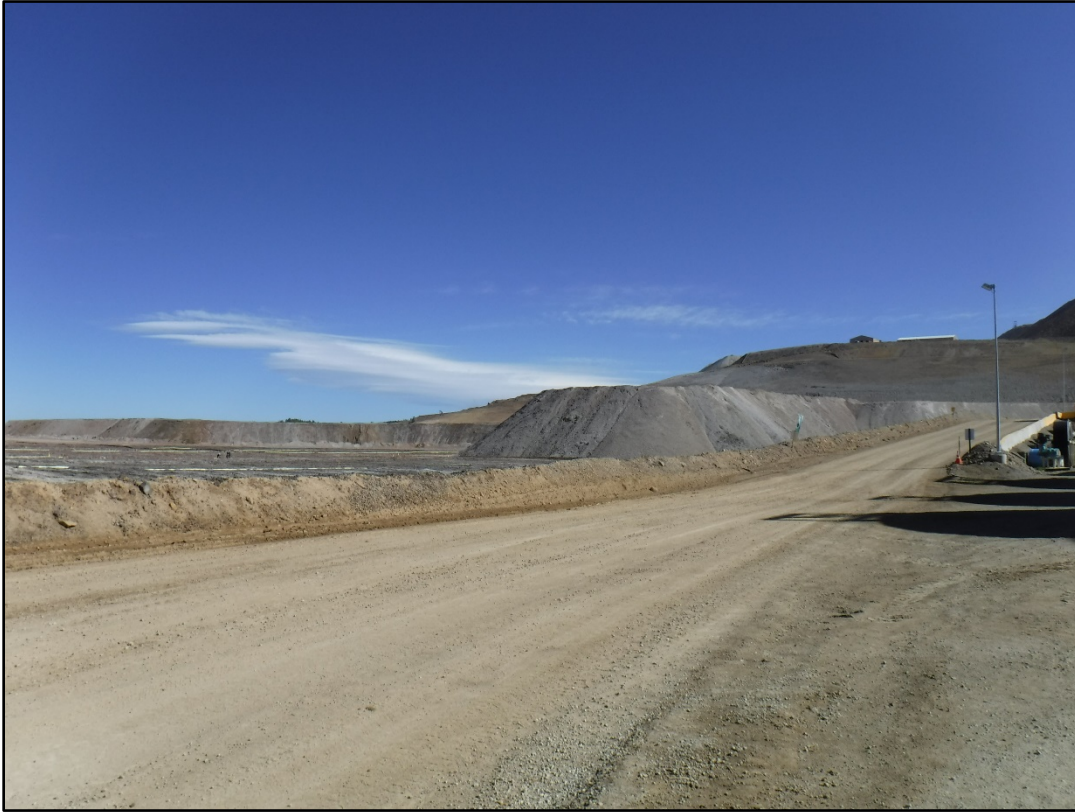
The operation is currently advancing the 9,950 foot lift, which is very close to the top elevation of the mill platform. The Division inspected active leaching surfaces on the SGVLF. The operation is required to minimize ponding of leaching solution to less than 3 feet by 3 feet in area. This is to prevent the ponds from being a wildlife attractant. Active leaching areas appeared to be well-ripped to minimize ponding. No ponding was observed. The elongated sump present at the southwestern toe of the SGVLF (near the ADR-2 Facility) that was filled with bird balls has received an abundant amount of storm water run-off that has scattered the balls. However, no ponded stormwater was observed.

**Photo 3:** The 9950' level (VLF2) being built out adjacent to the Mill

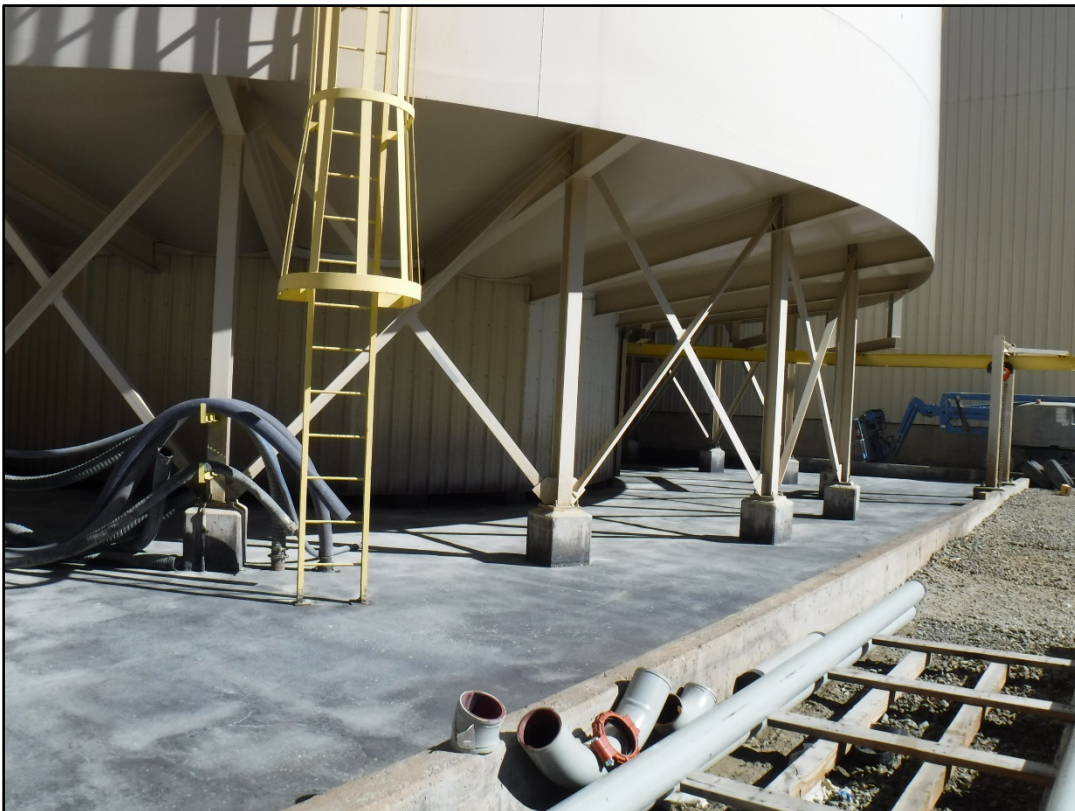
**Photo 4:** East side of the Mill (Processed Ore Thickener – east side), typical conditions

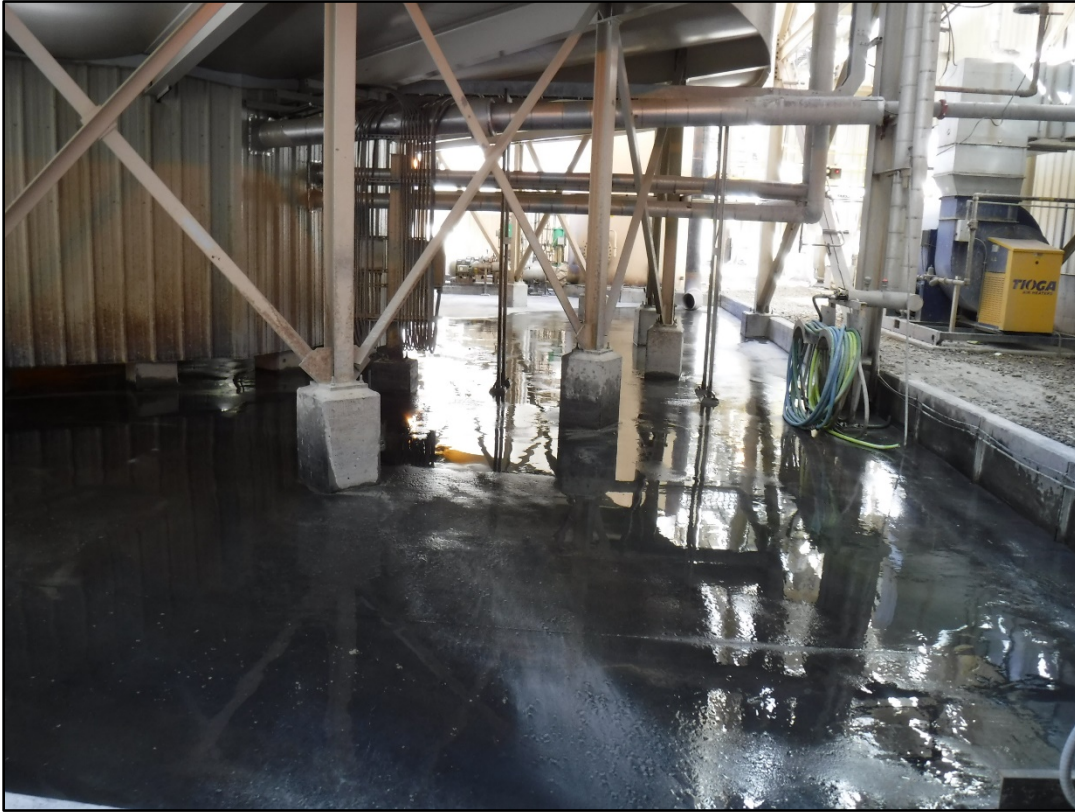
**Photo 5:** East side of the Mill (Processed Ore Thickener – west side), typical conditions

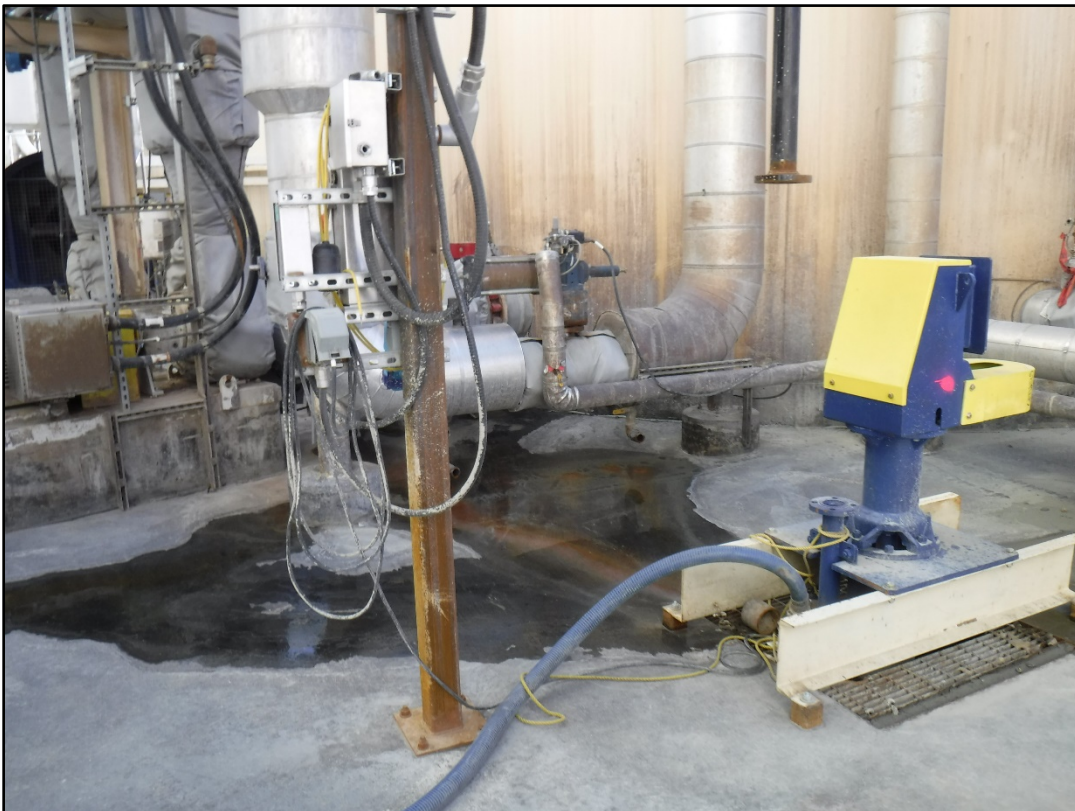
**Photo 6:** East side of the Mill (Neutral pH Process Water Tank), typical conditions

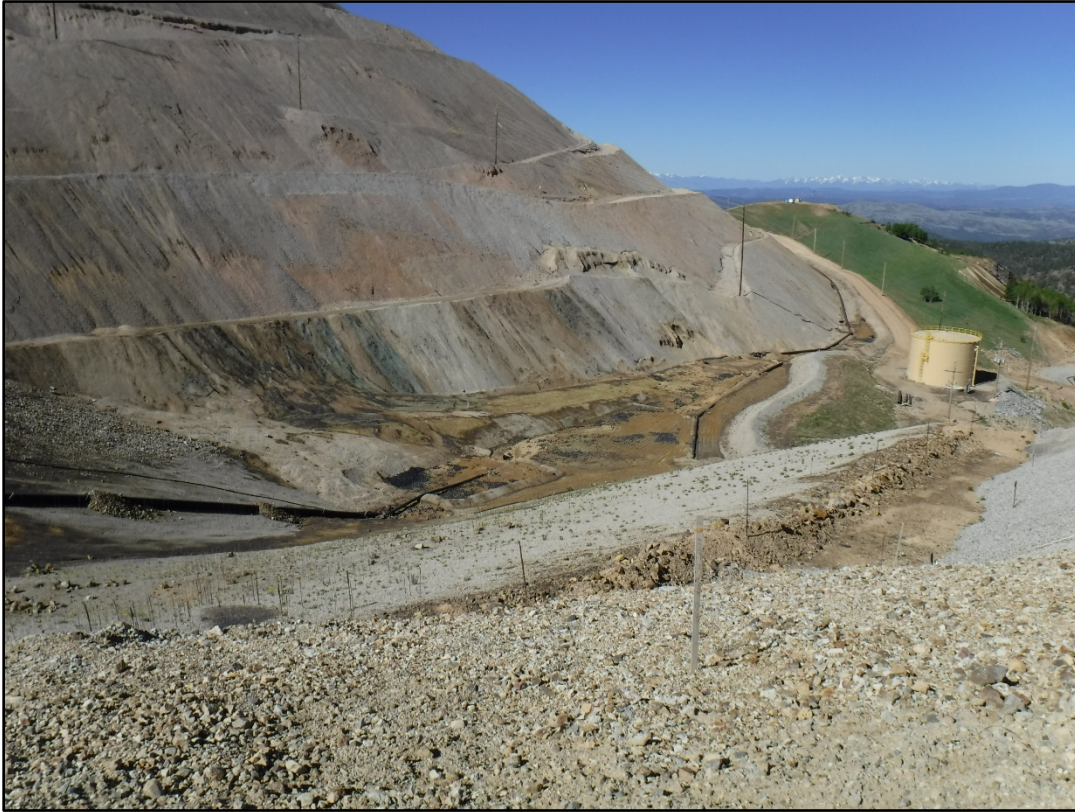
**Photo 7:** The elongated sump present at VLF1

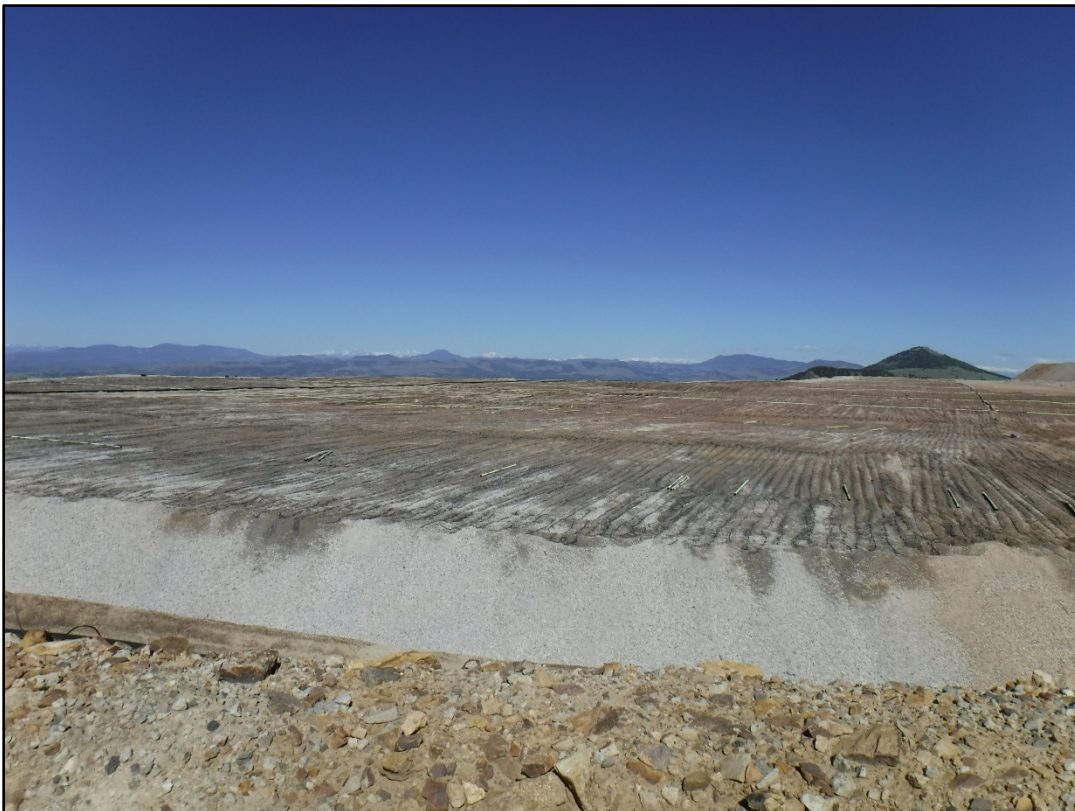
**Photo 8:** SGVLF active leaching areas appeared to be well-ripped to minimize ponding, 9900' level

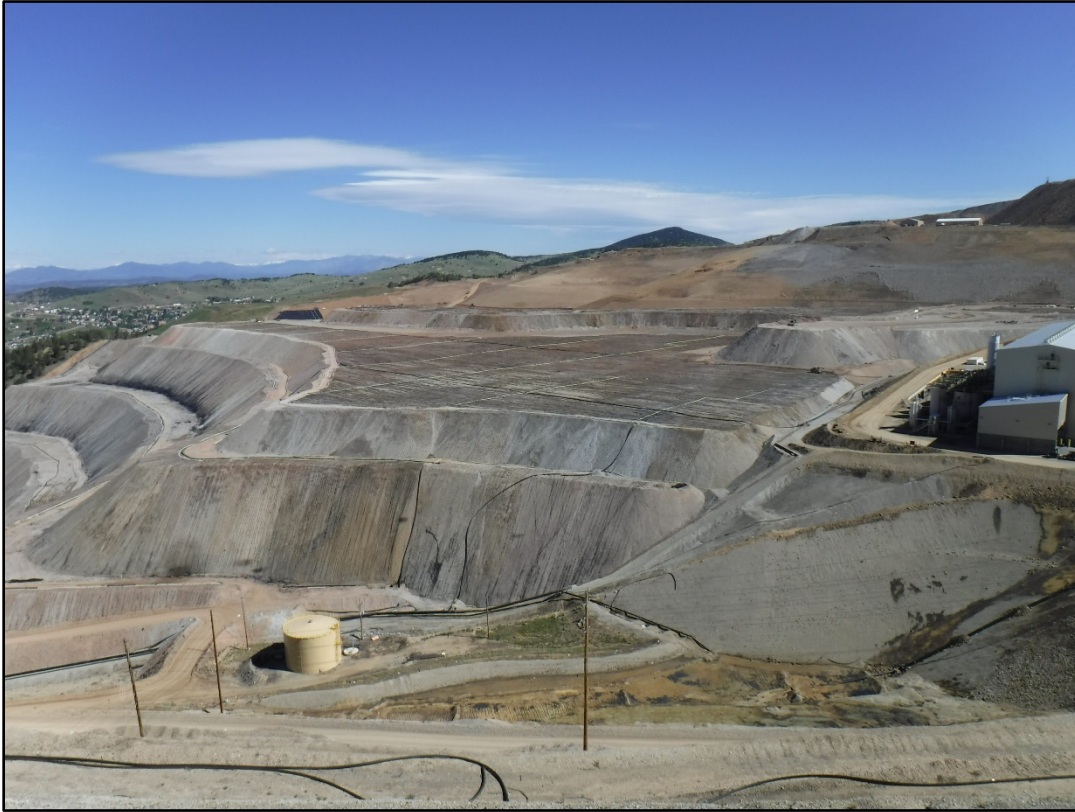
**Photo 9:** SGVLF overview

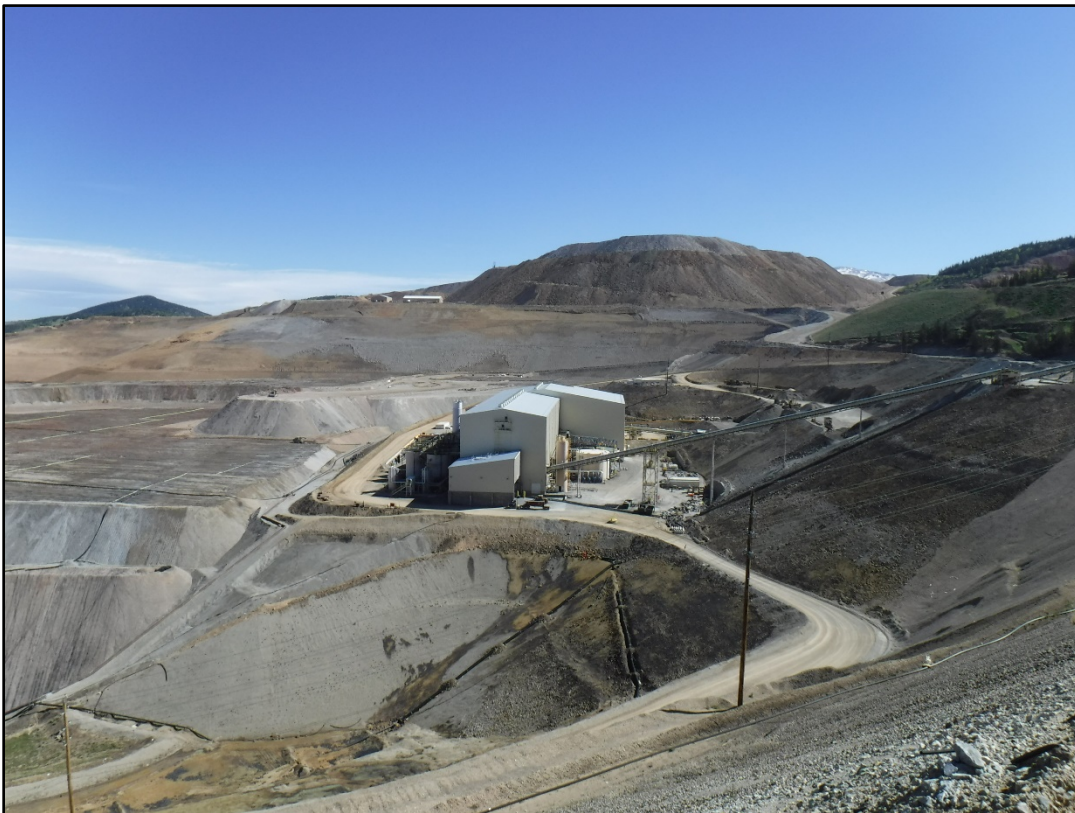
**Photo 10:** Mill Area overview

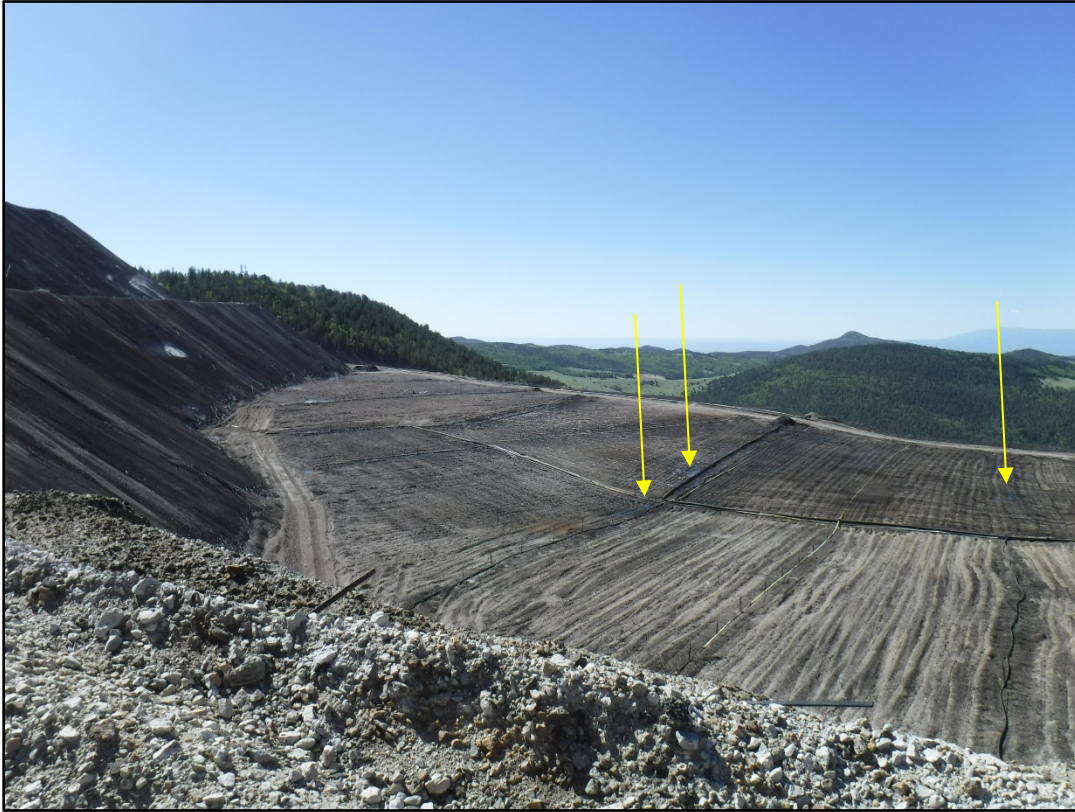
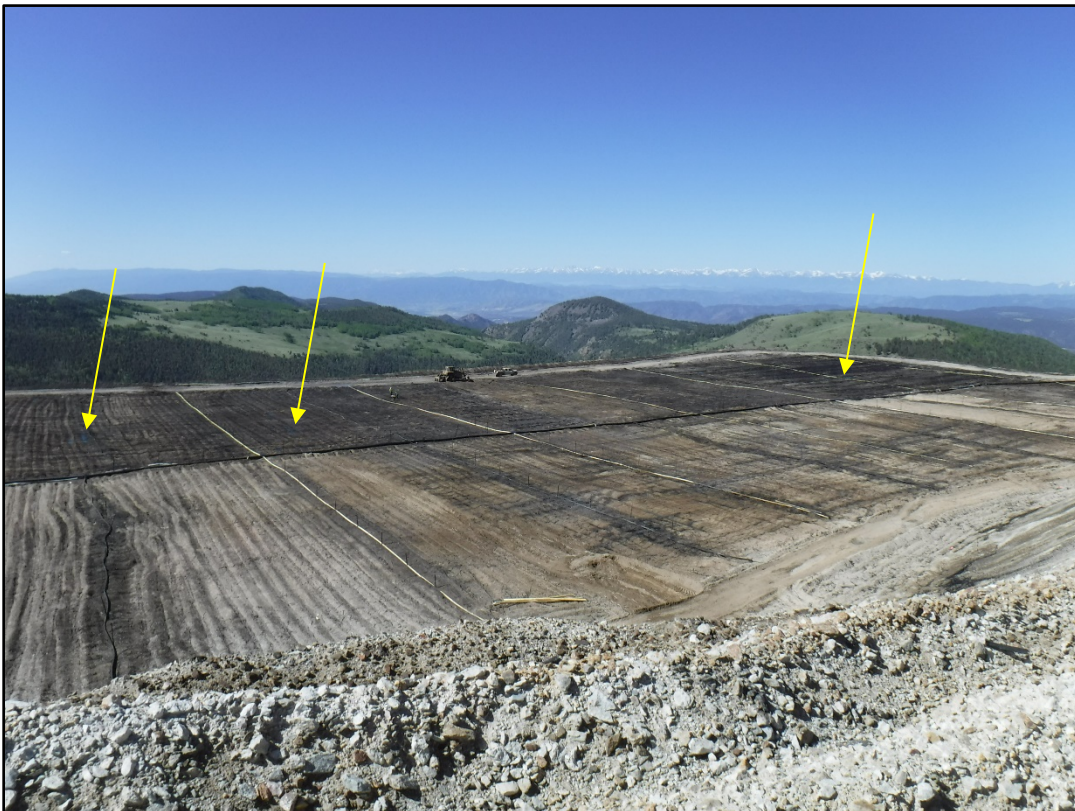
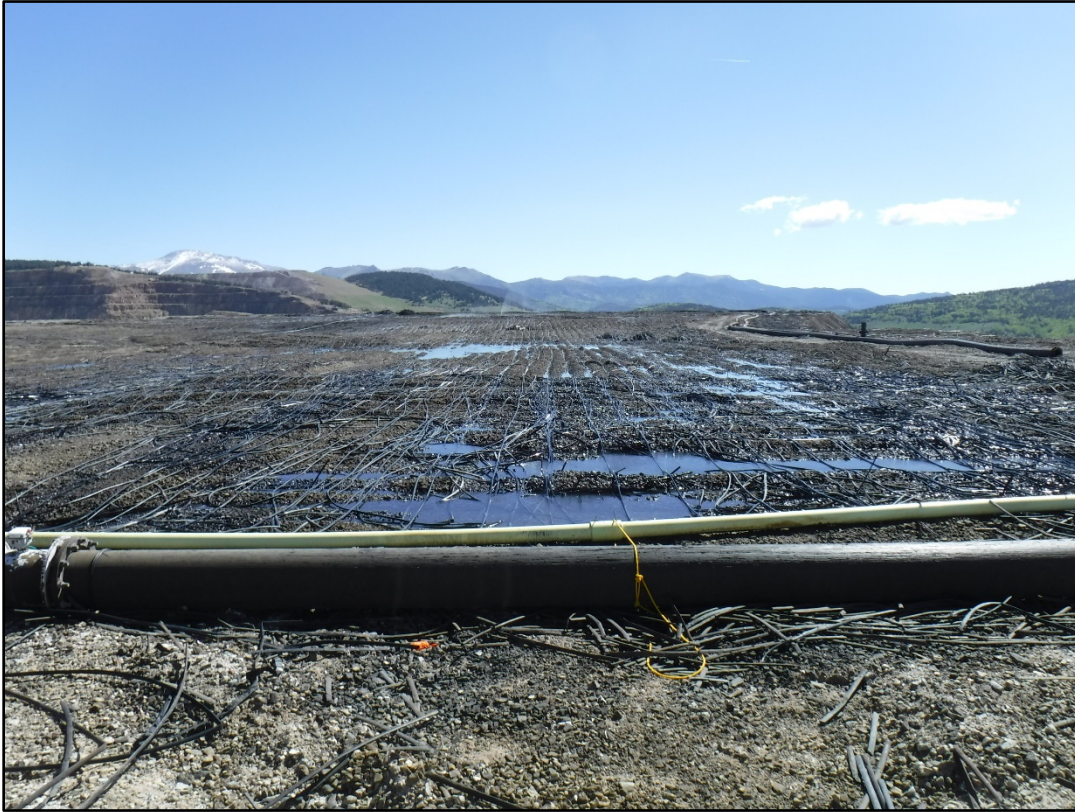
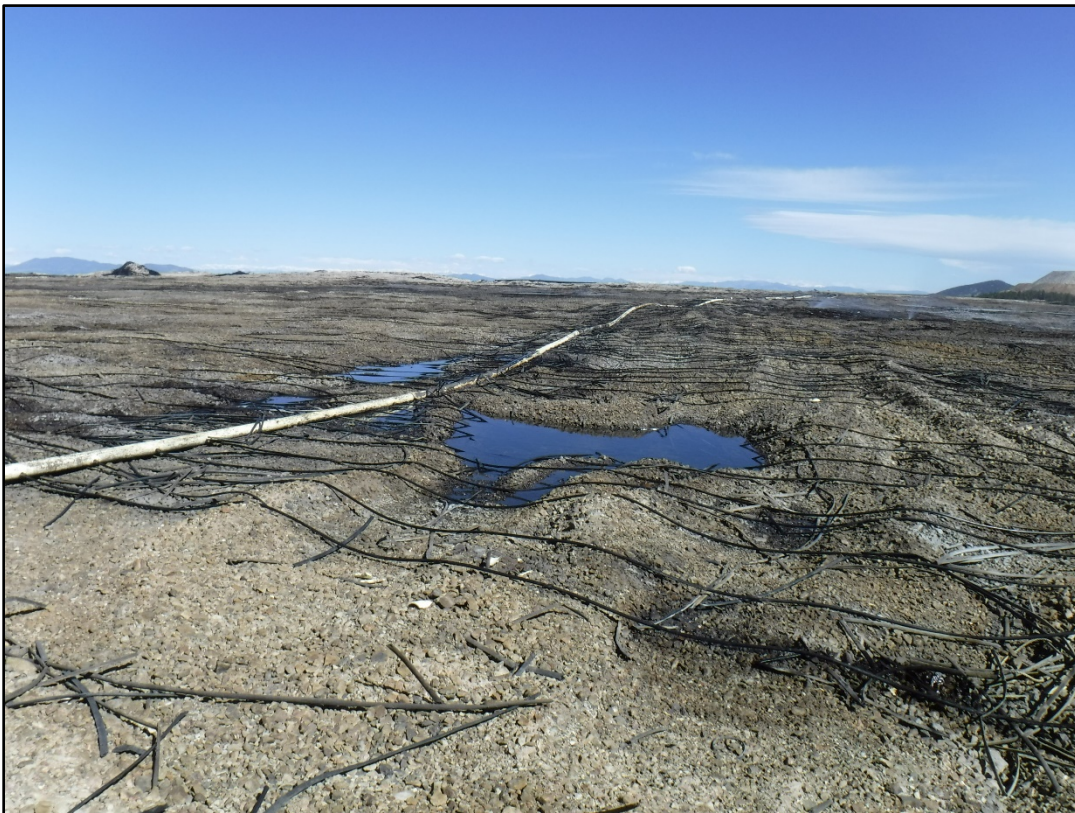
**PROBLEM:** A significant volume of process solution was ponded in the Arequa Gulch Valley Leach Facility. This is a potential attractant to wildlife. The surface area of the exposed fluid exceeded the permit condition (not to exceed 3 feet x 3 feet area).

The current and maximum elevation of ore placement in the AGVLF is 10,400 feet (for Phase V). The Division inspected active leaching surfaces on the AGVLF. These surfaces were well saturated and ponding of leachate, greater than 3 feet by 3 feet, was common. In addition, ponding of leachate was observed on the lower 10,200 foot level, although not as common as was observed on the upper level. During the close-out meeting the Operator indicated that the application rate of leachate had been reduced by approximately 120 gpm in these areas. Also, a crew that was observed on the 10,200 foot level was moved to the upper level to begin ripping the material to promote infiltration. While the weather in the recent past had been wet this was not a significant factor in the ponding. Finally, during an aerial inspection in early June there were several areas of ponding noted including the areas observed during this inspection. A problem is being cited in this report due

to the ponding observed in excess of the 3 foot by 3 foot requirement.

**Photo 11:** AGVLF 10,200' level east area, arrows show ponding

**Photo 12:** AGVLF 10,200' level west area, arrows show ponding

**Photo 13:** AGVLF 10,400' level, typical ponding observed

**Photo 14:** AGVLF 10,400' level, typical ponding observed

**CORRECTIVE ACTIONS:** Provide the Division with photographic evidence that measures were taken to allow the solution within this area to infiltrate into the pad or other wildlife mitigation measures have been employed by the corrective action date.

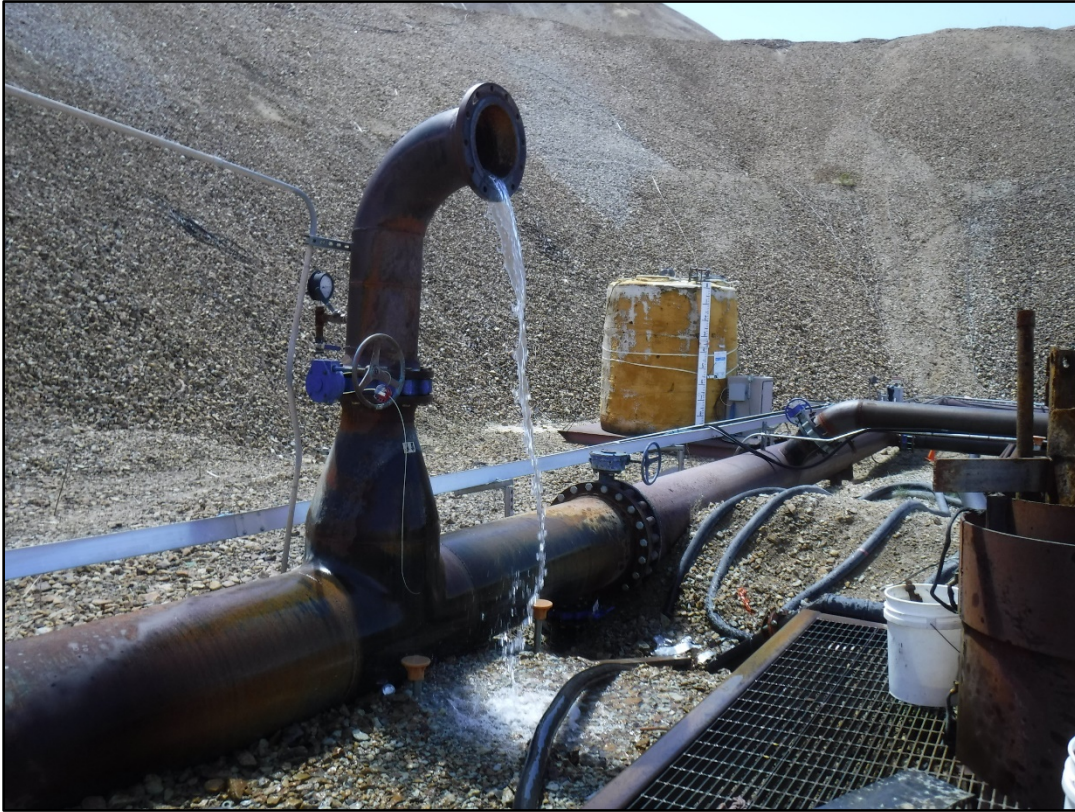
During inspection of the AGVLF Phase I HVSCS the stand pipe for pump #303 that connects the pump flow to the main solution pipe was leaking. The pump has been disconnected from the main pipe for maintenance. The remaining pipe had a valve that was intended to prevent flow from the main solution pipe from flowing back towards the pump. The valve was not working correctly and was allowing solution to discharge at an estimated rate of 10-15 gpm onto the surrounding ground surface. The solution was infiltrating as fast as it was being discharged. The Operator indicated that a maintenance crew had been dispatched to investigate and fix the issue.

**Photo 15:** Solution bypassing the gate valve at the 303 pump Phase I, AQVLF

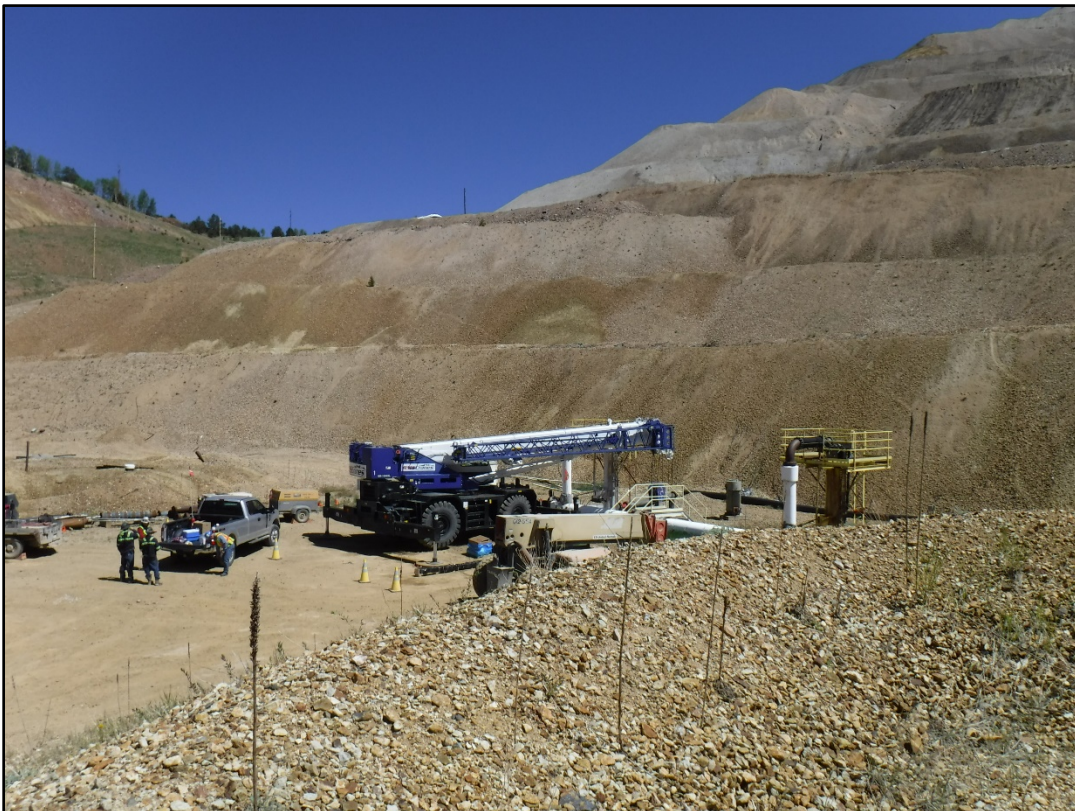
**Photo 16:** Phase II pump 5 maintenance

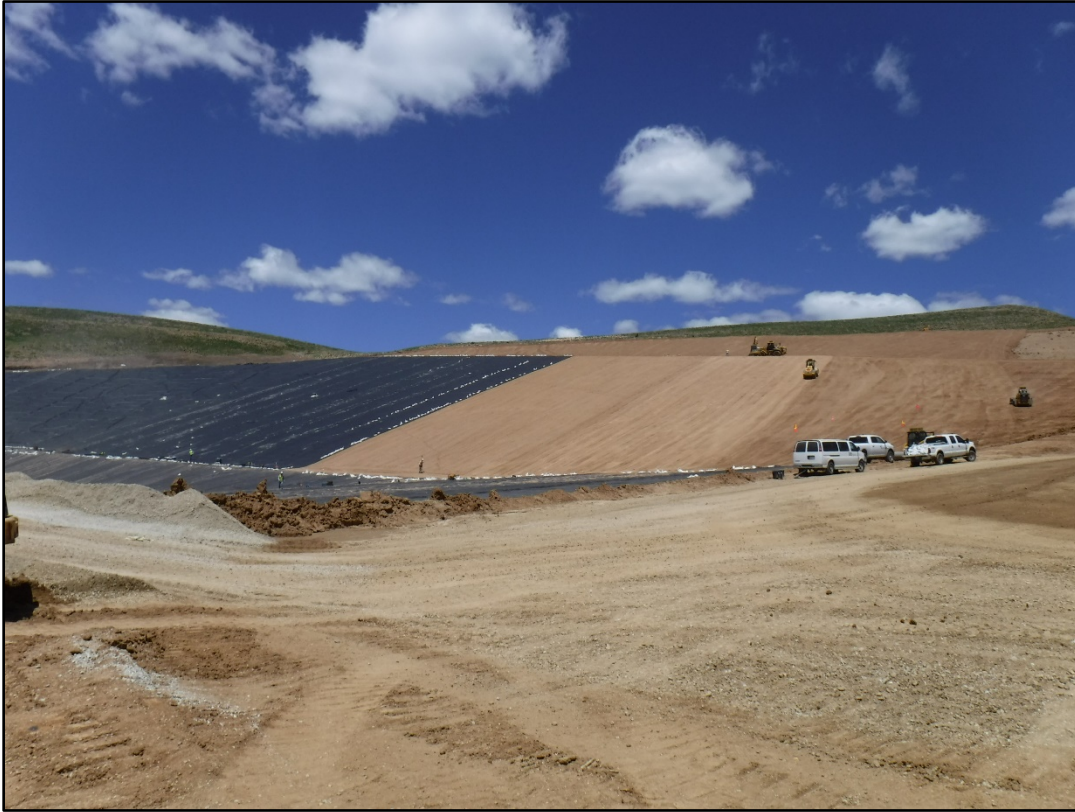
By noon approximately 60,000 square feet of liner had been deployed that day and subgrade was being prepped for additional panels to be deployed. Subgrade preparation includes density testing to confirm proper compaction, final survey of prepared surface, and final inspection by liner contractor to verify that the subgrade is free of any large and/or sharp particles that could damage the liner.

**Photo 17:** VLF 2 Phase 2 construction, panels deployed in morning and subgrade prep for additional liner placement

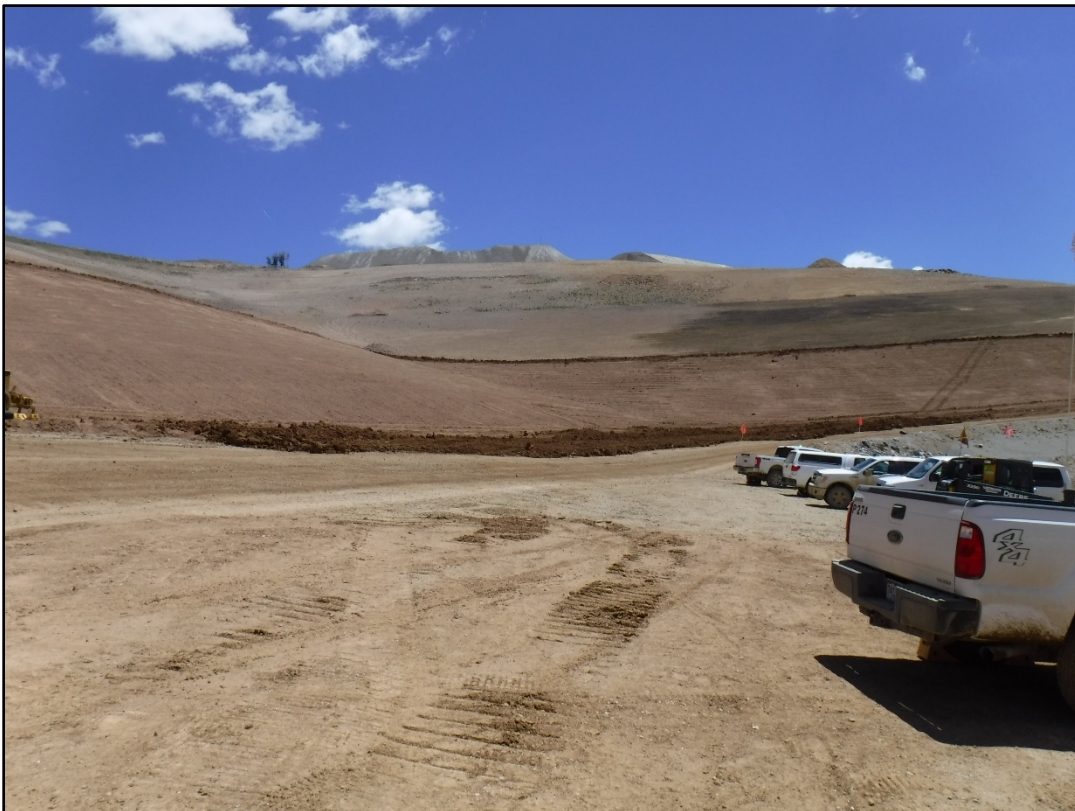
In addition to hauling DCF material other articulating haul trucks were transporting clay material for placement in areas that are planned for liner placement.

**Photo 18:** VLF 2 Phase 2 construction, clay material staging

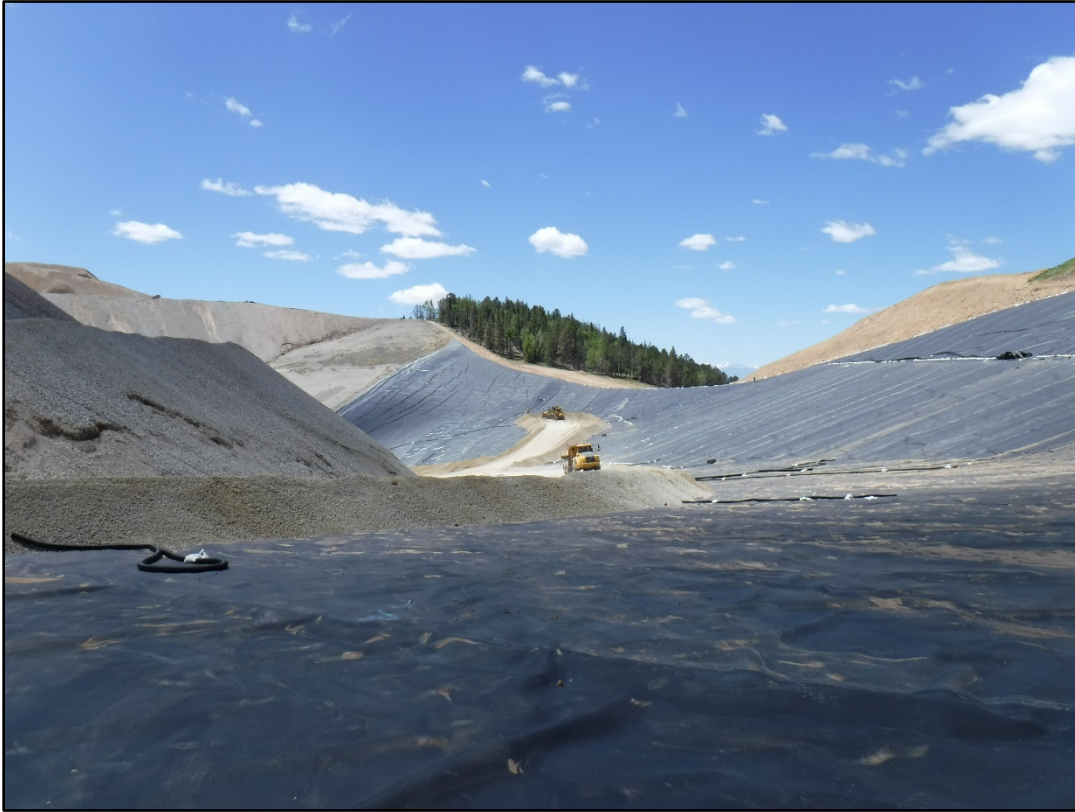
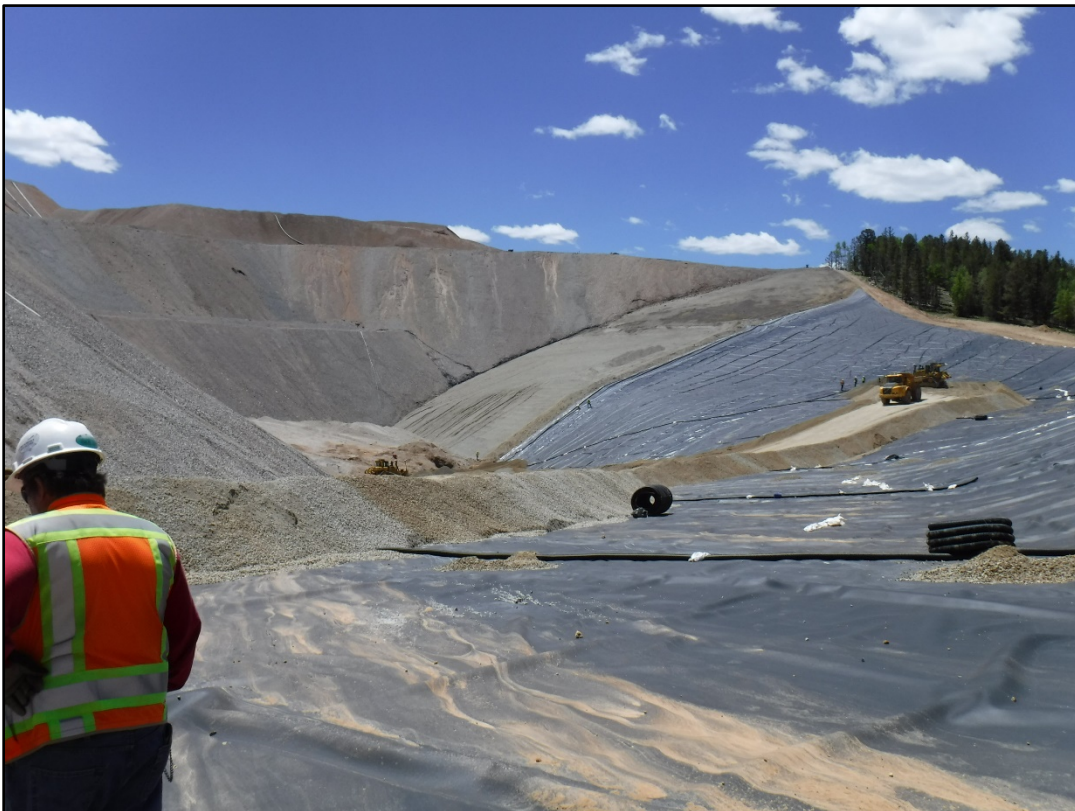
The Division observed the construction activities associated with the new liner construction in the Phase 2 area. The Operator informed the Division that due to weather delays the first volume of the QA/QC Report expected in mid-July has been rescheduled for mid-August. The Division observed hauling and placement of Drain Cover Fill (DCF) using articulating haul trucks. The trucks hauled DCF to LGP dozers that then spread the material out. The trucks travelled on a minimum of 4 foot thick DCF material that had been placed on a geofabric that lied directly on the textured liner. Travelling on thick DCF material is intended to protect the geomembrane liner from damage. As the material was spread by the dozers there were two laborers that watched for material larger than 2-inches and removed any wrinkles in the liner from being buried. The laborers also monitored for DCF thickness. Overseeing the two laborers was a NewFields employee for QA oversight.

**Photo 19:** VLF 2 Phase 2 construction, DCF hauling and placement

**Photo 20:** VLF 2 Phase 2 construction, DCF hauling and placement

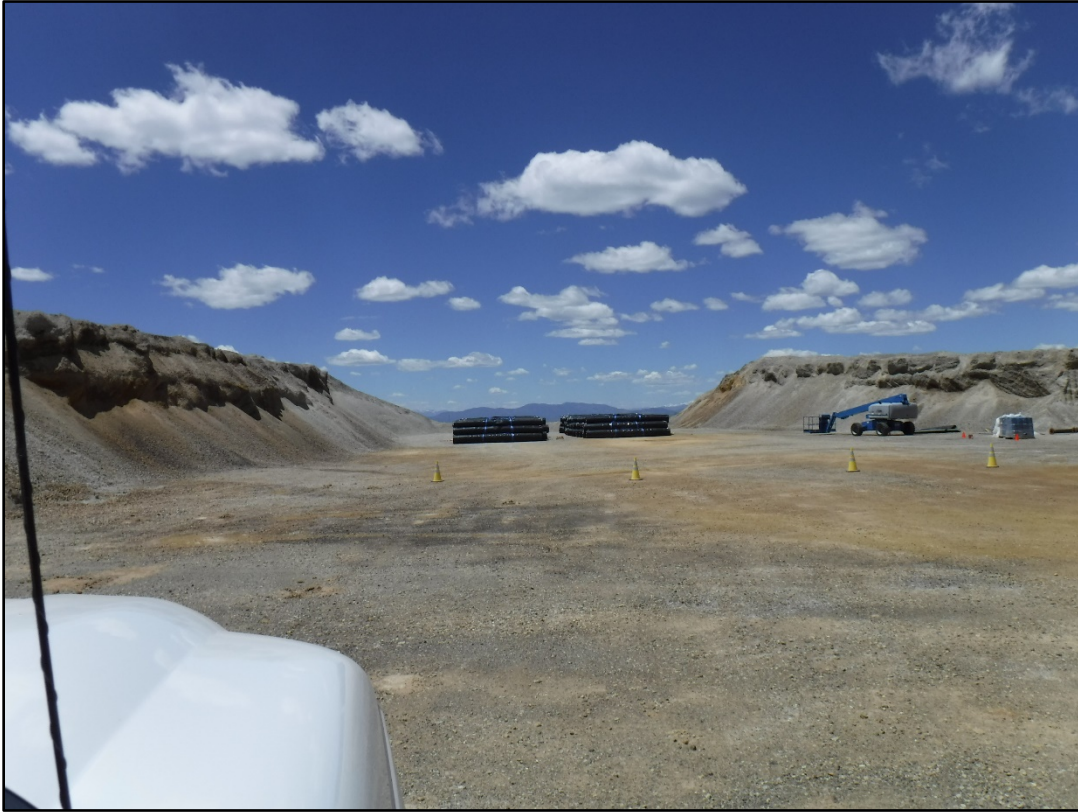
**Photo 21:** VLF 2 Phase 2 construction, liner storage area

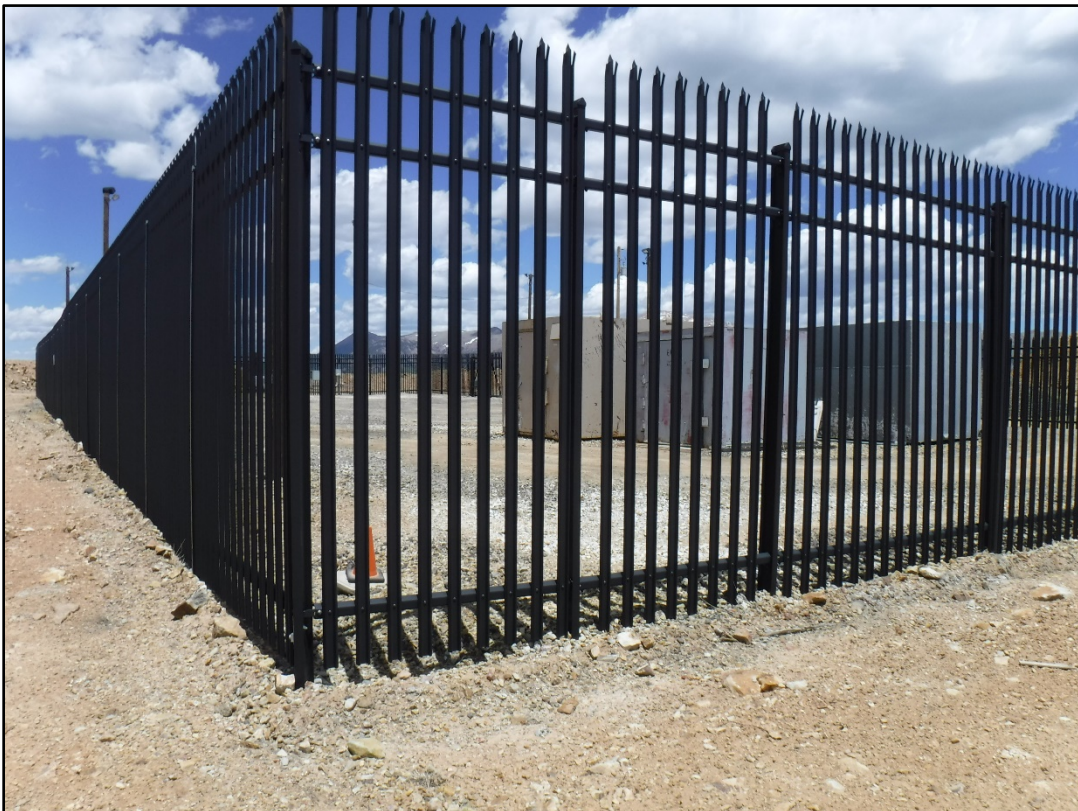
The Division walked the perimeter of the explosives storage area, no problems were observed.

**Photo 22:** Explosives storage area

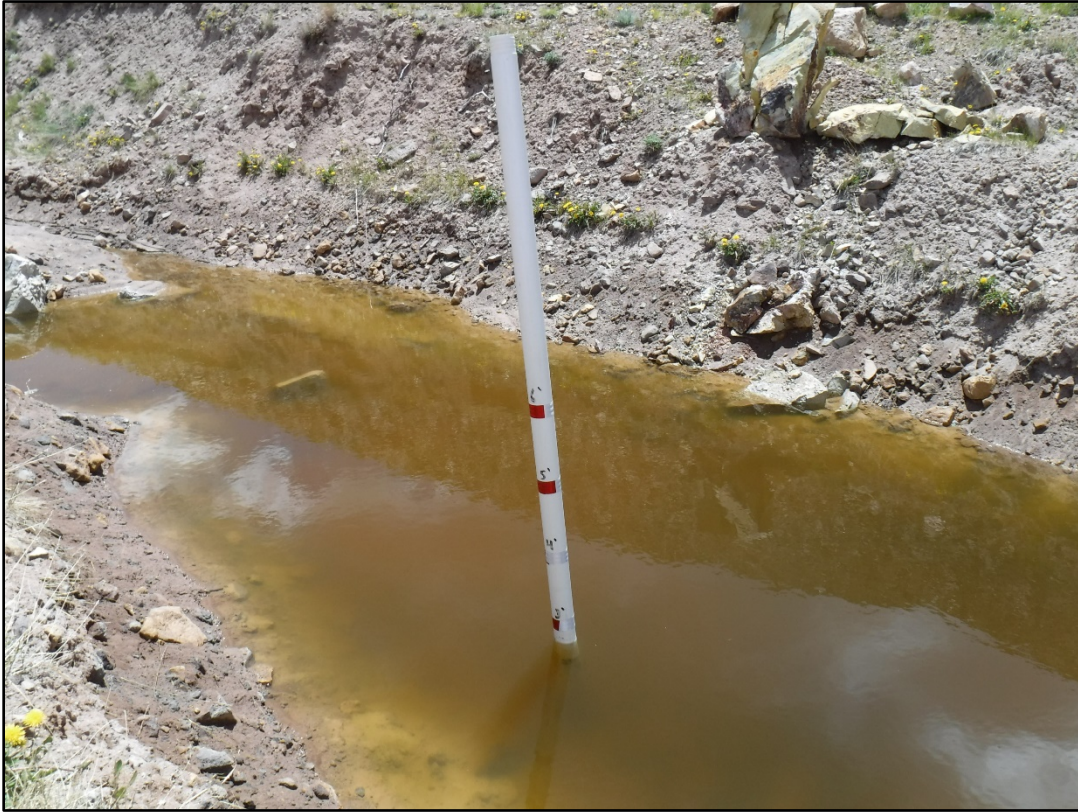
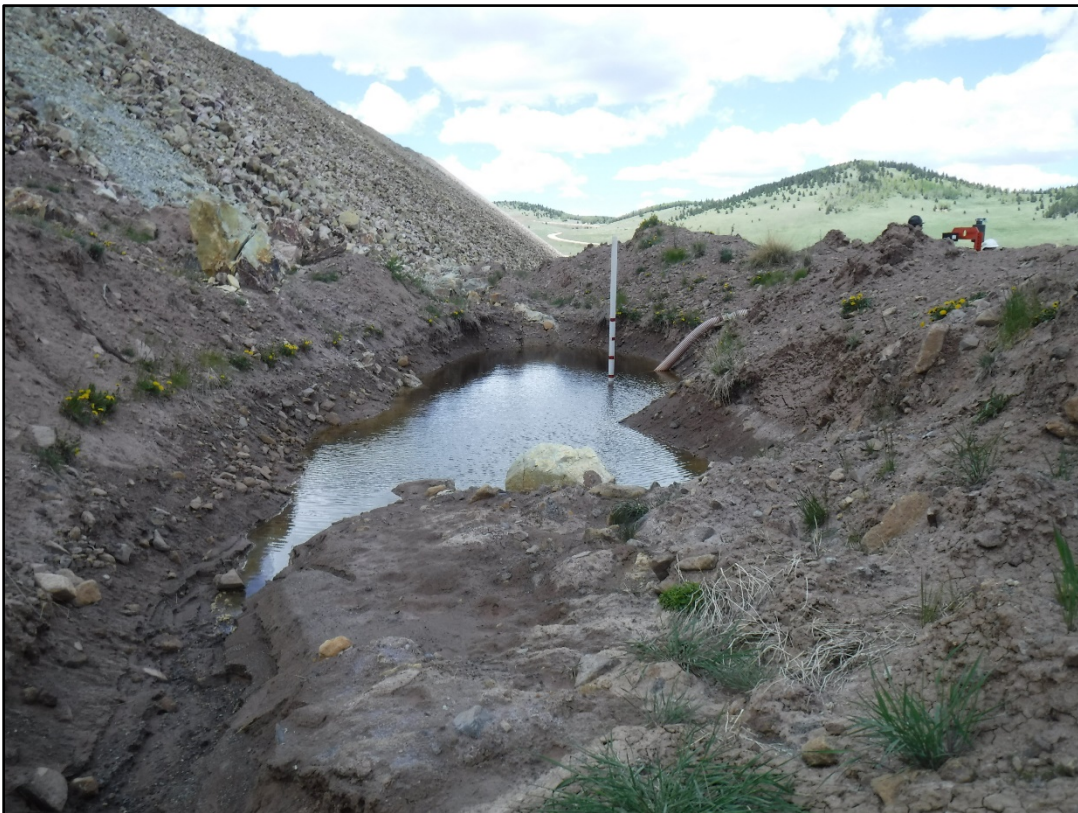
The Division inspected the seep area located at the eastern toe of the ECOSA. The seep accumulation trench was holding water during the inspection. The water was red in color and approximately 2-1/2 feet deep, as measured by a recently installed staff gauge. No water was observed flowing into the trench (within the toe berm of the ECOSA) from the south/southeast. The Operator pumps water out of the trench when they have approximately 5,000 gallons or a full truck volume. They are in the process of investigating the correlation between precipitation and volume seen at the seep and removing full truck volumes at one time aids in the investigation. The Operator removed six truck loads in May and have removed 1-2 truckloads a week during June. Water from the seep is transported and dumped onto a lined facility (one of the valley leach facilities).

**Photo 23:** Staff gauge installed at ECOSA seep pond

**Photo 24:** ECOSA seep pond, note no flow coming into pond
