**COLORADO DIVISION OF RECLAMATION, MINING AND SAFETY**  
**MINERALS PROGRAM INSPECTION REPORT**  
**PHONE: (303) 866-3567**

<b>MINE NAME:</b> Yakutat Land Pit	<b>MINE/PROSPECTING ID#:</b> M-2014-008	<b>MINERAL:</b> Sand and gravel	<b>COUNTY:</b> Washington
<b>INSPECTION TYPE:</b> Monitoring	<b>INSPECTOR(S):</b> Brock Bowles	<b>INSP. DATE:</b> June 16, 2019	<b>INSP. TIME:</b> 1100
<b>OPERATOR:</b> Washington County	<b>OPERATOR REPRESENTATIVE:</b> Steve Williams	<b>TYPE OF OPERATION:</b> 110c - Construction Limited Impact

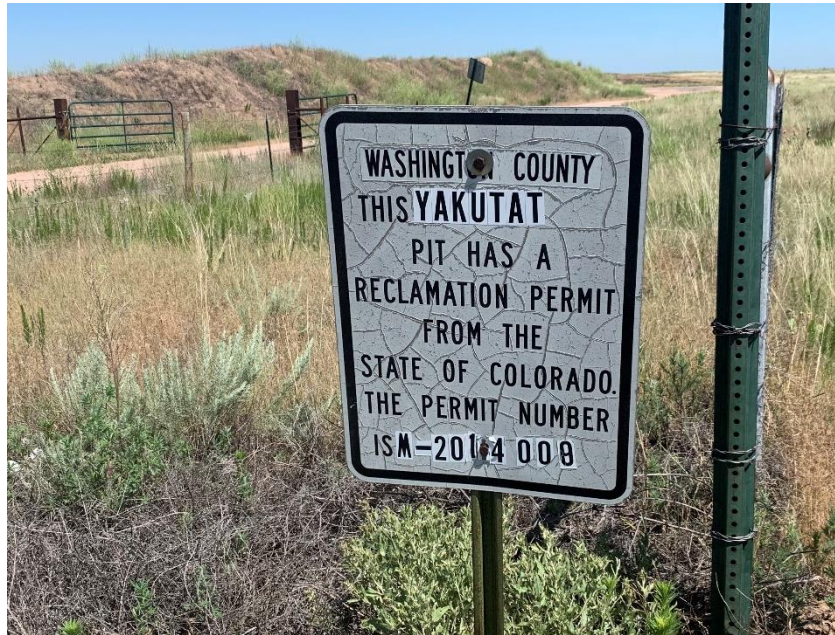
The permit identification sign was in place at the mine entrance and legible. The permit boundary was clearly delineated by a fence which was in good repair. The topsoil stockpile was in the northeast corner of the permit area, was well vegetated and appeared to be stable.

Permit identification sign looking north.

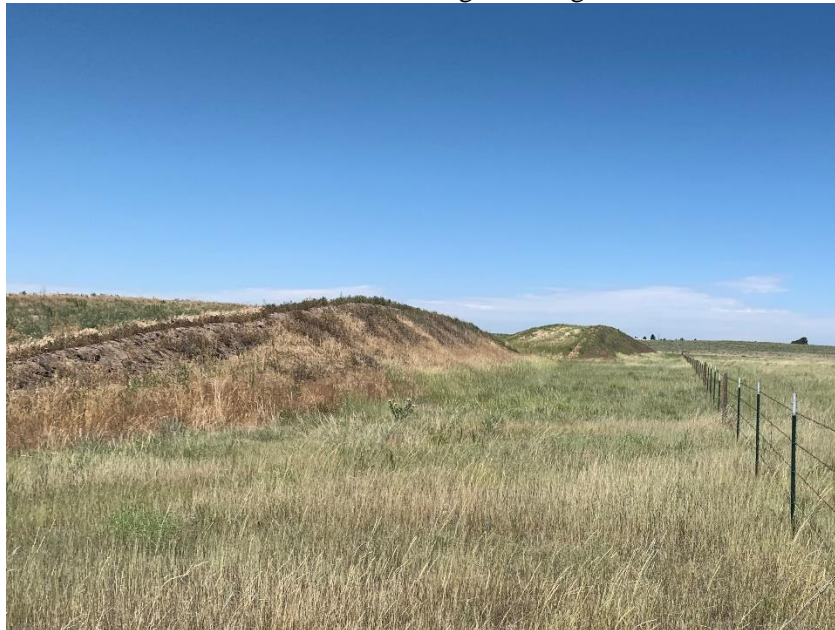
North permit boundary fence, looking west. Topsoil stockpile on left, overburden on right.

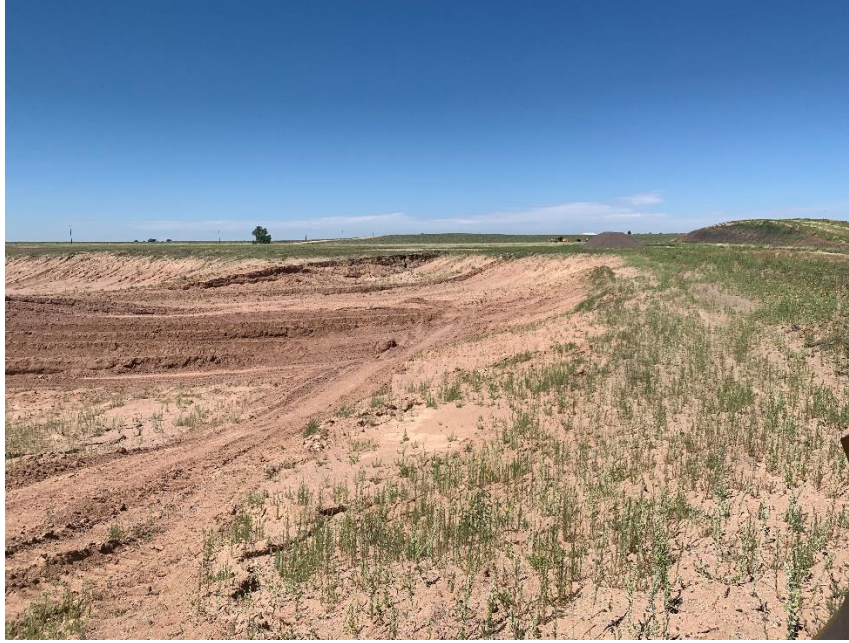
Mining activities were being conducted on the east side of the mine. About 9 acres have been disturbed. The highwall was about 8 feet high and the approved height is 20 feet. No mining activities were occurring during the time of the inspection; however, there was a bulldozer and two motor graders on site and the pit had recent activity.

Pit area looking west.

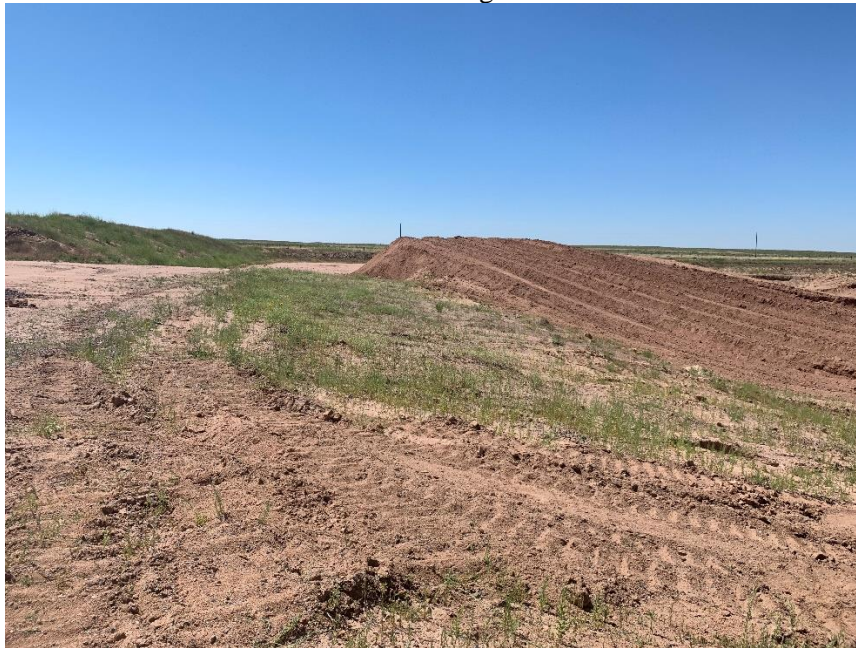
Gravel stockpile looking south.
