COLORADO DIVISION OF RECLAMATION, MINING AND SAFETY
MINERALS PROGRAM INSPECTION REPORT
PHONE: (303) 866-3567

MINE NAME: Laybourn Pit	MINE/PROSPECTING ID#: M-2016-074	MINERAL: Sand and gravel	COUNTY: Washington
INSPECTION TYPE: Monitoring	INSPECTOR(S): Brock Bowles	INSP. DATE: June 16, 2019	INSP. TIME: 1230
OPERATOR: Washington County	OPERATOR REPRESENTATIVE: Steve Williams	TYPE OF OPERATION: 110c - Construction Limited Impact

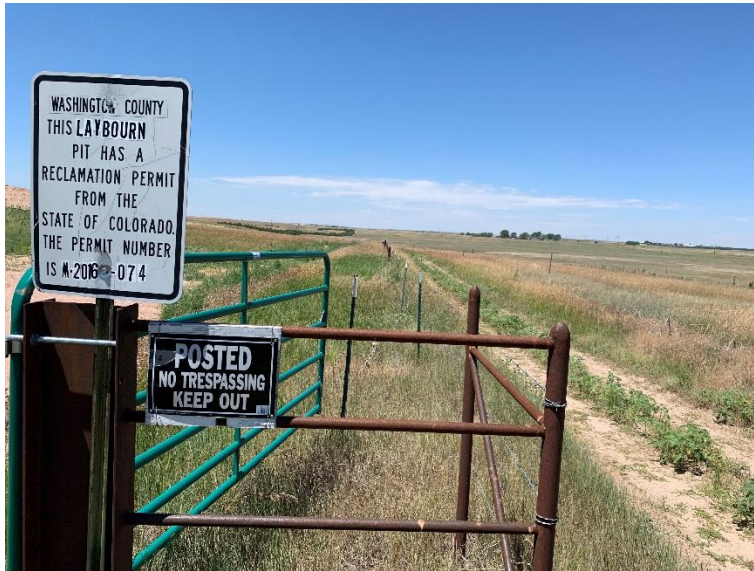
The permit identification sign was in place at the mine entrance and legible. The permit boundary was clearly delineated by a fence which was in good repair. The topsoil stockpile was in the southeast corner of the permit area, was well vegetated and appeared to be stable.

Permit identification sign; looking west.

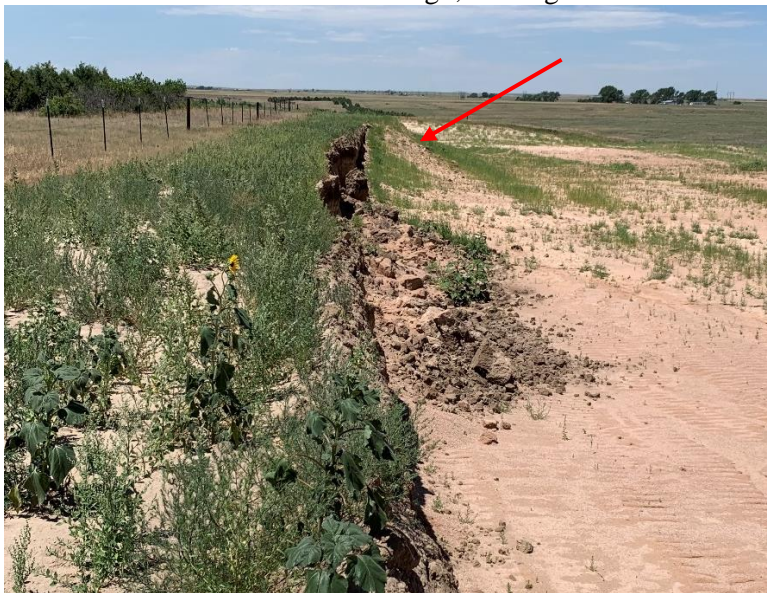
The highwall on the south side of the pit was about 10 feet high. The approved height is 15 feet. The highwall was sloughing in some areas but was not in danger of getting close to the permit boundary fenceline. The County owns the fence. Mr. Williams was aware of the highwall sloughing and has been backfilling the highwall as the pit advances to prevent any further damages.

Highwall sloughing on south side of pit looking west. Area where operator has backfilled highwall (red arrow).
