**MINERALS PROGRAM INSPECTION REPORT**  
**PHONE: (303) 866-3567**

<b>MINE NAME:</b> Henderson Mine	<b>MINE/PROSPECTING ID#:</b> M-1977-342	<b>MINERAL:</b> Molybdenum	<b>COUNTY:</b> Clear Creek, Grand
<b>INSPECTION TYPE:</b> Monitoring	<b>INSPECTOR(S):</b> Stephanie J. Mitchell	<b>INSP. DATE:</b> June 12, 2019	<b>INSP. TIME:</b> 09:00
<b>OPERATOR:</b> Climax Molybdenum Company	<b>OPERATOR REPRESENTATIVE:</b> Aaron Hilshorst	<b>TYPE OF OPERATION:</b> 112d-3 - Designated Mining Operation	
<b>REASON FOR INSPECTION:</b> Normal I&E Program	<b>BOND CALCULATION TYPE:</b> Partial Bond	<b>BOND AMOUNT:</b> \$37,993,785.00	
<b>DATE OF COMPLAINT:</b> NA	<b>POST INSP. CONTACTS:</b> None	<b>JOINT INSP. AGENCY:</b> None	
<b>WEATHER:</b> Clear	<b>INSPECTOR'S SIGNATURE:</b>

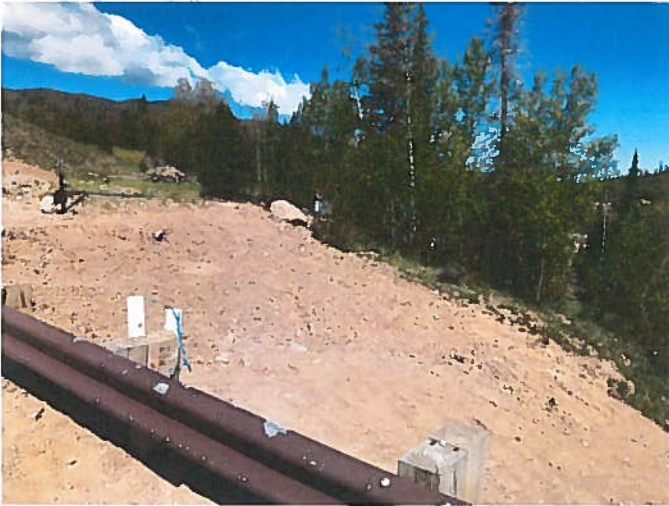
East Branch Dam Repair

On April 9, 2019, Henderson staff informed the Division of a sink hole along the left abutment of the East Branch Dam. Henderson excavated the area to locate the pipe. Appropriate notice and permits were received from Grand County to operate in County Road 3 and the pipe was replaced. The area was regraded and was not seeded. The Division recommends seeding and mulching the area that was excavated and regraded to reduce erosion.

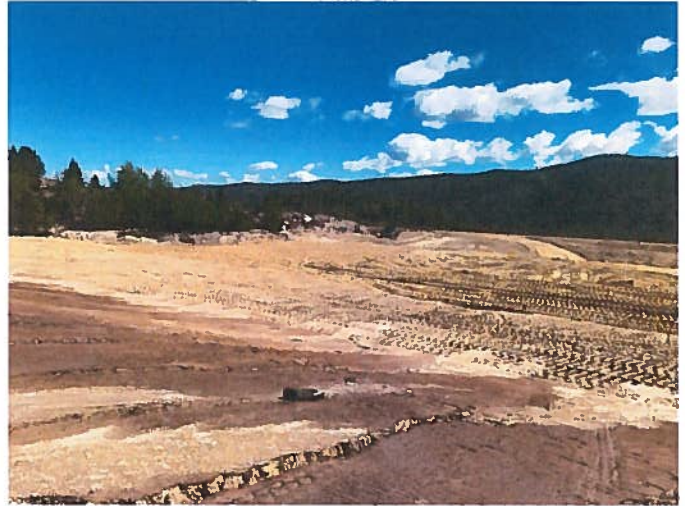
3 Dam Buttress Project area

The 3-Dam Buttress – Stage 1 project approved under TR-29 by the Division on April 4, 2018 is ongoing. 11,000 cubic yards of buttress material have been placed so far. Crews are using a sheep's foot roller for

compaction instead of a smooth flat roller. At the toe of the slope there is a pipe with erosional issues forming. The pipe will be extended at the toe of slope when the next lift is placed. Coherix is being used to keep the dust levels down.

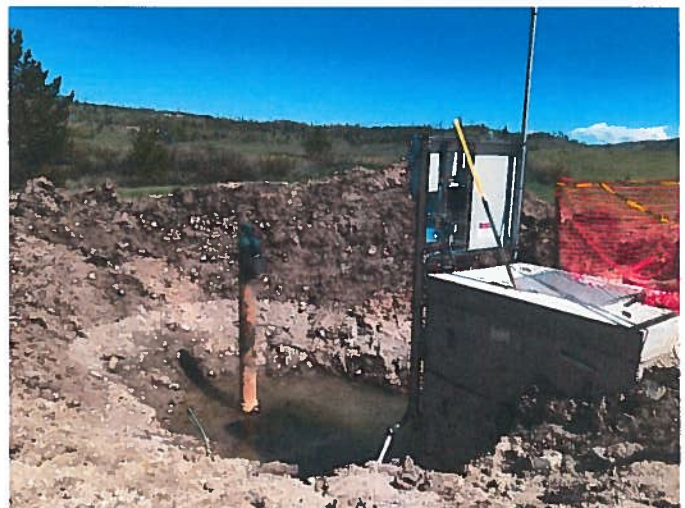
Repairs are being made, although groundwater is surfacing and the crews working on repair are having problems keeping the area dry. There is a leak in an unknown location and will be repaired when water levels go down or the water will be pumped out.

MLEX -5 Repair water hindering repair

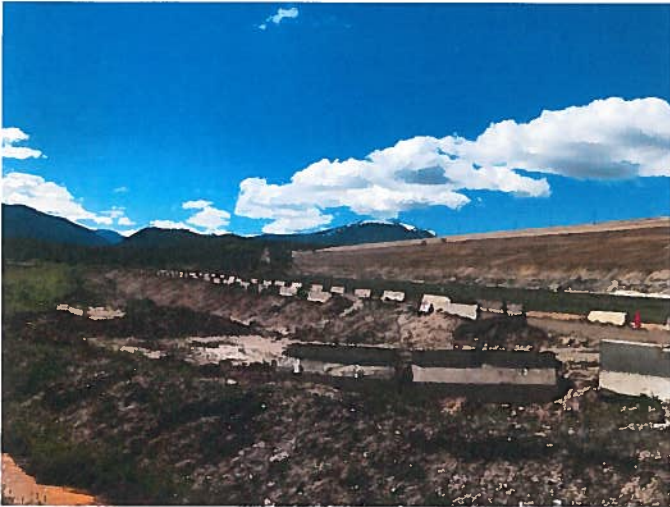
Road Raise topsoil berms

Preparations for road raise include topsoil stockpiled or pushed out of the way.

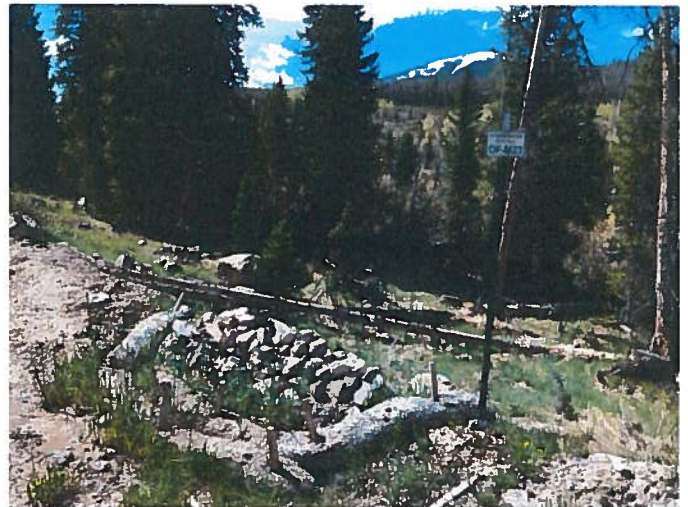
OF M-23

OF M-23: working properly

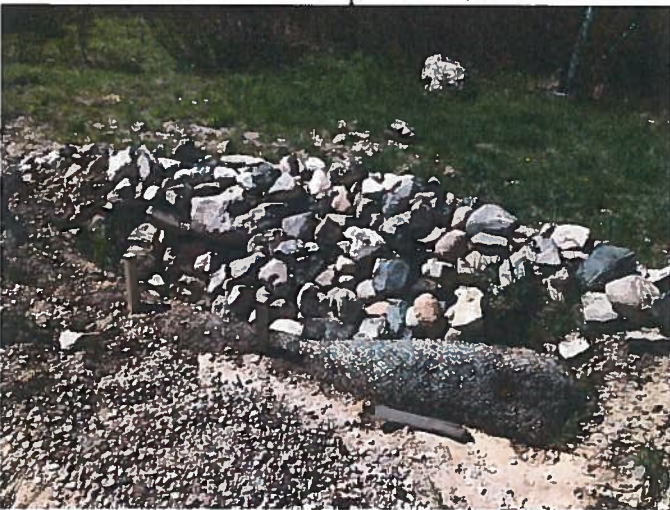
Outfall M-24

OF M-24: working properly, will need some maintaining in the future

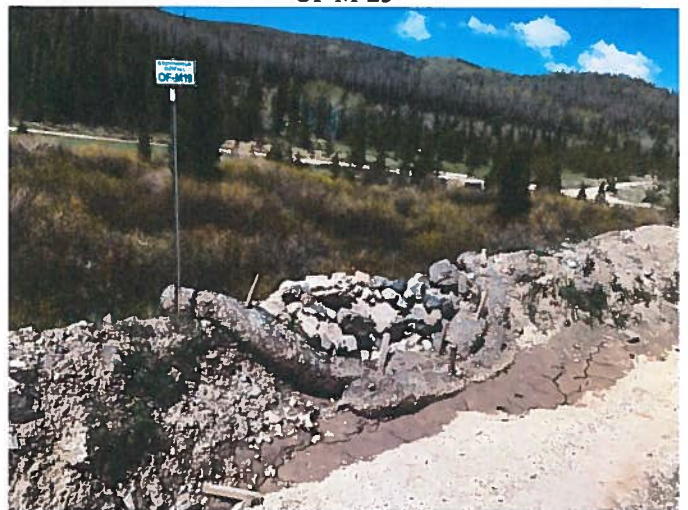
OF M-19

OF M-19: working properly

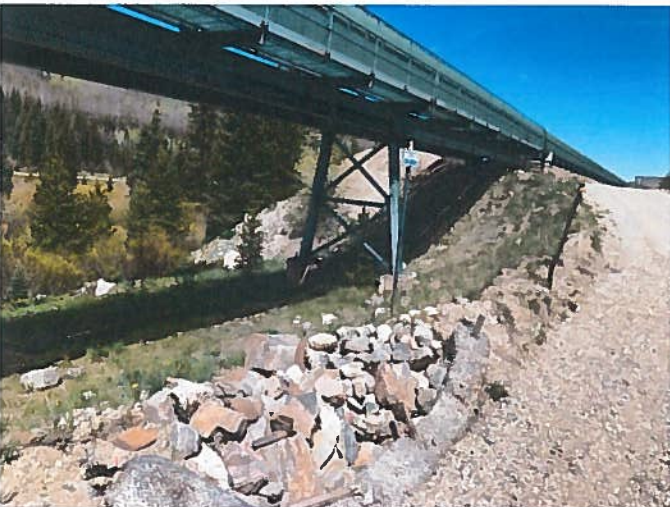
OF M-31

OF M-31: working properly

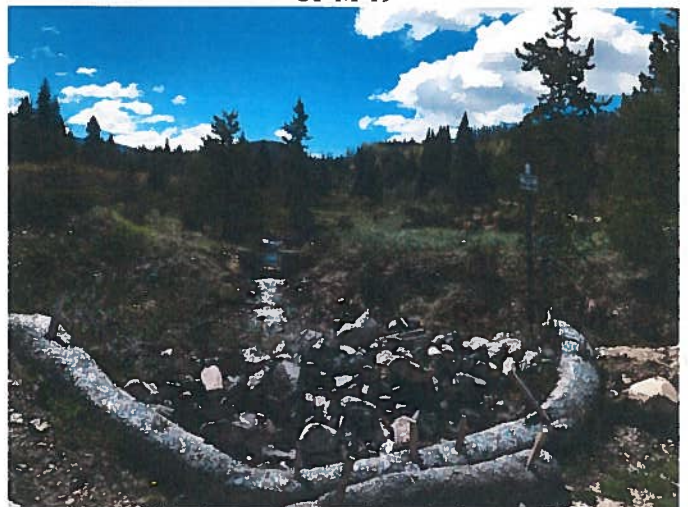
OF M-21

OF M-21: working properly

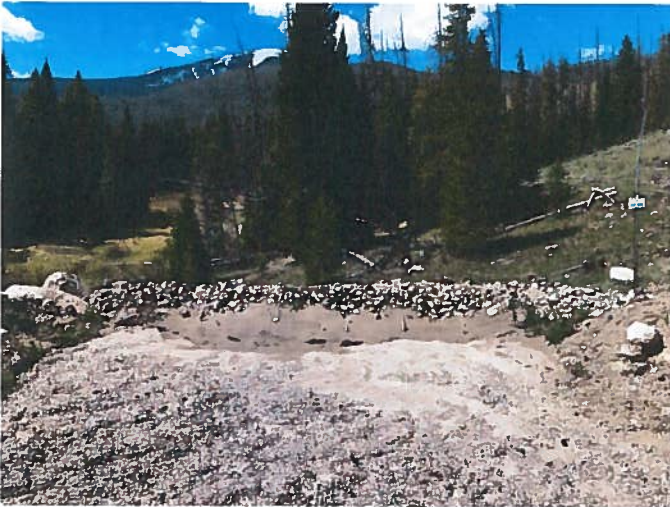
OF M-4

OF M-4: this outfall needs to be maintained/cleaned out

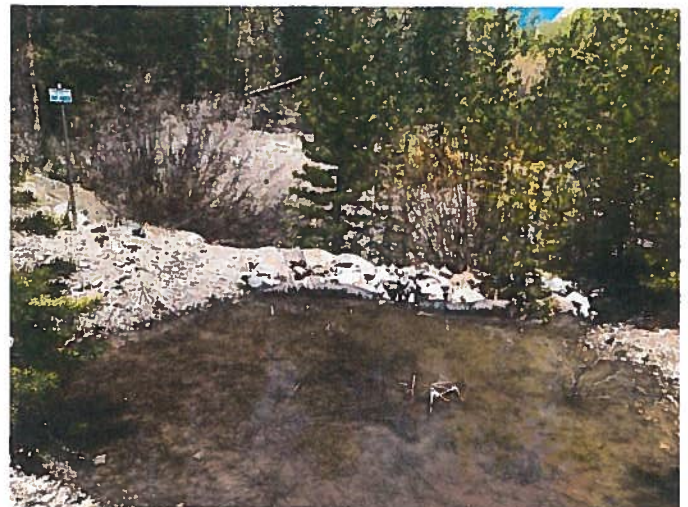
OF M-22

OF M-22, OF M-10, OF M-16, OF M-9, OF M-15, OF M-7, OF M-12, OF M30 and OF M-3: all working properly

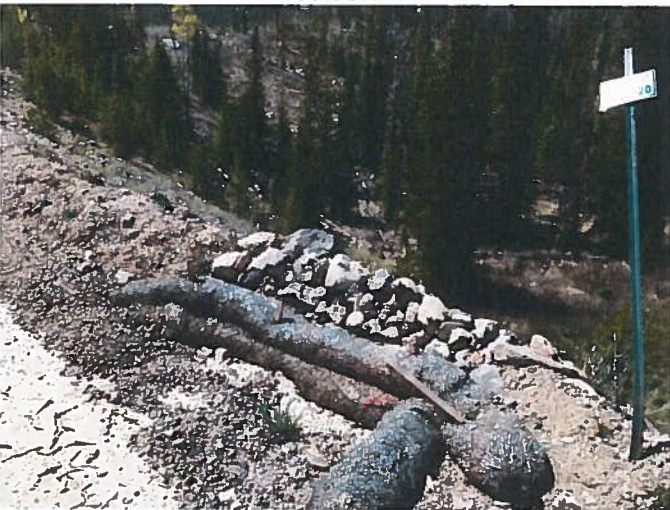
OF M-20

OF M-20: working properly

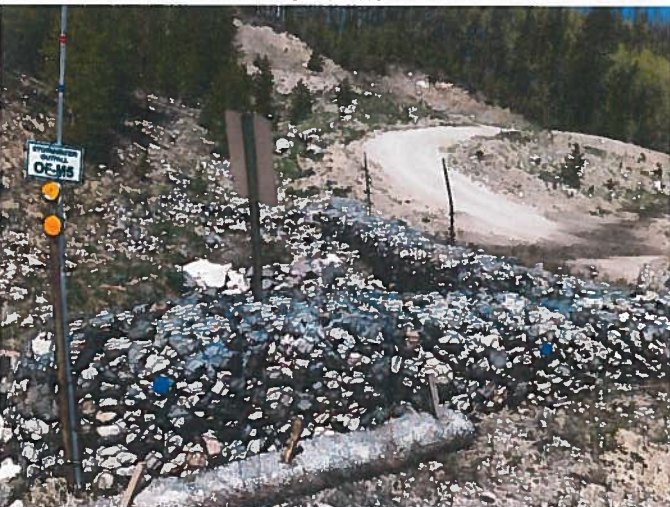
OF M-5

OF M-5: working properly
