Re: Bowie Resources, LLC, Bowie No. 2 Mine
Coal Mine Waste Banks & Instrumentation Monitoring
Pond Quarterly Inspections
Permit C-1996-083

Coal Mine Waste Bank Nos. 1, 2, & 3 Inspections –2nd Quarter 2019

Subject: Summary of Instrumentation Monitoring
2nd Quarter 2019
Bowie Coal Waste Disposal Area No. 2
Paonia, Colorado

Subject: Summary of Instrumentation Monitoring
2nd Quarter 2019
Bowie Coal Waste Disposal Area No. 3
Paonia, Colorado

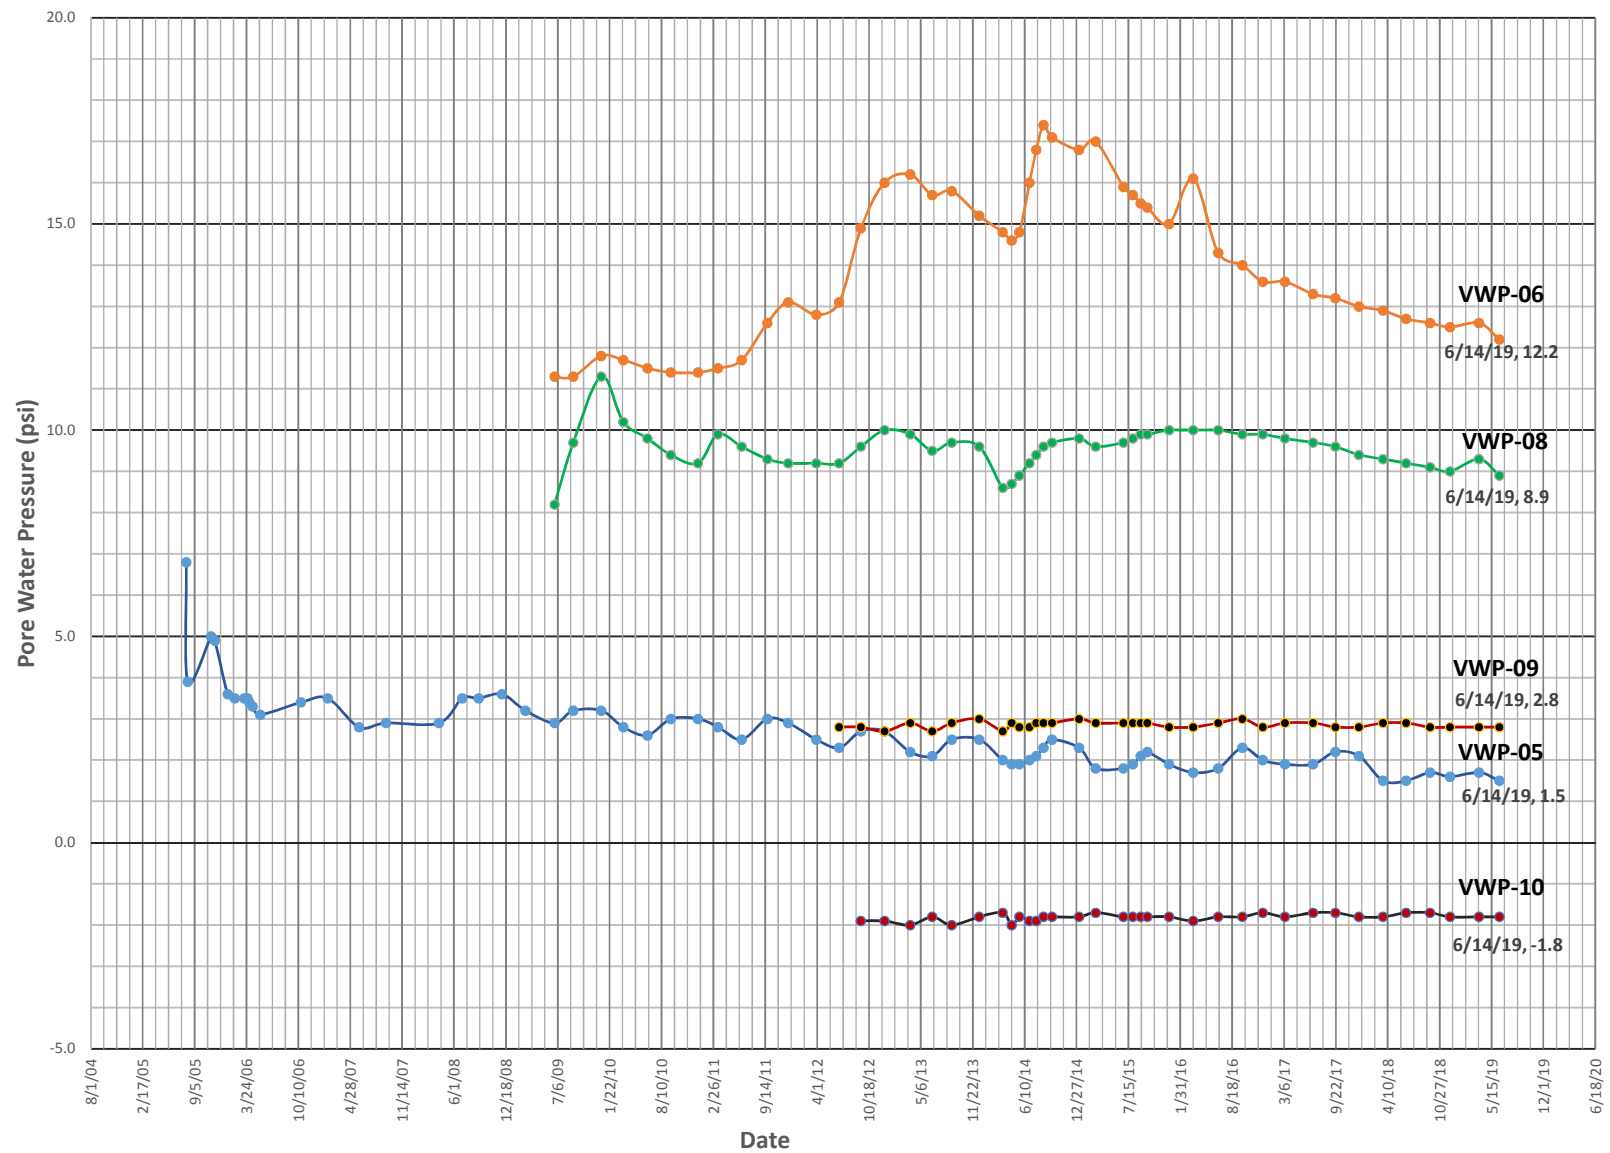
Figure 2 - Bowie Mine #2 - CWDA #2
Active Vibrating Wire Piezometer Data

As seen on Figure 2, the VWP readings are consistent either with previous recent or historic readings. Pore pressure readings went down slightly in three piezometers and stayed the same in two piezometers when compared to the Q1 readings.

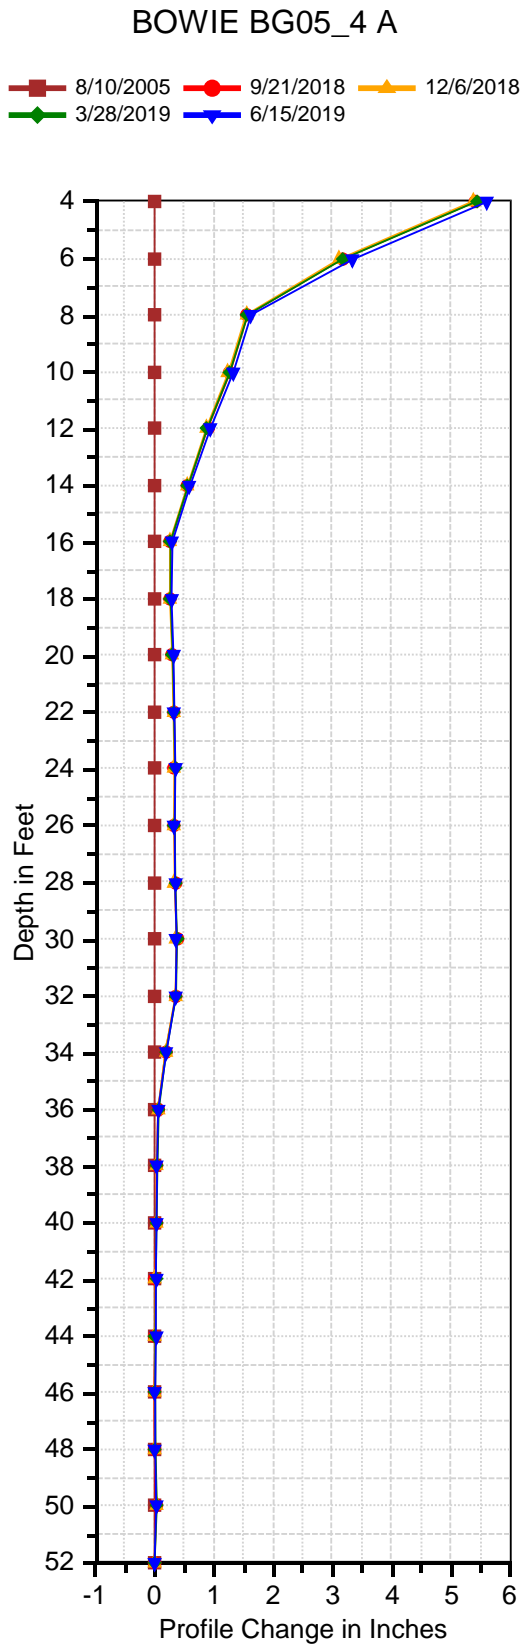
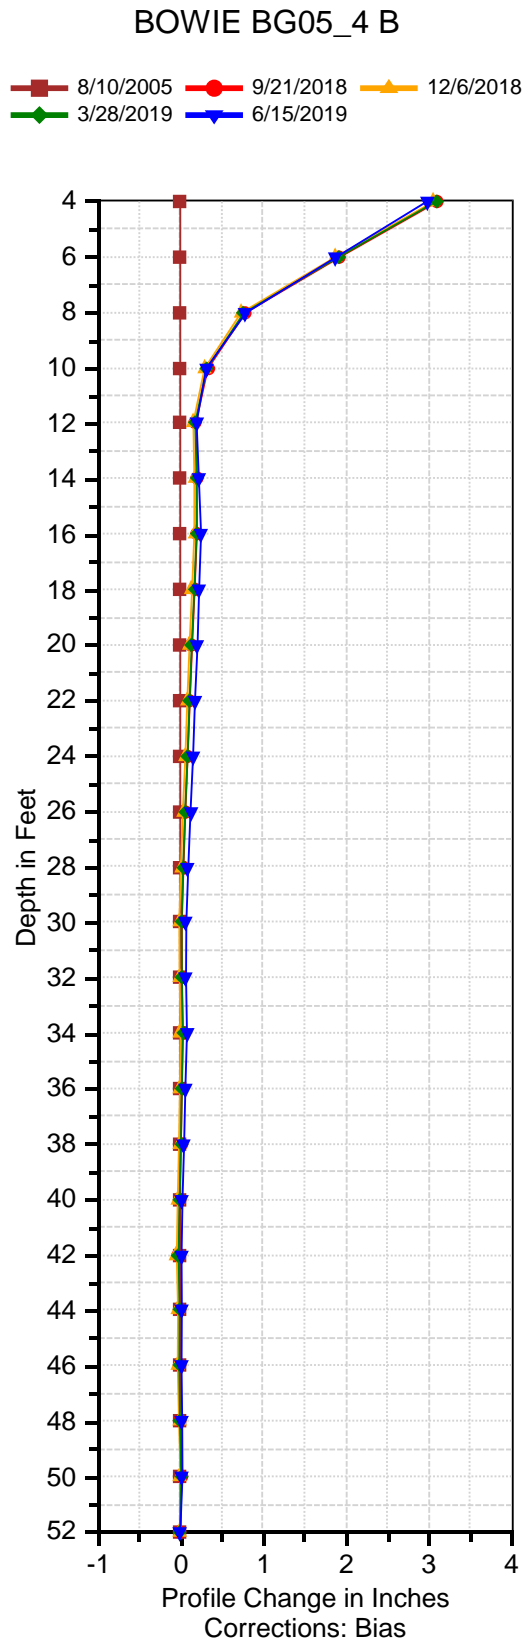
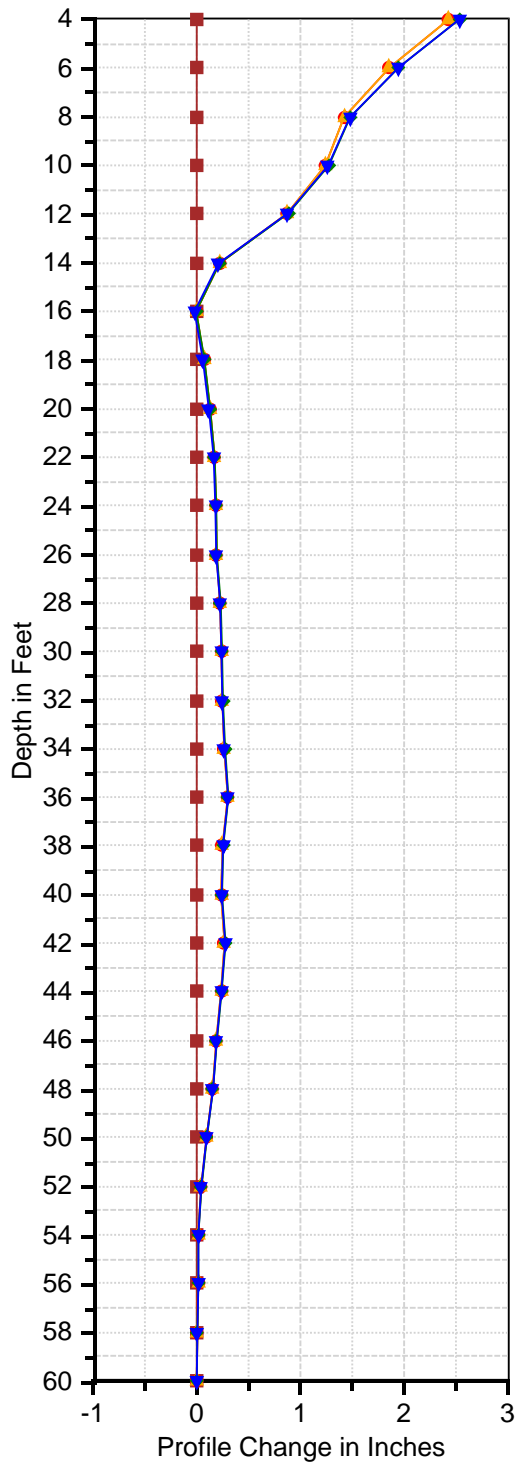
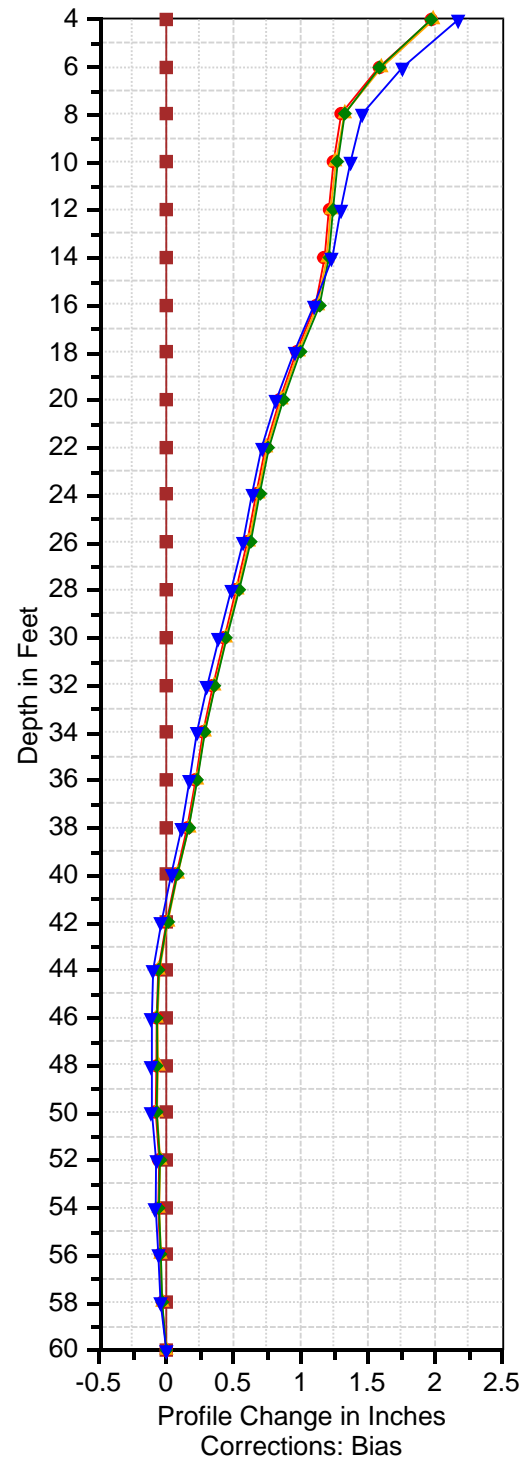
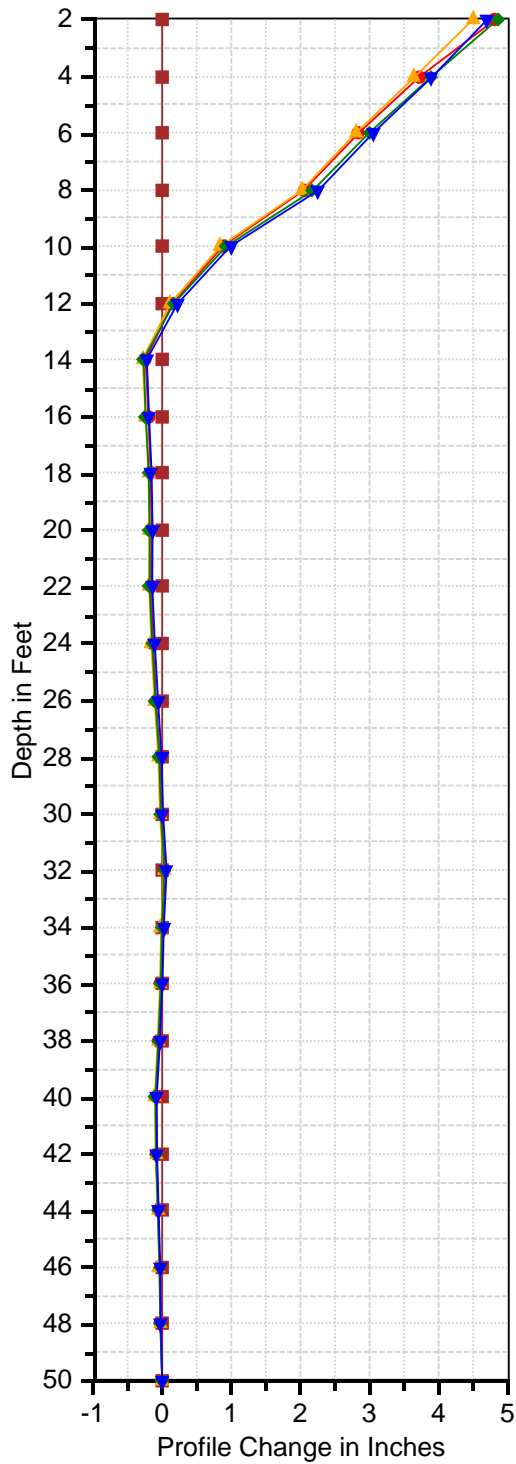
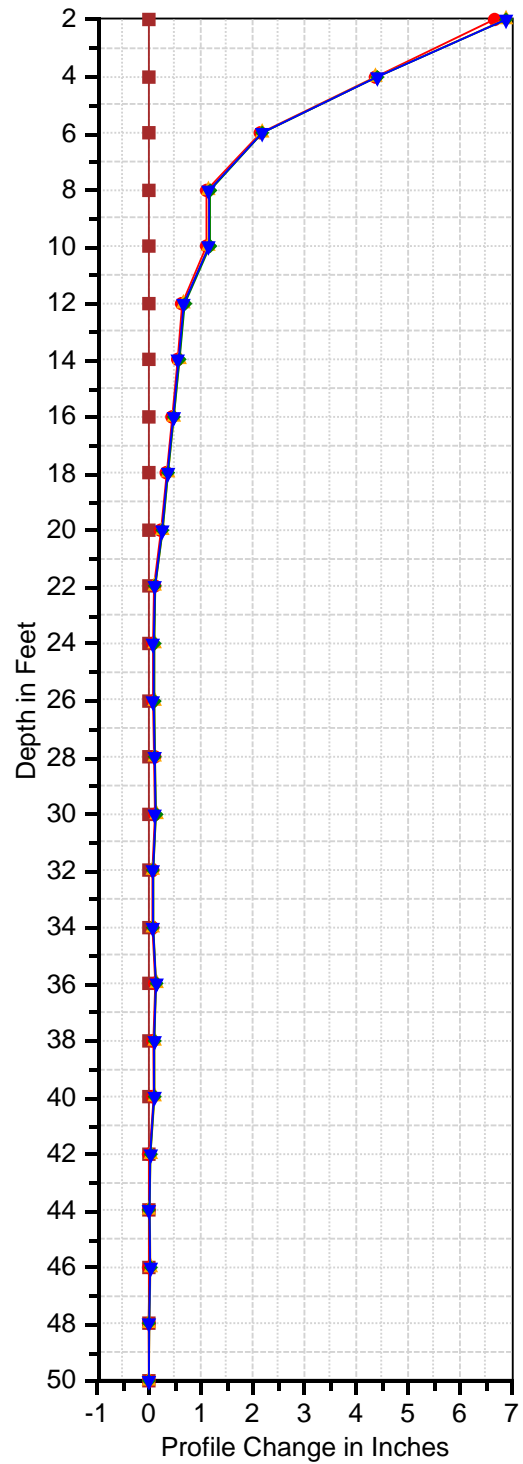
Figure 3 - Inclinator Displacement Curves

The latest inclinometer readings show a slight deflection near the top of BG05-5. However, the deflection is perpendicular to the slope direction. As a result, the reported deflection is not an indication of instability. In addition, the 3rd Quarter 2019 monitoring will provide an indication of whether or not the observed deflection reflects actual movement or is simply a measurement error. No significant movements were reported for the other inclinometers.

As described in previous reports, we believe historic displacements indicated on the plots for the approximate upper ten feet of the inclinometers are likely due to placement of cover soil on the face of the waste pile during normal operations for maintenance and revegetation. Recent downslope readings (Axis A) are generally consistent with previous readings. There appears to be a small displacement in the orthogonal direction (Axis B) for inclinometer BG05-5B above 14 feet. This is not as concerning since it is not in the downslope direction and likely relates to the casing being bumped by movement of cover soil or by a recording error. This discrepancy of less than 1/4-inch laterally should be evaluated during the next (Q3) reading.

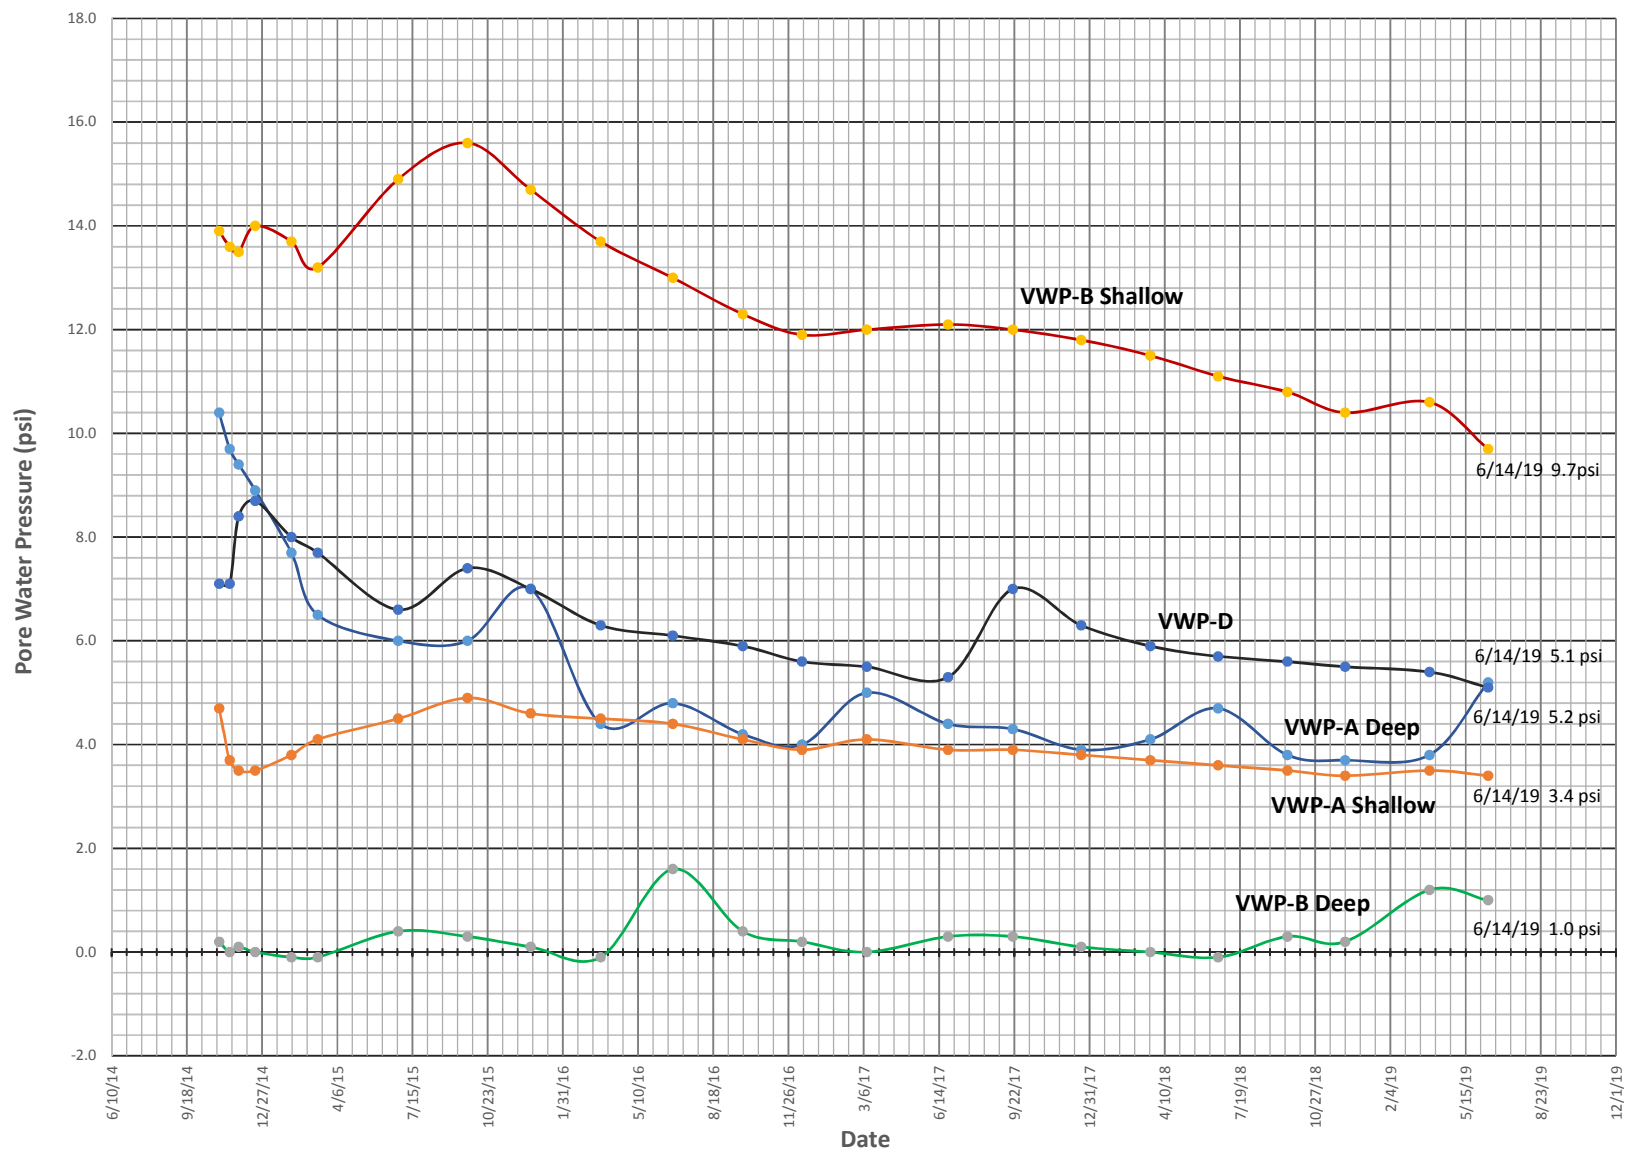
Figure 1 - Bowie Mine #2 - CWDA #3
Vibrating Wire Piezometer Data

As seen on Figure 1, the readings are either consistent with previous recent or historic readings. Only one piezometer (VWP-A Deep) had a pore pressure increase since the 1st quarter, but this VWP has showed the most erratic readings of all the piezometers since installation. The other four VWP's had variable amounts of pore pressure decreases. If you have any questions regarding this letter or the instrumentation monitoring at CWDA #3, please contact me at (907) 562-2000 or jholland@dowl.com.
