**COLORADO**Division of Reclamation,  
Mining and Safety

**MINERALS PROGRAM INSPECTION REPORT****PHONE: (303) 866-3567**

<b>MINE NAME:</b> Boone-Fillmore Pit	<b>MINE/PROSPECTING ID#:</b> M-1990-144	<b>MINERAL:</b> Sand and gravel	<b>COUNTY:</b> Pueblo
<b>INSPECTION TYPE:</b> Monitoring	<b>INSPECTOR(S):</b> Patrick Lennberg	<b>INSP. DATE:</b> July 11, 2019	<b>INSP. TIME:</b> 10:30
<b>OPERATOR:</b> R. Lewis Fillmore	<b>OPERATOR REPRESENTATIVE:</b> Ron Fillmore	<b>TYPE OF OPERATION:</b> 112c - Construction Regular Operation

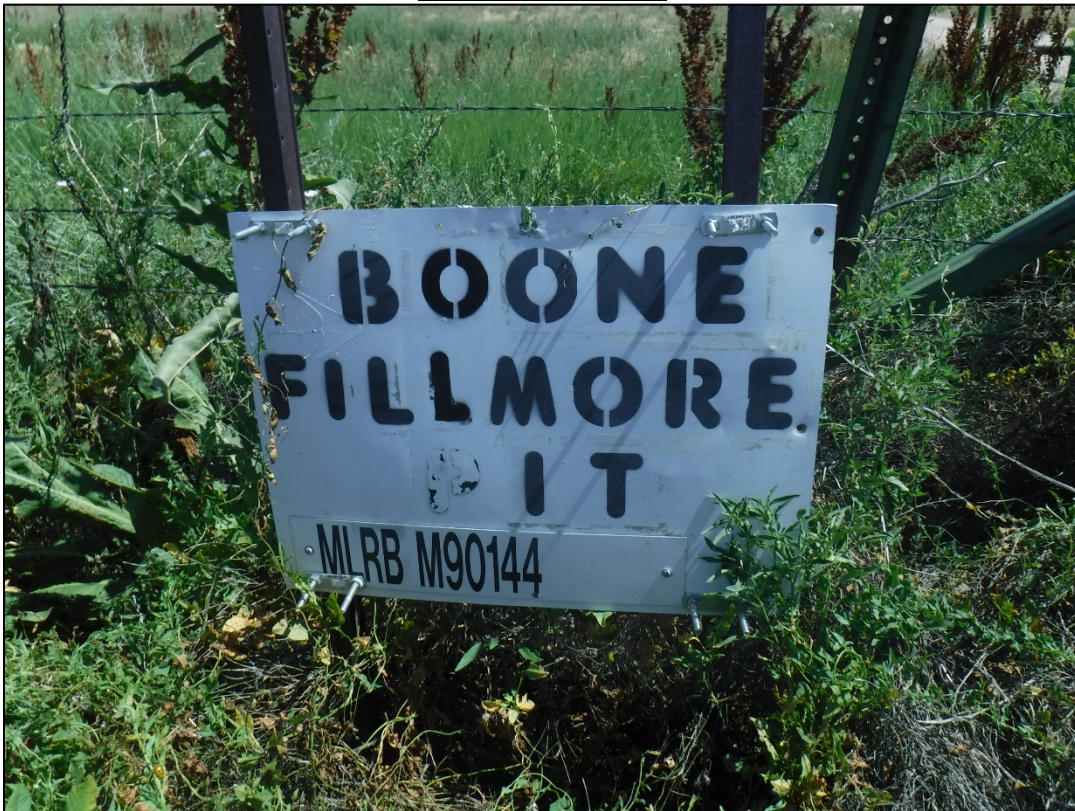
**Photo 1:** Mine sign at entrance off of State Highway 96

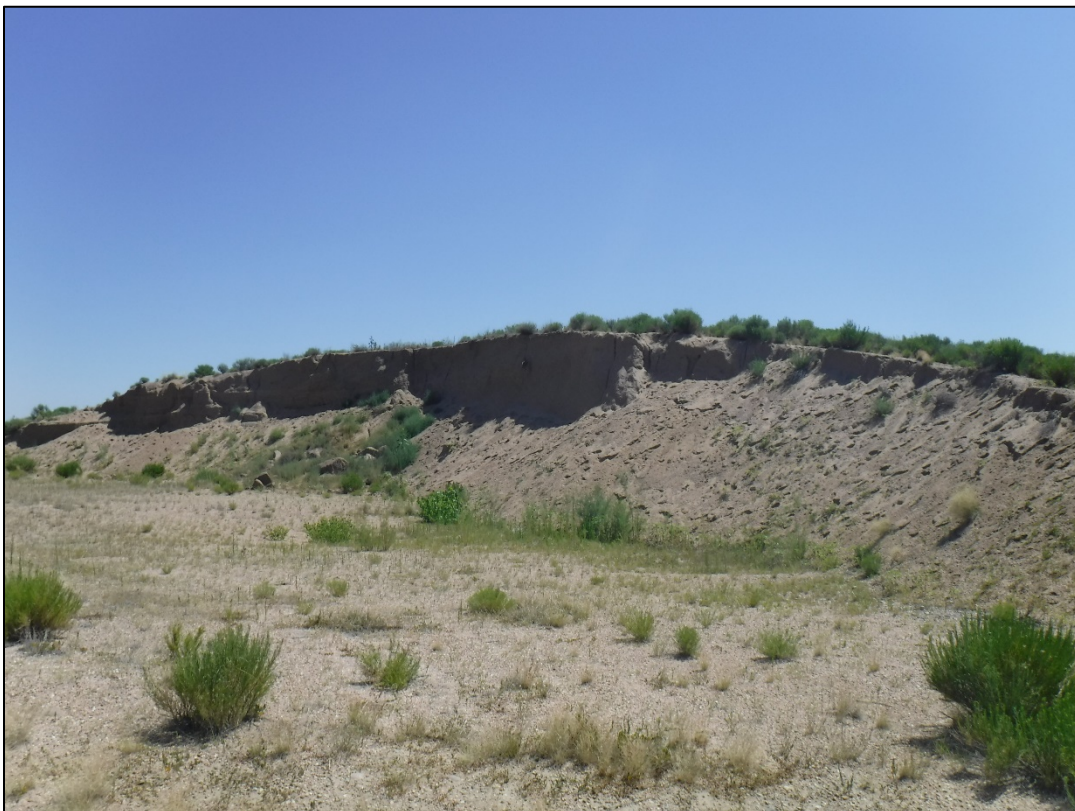
**Photo 2:** Large stockpile of material at the east end of the site near the mine entrance, looking northeast

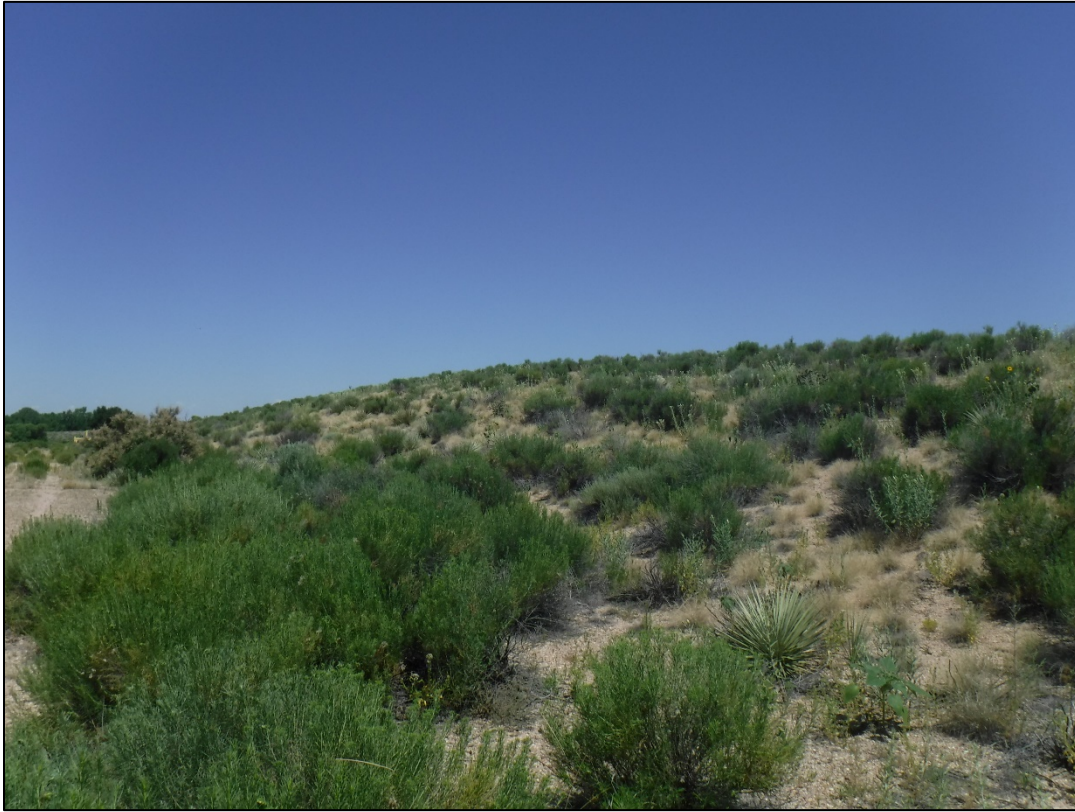
**Photo 3:** Large stockpile near the mine entrance but looking across the pile towards the west

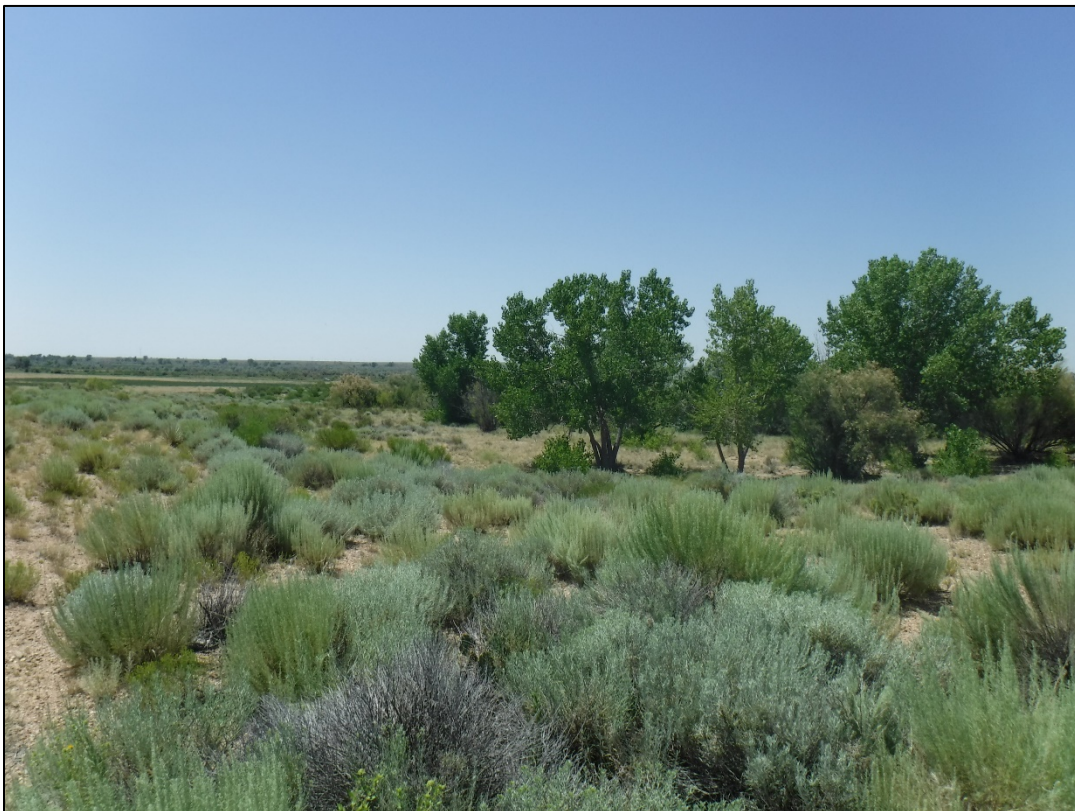
**Photo 4:** Vegetation conditions at the eastern most portion of the permit boundary

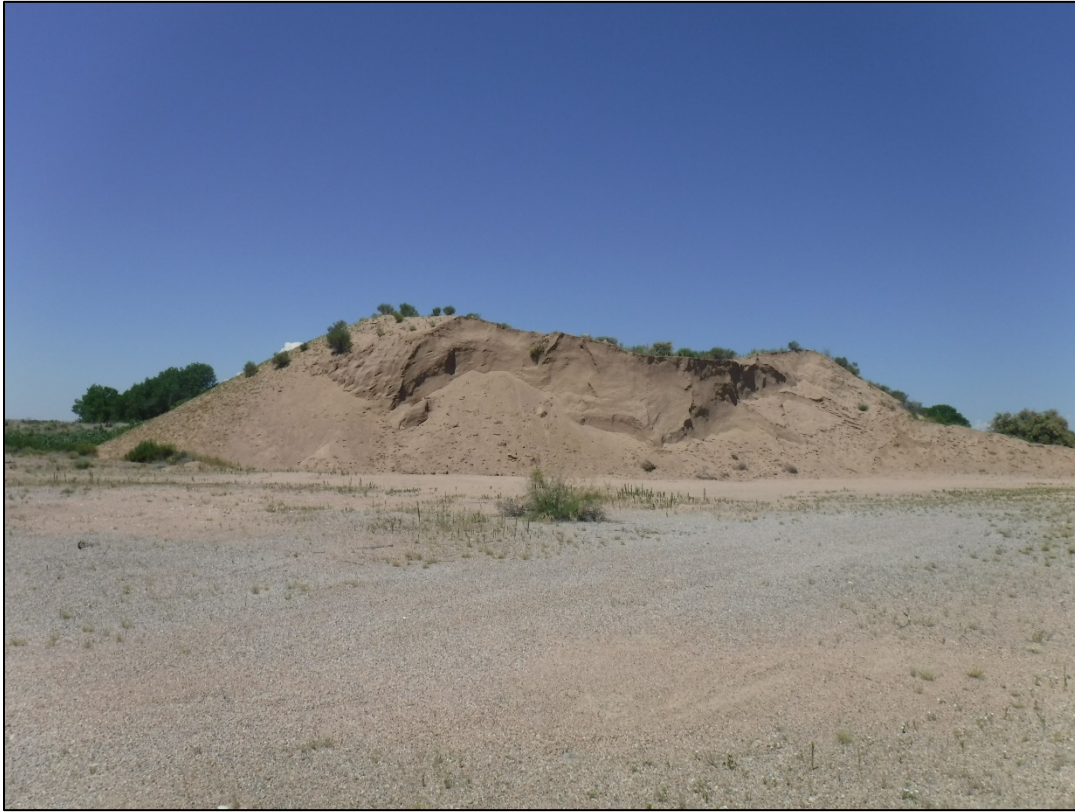
**Photo 5:** Stockpile of material located in the central west portion of the site

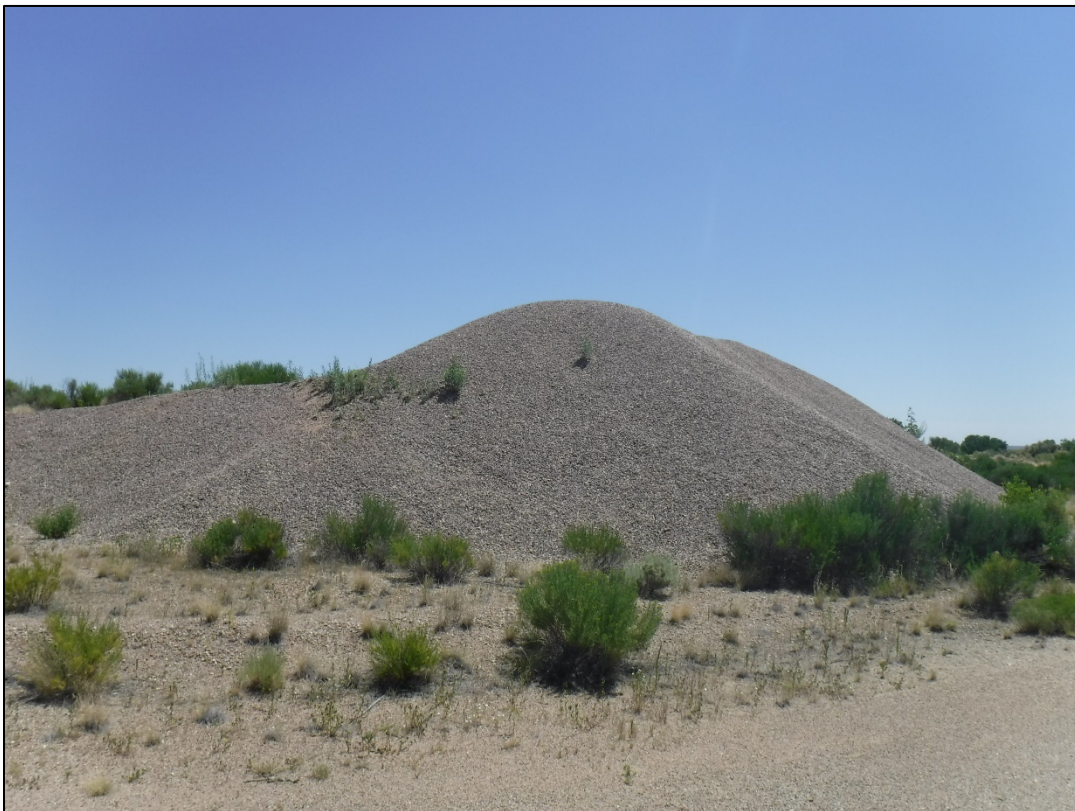
**Photo 6:** Stockpile of material located adjacent to the pile pictured above

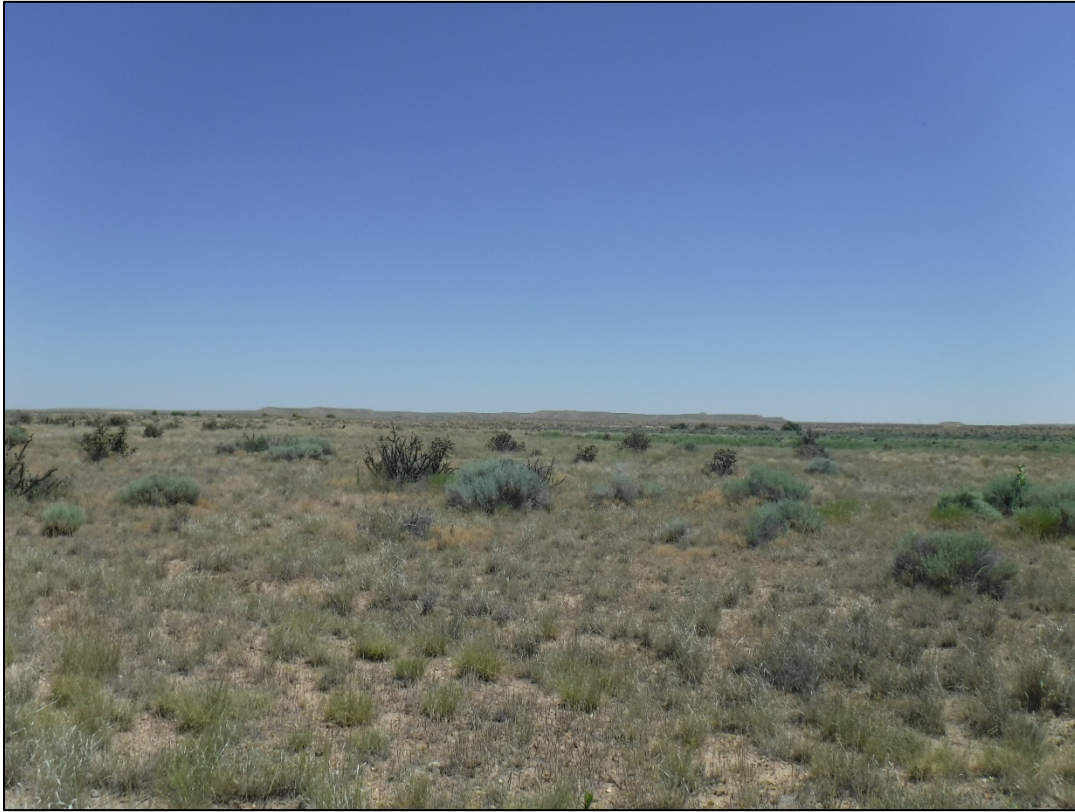
**Photo 7:** Unmined area in the northwest portion of the permit area, looking north

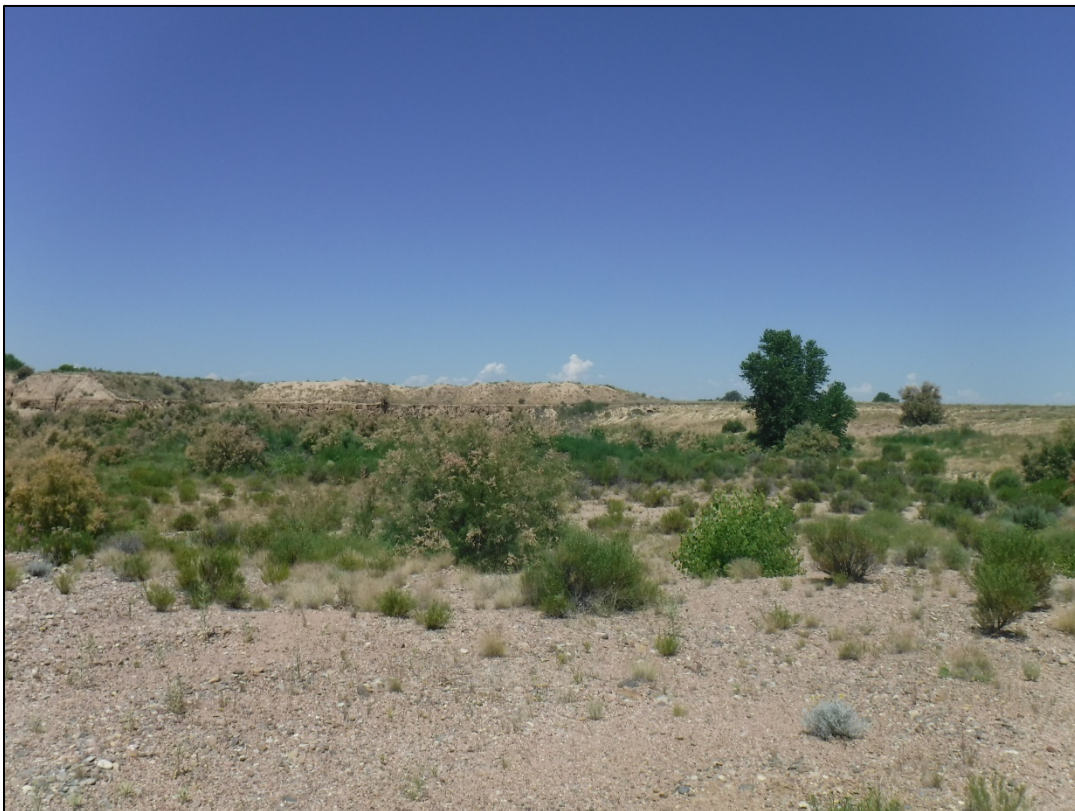
**Photo 8:** Former pit area located north central area of the permit

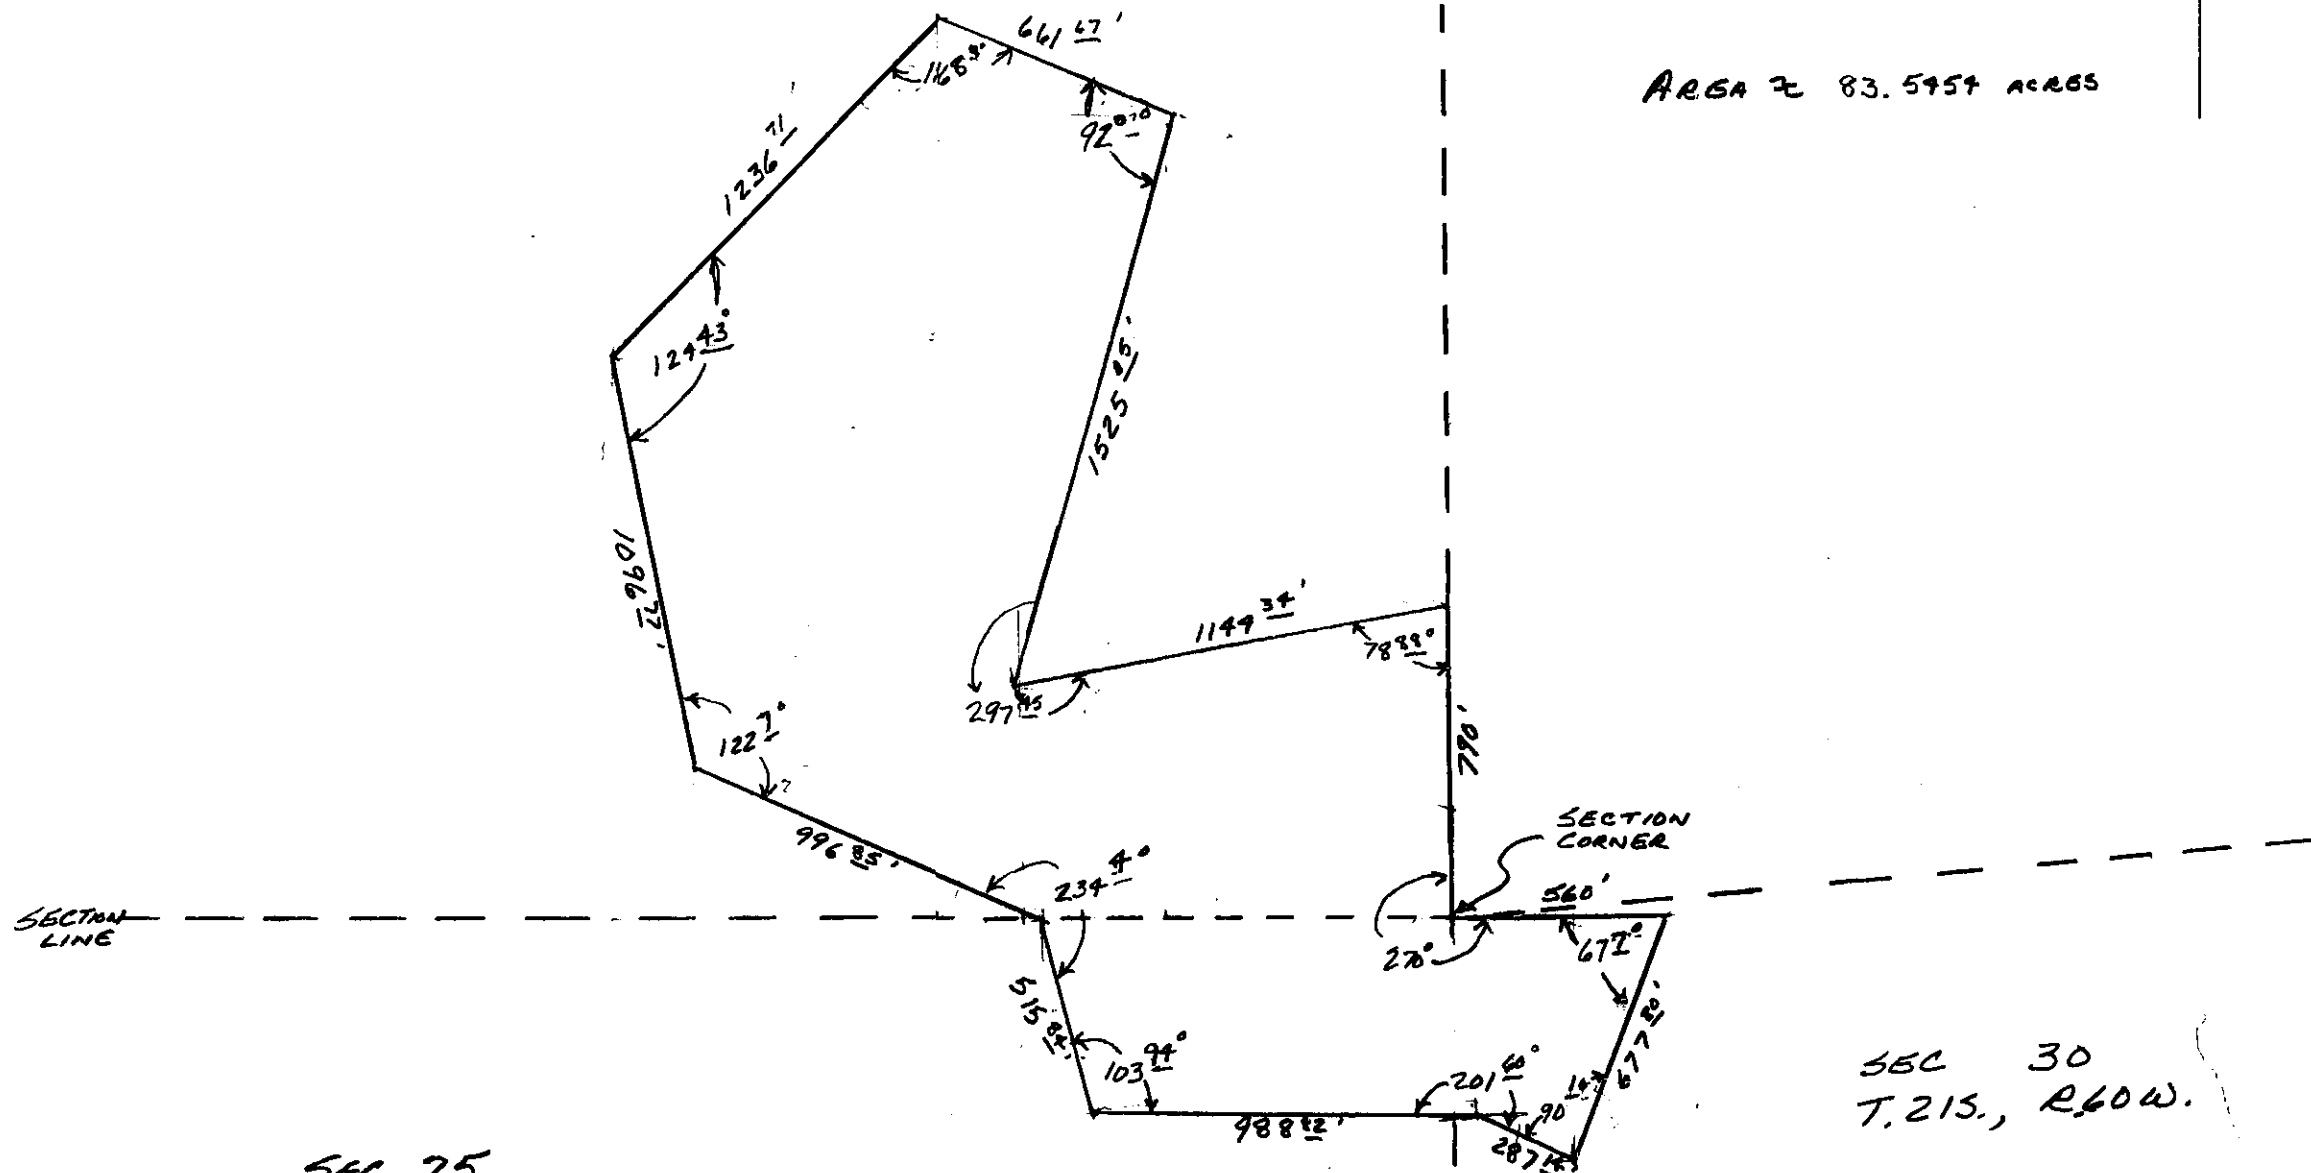
PIT Layout & Ownership

**PROBLEM:** The affected area boundary markers are missing. This is a problem for failure to maintain boundary markers around the affected area as required by Section 3.1.12(2) of the rule.

**CORRECTIVE ACTIONS:** The Operator will use the approved metes and bounds survey (Attachment 1) to accurately locate and install new permit boundary markers within 30 days of mailing this inspection report. The survey should be completed by a licensed surveyor to achieve the most accurate placement of the markers. Once the survey is complete the Operator will submit a map of the placed boundary markers along with latitude and longitude coordinates of each corner of the permit boundary.
