**COLORADO**Division of Reclamation,
Mining and Safety

MINERALS PROGRAM INSPECTION REPORT**PHONE: (303) 866-3567**

MINE NAME: Ordway Pit	MINE/PROSPECTING ID#: M-2006-054	MINERAL: Sand and gravel	COUNTY: Crowley
INSPECTION TYPE: Surety-Related Inspection	INSPECTOR(S): Patrick Lennberg	INSP. DATE: July 18, 2019	INSP. TIME: 08:00
OPERATOR: Ordway Feedyard Ltd. Liability Co.	OPERATOR REPRESENTATIVE: Tony Warnock	TYPE OF OPERATION: 112c - Construction Regular Operation

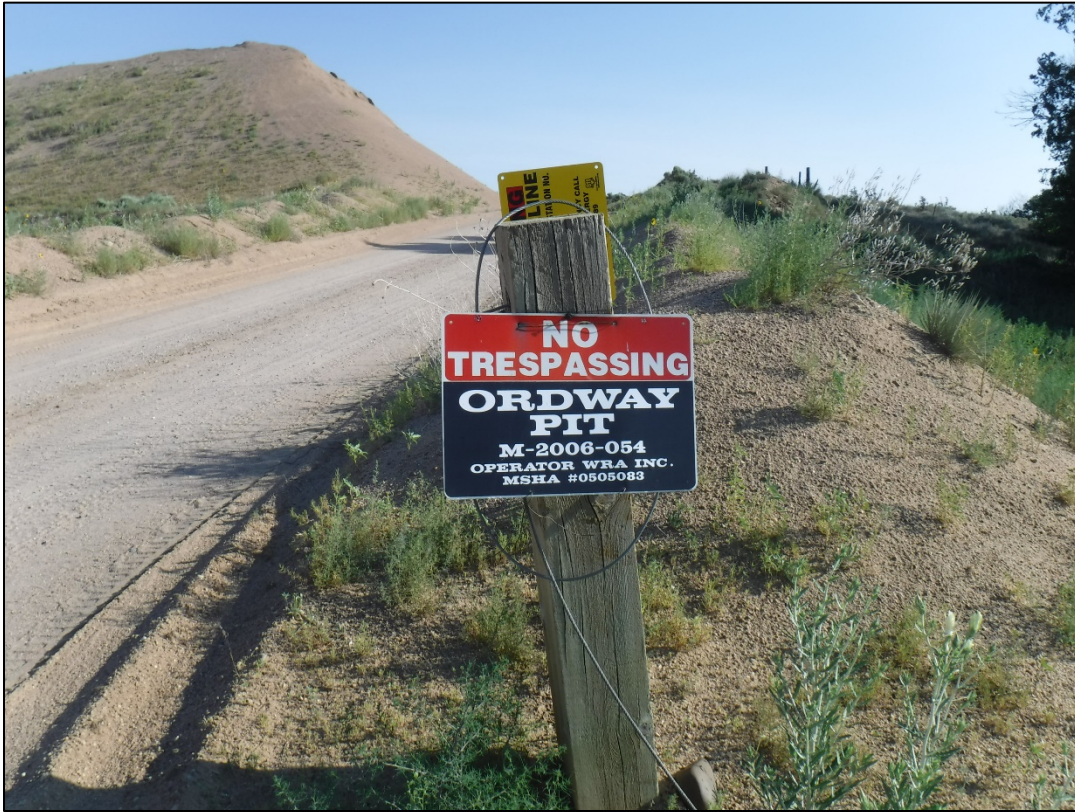
A mine sign was observed at the entrance to the mine in the southeast corner of the permit area as required by Rule 3.1.12. However, the permit boundary markers could not be located at the southeast and northeast corners. The corner marker that is supposed to be ~1,400 feet to the northwest of the southeast corner, near the active sedimentation pond, also could not be located. This matter is being cited as a problem in this report pursuant to Rule 3.1.12(2).

Photo 1: Mine sign at entrance off of Co Rd B in the southeast portion of permit area

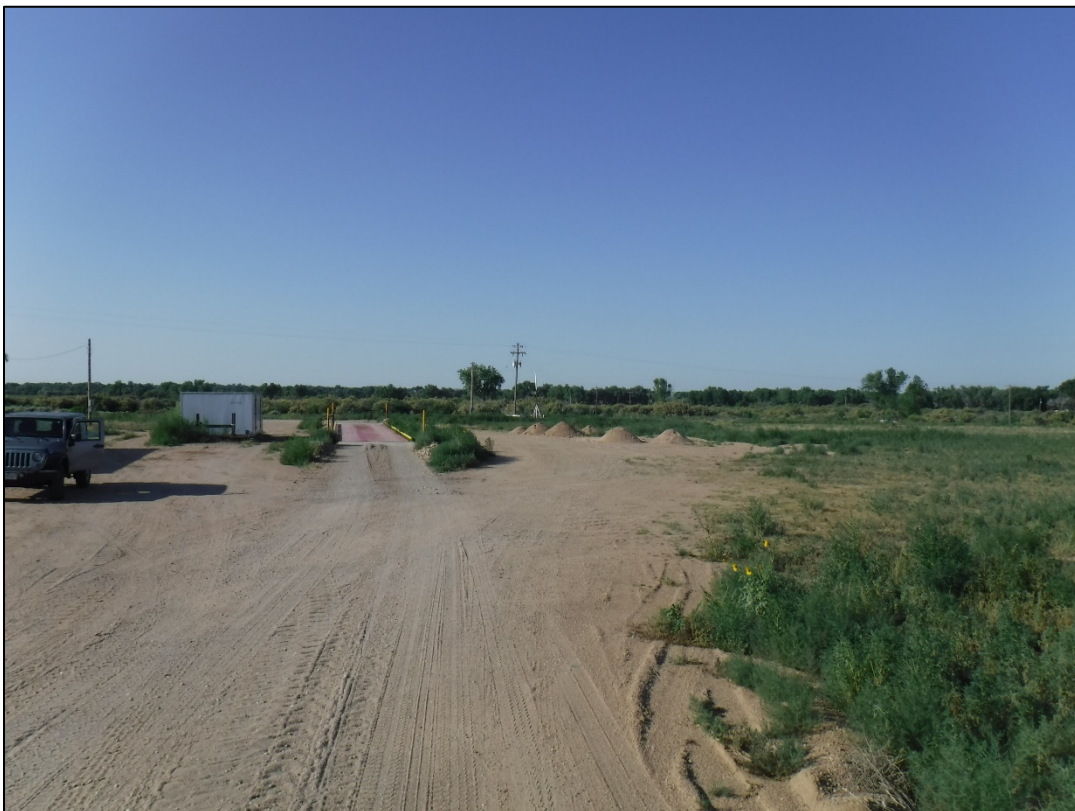
Additionally, in the original permit application a scale house was not identified as being part of the mine operations. The scale house was installed between late 2017 and 2018. A new haul road has been substantially improved from the prevailing conditions that existed during the operation's limited use in the past. New or improved roads must be included as part of the permitted acreage. The upgraded haul road and scale house may require additional financial warranty for reclamation costs.

A total of 4.1 acres of land affected outside of the permit boundary, approximately 0.67 acres related to the scale house and 3.4 acres associated with stockpiles, is being cited as a Possible Violation pursuant to C.R.S. 34-32.5-116(4)(i) for failure to protect areas outside of the affected land from damages occurring during the mining operation.

Photo 2: Scale house and scales at mine entrance, looking south

CORRECTIVE ACTIONS: This possible violation will require a hearing before the Mined Land Reclamation Board. The schedule and other details for the MLRB hearing will be provided under a separate document to be sent via certified mail to the operator.

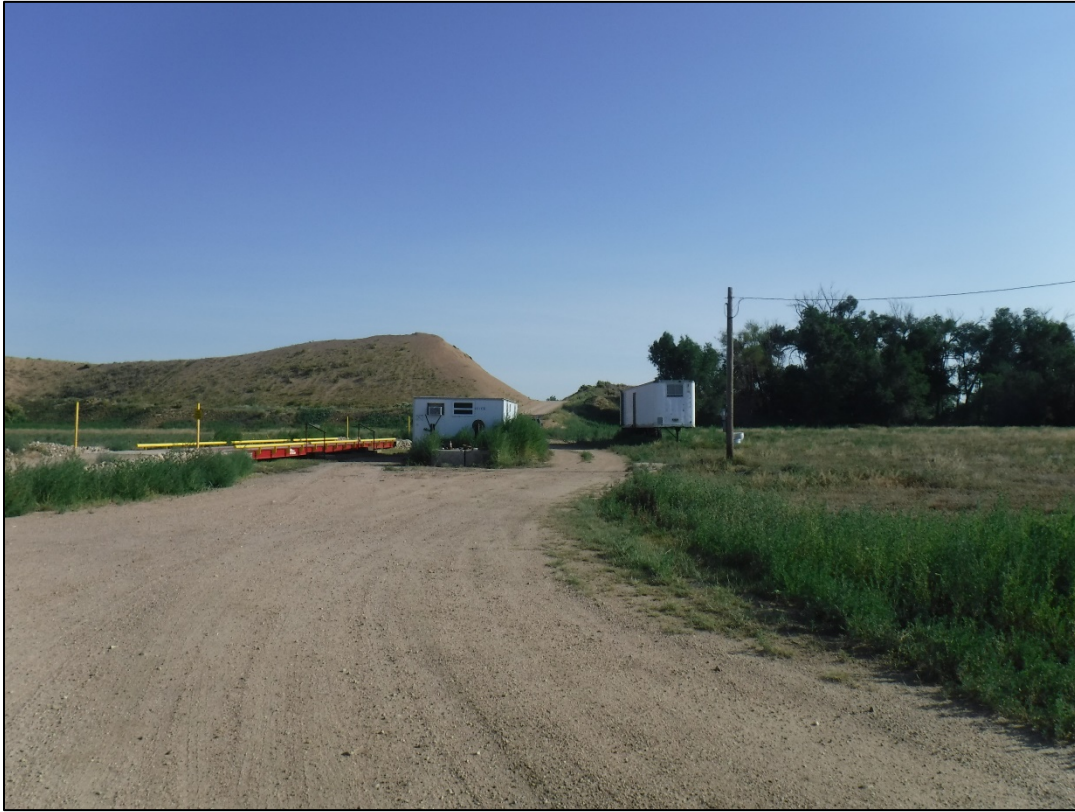
Photo 3: Scale house and scales at mine entrance, looking north

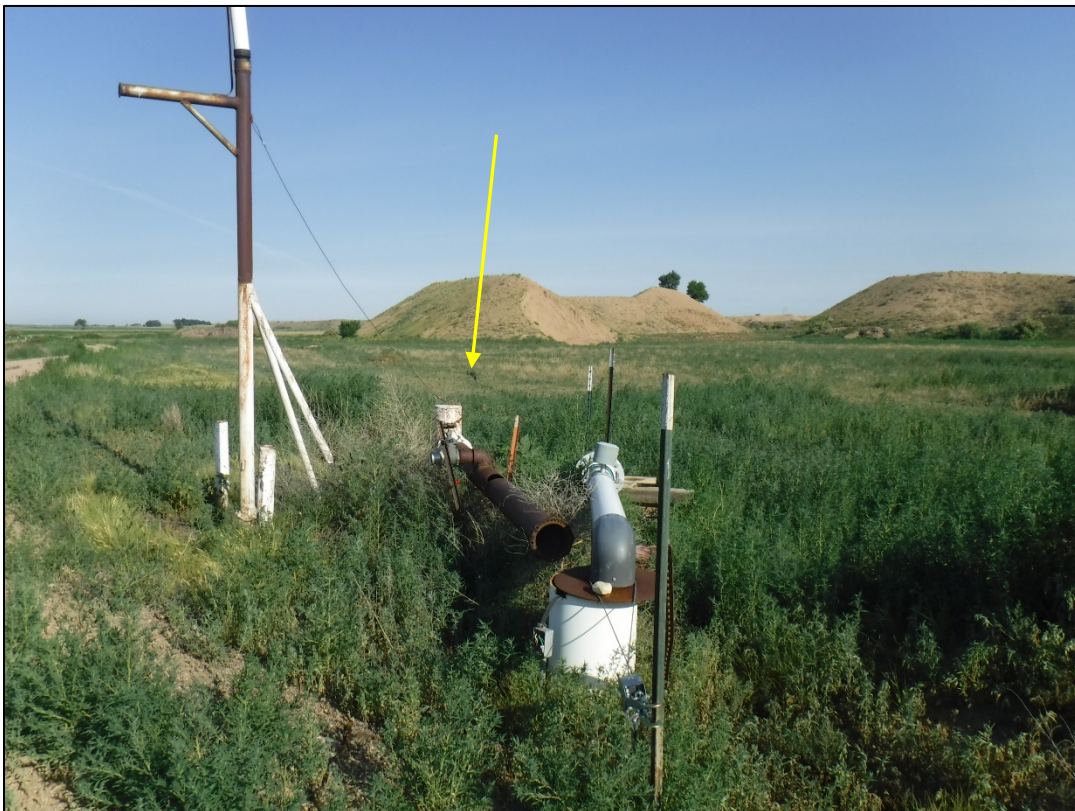
PROBLEM: The currently approved mine plan does not permit the usage of water in the mining operation. The current mine plan needs to be updated and clarified pursuant to C.R.S. 34-32.5-112 (1)(c)(VI). The operator must provide sufficient information to describe or identify how the operator intends to conduct the operation.

The site was active at the time of inspection. There was a mobile screening operation that was located towards the west end of the disturbed area that was utilizing water to wash the gravel. The water was being sourced from a groundwater well that is located near mine entrance road by the scale house and piped to the settling ponds. The use of water in the mining operation is not part of the approved mining plan. This matter is being cited as a Problem in this report pursuant to C.R.S. 34-32.5-112 (1)(c)(VI) for failure to conduct mining as described in the mining plan. The Division also marked several GPS coordinates using a handheld Garmin 64 ST along with imagery from GoogleEarth Pro and determined that the mining operation has affected approximately 31 acres. As mentioned above the approved plan only allows for 20 acres of disturbance with concurrent reclamation. This matter is being cited as a Problem in this report pursuant to C.R.S. 34-32.5-116 (1) for failure to conduct reclamation as prescribed in the reclamation plan.

Photo 4: Groundwater well being used to source water for washing gravel, arrow indicates location of piping

CORRECTIVE ACTIONS: The operator shall submit a Technical Revision, with the required \$216 revision fee, to update and clarify the current approved mine plan to reflect existing and any proposed activities by the corrective action date.

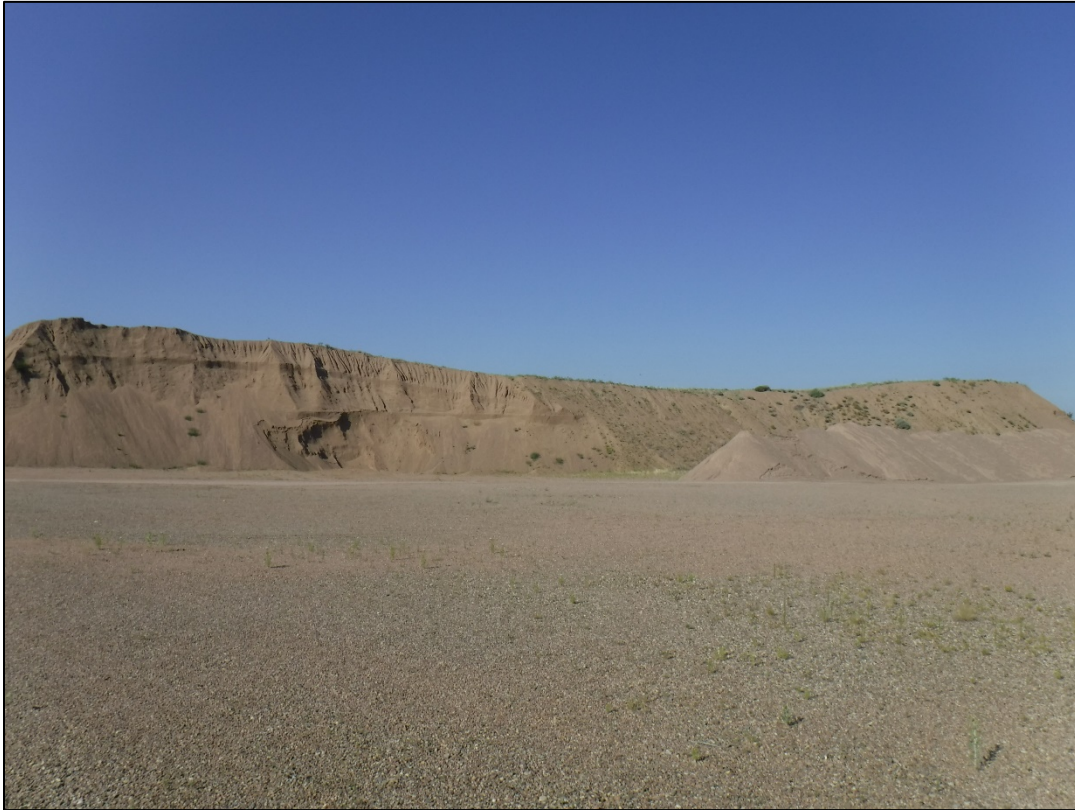
As noted in the 2016 inspection there is 3.4 acres of disturbance outside of the southern permit boundary, which included a large gravel stockpile that is located partially inside of and partially outside of the permit area. This stockpile is approximately 20-25 feet in height and occupies a footprint of approximately 1.7 acres. The adjacent disturbance also includes an area that appears to have been stripped of topsoil, including a topsoil berm and a small sand stockpile (located west of the former haul road) and a small stockpile of reclaimed asphalt pavement (located east of the former haul road). According to the original operator, this disturbance was created by a temporary asphalt batch plant that was operated adjacent to the permit area in 2011 by Lafarge. The landowner allowed Lafarge to operate the batch plant on 10 acres located just south of the permitted mine site for approximately 3 months to fulfill a construction contract for a road project located

south of La Junta. In the 2016 inspection report the Division recommended the stockpiled material either be removed from the site, relocated within the approved permit area or incorporate into the permit area through an Amendment. To date nothing has been done with these piles.

Photo 5: Large northern stockpile of material created by original mining operations (2 acres in size), smaller piles are from current mining operations

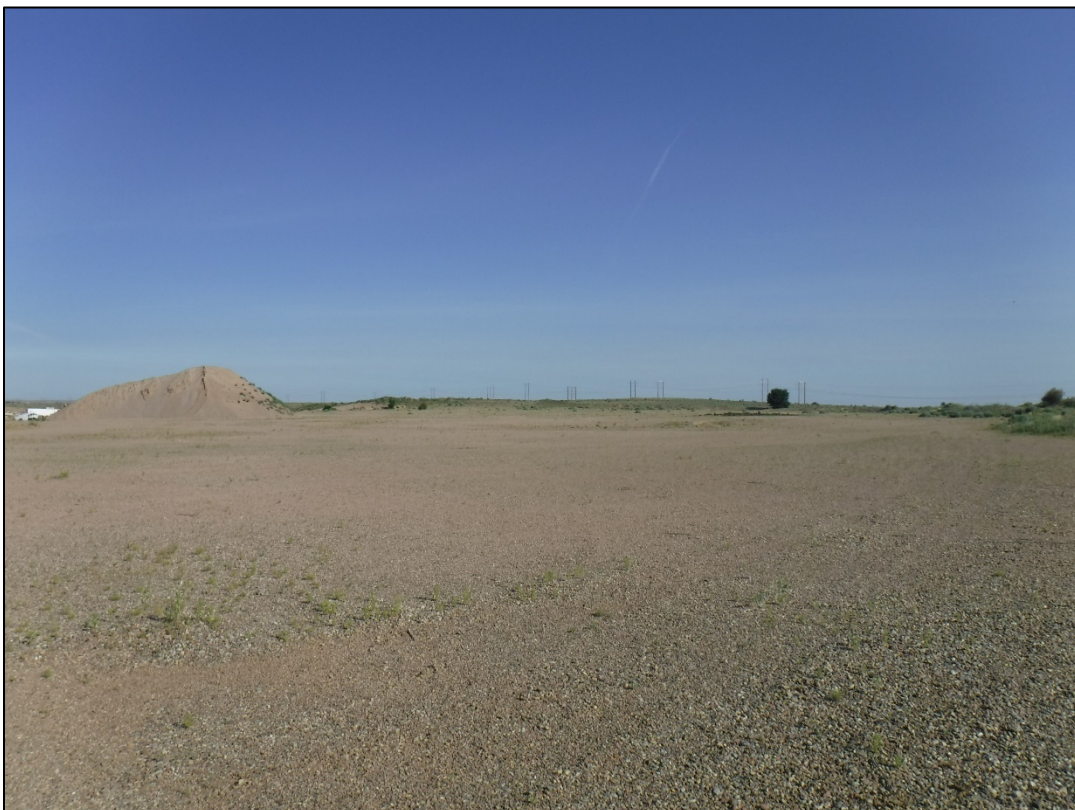
Photo 6: Flat area at the eastern most disturbance, looking north where the haul road enters mine

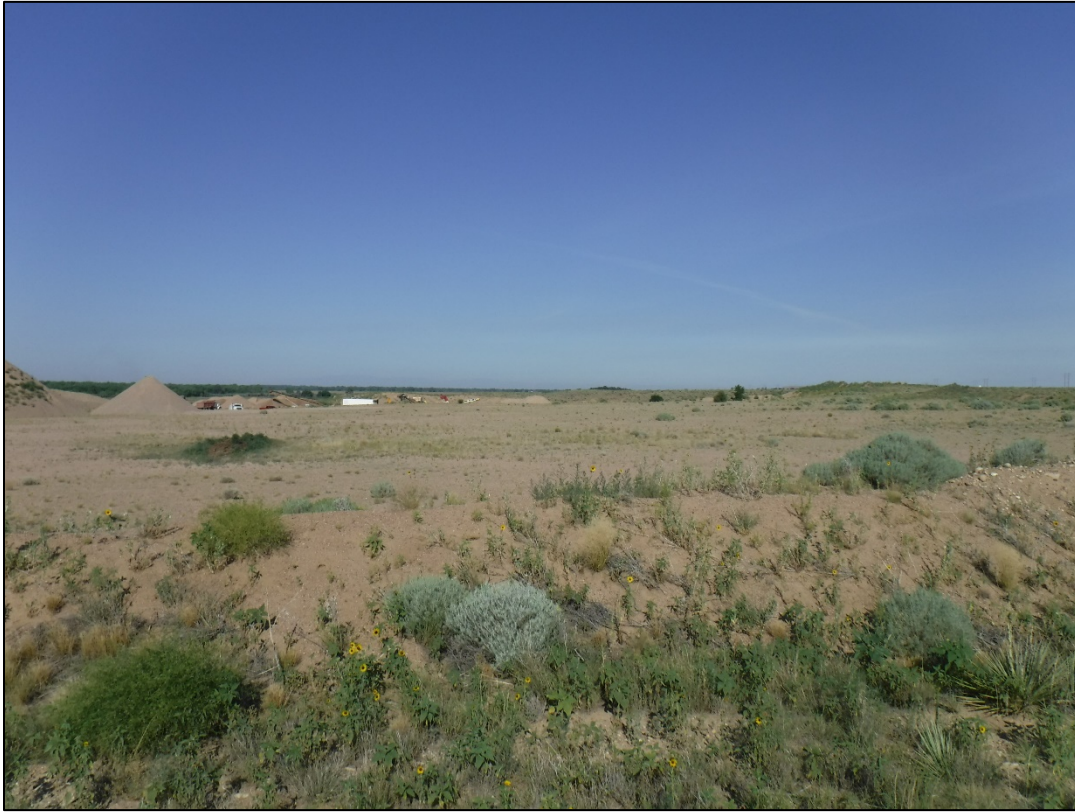
Photo 7: Looking west from the eastern most perimeter berm across the disturbed area

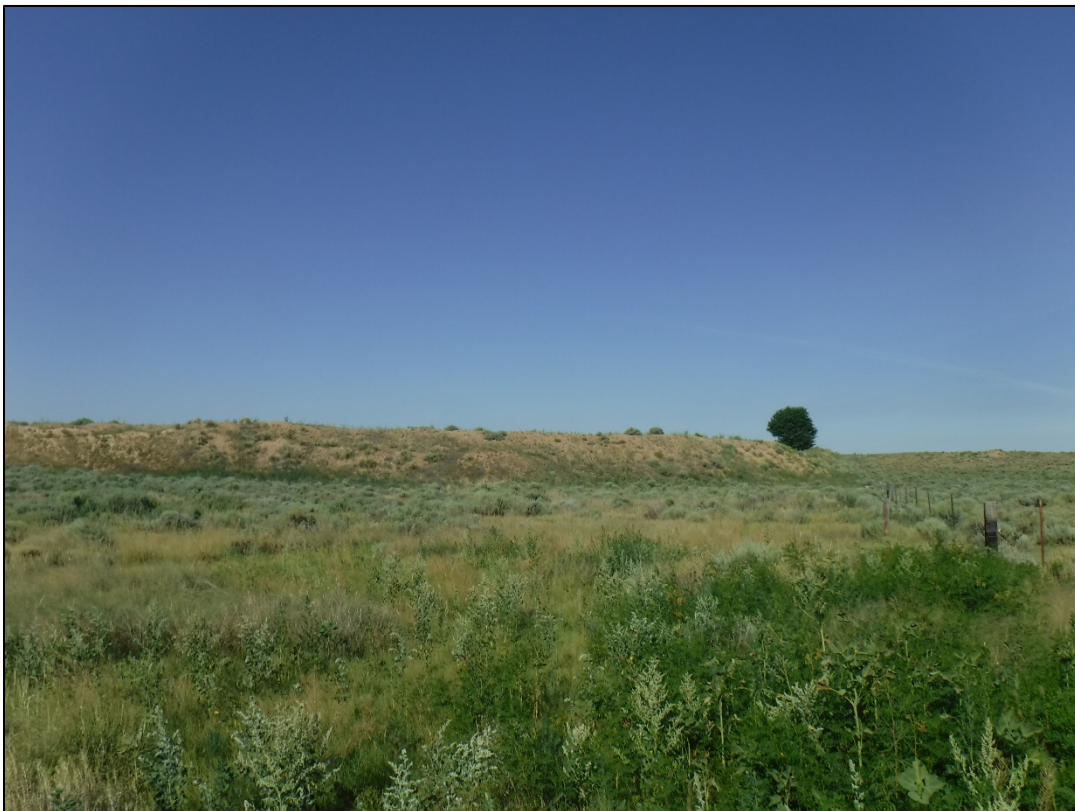
Photo 8: Looking west from the approximate location of the NE permit corner towards the mining area

CORRECTIVE ACTIONS: The operator shall conduct a survey and replace the boundary markers in the correct location(s). The operator shall provide proof to the Division that this has been done by the corrective action date.

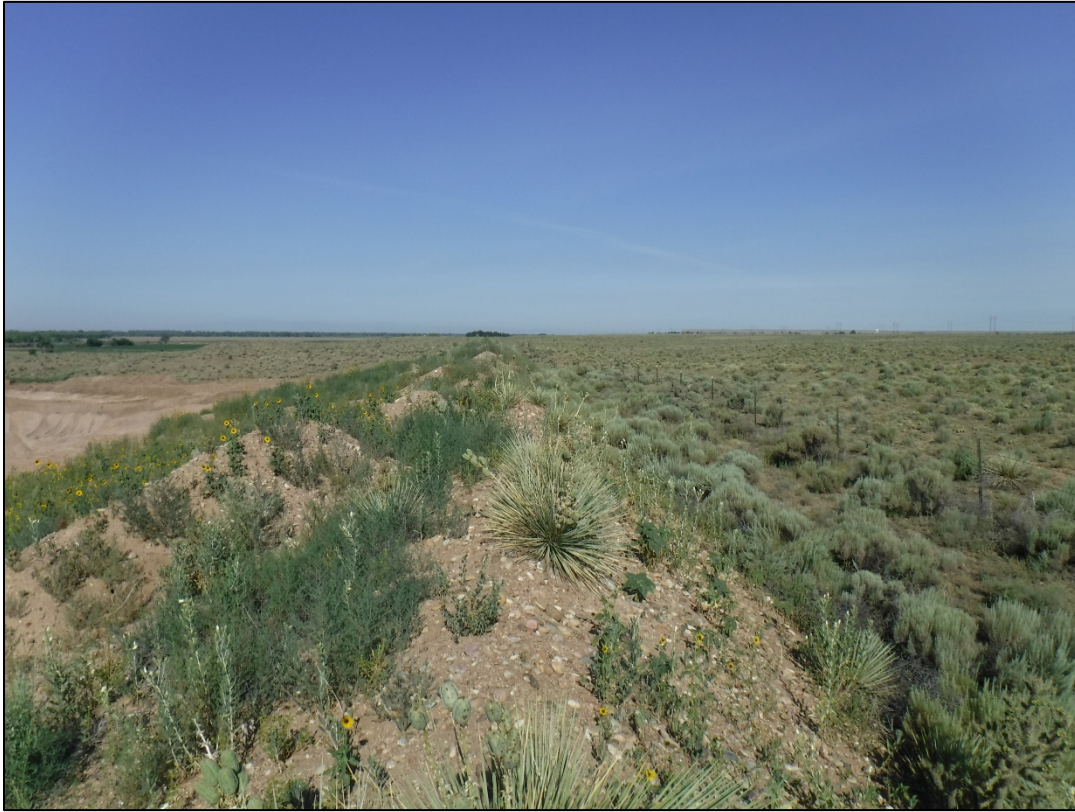
Photo 9: Topsoil berm along the northern boundary of disturbance looking west

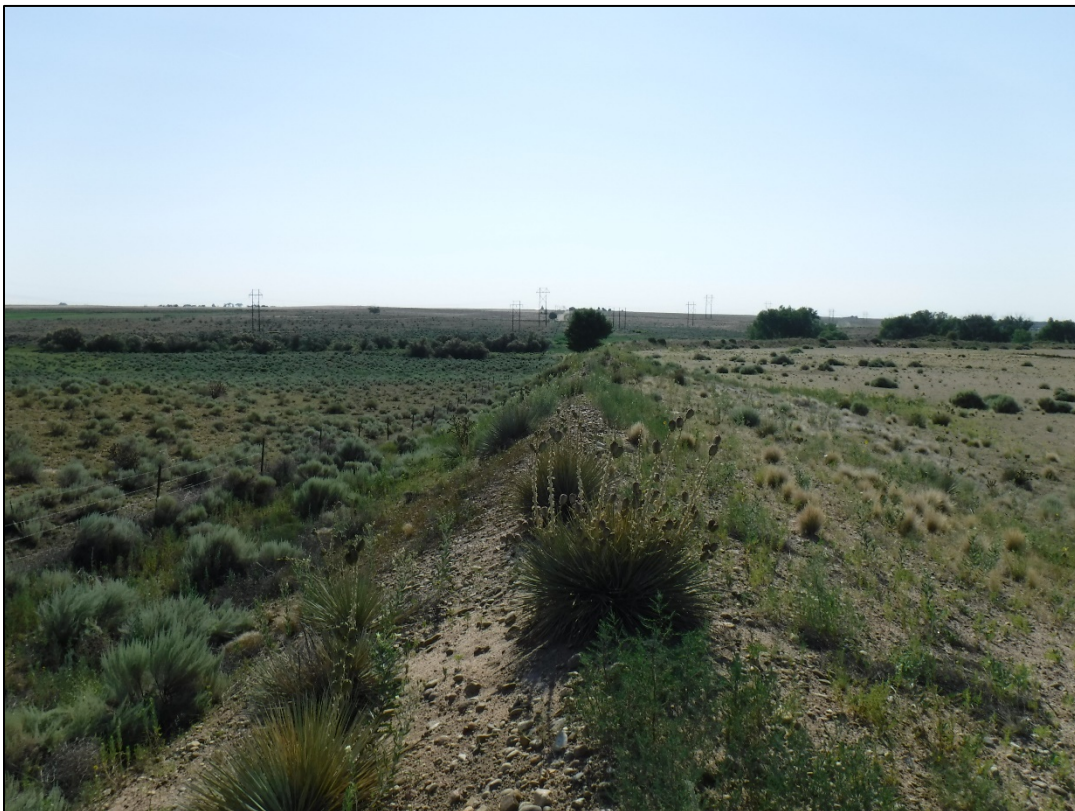
Photo 10: Topsoil berm along the northern boundary of disturbance looking east

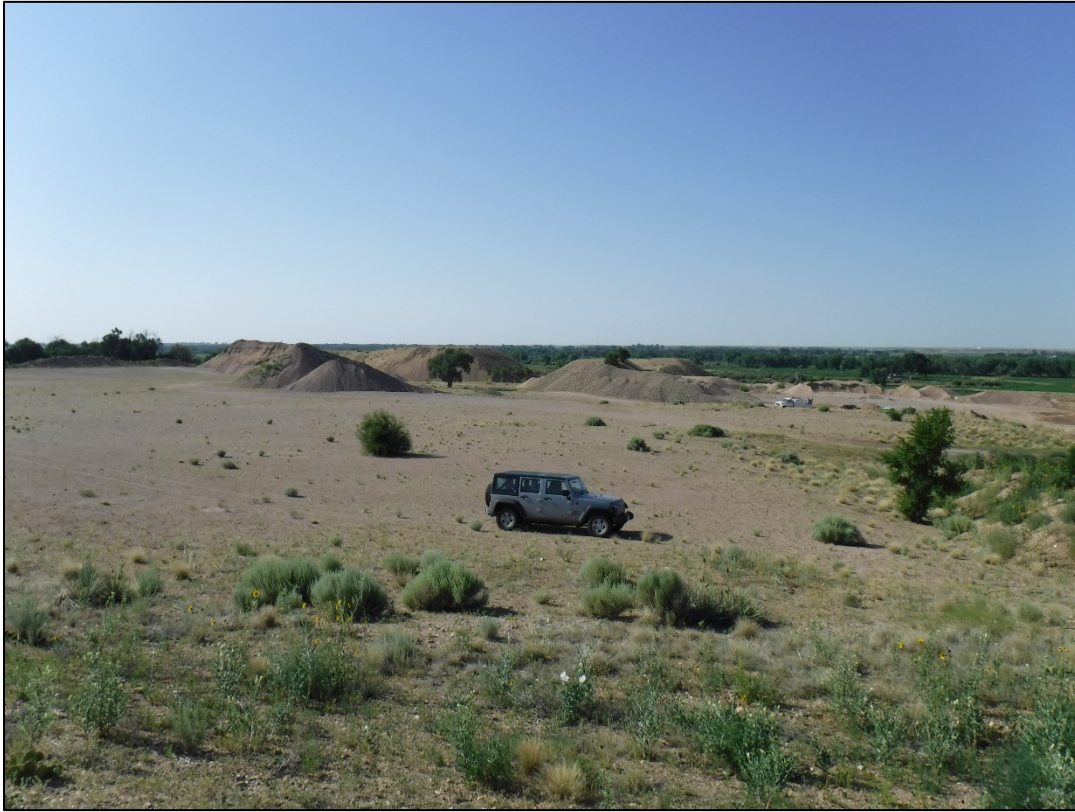
Photo 11: Looking southeast from northern berm across mine site

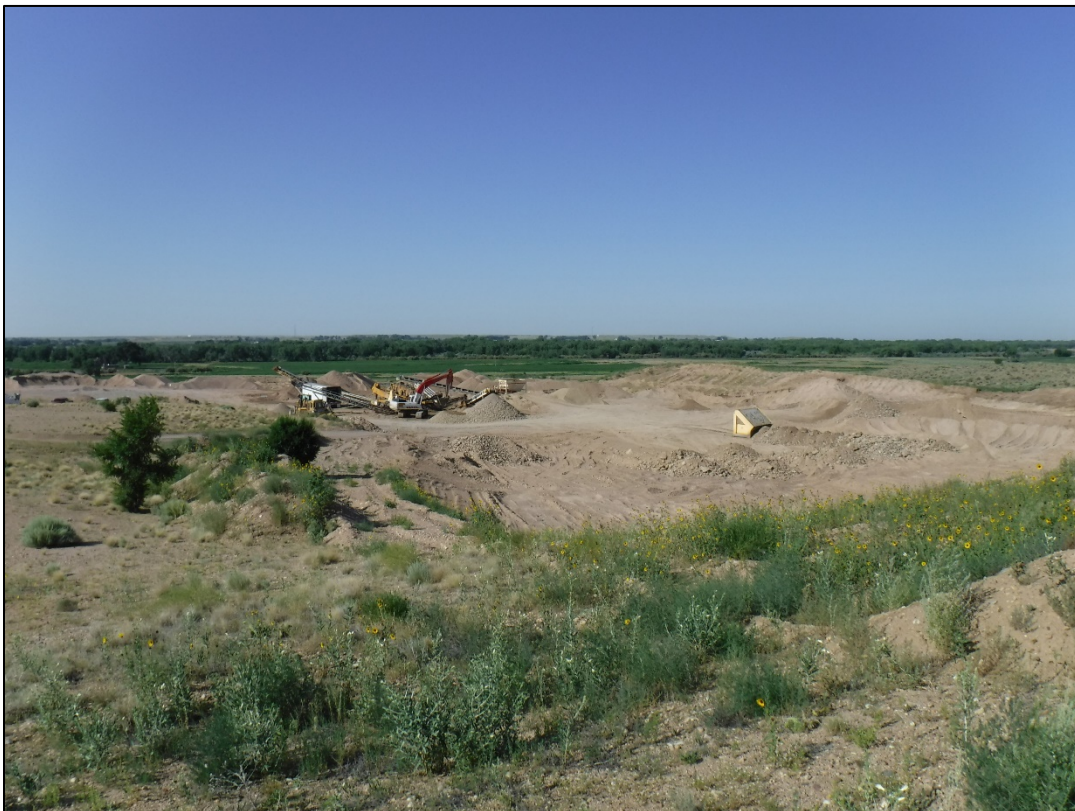
Photo 12: Looking southwest to the active mining operations

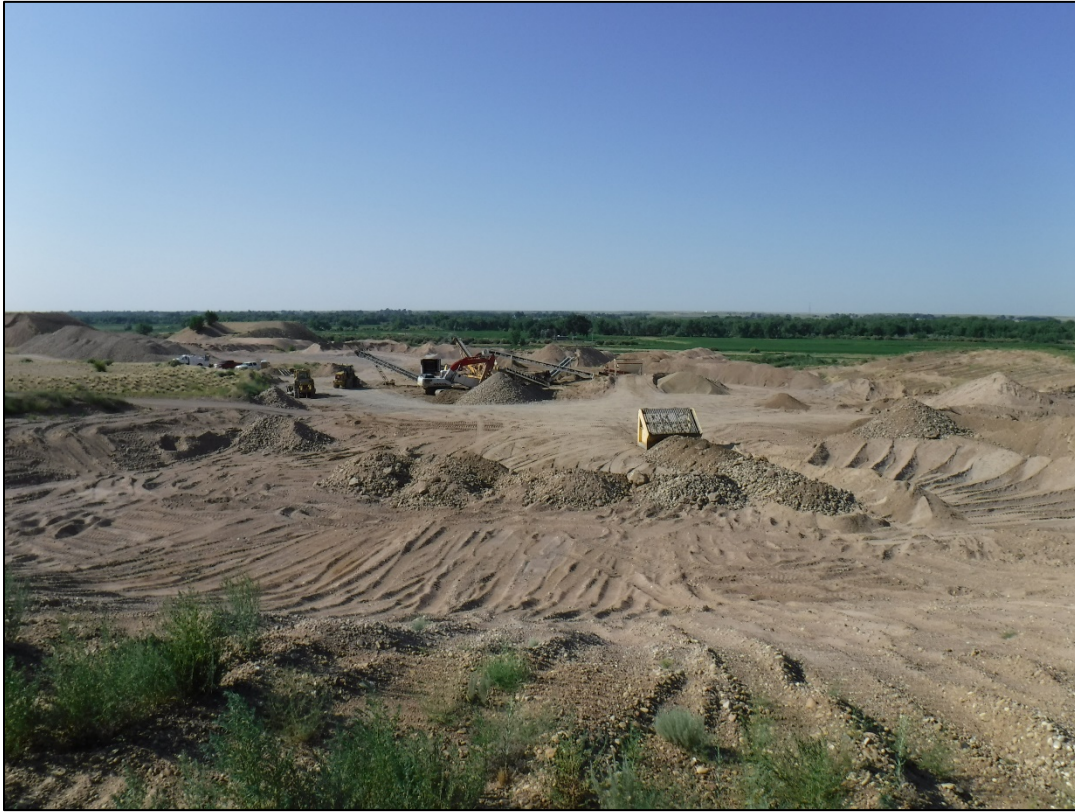
Photo 13: Looking south at the mining operations

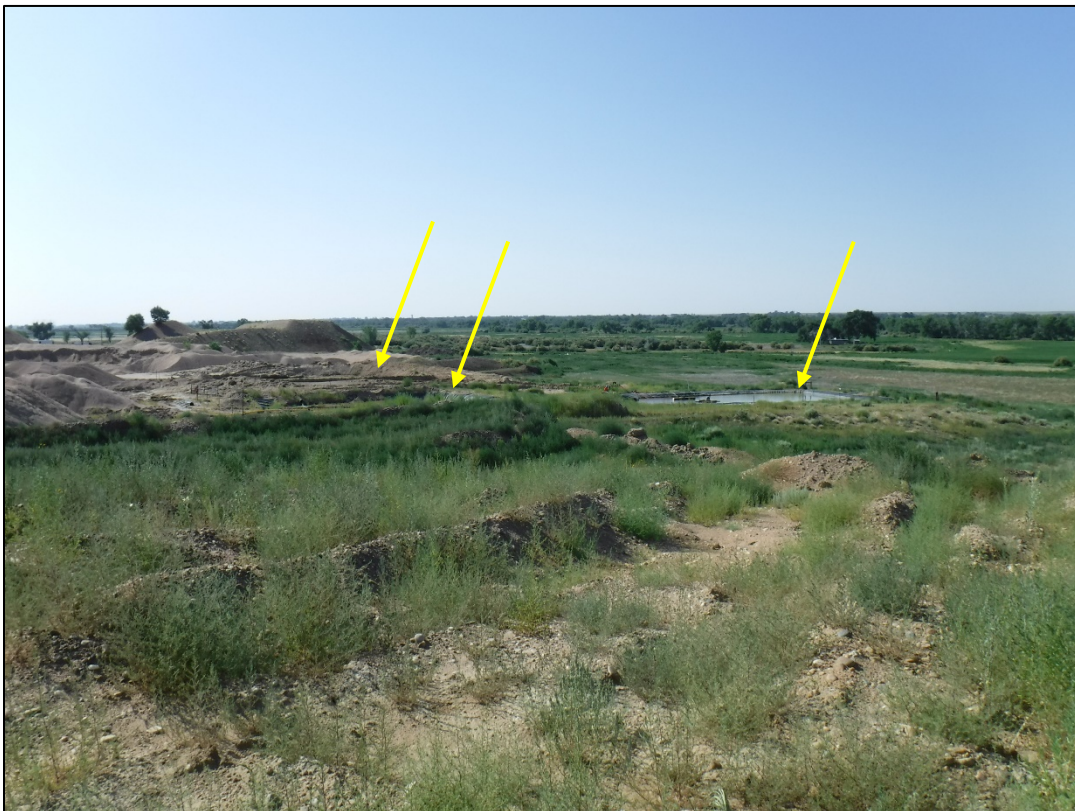
Photo 14: Looking east from the west side of disturbance area, arrows mark ponds used for washing material

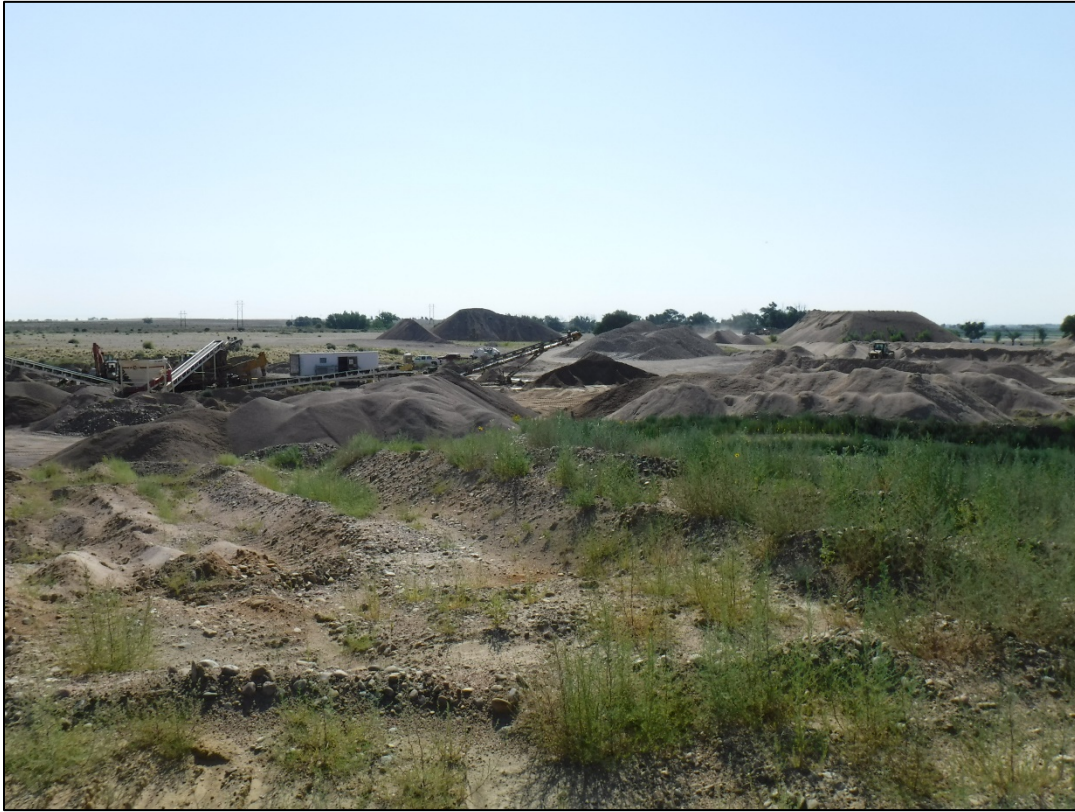
Photo 15: Looking east across the processing operations

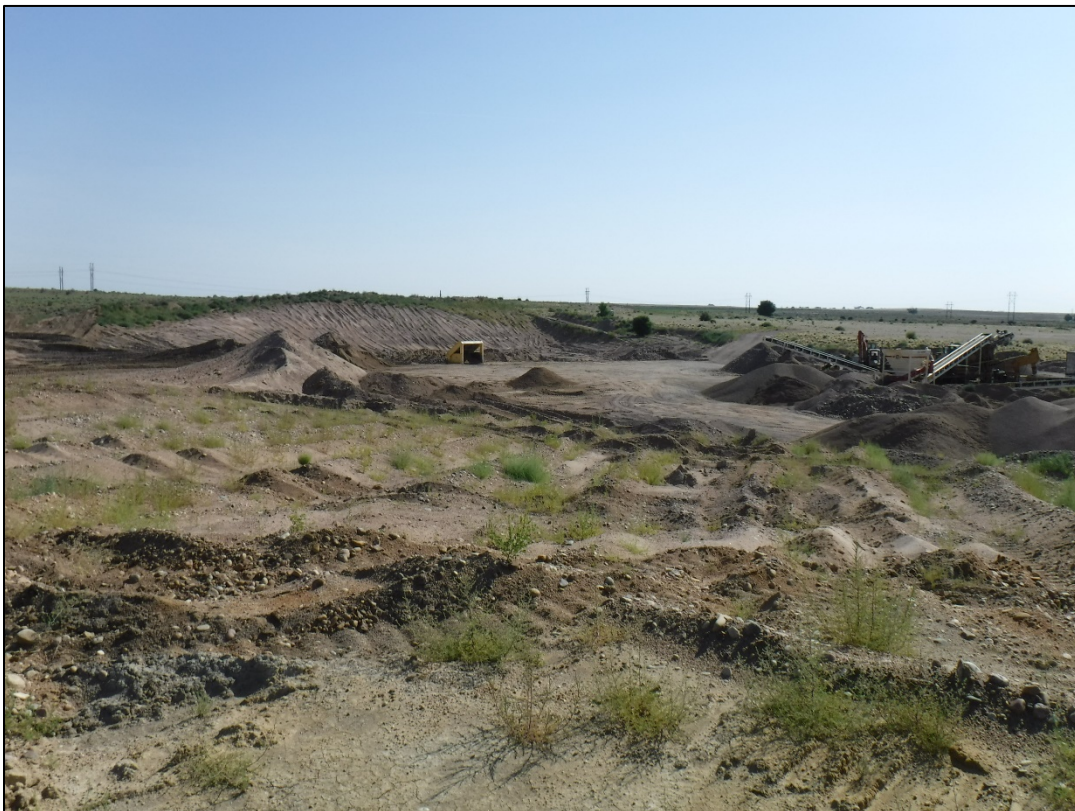
Photo 16: Looking northeast across the active mining area

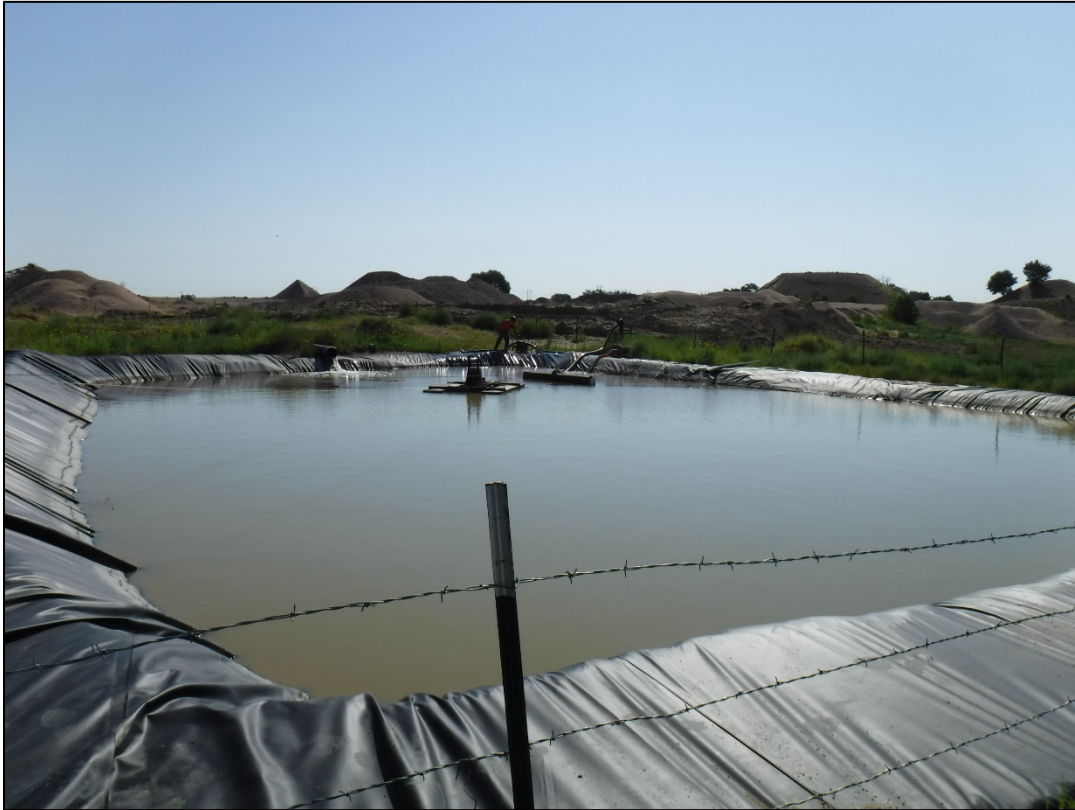
Photo 17: Southern-most lined settling pond taken from the approximate permit boundary location

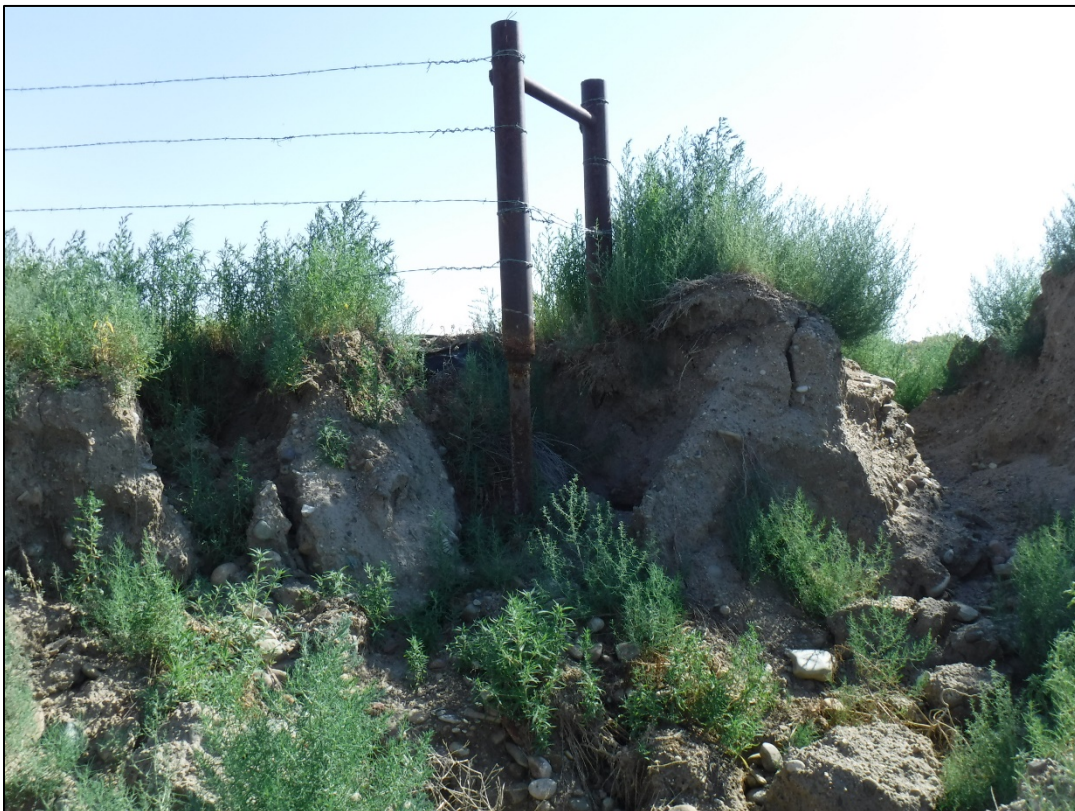
Photo 18: Erosion at the southeastern corner of the southern lined pond

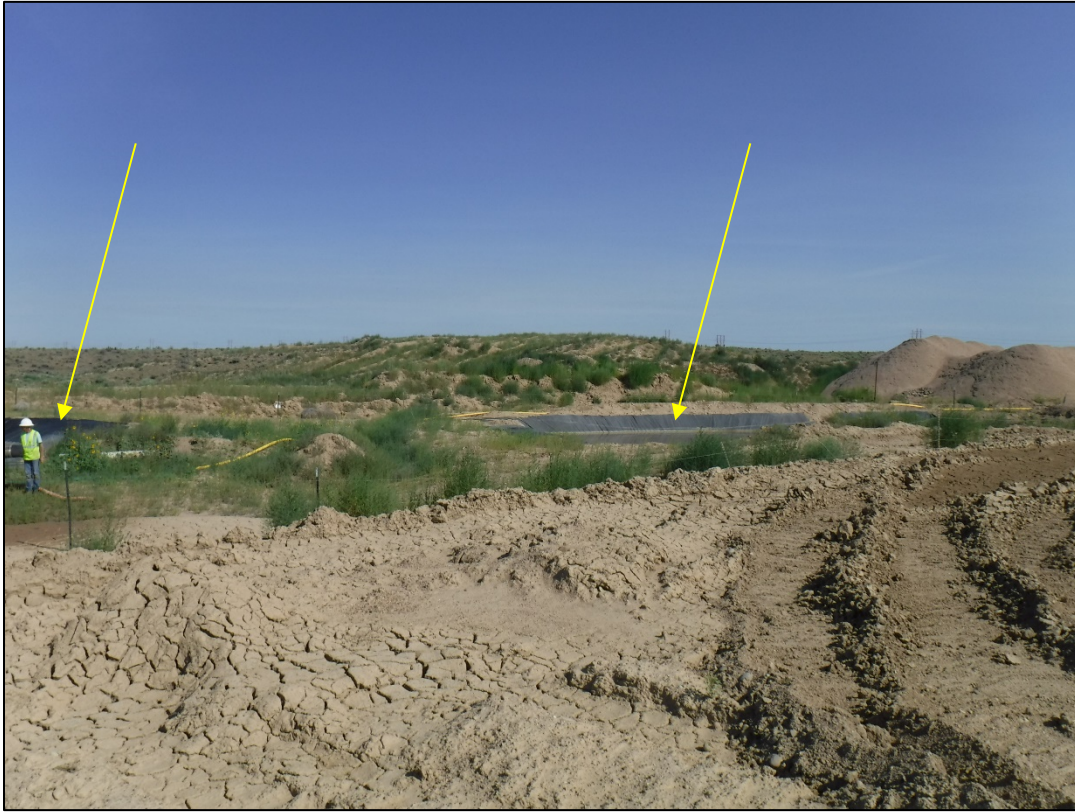
Photo 19: Looking west at both lined ponds, yellow arrows

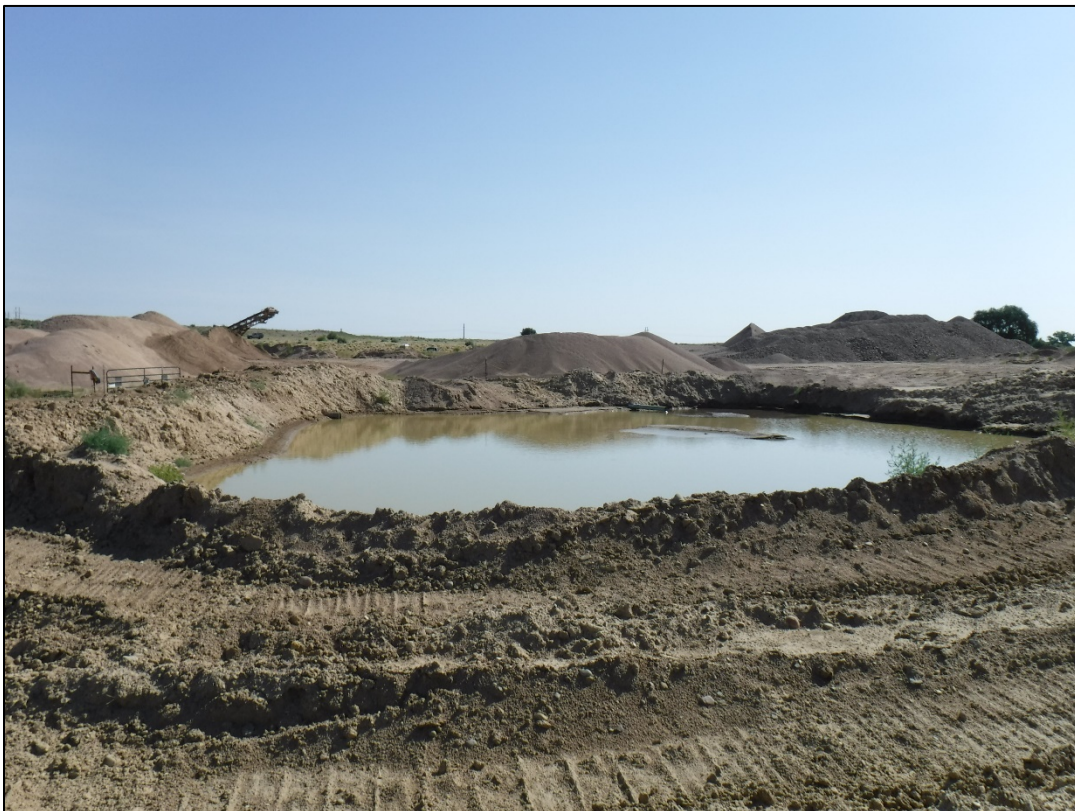
Photo 20: Looking north across the unlined pond immediately east of the lined ponds

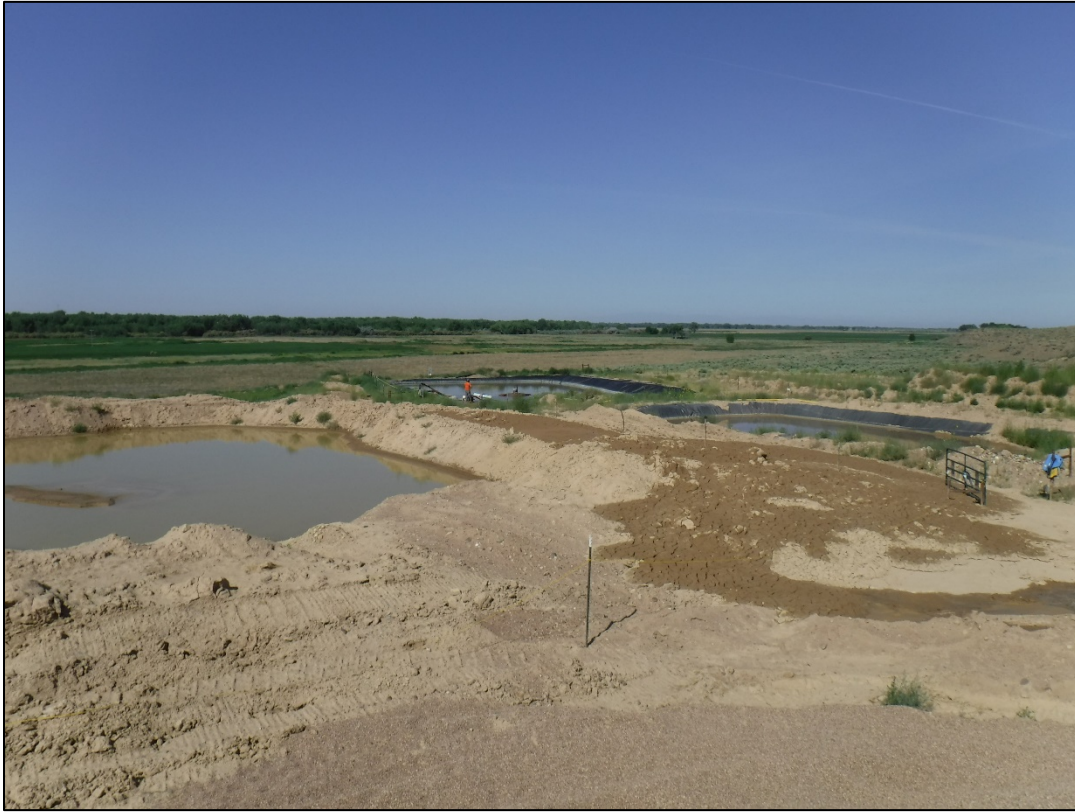
Photo 21: All three ponds

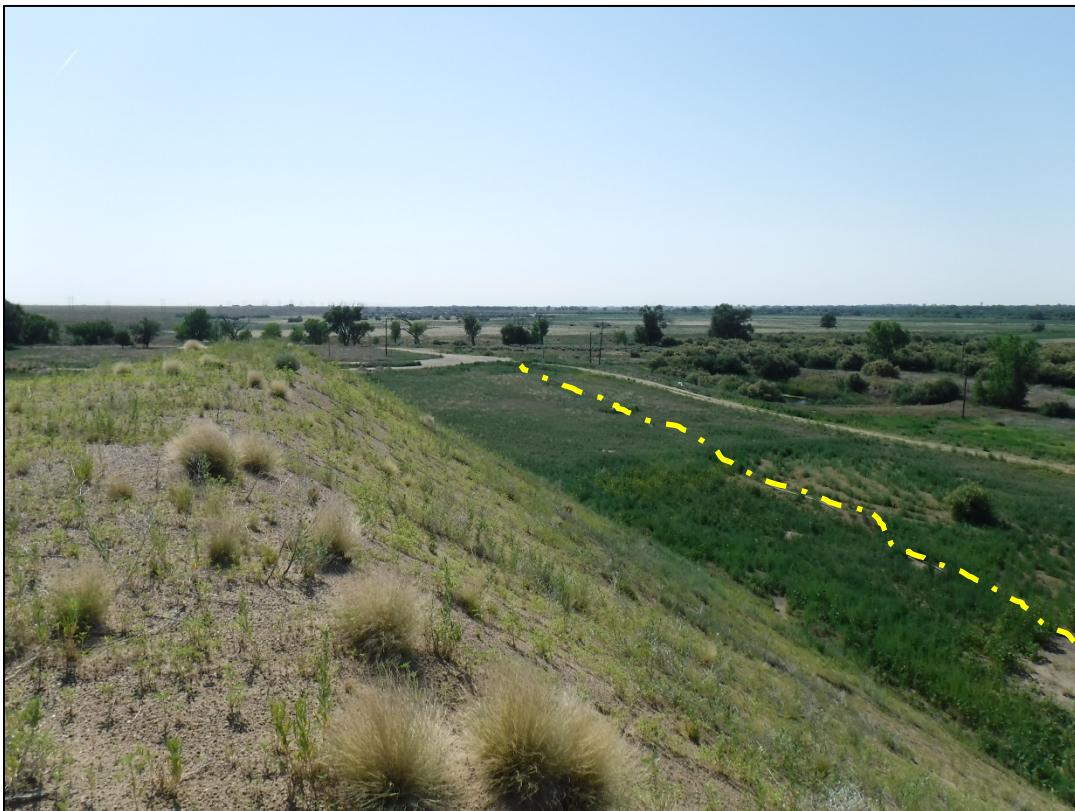
Photo 22: Looking from the top of the southern pile, beyond the permit boundary, to the well water pipe marked in yellow
