MINERALS PROGRAM INSPECTION REPORT
PHONE: (303) 866-3567

MINE NAME: Clay Pit No. 21	MINE/PROSPECTING ID#: M-2009-060	MINERAL: Clay (general)	COUNTY: Moffat
INSPECTION TYPE: Monitoring	INSPECTOR(S): Amy C. Yeldell	INSP. DATE: July 16, 2019	INSP. TIME: 11:30
OPERATOR: Moffat County	OPERATOR REPRESENTATIVE: None	TYPE OF OPERATION: 112c - Construction Regular Operation	
REASON FOR INSPECTION: Normal I&E Program	BOND CALCULATION TYPE: None	BOND AMOUNT: \$0.00	
DATE OF COMPLAINT: NA	POST INSP. CONTACTS: None	JOINT INSP. AGENCY: None	
WEATHER: Clear	INSPECTOR'S SIGNATURE:

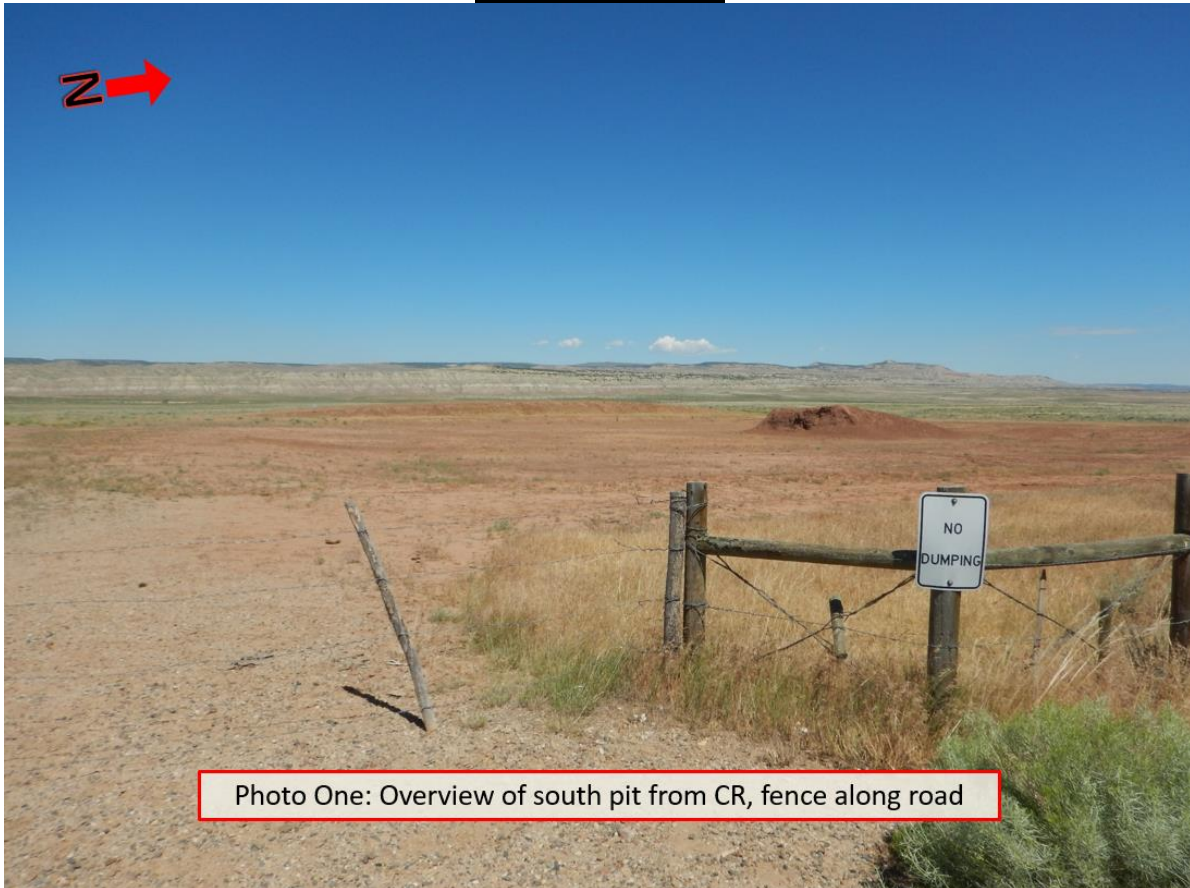
The mine identification sign and affected area boundary markers are in place and in compliance with Rule 3.1.12. The sign is located at the entrance of the permit boundary. T-posts have been placed to clearly delineate permit boundaries as well as a wire fence along the county road. The permit boundary has been brush hogged.

Photo One: Overview of south pit from CR, fence along road

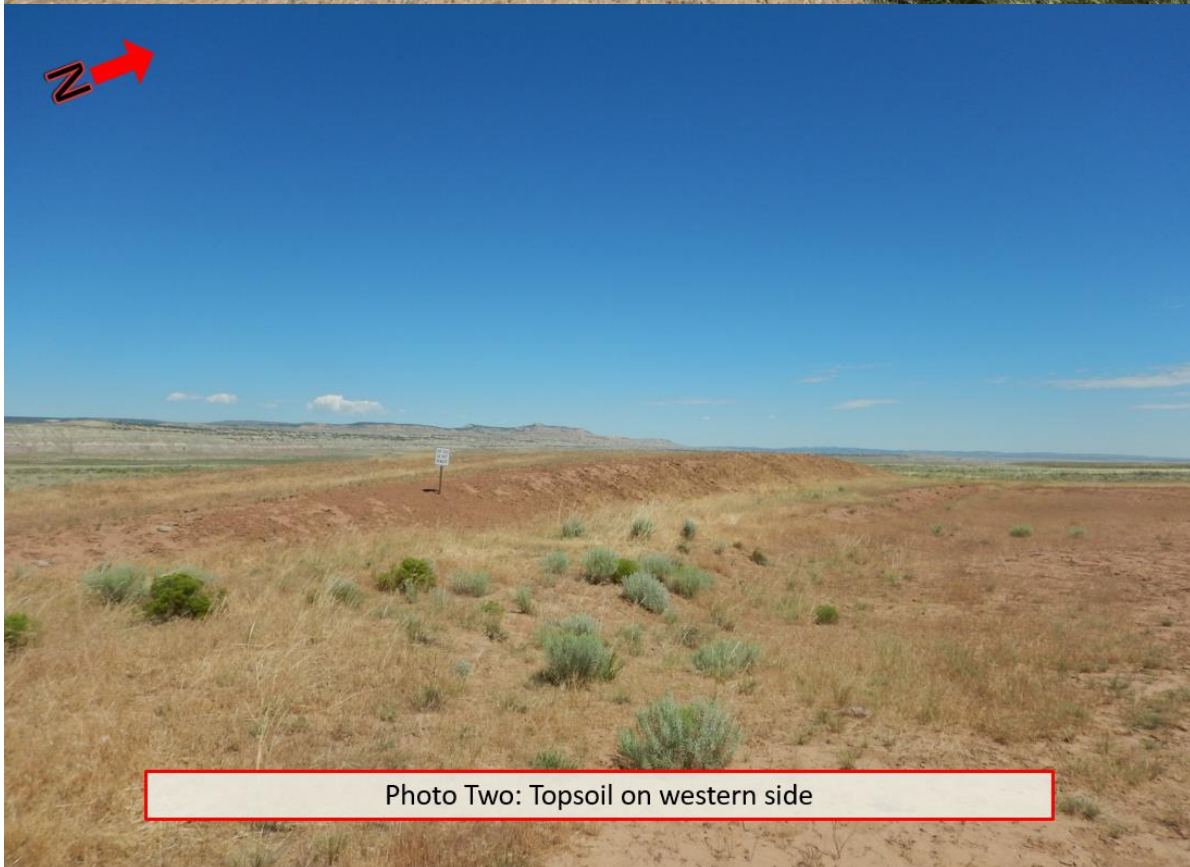
The topsoil pile is located on the western side of the mine. The topsoil and overburden piles are clearly marked with signage to prevent accidental loss. No erosion was observed. All slopes within the pit have been graded to a 3H: 1V or less. The site a bowl with the pit floor that has been mined to a depth of approximately 10'.

Photo Two: Topsoil on western side
