MINERALS PROGRAM INSPECTION REPORT
PHONE: (303) 866-3567

MINE NAME: Tuttle Pit No 1	MINE/PROSPECTING ID#: M-1992-007	MINERAL: Borrow material for	COUNTY: Moffat
INSPECTION TYPE: Monitoring	INSPECTOR(S): Amy C. Yeldell	INSP. DATE: July 17, 2019	INSP. TIME: 08:30
OPERATOR: Moffat County	OPERATOR REPRESENTATIVE: Tim Dilldine	TYPE OF OPERATION: 112c - Construction Regular Operation	
REASON FOR INSPECTION: Normal I&E Program	BOND CALCULATION TYPE: None	BOND AMOUNT: \$0.00	
DATE OF COMPLAINT: NA	POST INSP. CONTACTS: None	JOINT INSP. AGENCY: None	
WEATHER: Clear	INSPECTOR'S SIGNATURE:

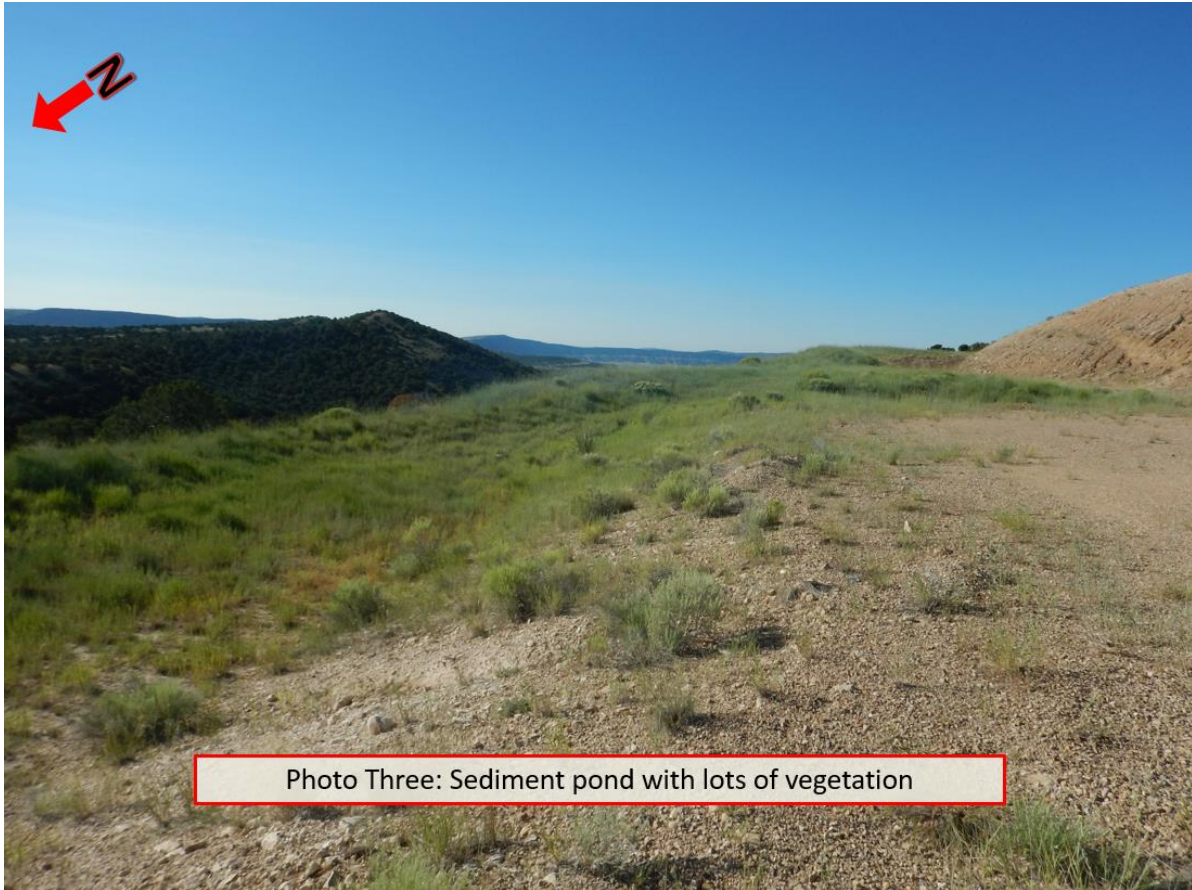
Photo Three: Sediment pond with lots of vegetation

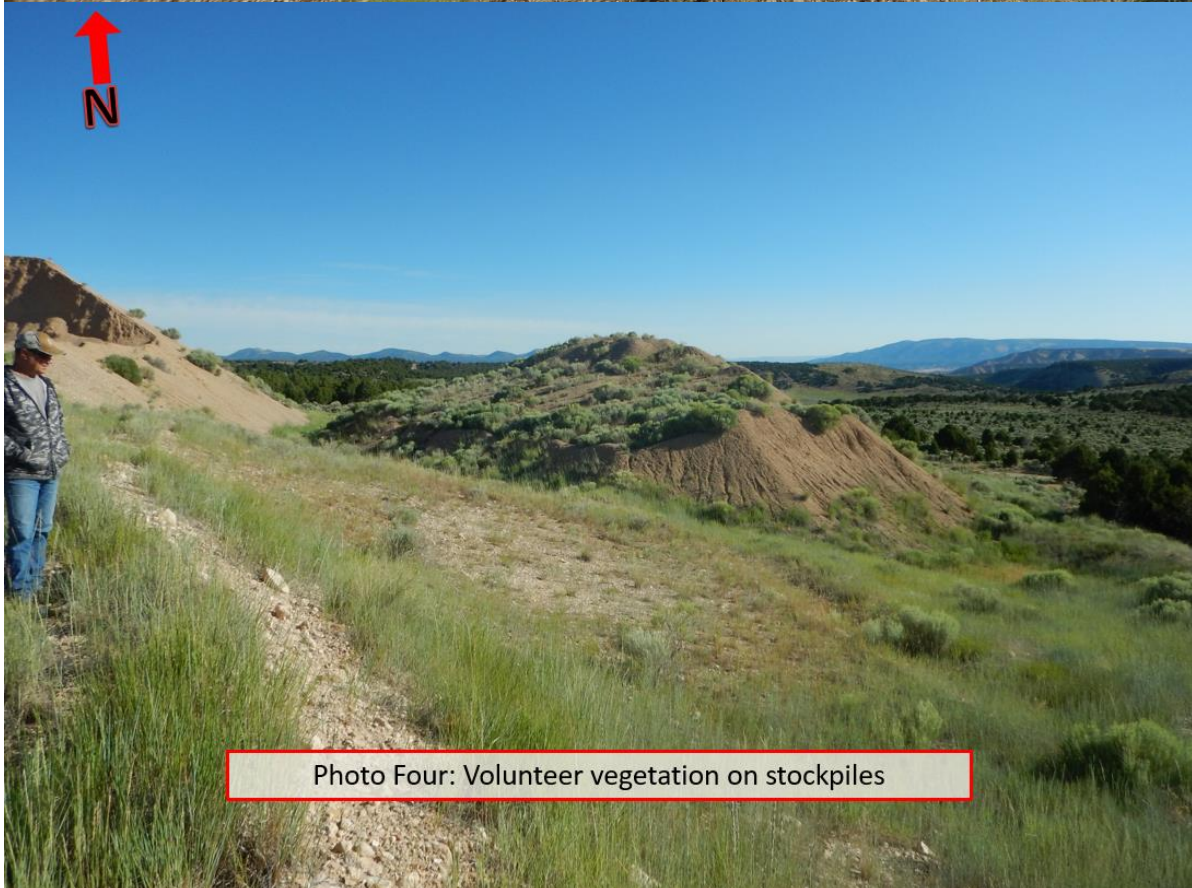
Photo Four: Volunteer vegetation on stockpiles
