**MINERALS PROGRAM INSPECTION REPORT**  
**PHONE: (303) 866-3567**

<b>MINE NAME:</b> Raindance Sand and Gravel Mine	<b>MINE/PROSPECTING ID#:</b> M-2004-022	<b>MINERAL:</b> Sand and gravel	<b>COUNTY:</b> Weld
<b>INSPECTION TYPE:</b> Monitoring	<b>INSPECTOR(S):</b> Peter S. Hays	<b>INSP. DATE:</b> June 6, 2019	<b>INSP. TIME:</b> 11:30
<b>OPERATOR:</b> Raindance Aquatic Investments, LLC	<b>OPERATOR REPRESENTATIVE:</b> Cody Wooldridge	<b>TYPE OF OPERATION:</b> 112c - Construction Regular Operation	
<b>REASON FOR INSPECTION:</b> Normal I&E Program	<b>BOND CALCULATION TYPE:</b> None	<b>BOND AMOUNT:</b> \$28,000.00	
<b>DATE OF COMPLAINT:</b> NA	<b>POST INSP. CONTACTS:</b> None	<b>JOINT INSP. AGENCY:</b> None	
<b>WEATHER:</b> Clear	<b>INSPECTOR'S SIGNATURE:</b>

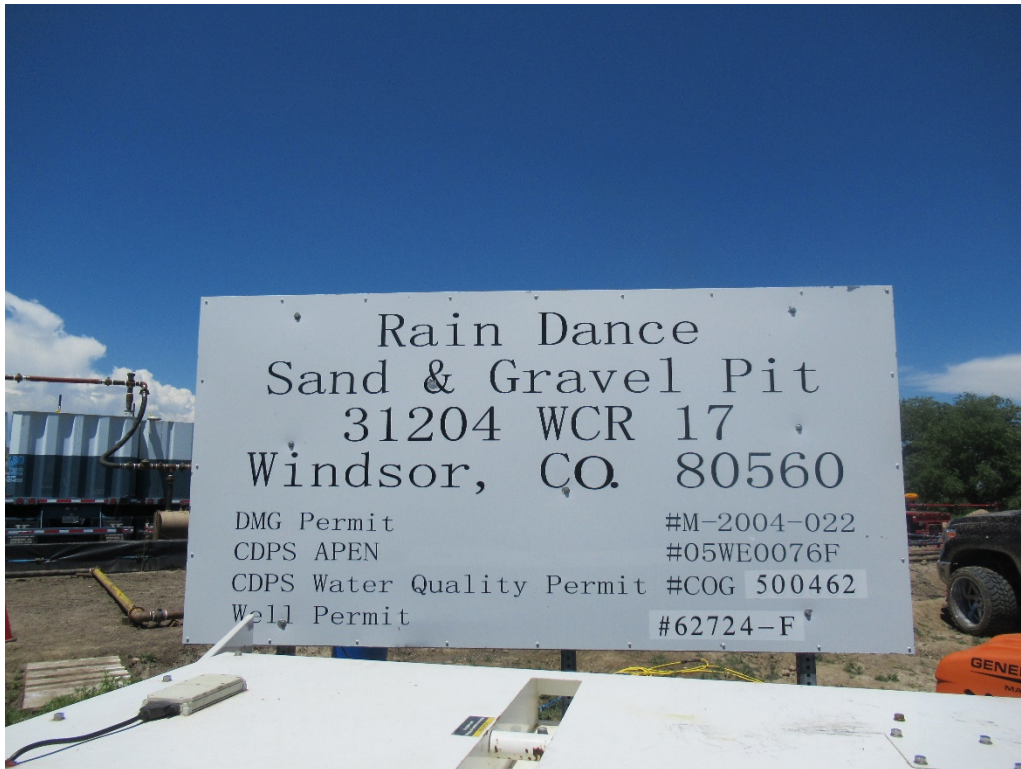
An entrance sign was posted and permit boundary markers were observed as required by Rule 3.1.12. Photographs taken during the inspection are attached.

Raindance Mine sign

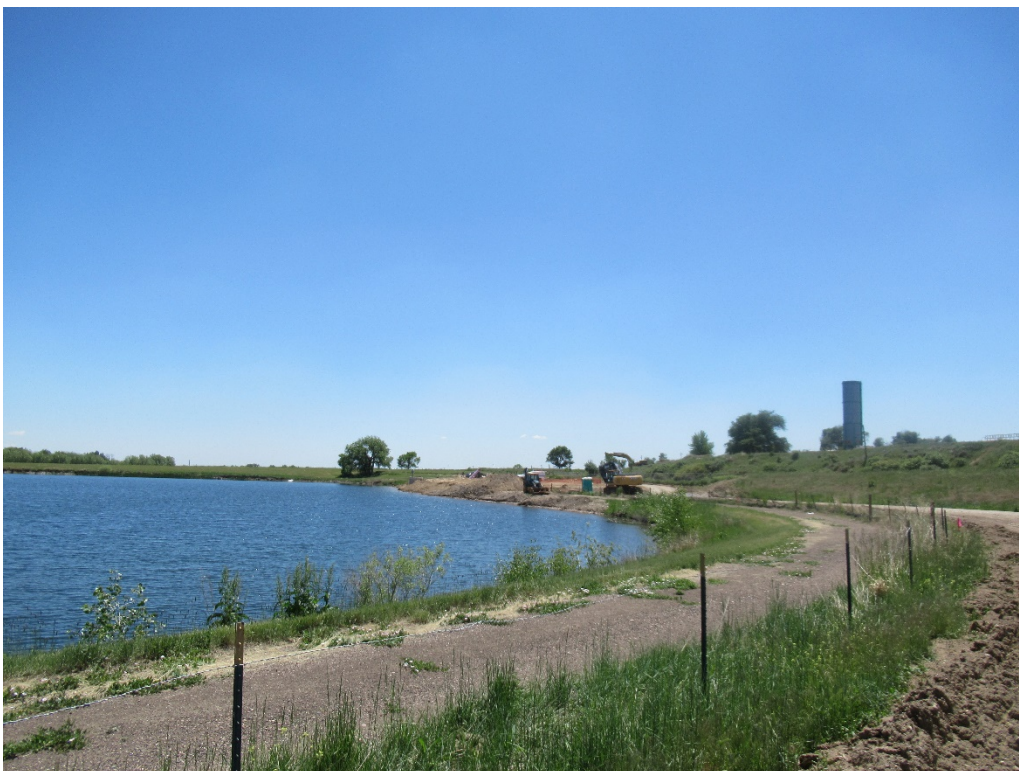
The Division will require the Operator to submit another technical revision to update the Reclamation Plan Map due to the following site changes since the approval of TR-02. The pump station was under construction on the south side of the reservoir. The location of the pump station is different than the location approved under TR-02. A new oil and gas facility was installed in the northwest corner of the site. TR-02 lists this area as Lots 4 and 5 approved by the Town of Windsor, not an oil and gas facilities. The oil and gas facilities installation were recently completed and the area was being regraded during the inspection. The Operator was required to construct a temporary section of the Poudre River Trail around the west side of the reservoir while the oil and gas facilities construction blocked the trail. The temporary trail consists of a crusher fines surface. The Operator stated the southern portion of the temporary trail would be removed and reclaimed. The northern portion of the temporary trail will remain for access to an adjacent property per an agreement between Raindance and the property owner.

View of the temporary trail and pump station construction from the southwest corner of the reservoir looking east

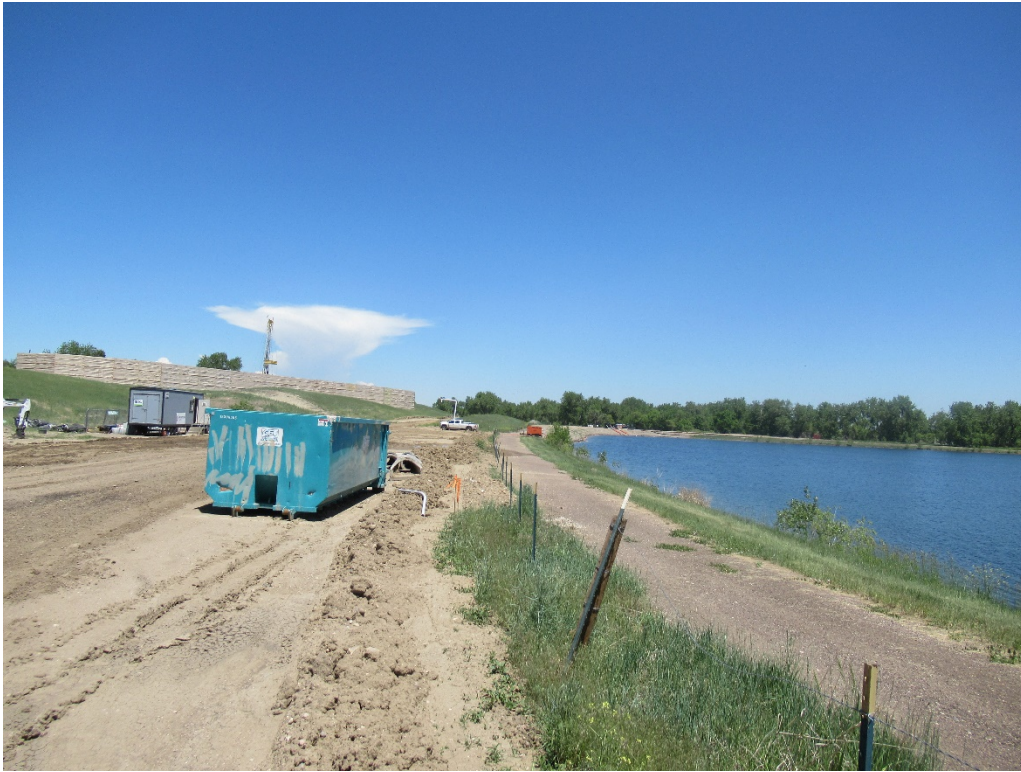
The approved post-mining land use is pastureland and developed water resource. The Operator stated tamarisks were recently removed from the shoreline of the reservoir. No noxious weeds were observed during the inspection. As stated above, the oil and gas area located in the northwest area of the site was being regraded for reclamation. A temporary access road along the northern portion of the site and a temporary culvert located in the northeast corner of the site will be removed and reclaimed by the Operator. The northwest corner of the reservoir shoreline was backfilled and will require reclamation by the Operator. The remaining site reclamation associated with the oil and gas facilities is expected to be completed soon.

View of the temporary trail and oil and gas facilities from the southwest corner of the reservoir looking north

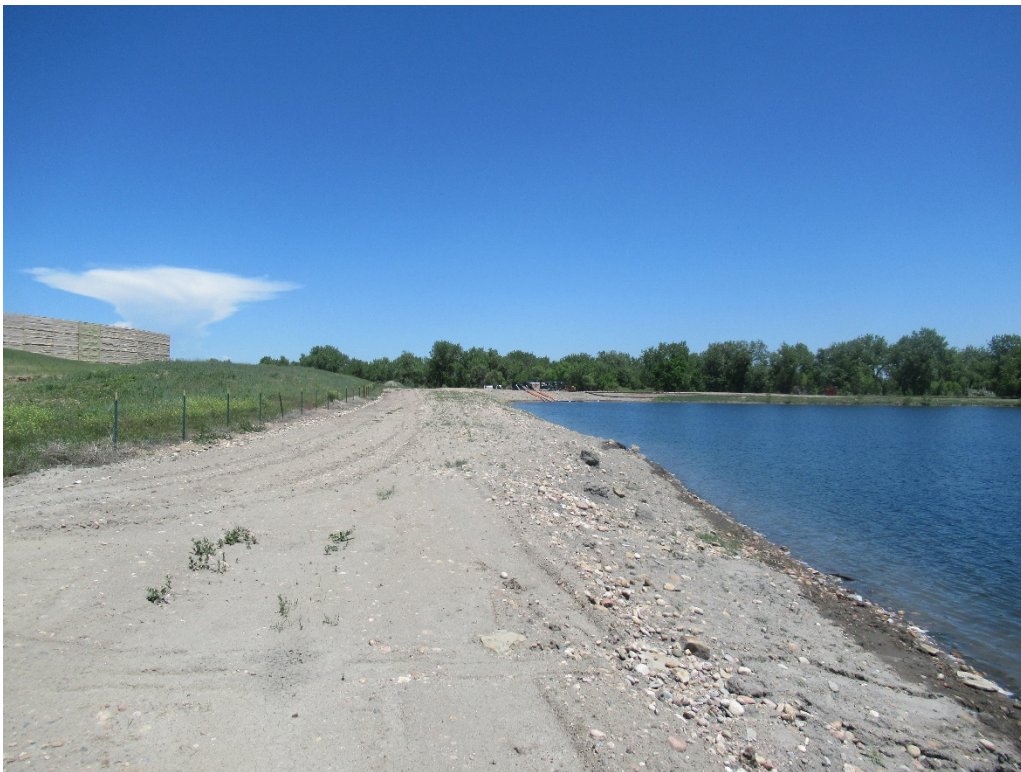
Backfill area located in the northwest corner of the reservoir

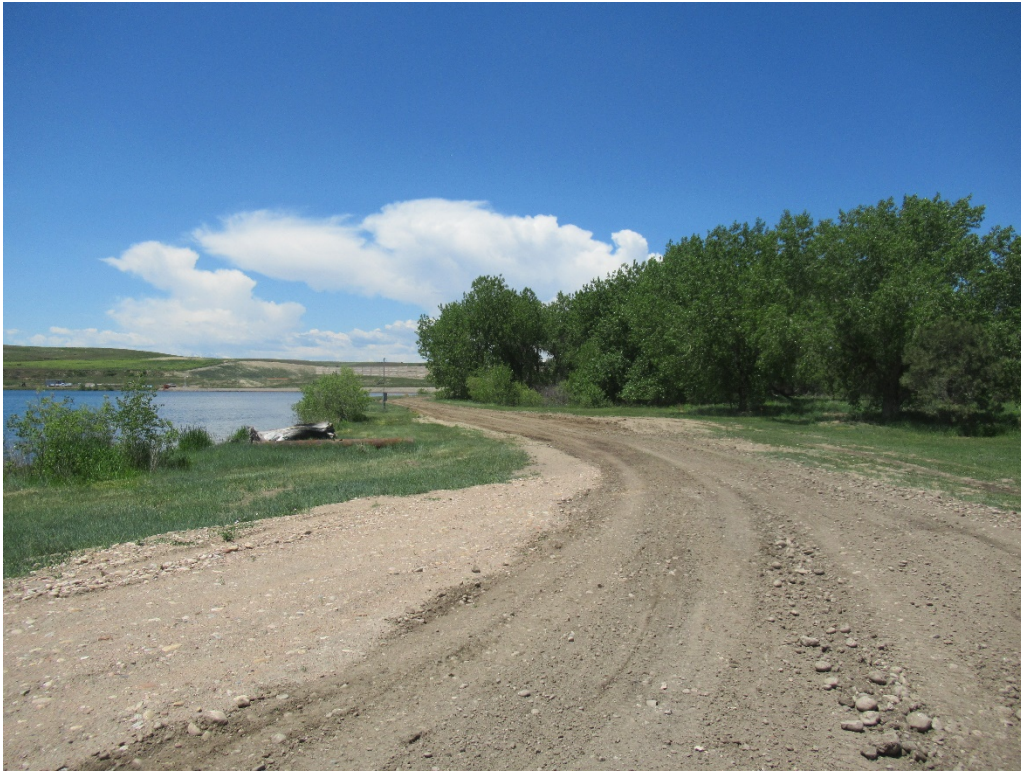
View of the temporary road in the northern portion of the site
