**MINERALS PROGRAM INSPECTION REPORT**  
**PHONE: (303) 866-3567**

<b>MINE NAME:</b> Martin Pit 1-A	<b>MINE/PROSPECTING ID#:</b> M-1990-140	<b>MINERAL:</b> Sand and gravel	<b>COUNTY:</b> Moffat
<b>INSPECTION TYPE:</b> Monitoring	<b>INSPECTOR(S):</b> Amy C. Yeldell	<b>INSP. DATE:</b> July 16, 2019	<b>INSP. TIME:</b> 14:00
<b>OPERATOR:</b> Duran & Pearce Contractors, Inc.	<b>OPERATOR REPRESENTATIVE:</b> None	<b>TYPE OF OPERATION:</b> 112c - Construction Regular Operation	
<b>REASON FOR INSPECTION:</b> Normal I&E Program	<b>BOND CALCULATION TYPE:</b> Partial Bond	<b>BOND AMOUNT:</b> \$34,770.00	
<b>DATE OF COMPLAINT:</b> NA	<b>POST INSP. CONTACTS:</b> None	<b>JOINT INSP. AGENCY:</b> None	
<b>WEATHER:</b> Clear	<b>INSPECTOR'S SIGNATURE:</b>

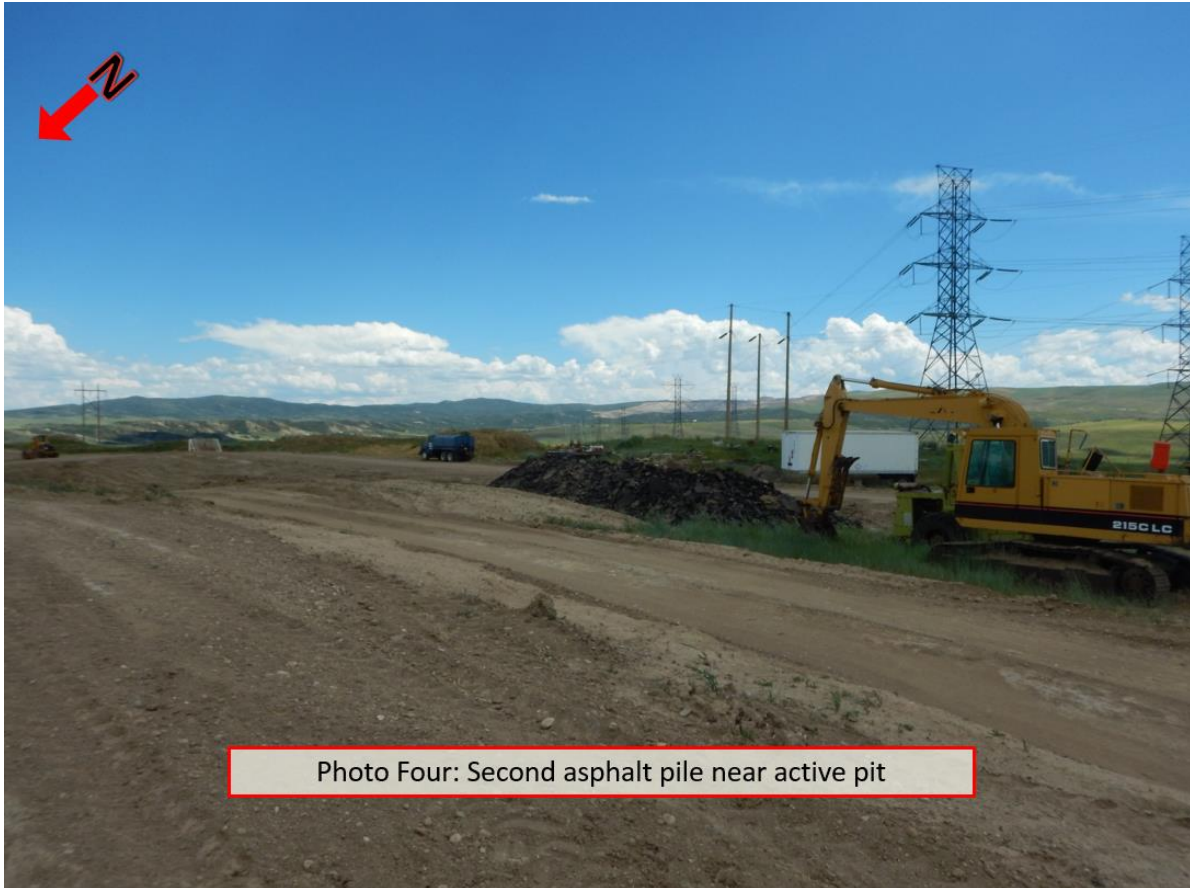
Photo Four: Second asphalt pile near active pit

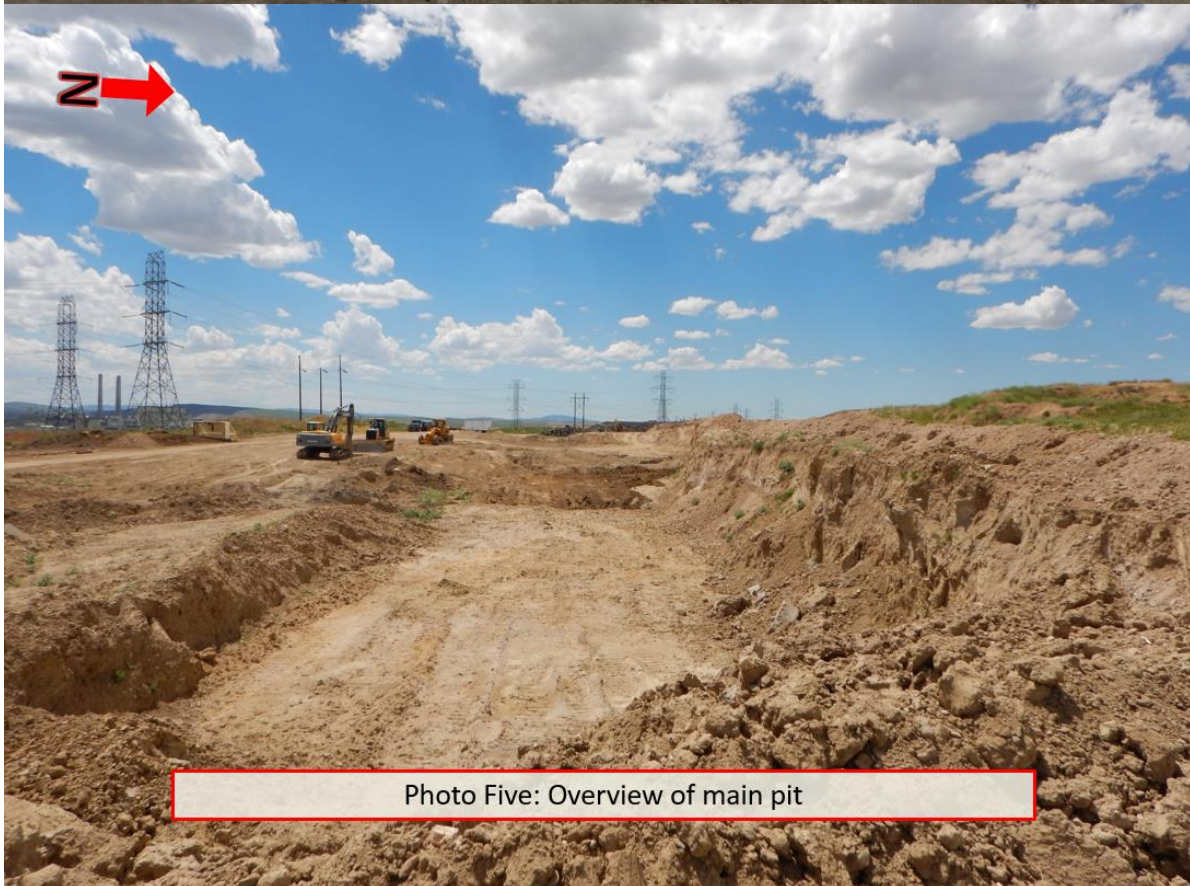
Photo Five: Overview of main pit
