**MINERALS PROGRAM INSPECTION REPORT****PHONE: (303) 866-3567**

<b>MINE NAME:</b> Henderson Development	<b>MINE/PROSPECTING ID#:</b> M-1980-110	<b>MINERAL:</b> Sand and gravel	<b>COUNTY:</b> Adams
<b>INSPECTION TYPE:</b> Surety Release Inspection	<b>INSPECTOR(S):</b> Jared L. Ebert	<b>INSP. DATE:</b> July 17, 2019	<b>INSP. TIME:</b> 10:00
<b>OPERATOR:</b> E-470 Public Highway Authority	<b>OPERATOR REPRESENTATIVE:</b> Derek Slack	<b>TYPE OF OPERATION:</b> 112c - Construction Regular Operation

<b>REASON FOR INSPECTION:</b> Surety Release Requested	<b>BOND CALCULATION TYPE:</b> None	<b>BOND AMOUNT:</b> \$0.00
<b>DATE OF COMPLAINT:</b> NA	<b>POST INSP. CONTACTS:</b> None	<b>JOINT INSP. AGENCY:</b> County
<b>WEATHER:</b> Clear	<b>INSPECTOR'S SIGNATURE:</b>

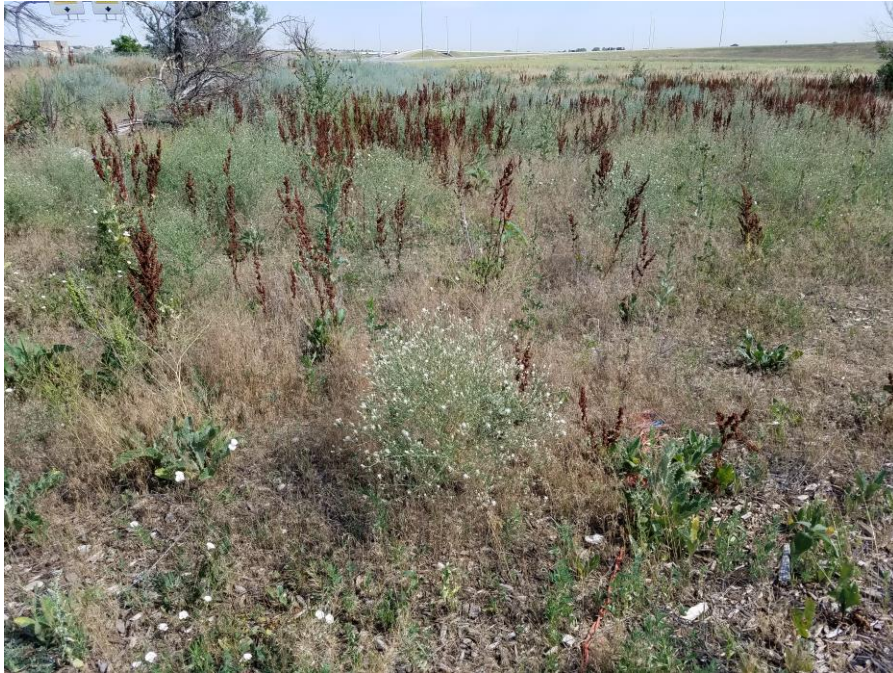
**PROBLEM:** There are state-listed noxious weeds present on site. This is a problem for failure to employ weed control methods for state listed noxious weed species within the permitted area, and to reduce the spread of weeds to nearby areas as required by Section 3.1.10 (6) of the rule.

As discussed above, the Operator utilized an un-approved seed mixture at the site. However, the seed mixture utilized would be acceptable for use but needs to be included in the approved reclamation plan. Several bare areas or areas with significant weed patches were observed at the site. E-470 will need to manage the noxious weeds at the site and monitor the establishment of the desired vegetation and conduct re-seeding of some of these bare areas should the desired vegetation fail to germinate and establish.

Figure 1. From near the entrance of the mine site looking north. Patch of knapweed observed.

**CORRECTIVE ACTIONS:** Implement approved weed control plan and provide proof to the Division that this has been done. If a weed control plan is not already in place, the operator shall develop a weed control and management plan in accordance with Section 3.1.10 (6) of the Rule. This plan should be developed in consultation with the county extension agency, or weed control district office and should include specific control measures to be applied, a schedule for when control measures will be applied and a post-treatment

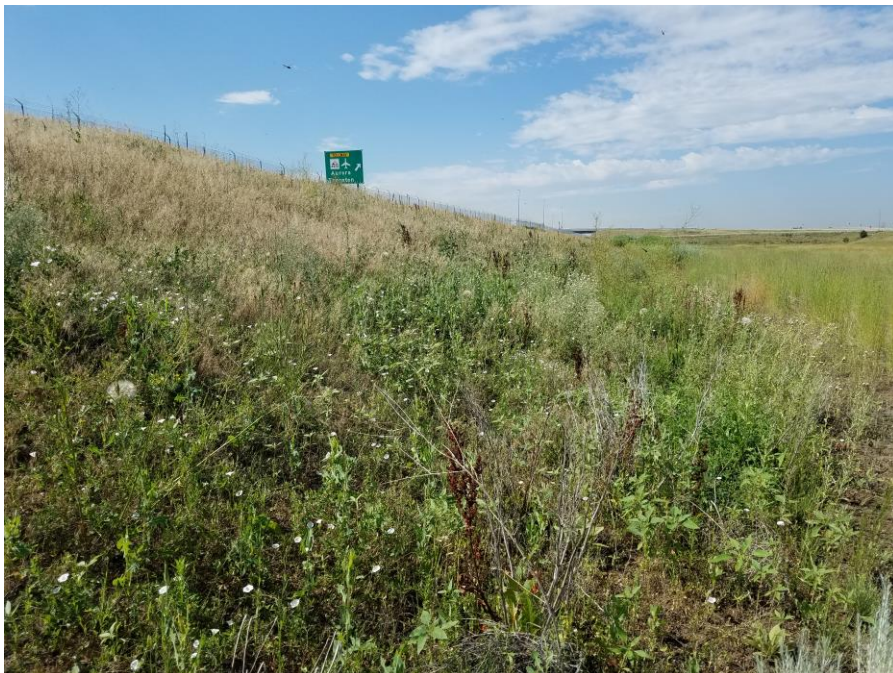
Figure 2. From the east side of the site looking south.

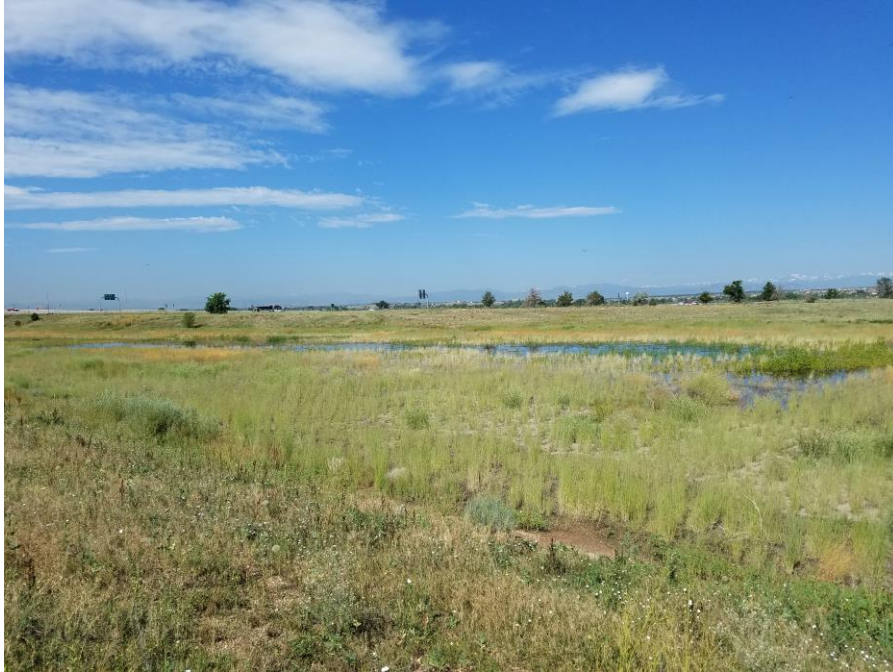
**PROBLEM:** Water was observed within the pit basin that does not appear to infiltrate or otherwise discharge within 72 hours. This is a problem related to 34-32.5-116(4)(h) of the Colorado Revised Statutes and 3.1.6(1)(a) of the Construction Materials Rules and Regulations governing injury to existing water rights.

Standing water was observed at the base of the pit at the southern end of the site. After the inspection, Mr. Slack sent a copy of a letter sent to the State Engineer's Office (SEO) regarding the closeout and well abandonment for the site. This letter described that surface water run-off collects within the pit from time to time and they made a demonstration that the water collected at the site is not exposed groundwater. Currently, the operator has a temporary substitute water supply plan (SWSP) in place to cover lagged depletions from the evaporation associated with the previously exposed groundwater at the site.

**Figure 3. Standing water observed at the site. From the south end of the site from the east side looking west.**

**CORRECTIVE ACTIONS:** The Operator shall demonstrate that the operation is in compliance with the Office of the State Engineer (SEO), show evidence that the Operator is taking measures to bring the site into compliance with the SEO, or submit a plan to bring the site into compliance with the SEO.

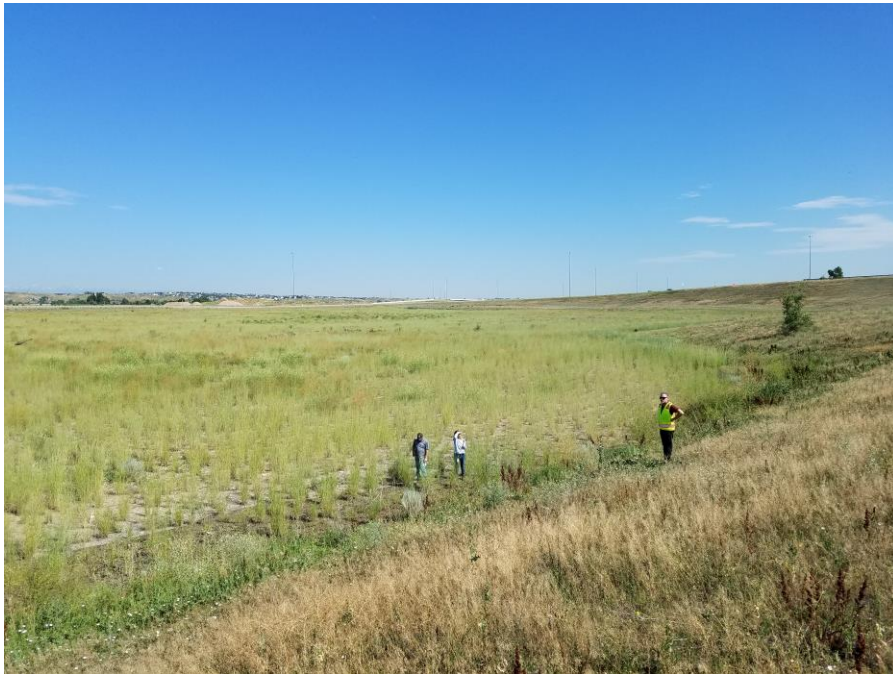
**Figure 4. From the eastern side of the site looking northwest.**

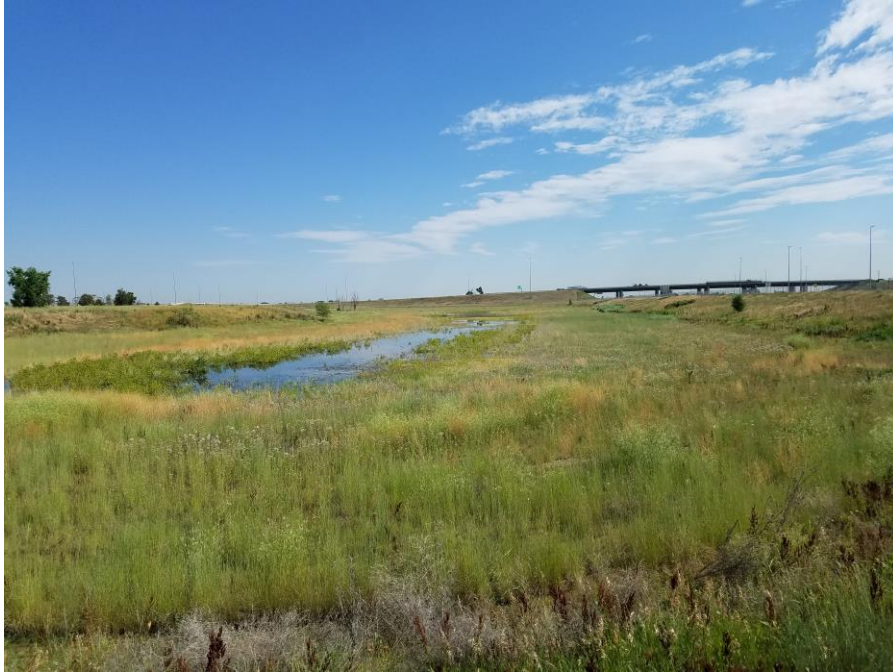
Figure 5. From the south end of the site looking north.
