MINERALS PROGRAM INSPECTION REPORT
PHONE: (303) 866-3567

MINE NAME: Nicholson Gravel Pit	MINE/PROSPECTING ID#: M-1986-048	MINERAL: Sand and gravel	COUNTY: Morgan
INSPECTION TYPE: Monitoring	INSPECTOR(S): Brock F. Bowles	INSP. DATE: July 30, 2019	INSP. TIME: 11:30
OPERATOR: R & J Yetter Sand & Gravel LLC	OPERATOR REPRESENTATIVE: Jewelie and Russ Yetter	TYPE OF OPERATION: 112c - Construction Regular Operation	
REASON FOR INSPECTION: Normal I&E Program	BOND CALCULATION TYPE: Complete Bond	BOND AMOUNT: \$43,357.00	
DATE OF COMPLAINT: NA	POST INSP. CONTACTS: None	JOINT INSP. AGENCY: None	
WEATHER: Clear	INSPECTOR'S SIGNATURE:

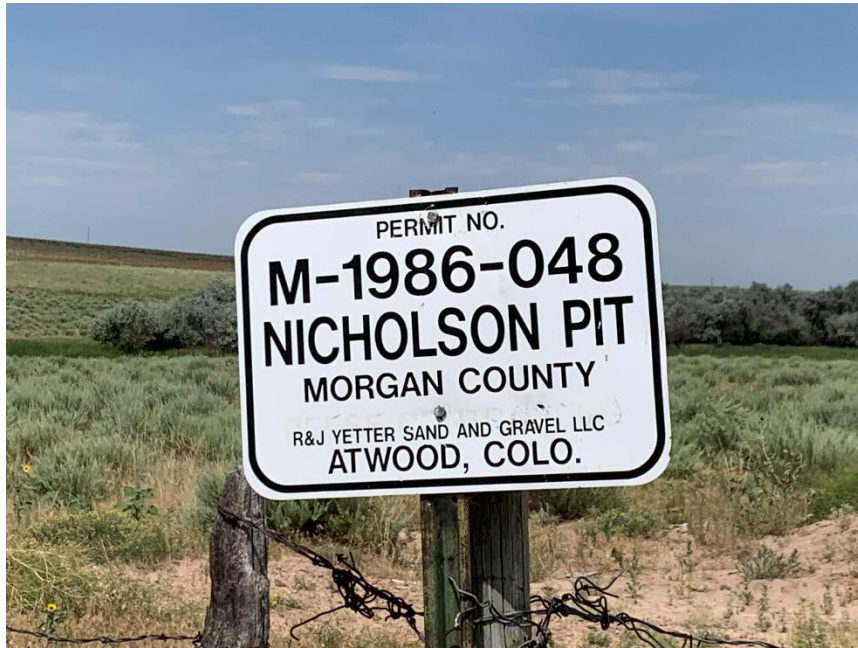
The permit identification sign was in place at the mine entrance and legible. The permit boundary markers were in place and had white PVC pipe over them making them easy to spot.

Mine entrance sign

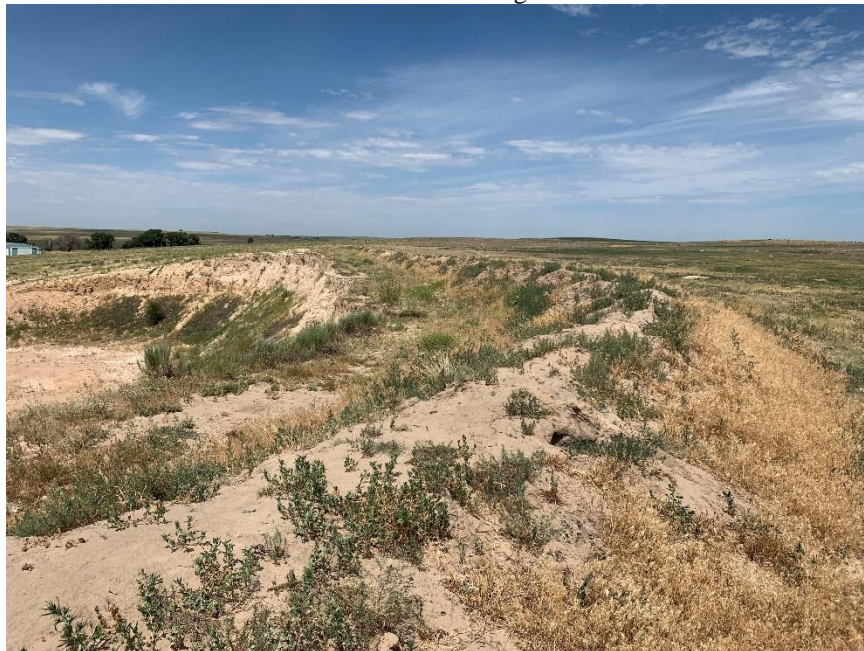
The topsoil stockpile was on the west side of the permit area, was well vegetated and appeared to be stable. Topsoil was salvaged from in front of the pit. Some topsoil is piled into a small berm in front of the pit. The operator explained that the berm is used as topsoil storage and to prevent the landowner from accidentally driving off the highwall as the area around the pit is actively used for grazing.

Topsoil berm in front of highwall
