**COLORADO**Division of Reclamation,
Mining and Safety

MINERALS PROGRAM INSPECTION REPORT**PHONE: (303) 866-3567**

MINE NAME: Robinson Sons Gravel Pit No. 1	MINE/PROSPECTING ID#: M-2008-076	MINERAL: Sand and gravel and	COUNTY: Las Animas
INSPECTION TYPE: Monitoring	INSPECTOR(S): Jared L. Ebert	INSP. DATE: July 29, 2019	INSP. TIME: 12:00
OPERATOR: Robinson Sons Inc.	OPERATOR REPRESENTATIVE: Daniel Robinson	TYPE OF OPERATION: 112c - Construction Regular Operation

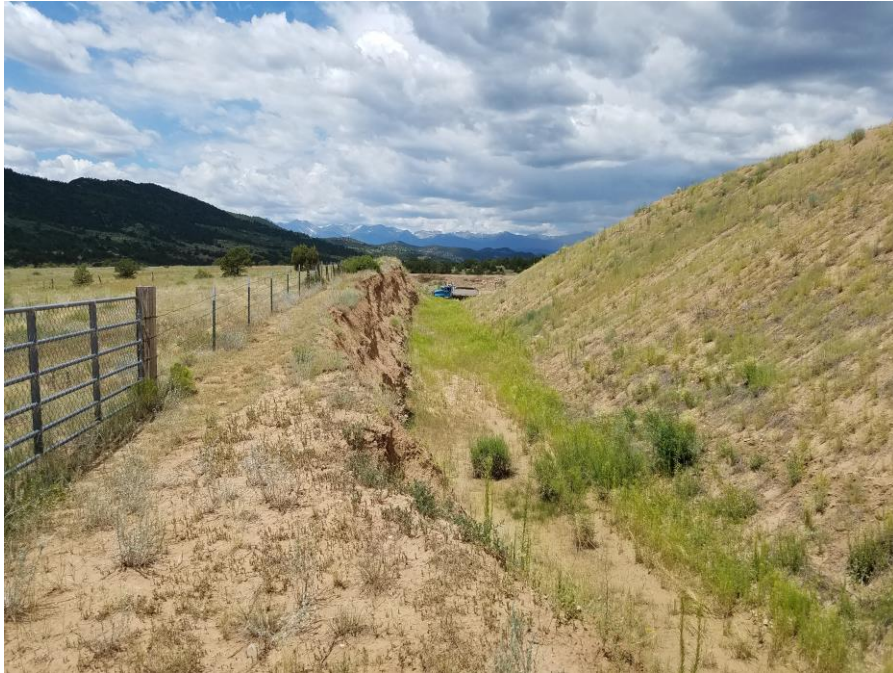
Figure 1. From the south central portion of the permit boundary looking west.

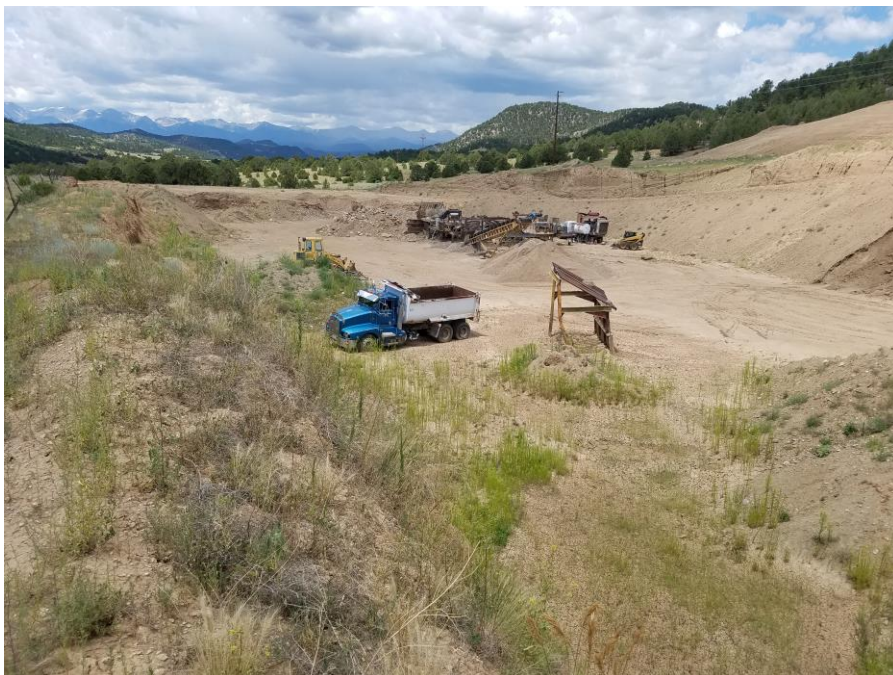
Area 1 consists of a large rectangular shaped pit excavation, a former overburden storage area and a partially regraded area. The pit appears to be on average 20 feet deep with near vertical highwalls along the southern permit boundary. The western and northern pit walls vary in angle but on average were set near the angle of repose. Robinson has graded the eastern quarter of the pit slopes to a 3H:1V angle or less. A small ephemeral drainage enters through a culvert that drains into the pit basin. A large stockpile of topsoil is located in the southeast corner of the Area 1 pit basin. This pile appears to be acting as an impoundment and does not allow the affected land to drain and standing water was observed in the base of the pit. The southern pit slopes were found to be near vertical in most places and there is no room for Robinson to cut and fill these slopes. However, a large pile of overburden is located at the base of this highwall and is available for backfill material. Northwest of the pit excavation is an area that appears to have been previously used for overburden storage. This area has been graded to nearly blend in with the surrounding hillside. However, the eastern portion of this area has steep near angle of repose side slopes. The Division estimates about 35% of the earthwork is completed in the Area 1 portion of the affected land.

Figure 2. From the south western end of the south boundary looking west by northwest into Area 1 pit.

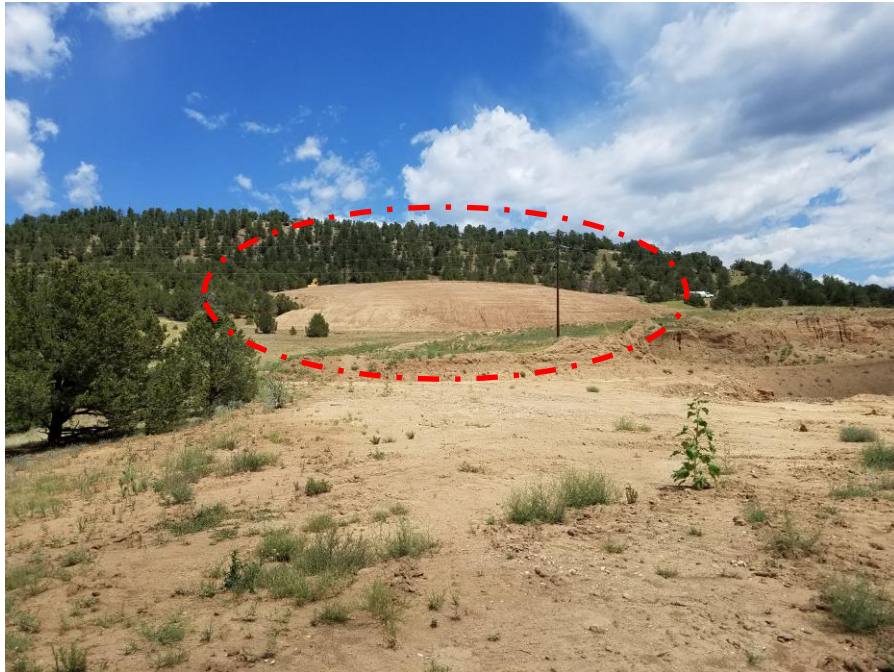
Figure 3. From the southwest corner of the Area 1 affected land looking north. The overburden storage area outlined in red.

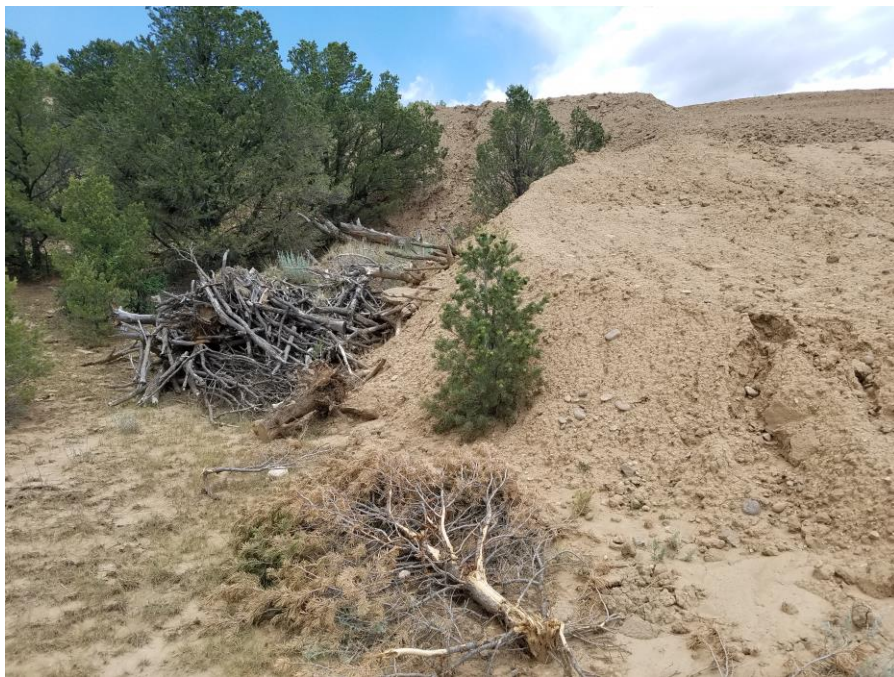
As discussed above, Robinson has graded portions of the affected land. The graded portions of the affected land were stable at the time of the inspection and blended in with the surrounding topography. Graded pit slopes were no steeper than 3H:1V in Area 1. Several steeper slopes were observed in the Reclamation Area Only parcel that will need to be graded and stabilized. Portions of all the affected land require additional backfilling and grading to comply with the reclamation plan.

Figure 4. From the southwest end of the former overburden storage area looking north. Steep slope area that will need to be graded.

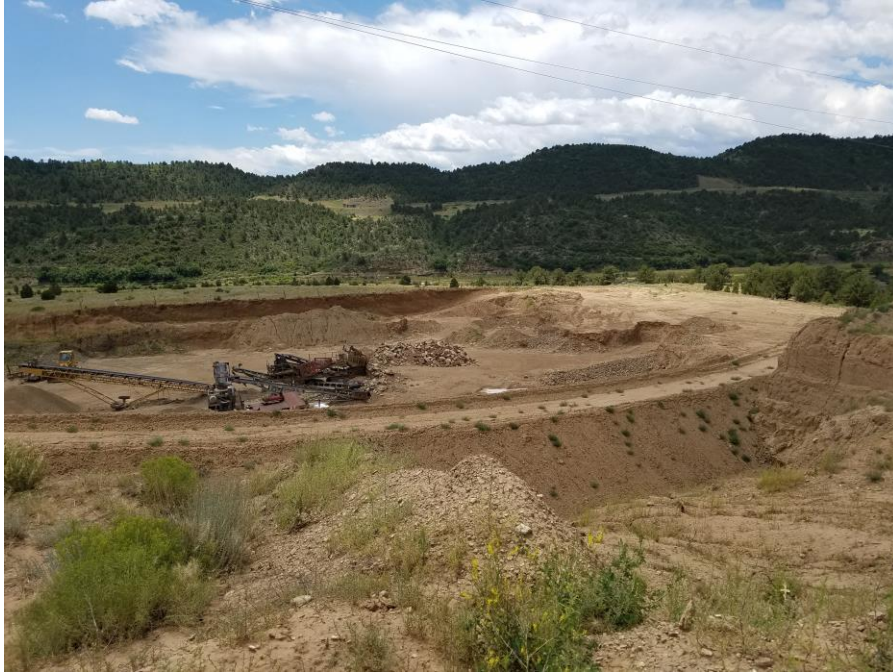
Figure 5. From the north side of the southwest portion of Area 1 looking south.

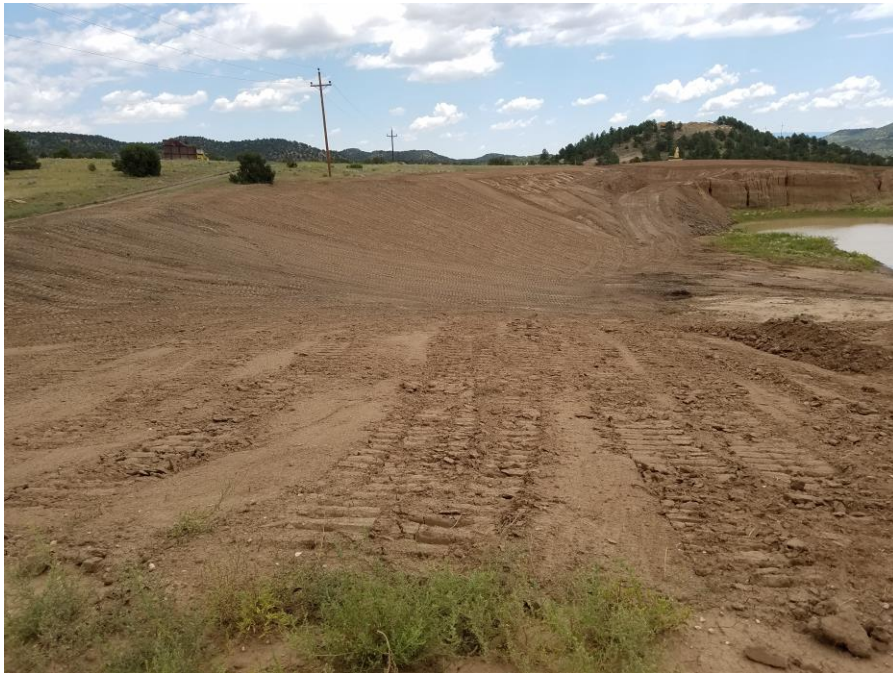
Figure 6. From the north central portion of Area 1 looking southeast at the graded portion of Area 1.

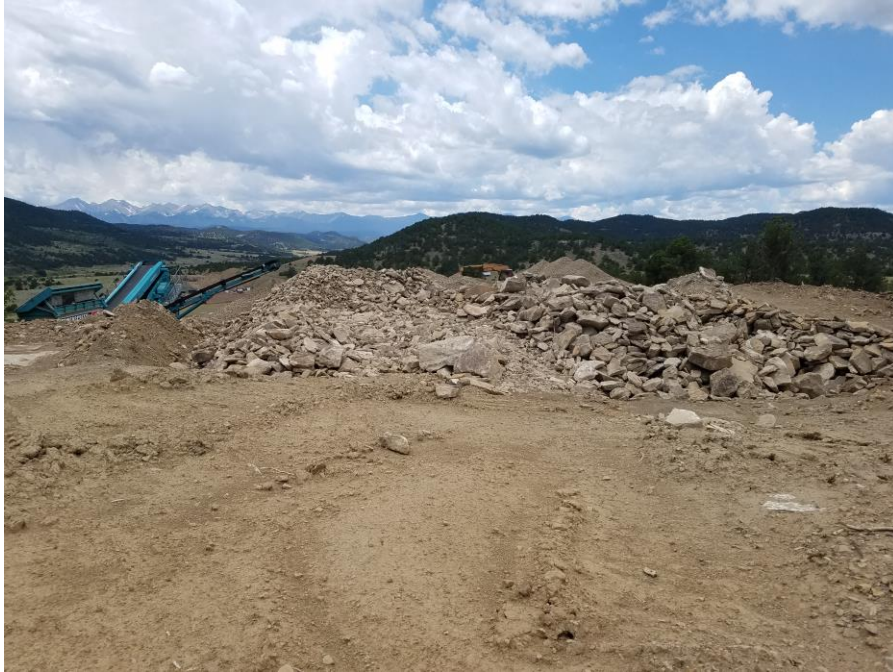
Area 2 consists of an access road, a lower work area and an upper area on top of the hill. Robinson has excavated and lowered the top of the hill in Area 2 and various stockpiles of product and a crusher are stored

Figure 7. Top area of Area 2.

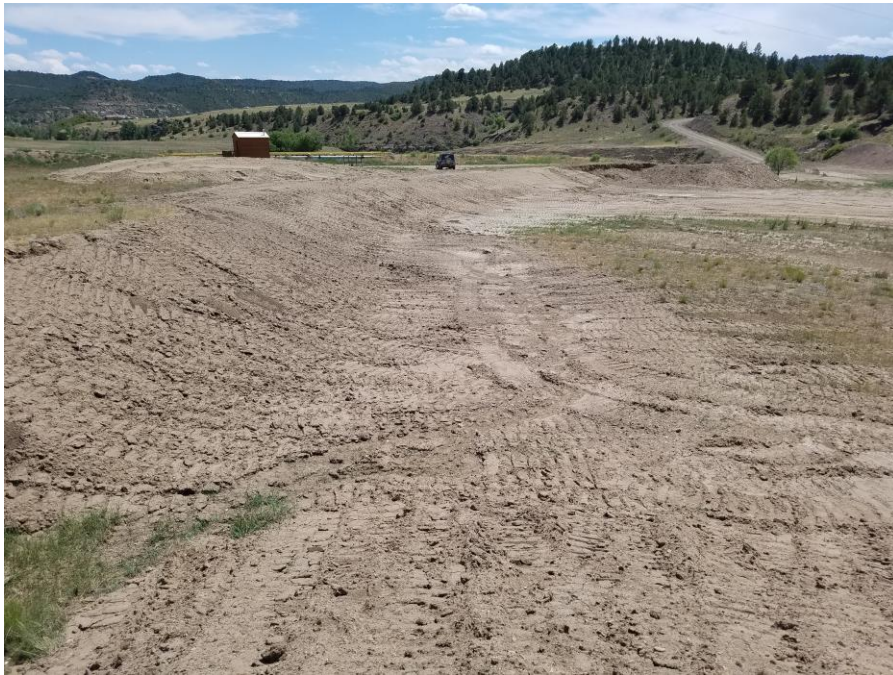
Figure 8. Reclamation Area Only parcel. North of the access road looking south from the east end.

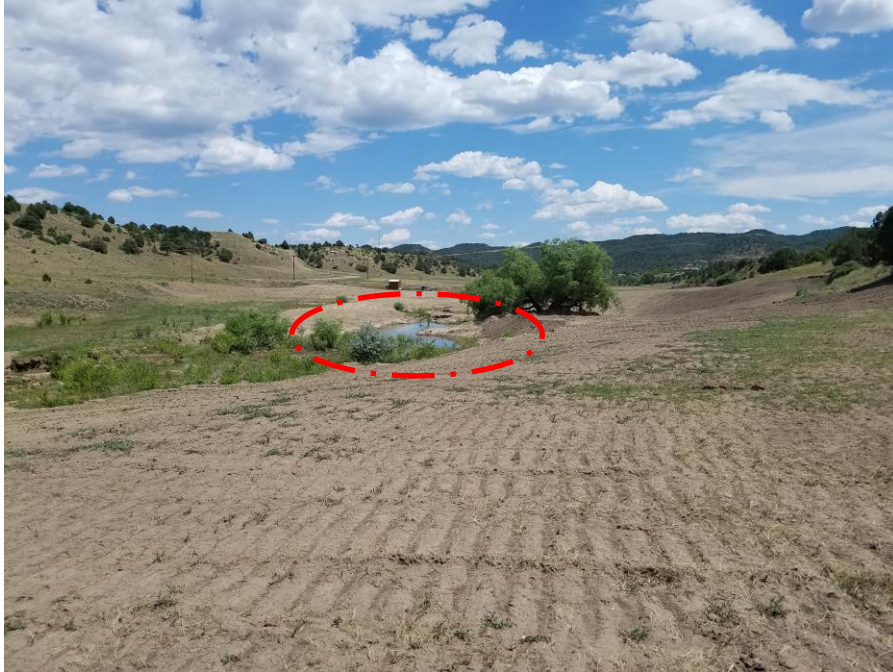
PROBLEM: The Division has no evidence that the operator has a valid well permit, substitute water supply plan, or approved water augmentation plan for the exposed groundwater and/or impounded surface water in the two pit basins located in the Reclamation Area Only parcel near the entrance to the site north and south of the access road. This is a problem related to section 34-32.5-116(4)(h) of the Colorado Revised Statutes and 3.1.6(1)(a) of the Construction Materials Rules and Regulations governing injury to existing water rights.

The two basins/impoundments discussed above are holding water. This issue is cited as a problem at the beginning of this report. Robinson must either submit documentation that they have approval from the Division of Water Resources for the impoundment of this water or backfill these basins so that water is no longer impounded.

Figure 9. From the north end of the Reclamation Area Only parcel looking south. Northern water basin highlighted in red.

CORRECTIVE ACTIONS: The Operator shall demonstrate that the operation is in compliance with the Colorado Division of Water Resources (DWR), show evidence that the operator is taking measures to bring the site into compliance with the DWR, or backfill the pits to at least two feet above the water surface by the corrective action date specified.

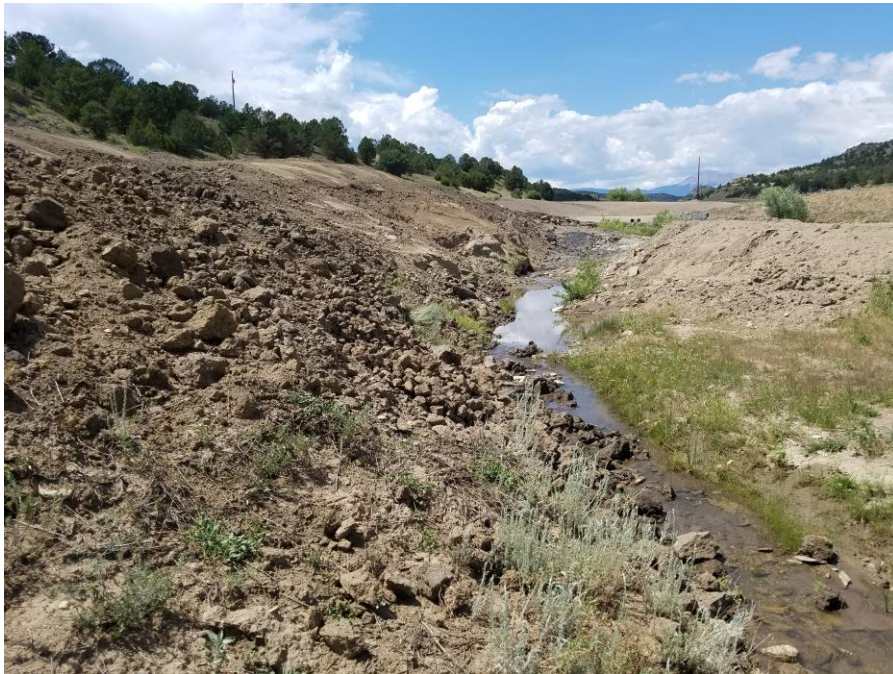
Figure 10. Re-established stream channel on the south side of the Reclamation Area only parcel looking north.

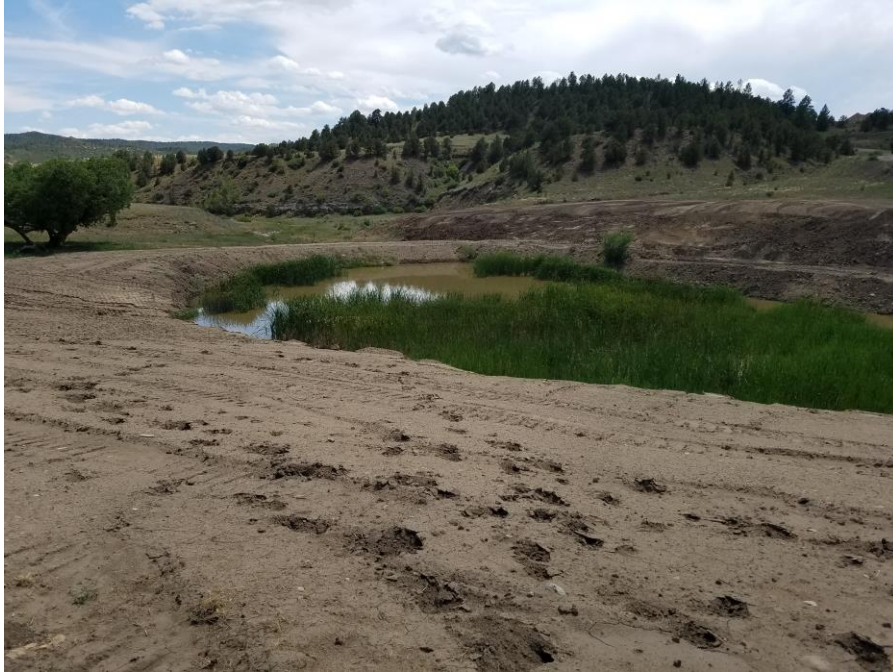
Figure 11. Pit basin on the south side of the access road from the east side looking west.
