MINERALS PROGRAM INSPECTION REPORT

MINE NAME: Eagle-Gypsum Mine	MINE/PROSPECTING ID#: M-1984-041	MINERAL: Anhydrite, gypsum	COUNTY: Eagle
INSPECTION TYPE: Monitoring	INSPECTOR(S): Stephanie J. Mitchell	INSP. DATE: July 8, 2019	INSP. TIME: 10:00
OPERATOR: American Gypsum Company LLC	OPERATOR REPRESENTATIVE: Jon Edeen	TYPE OF OPERATION: 112c - Construction Regular Operation

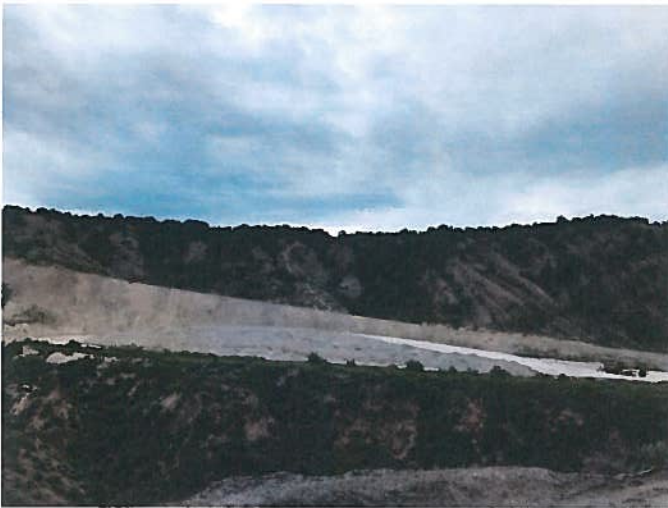
Ore Pad

Adequate mine identification signage was noted at the entrance to the site. The affected area was adequately marked with fencing and posts. The ore stockpile is currently at 27,000 tons.

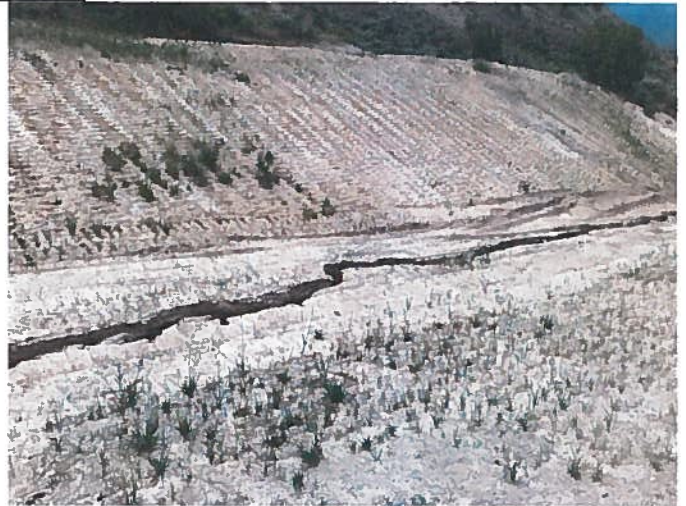
PROBLEM/POSSIBLE VIOLATION: Problem: Erosion gullies and ruts were observed on-site. This is a problem at this time for failure to protect the affected land from erosion pursuant to C.R.S. 34-32.5-116 (4) (j).

Gully – needs rip rap

CORRECTIVE ACTIONS: The operator shall provide photo documentation to the Division verifying erosion gullies and ruts have been repaired, and that the site has have been reconstructed and stabilized to prevent erosion damage by the corrective action date.

Ponds and Stormwater structures were inspected. Pond 1 appears to be functioning properly. Pond 1 b has a large gully forming at the entrance to the pond. This is considered a problem at the beginning of the inspection report. The Division recommends rip rap be added to the gully and some check dams. Pond 1 a needs repair. The liner is showing through the rip rap channel.

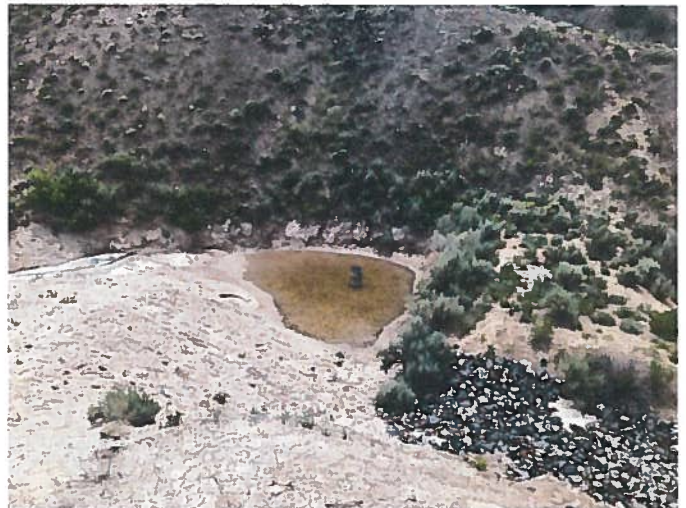
Stormwater Structure 6

Stormwater Structure, 2,3,4,5 and 6 were all inspected and appear to be working properly. The Operator is encouraged to keep up maintenance and clean out the features.

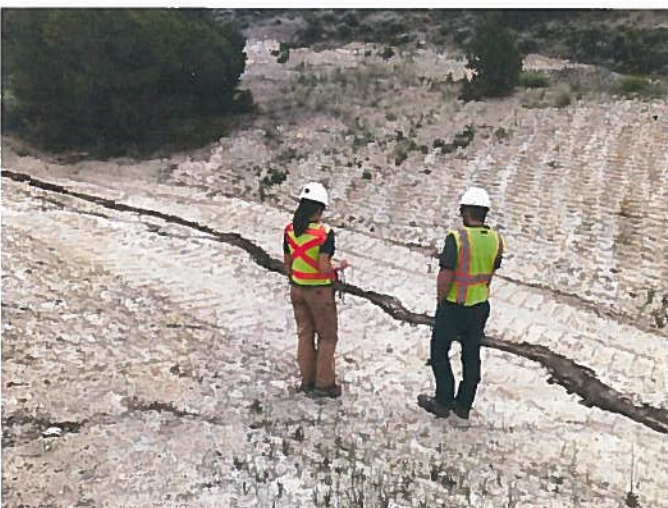
Gully by Pond 1b

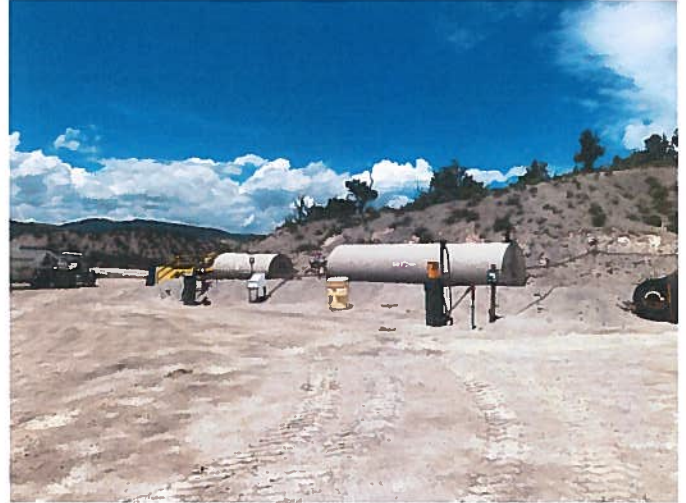
Fuel Storage

Fuel storage is with adequate secondary containment.

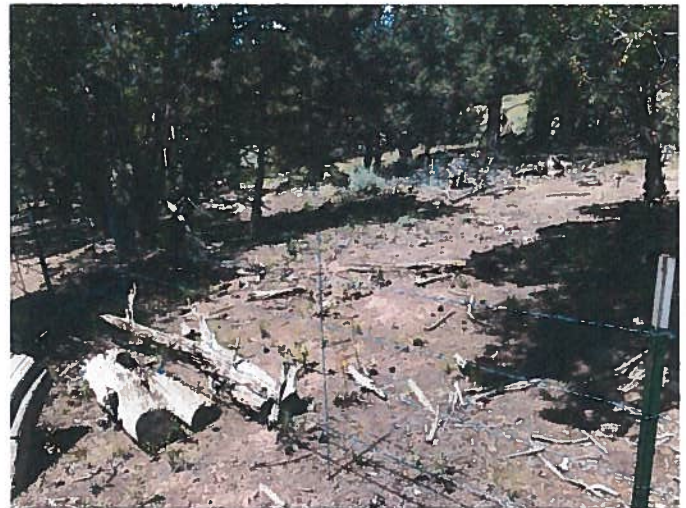
Fence above highwall

A fence above the highwall was installed in 2016 and was inspected.
