**MINERALS PROGRAM INSPECTION REPORT**  
**PHONE: (303) 866-3567**

<b>MINE NAME:</b> Wagner/Kauffman Pit #3	<b>MINE/PROSPECTING ID#:</b> M-1999-069	<b>MINERAL:</b> Sand and gravel	<b>COUNTY:</b> Larimer
<b>INSPECTION TYPE:</b> Monitoring	<b>INSPECTOR(S):</b> Amy Eschberger	<b>INSP. DATE:</b> July 11, 2019	<b>INSP. TIME:</b> 10:00
<b>OPERATOR:</b> Jake Kauffman & Son, Inc.	<b>OPERATOR REPRESENTATIVE:</b> Troy Kauffman, Dan Giroux	<b>TYPE OF OPERATION:</b> 112c - Construction Regular Operation	
<b>REASON FOR INSPECTION:</b> Normal I&E Program	<b>BOND CALCULATION TYPE:</b> None	<b>BOND AMOUNT:</b> \$570,000.00	
<b>DATE OF COMPLAINT:</b> NA	<b>POST INSP. CONTACTS:</b> None	<b>JOINT INSP. AGENCY:</b> None	
<b>WEATHER:</b> Clear	<b>INSPECTOR'S SIGNATURE:</b>

**M-1999-069 / Wagner-Kauffman Pit #3 / Jake Kauffman & Son, Inc.**

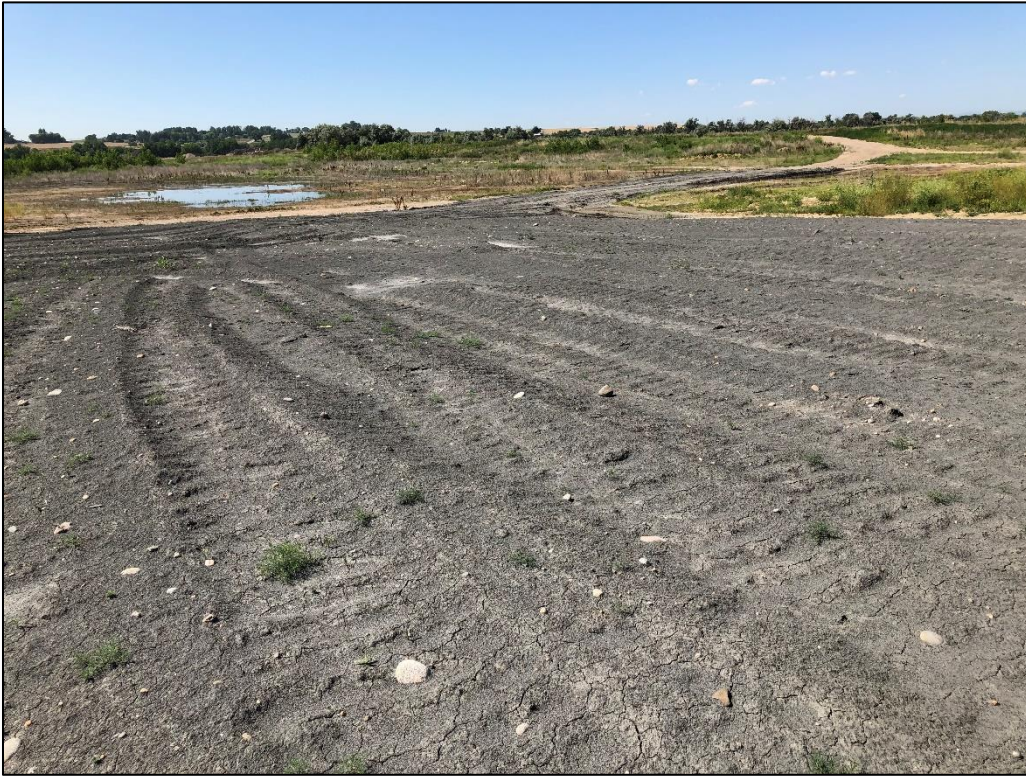
**Photo 1.** View looking south across east pit, showing majority of pit backfilled and graded nearly flat.

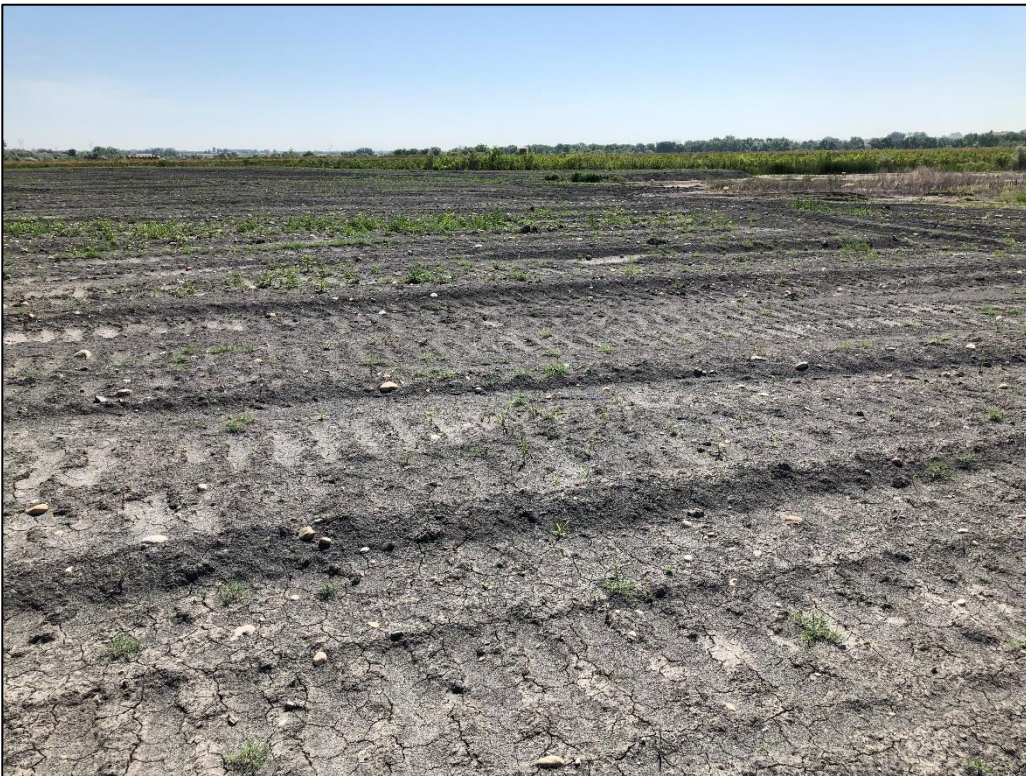
**Photo 2.** View looking east across east pit, showing majority of pit backfilled and graded nearly flat.

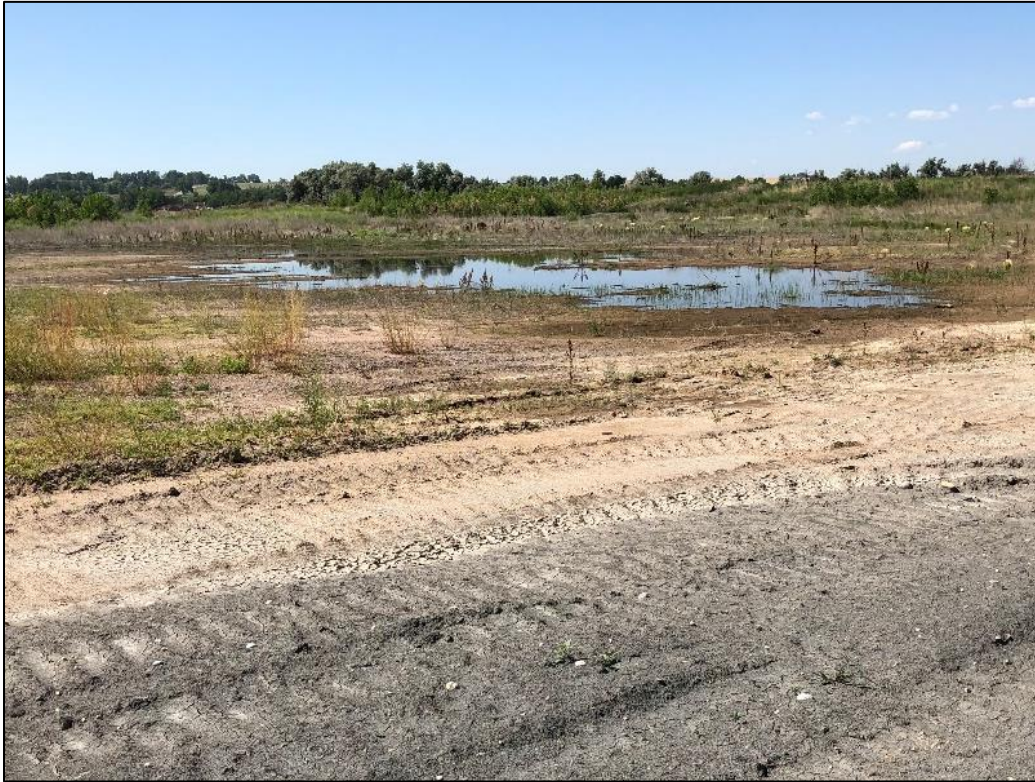
The Division first inspected the triangular-shaped pit located east of the outlet ditch (east pit). This pit disturbance covers approximately 22 acres. During its April 14, 2017 inspection, the Division observed the east pit to be holding approximately 5.8 acres of water at a depth of approximately 2 feet. The operator's Substitute Water Supply Plan (SWSP) covers 0.0145 acres of groundwater exposed in the temporary dewatering trench (located in the west pit), and does not cover any additional exposed groundwater for this permit. Therefore, in late 2017, the operator backfilled this pit a minimum of two feet above the static groundwater level. Since that time, the operator has continued backfilling the pit from the north to the south to create a more ideal grade for outdoor storage. The majority of this pit has been backfilled and graded to nearly flat. Technical Revision No. 4 (TR-4, approved in 2017) authorizes the operator to import inert materials to the site for backfilling the pits. During the current inspection, the Division observed some shallow puddles at the southern edge of the east pit. The operator indicated this area had been dry since it was backfilled in 2017, but some ponding was observed in this area again this spring. The operator believes the higher than average precipitation the area has been receiving this year may have raised the groundwater table to higher than normal static conditions and also created some ponding of meteoric water in low-lying areas. While the operator expects this area to dry out, the Division recommended the operator place additional backfill in this area to cover the ponded water, thus ensuring compliance with the Division of Water Resources.

**Photo 3.** View looking south across east pit, showing ponding present at lower, southern edge of pit due to recent heavy precipitation events.

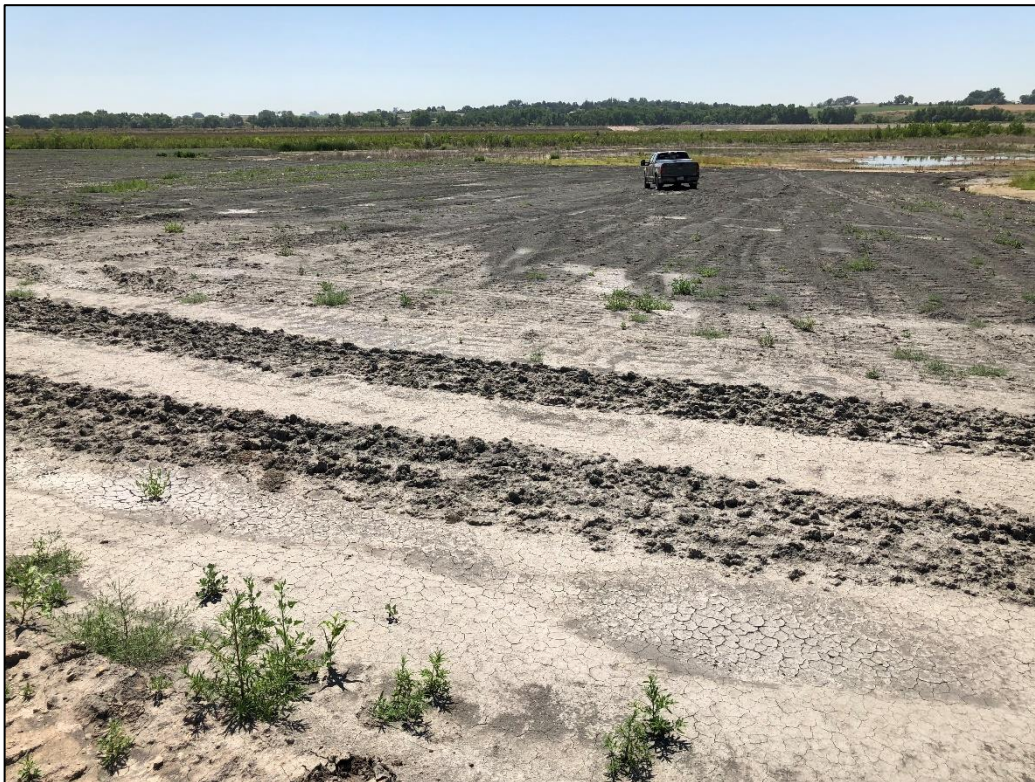
**Photo 4.** View looking southeast across east pit from its northern edge, showing majority of pit backfilled and graded nearly flat.

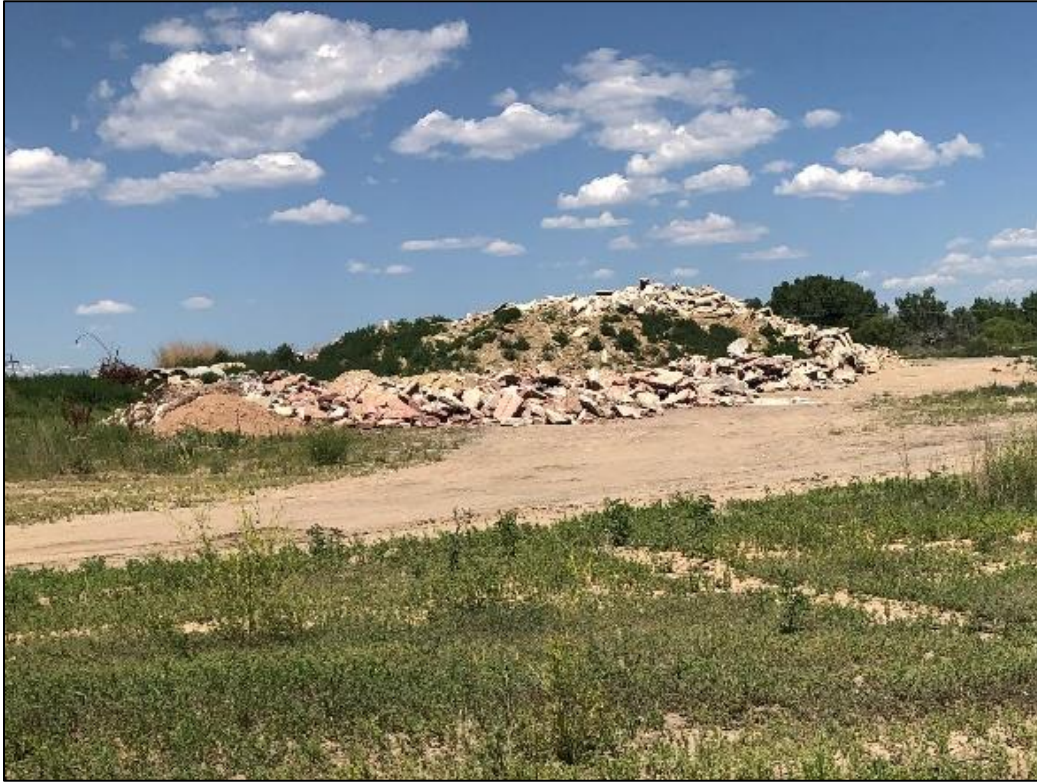
Concrete rubble is currently stockpiled in the northwestern portion of the east pit, in accordance with the post-

**Photo 5.** View looking west showing concrete rubble stockpiled in northwestern portion of east pit, in accordance with the post-mining land use of outdoor storage.

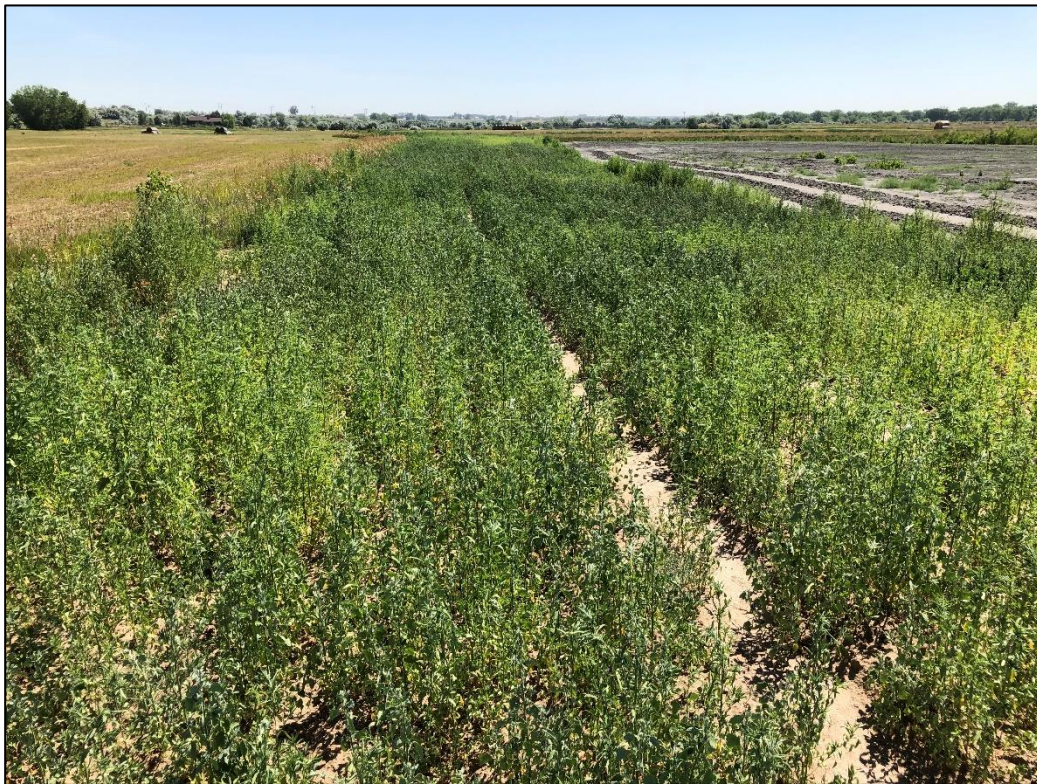
mining land use of outdoor storage. The large topsoil stockpile that was stored at the northern edge of this pit during the Division's May 22, 2018 inspection, has been spread out across the northern portion of the pit which does not require additional backfilling. The footprint area of the old stockpile is vegetated with primarily annual weeds at this time, which is in contrast to the adjacent lands to the north which have a good establishment of native grasses. The Division recommends the operator employ methods of weed control to prevent the growth and spread of weeds on site, particularly for any state-listed noxious weed species, as required by Rule 3.1.10(6).

**Photo 6.** View looking east along northern edge of east pit, showing area where topsoil stockpile was spread out. This area is currently overgrown with primarily weeds.

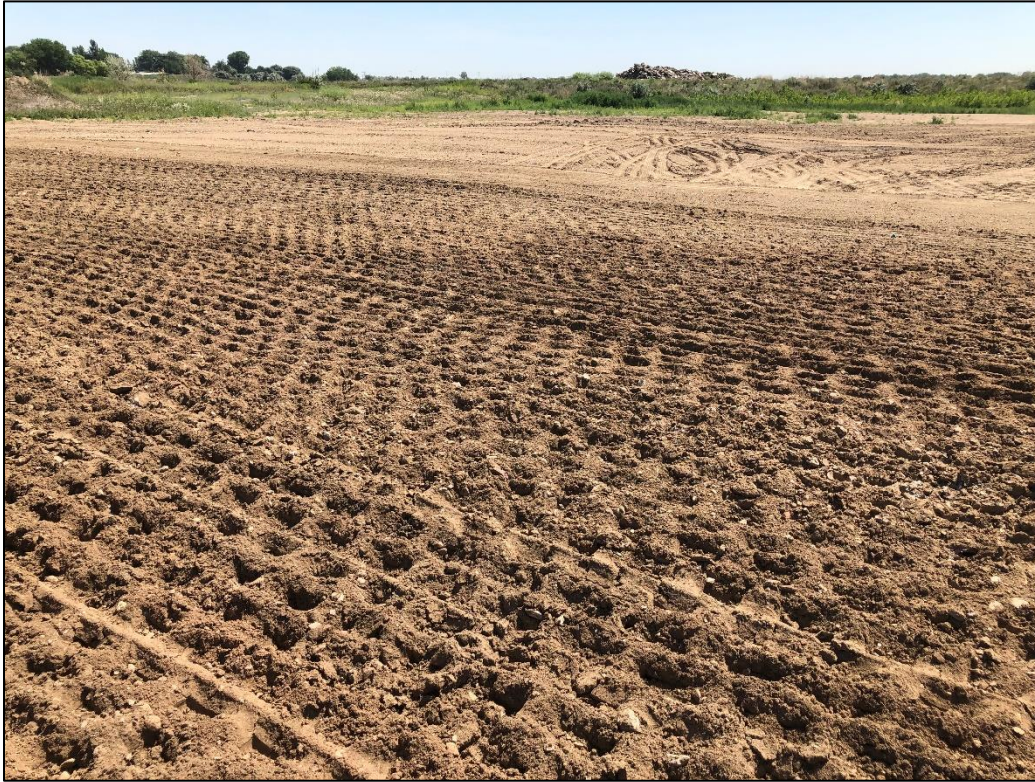
**Photo 7.** View looking northeast across northern portion of west pit (west of outlet ditch) which has been backfilled since last inspection.

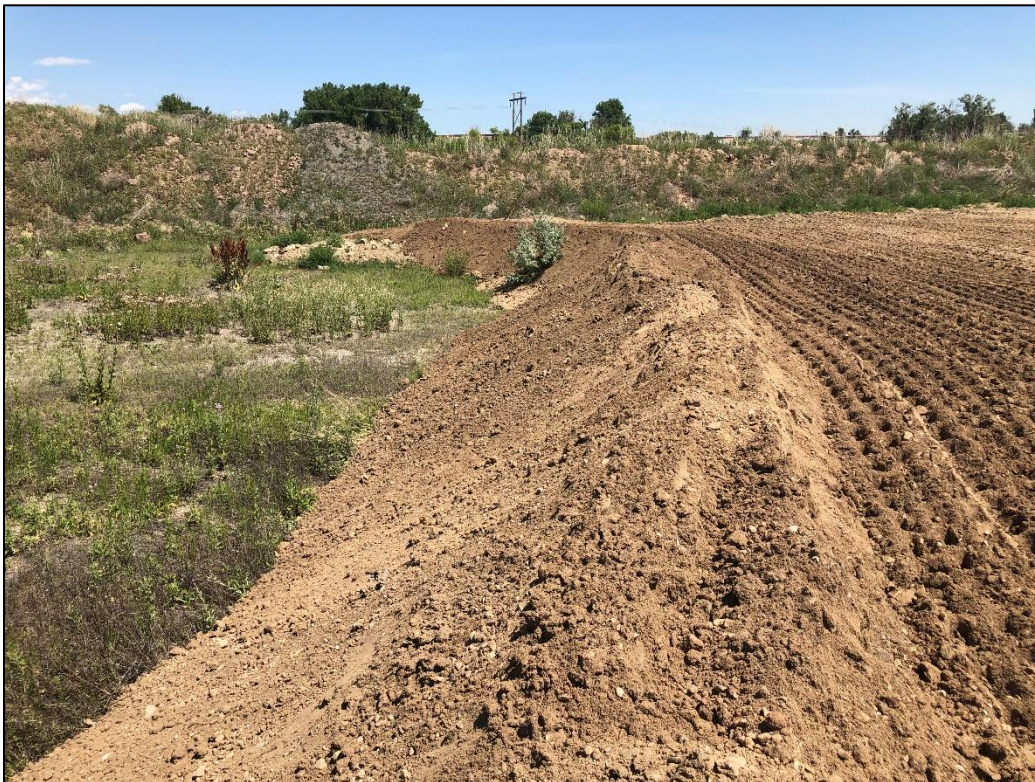
**Photo 8.** View looking north across northern portion of west pit, showing edge of backfilled portion (at right). Note large overburden stockpile stored along northern edge of pit (in background).

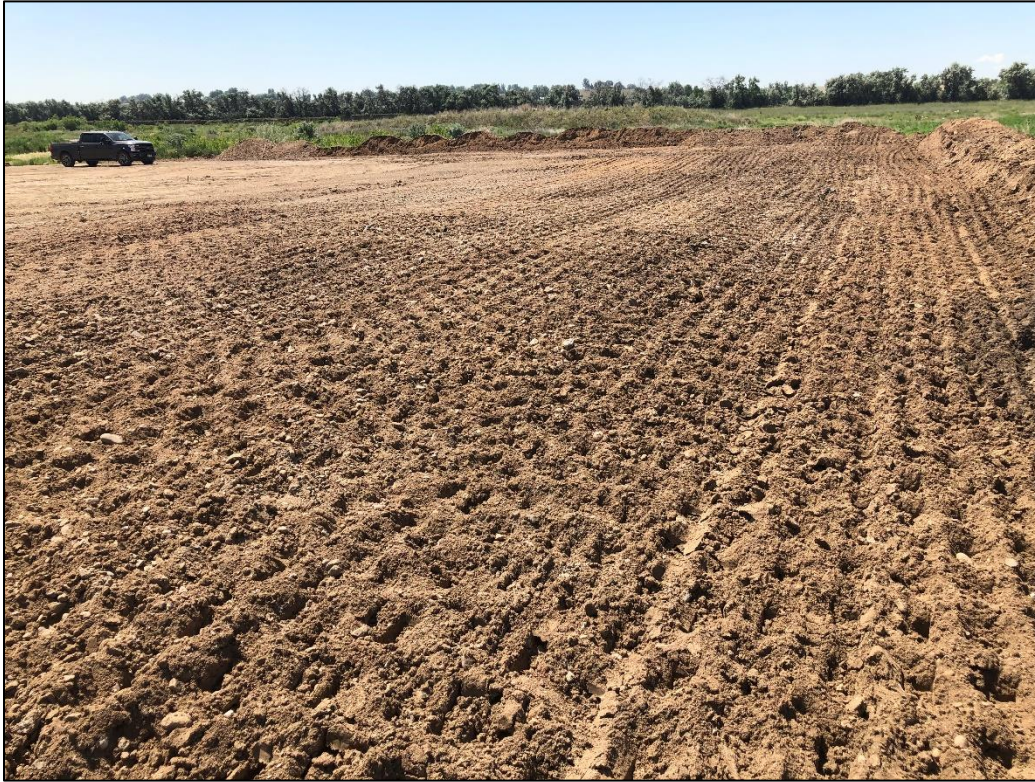
**Photo 9.** View looking south across northern portion of west pit which has been backfilled since last inspection.

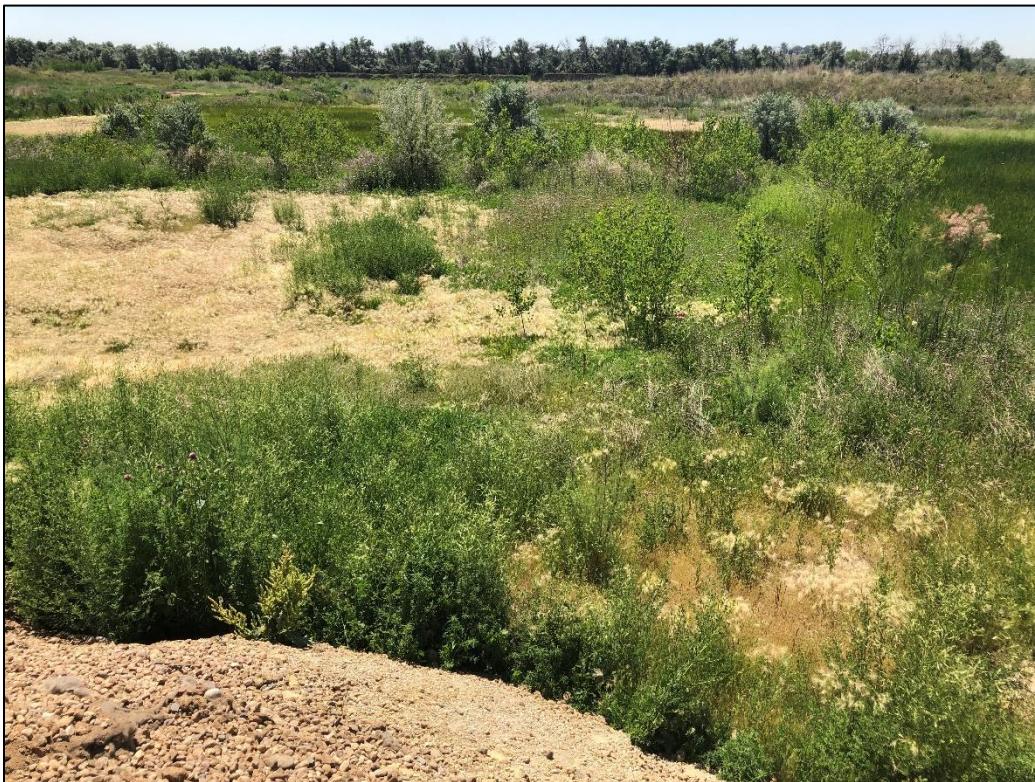
**Photo 10.** View looking south across unbackfilled southern portion of west pit.

- Backfilling the pits to a minimum of two feet above the static groundwater level. No portion of the affected lands can be released from the permit with exposed groundwater that is not covered under a water court approved augmentation plan.
- Leveling out the backfilled areas for outdoor storage use.
- Grading/backfilling portions of the southern slope of the west pit which are steeper than the approved 3H:1V final slope configuration.

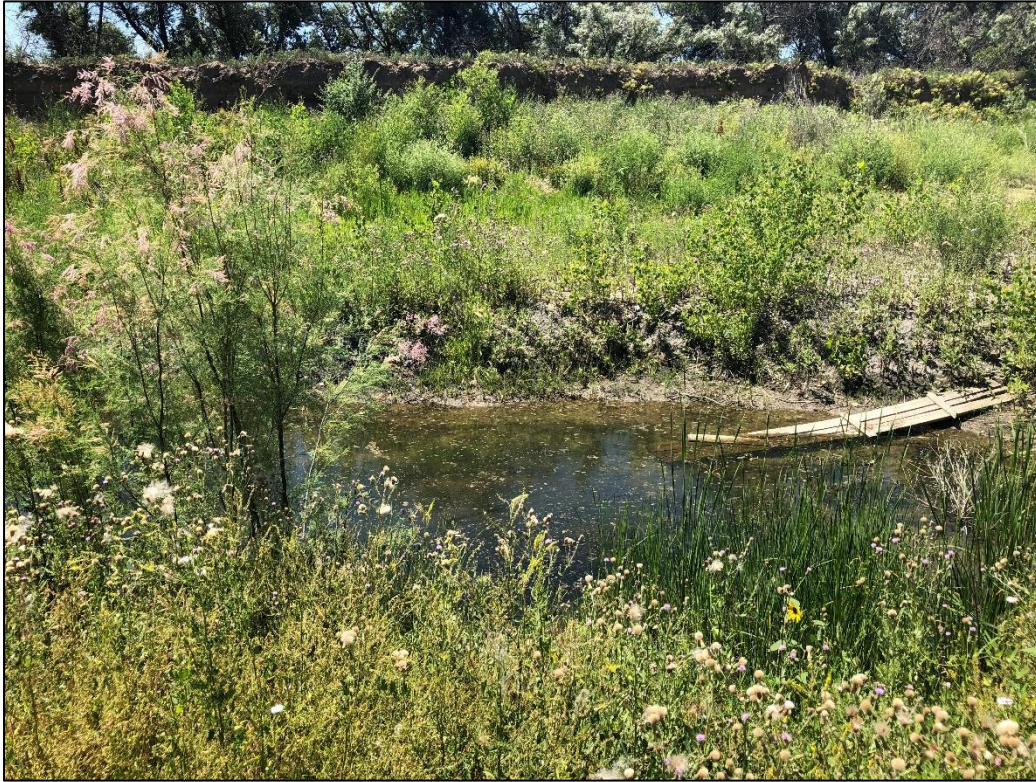
The Division inspected the west pit located west of the outlet ditch. This pit is approximately 15 feet deep and covers approximately 34 acres. The west pit was observed to be dry during the inspection, besides the small dewatering trench located at the southern edge of the pit (which is covered by the operator's SWSP). The operator continues to pump water from the dewatering trench and discharge the water into the adjacent unlined pond located in the Kauffman Pit permit area, as authorized under the SWSP. The operator currently pumps from the trench about once per week. The operator continues to backfill the west pit generally from the north to the south. Since the Division's last inspection of the site on May 22, 2018, the operator has placed approximately 8 feet of backfill material in the northern portion of the pit, covering approximately 2-3 acres. As mentioned above, the approved reclamation plan requires the operator to backfill the pits to a minimum of two feet above the static groundwater level. However, the static groundwater level in this pit will not be known until the dewatering operations have ceased. For final release, the operator will need to stop dewatering, and backfill the pit to cover any exposed groundwater, which will most likely occur in the lower southern portion of the pit. A few overburden stockpiles are stored in the pit, including one large stockpile along its northern edge. This material will be used in reclamation. The majority of the pit slopes have been graded to 3H:1V or flatter and revegetated with native grasses. Only portions of the southern pit wall (near the dewatering trench) have steeper slopes.

**Photo 11.** View of small dewatering trench present at southern edge of west pit, from which water is pumped and discharged into adjacent Kauffman Pit pond.

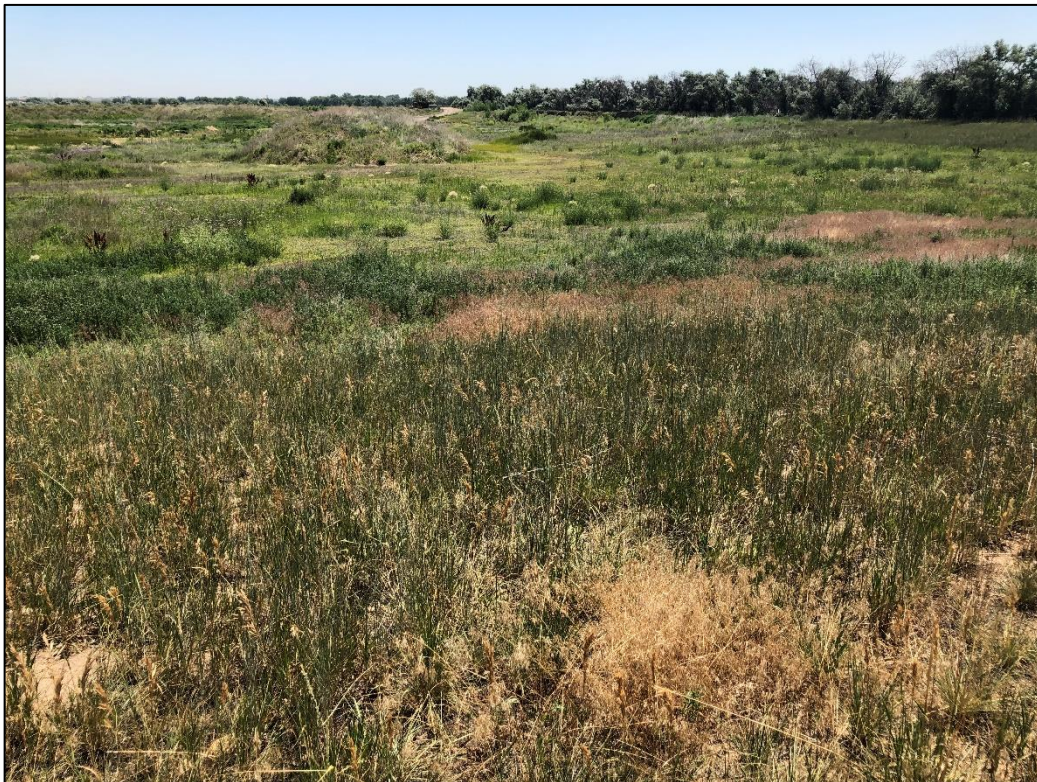
**Photo 12.** View looking southeast across west pit from its western edge.

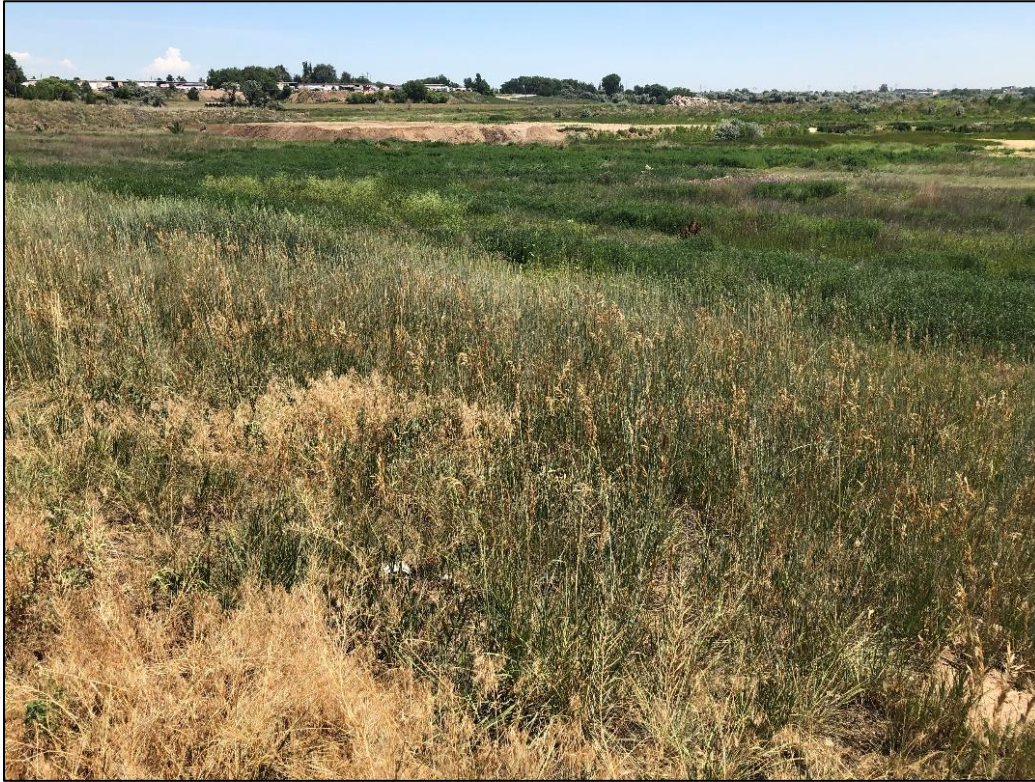
**Photo 13.** View looking northeast across west pit from its western edge. Note backfilled portion in background (top, center).
