COLORADO
Division of Reclamation,
Mining and Safety
Department of Natural Resources

Permit Number: C-1981-035 Mine Name: King Coal Mine Operator: GCC Energy, LLC Operator Address: Mr Jordan McCourt 6473 County Road 120 Hesperus, CO 81326	County: La Plata Operation Type: Underground Permit Status: Active Ownership: Federal
	Operator Representative Present: Leo Campazano
Operator Representative Signature: (Field Issuance Only)

Inspection Start Date: August 7, 2019 Inspection Start Time: 08:45 Inspection End Date: August 7, 2019 Inspection End Time: 10:17		Inspection Type: Coal Partial Inspection Inspection Reason: Normal I&E Program Weather: Clear	
Joint Inspection Agency: None		Joint Inspection Contacts:	
Post Inspection Agency: None		Post Inspection Contacts:	
Inspector(s): Lucas J. West	Inspector's Signature:

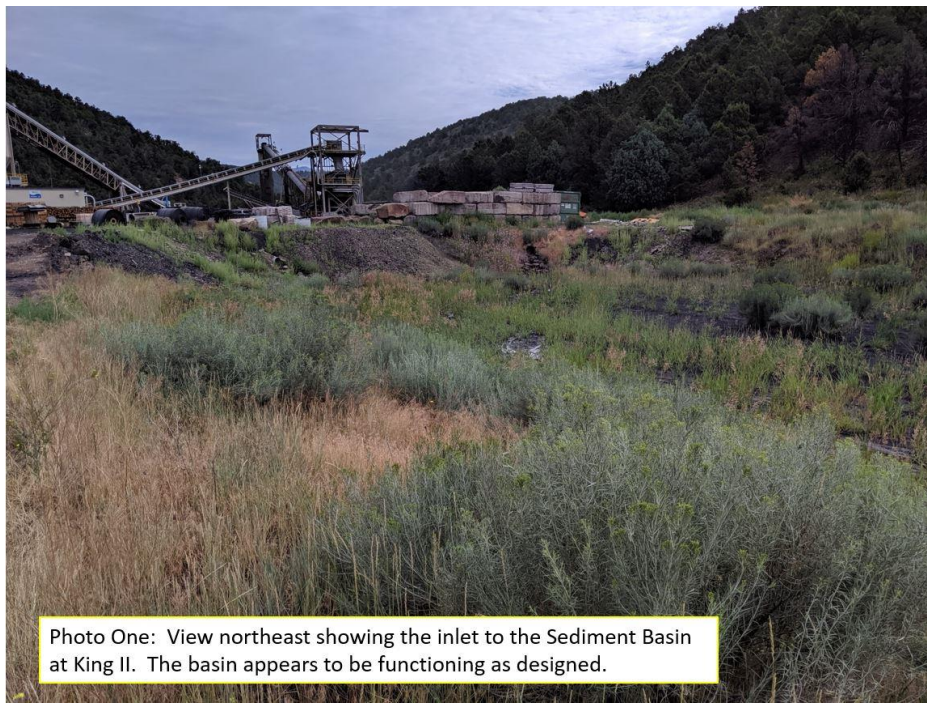
At King II the large sediment basin was observed and was functioning as designed at the time of the inspection. The ditches and culverts leading to the basin are in good condition. A precipitation event occurred the night of August 6, 2019 and all inspected elements of the system appeared to be functioning as designed. A small amount of standing water was observed at the East end of the basin.

Photo One: View northeast showing the inlet to the Sediment Basin at King II. The basin appears to be functioning as designed.

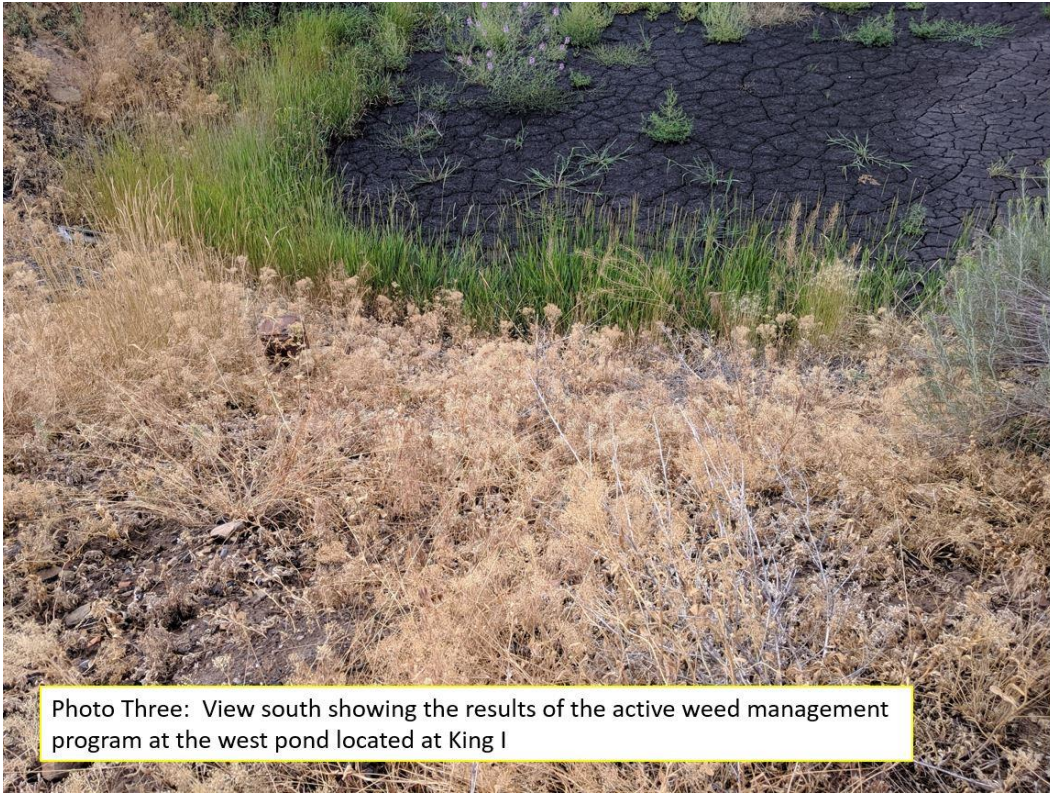
At King I the East and West Ponds were observed. The sediment load in both ponds was visually measured and confirmed to have sufficient capacity as prescribed in the PAP. A small amount of standing water was observed in the East Pond. Evidence of weed management was observed throughout the site but most notably on the North banks of the West Pond.

Photo Three: View south showing the results of the active weed management program at the west pond located at King I

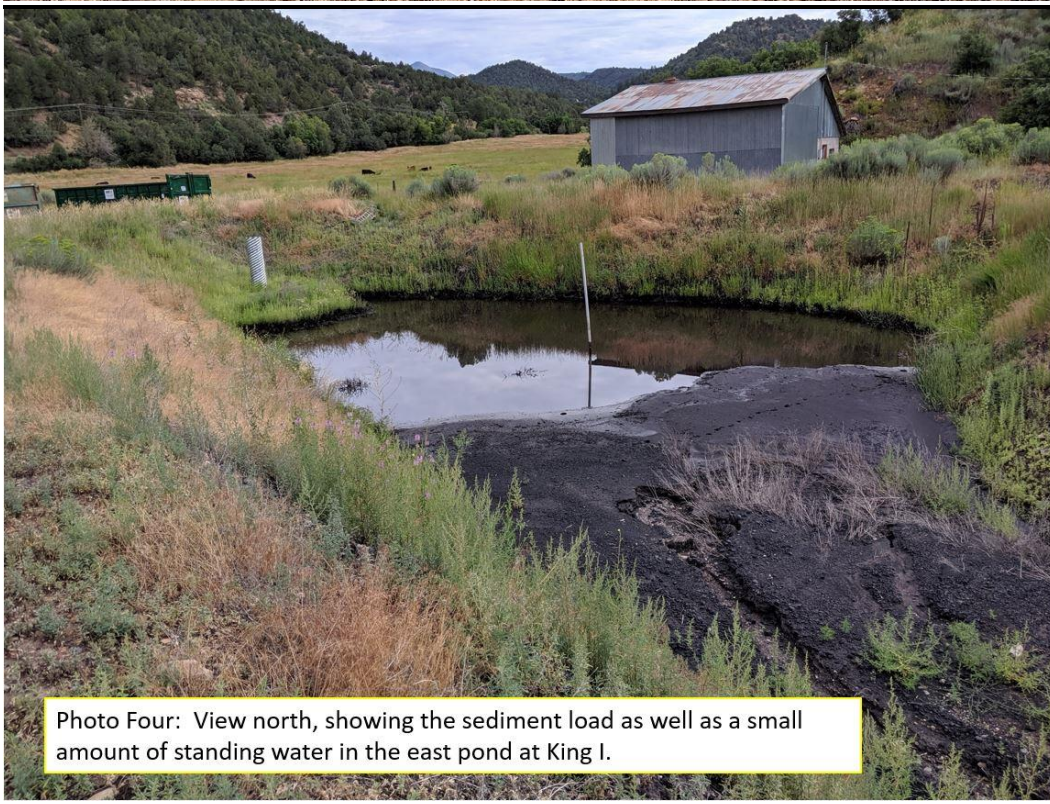
Photo Four: View north, showing the sediment load as well as a small amount of standing water in the east pond at King I.

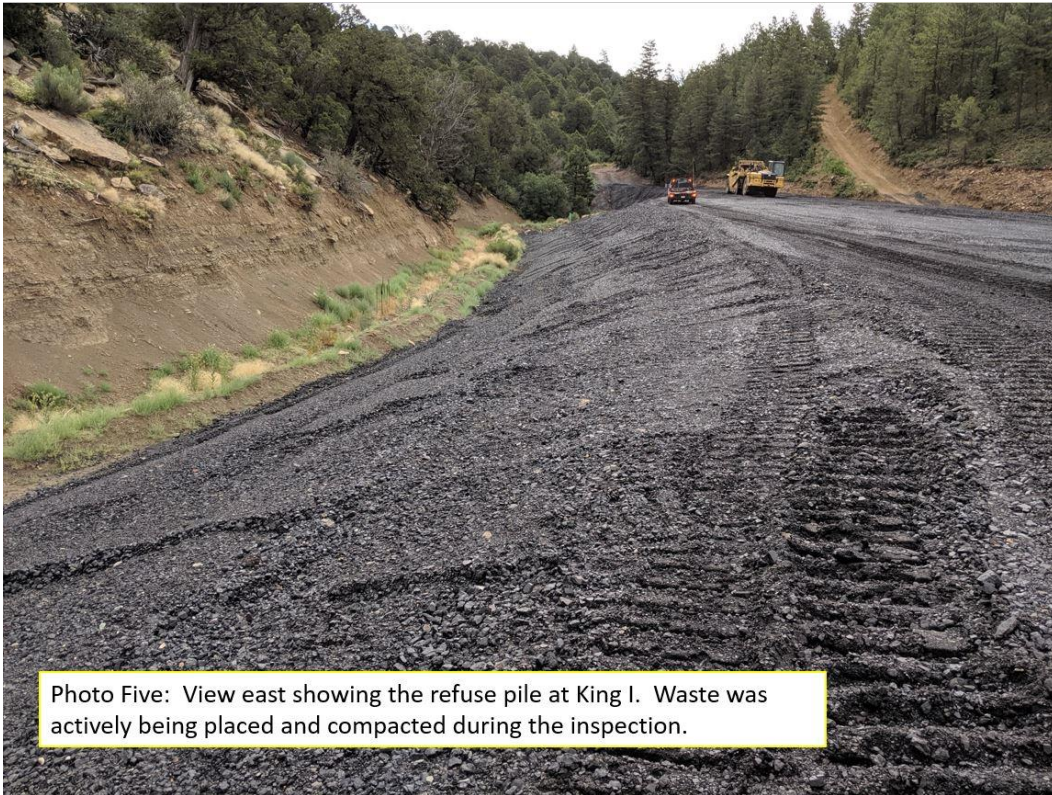
During the inspection material was actively being placed on the refuse pile at King I. The material was being transported from King II and staged on the Temporary Coal Mine Waste Medium Storage Area. It was then being transported onto the Refuse Pile and being placed by way of a belly dump scraper. The refuse was being installed in lifts and compacted in compliance with their permit. The pile appears to exhibit positive drainage and no impounded water or signs of erosion was noted. The clear water ditch running along the North side of the Refuse Pile was observed (Reach One). No coal waste or negative impacts to the ditch were noted. Discussions with Jordan McCourt indicate that the vegetation grubbing and prep work for the construction of the new clear water ditch has been completed and construction will begin in the next few weeks. No problems with the Refuse Pile or clear water ditch were noted at this time.

Photo Five: View east showing the refuse pile at King I. Waste was actively being placed and compacted during the inspection.

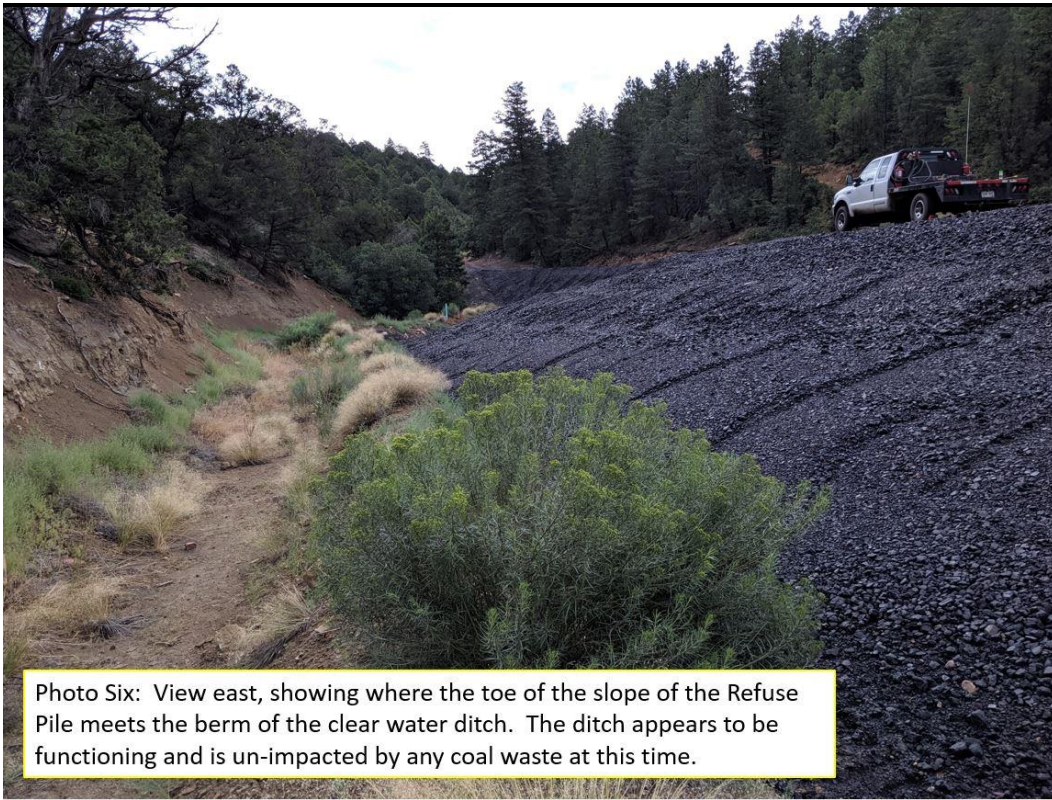
Photo Six: View east, showing where the toe of the slope of the Refuse Pile meets the berm of the clear water ditch. The ditch appears to be functioning and is un-impacted by any coal waste at this time.
