MINERALS PROGRAM INSPECTION REPORT
PHONE: (303) 866-3567

MINE NAME: Western Slope Flagstone Quarry No. 2	MINE/PROSPECTING ID#: M-1996-076	MINERAL: Gravel	COUNTY: Mesa
INSPECTION TYPE: Monitoring	INSPECTOR(S): Amy C. Yeldell, Lucas J. West, Travis H. Marshall	INSP. DATE: July 15, 2019 to July 23, 2019	INSP. TIME: Various
OPERATOR: Rudolph Fontanari	OPERATOR REPRESENTATIVE:	TYPE OF OPERATION: 112c - Construction Regular Operation	
REASON FOR INSPECTION: High Priority	BOND CALCULATION TYPE: None	BOND AMOUNT: \$88,251.00	
DATE OF COMPLAINT: NA	POST INSP. CONTACTS: None	JOINT INSP. AGENCY: None	
WEATHER: Clear	INSPECTOR'S SIGNATURE:

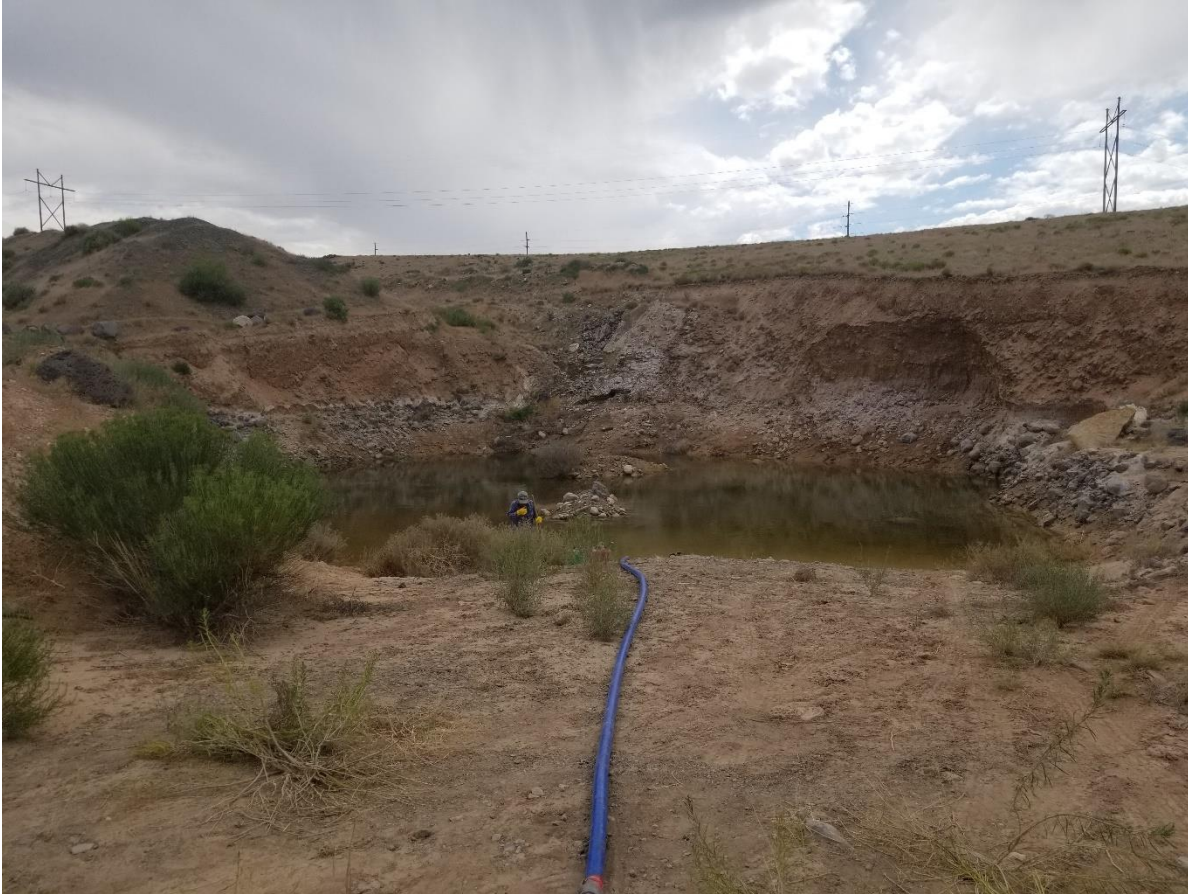
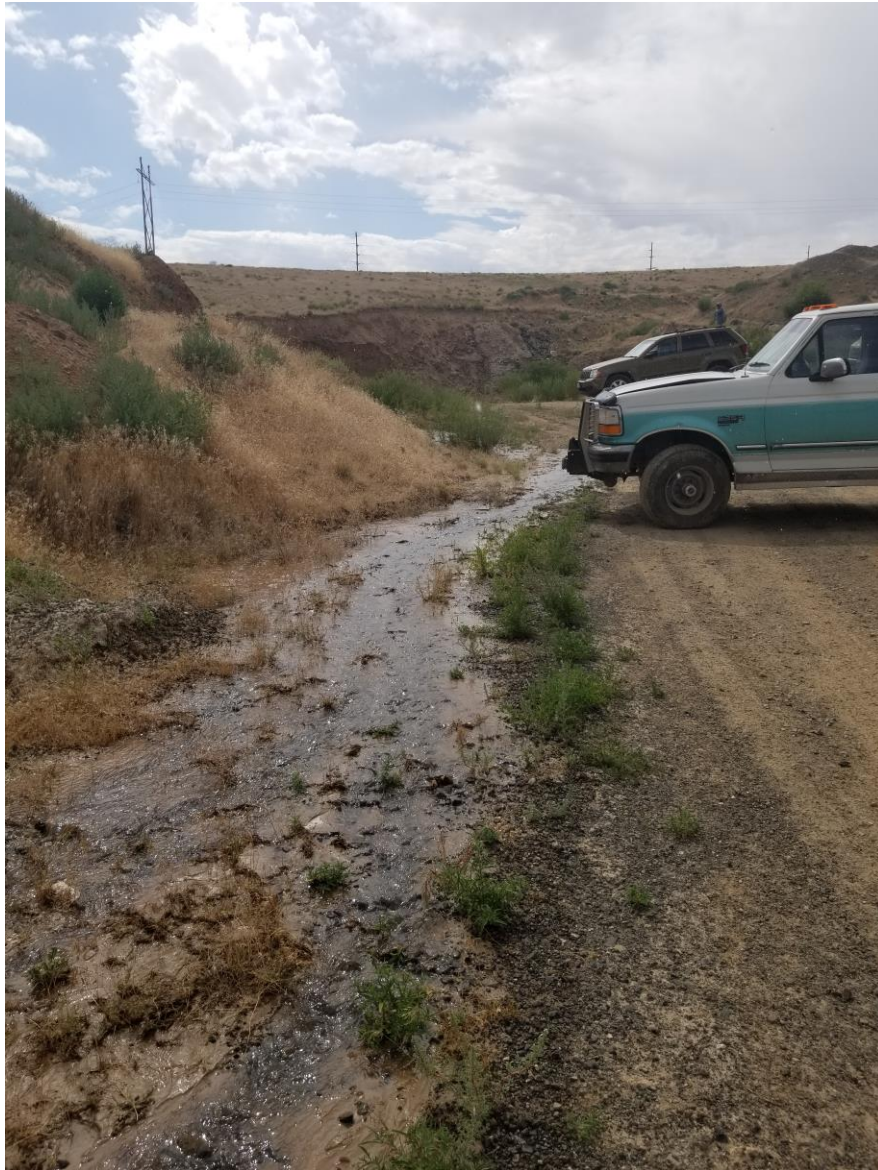
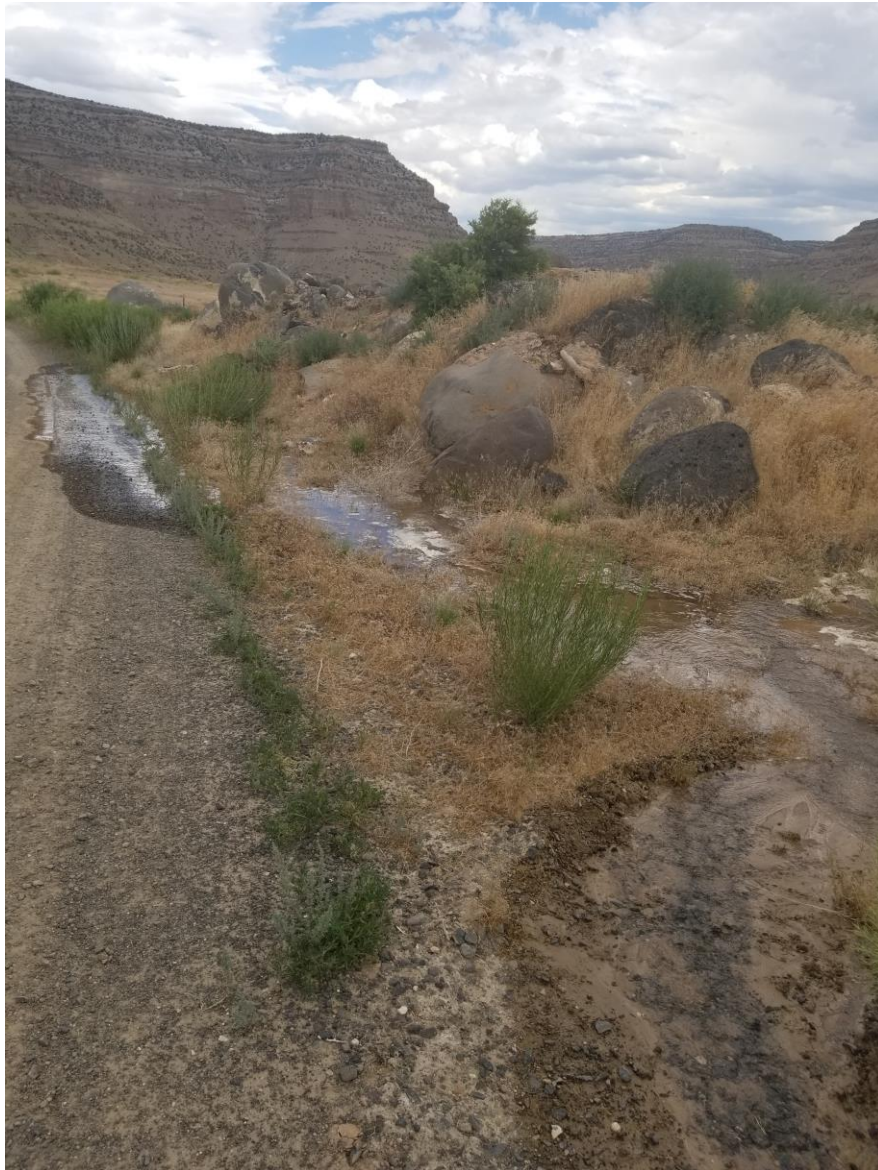
Mr. Fontanari stated that he began pumping down the west pit/pond that day at 11:45 am and that he would continue to pump until dark but that they may not pump the pit completely dry. Staff estimated that the west pit/pond had been dewatered approximately 7 ft. as compared to the 7-12-2019 inspection. It was estimated that approximately 10 ft. of water on average remained in the pit and perhaps up to 12 ft. in the deeper areas. Pumping of the west pit/pond has had no impact on water levels in the east pit/pond. The pump, dewatering the west pond, was discharging water into a rip-rap armored stormwater channel which ran down the north eastern hillside towards I-70 and outside of the permit boundary. Water then goes into a culvert under I-70 for discharge into the Colorado River. Water was discharged into a previously dry area that did not have additional rock fall impacts. Mr. Fontanari's truck was parked in a manner blocking accesses to the mine via the haul road, allowing access to the pit only from Rapid Creek Rd. All water risers were off and ditches appeared to be drying out. I-70 was open with one lane closed eastbound due to rock fall issues.

7-15-19 Pit being pumped out, water discharged into roadside ditch

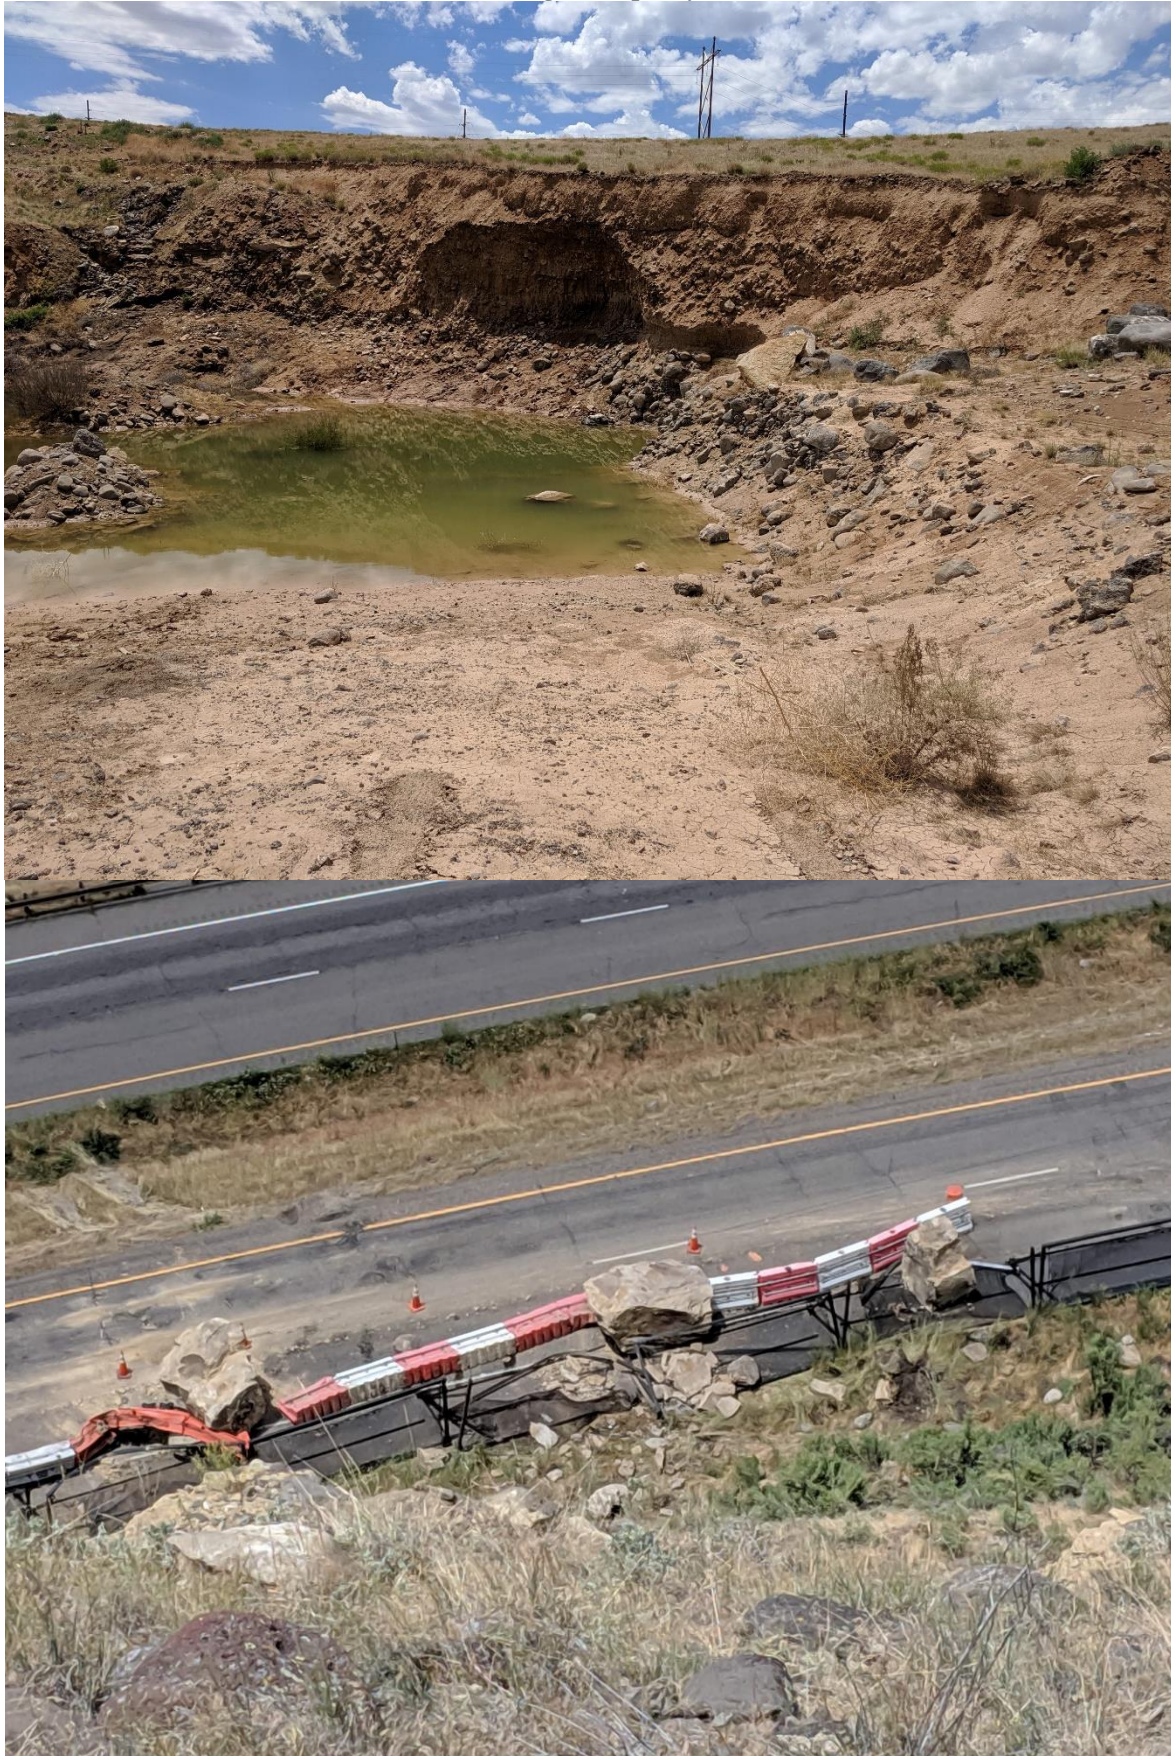
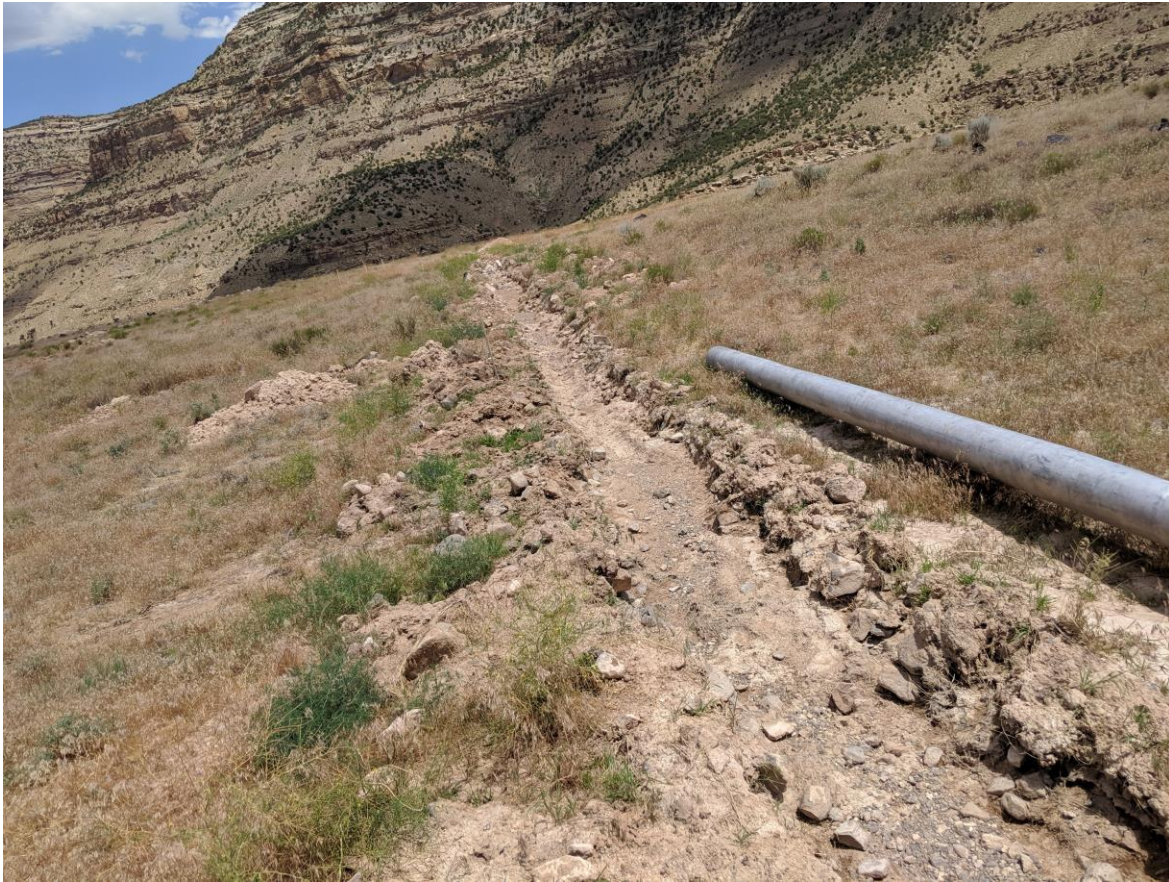
Approximately 4-5 feet of water still remains in the west pit. The water level is an average of 3-4 feet lower than observed on yesterday's inspection. The water level in the pit to the east of the road has not changed. The pump, and hoses have been removed from the west pit/pond, and the discharge point looked ok. Some minor sedimentation was observed. The flow path to the rip rap channel leading down the hill was also inspected.

A new major concern has arisen, as a result of today's inspection. While in the upper field, CDOT and their contractors were conducting active rock scaling, which was shutting down both directions of Interstate 70 in 30 min intervals. After discussions on site, CDOT showed me a series of new stress cracks trending from north northeast to south southwest. The cracks have originated within the last few days and measure from 1/4' wide to 1'. It appears that as a result of the water applied by Fontanari the area has been destabilized and may be at

risk for a potential rotational or other geotechnical failure as the dip and gradient of the area leans to the north toward I-70 and the Colorado River.

7-16-19 Pit water level continuing to drop, dry ditches, rock fall onto I-70

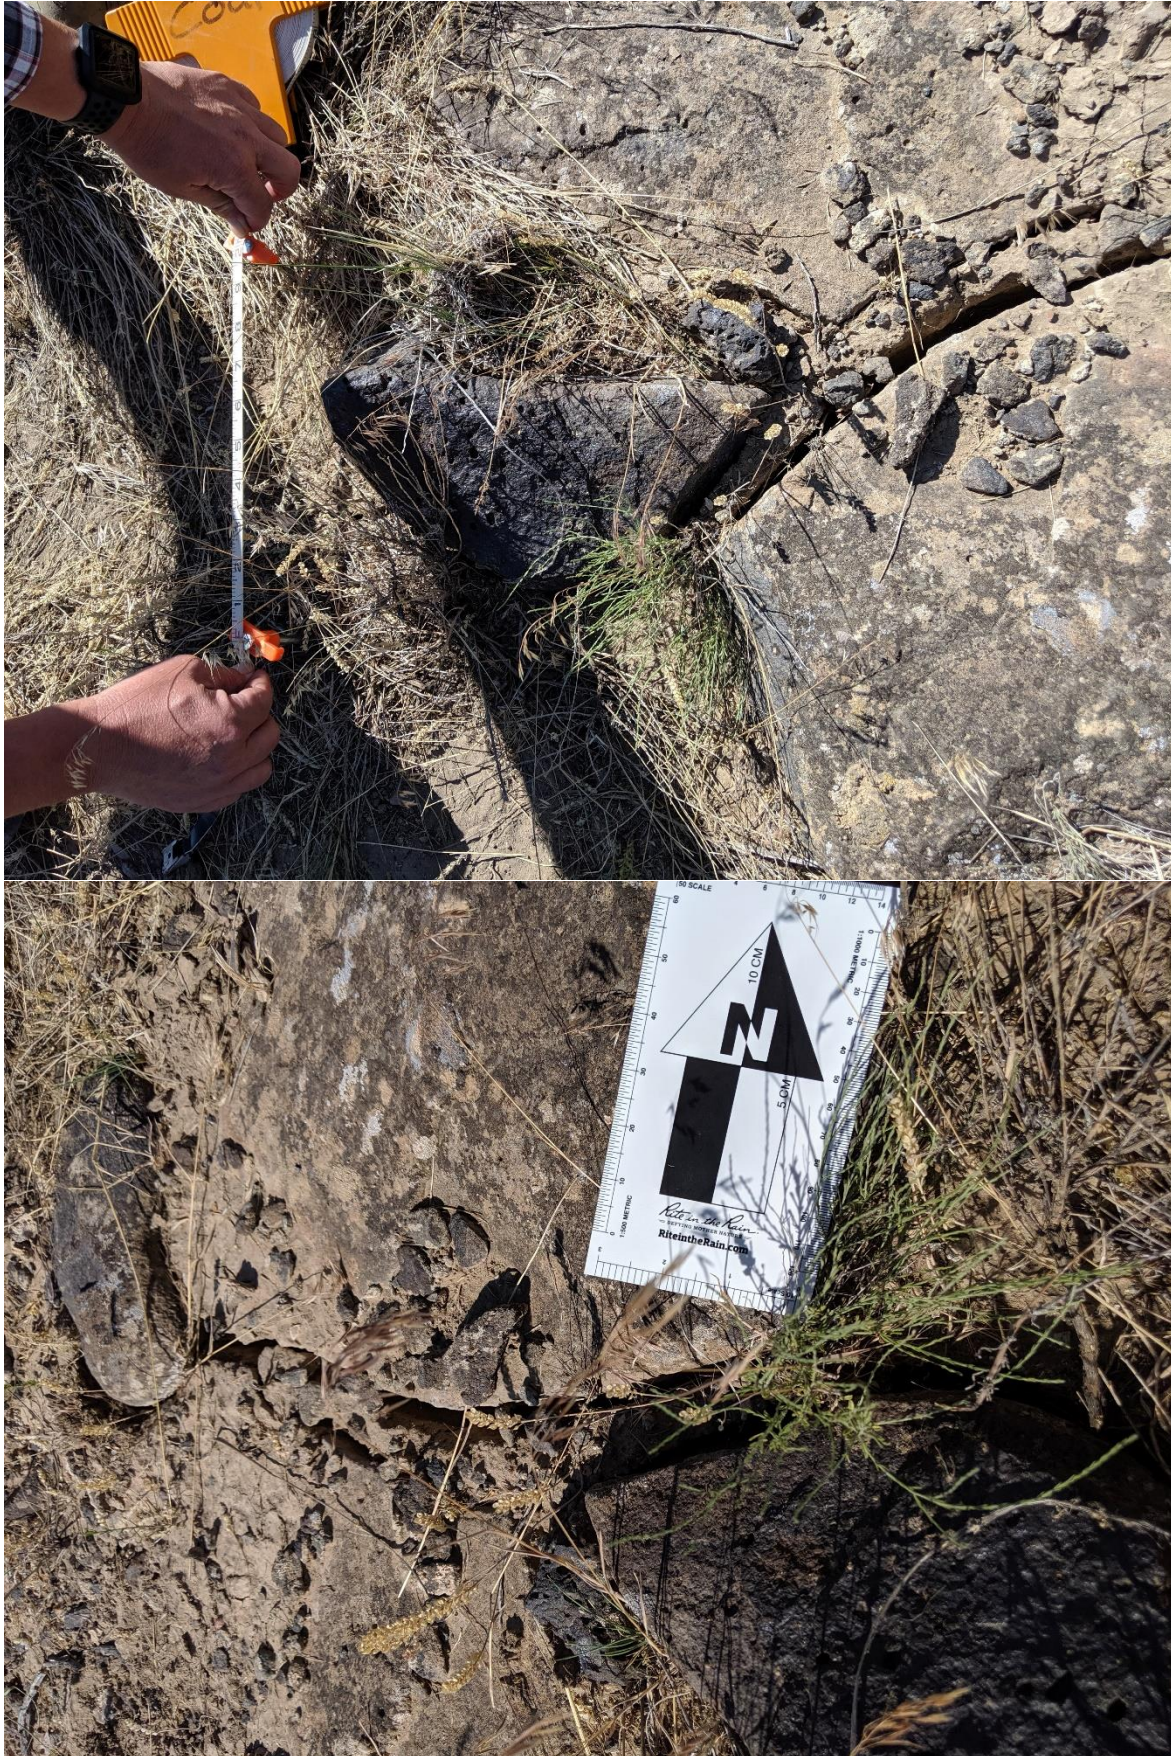
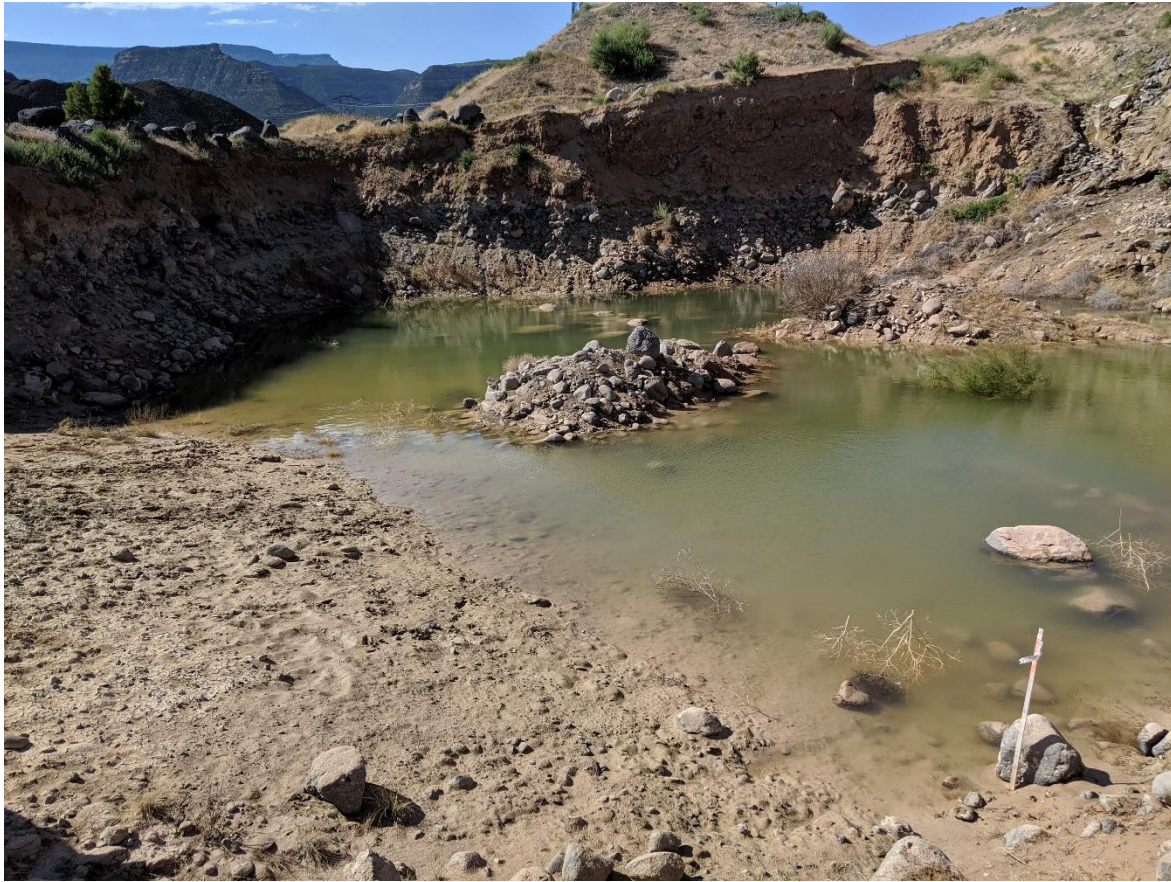
The stress cracks on the northern portion were more thoroughly observed. A GPS track of the crack path was taken. DRMS established a monitoring point that consists of two stakes driven on either side of the crack, at a known distance of 12 inches apart. That way during the follow up inspections DRMS can monitor to see if there is any significant movement. The location of the stakes were marked with a survey lathe and orange survey tape. The cracks were more extensive then observed yesterday. I-70 East Bound remains shut down to one lane.

7-17-19 Documentation of crack and stakes, pond dewatering process.

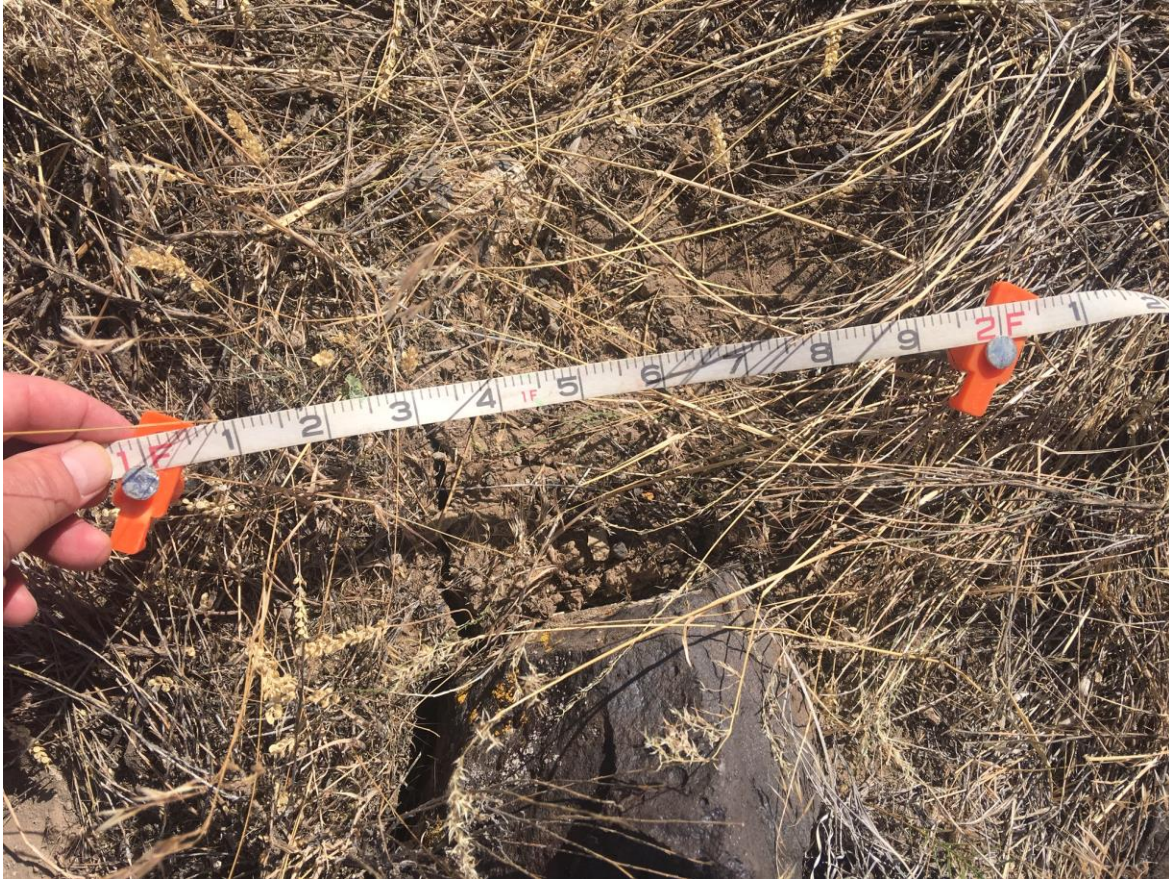
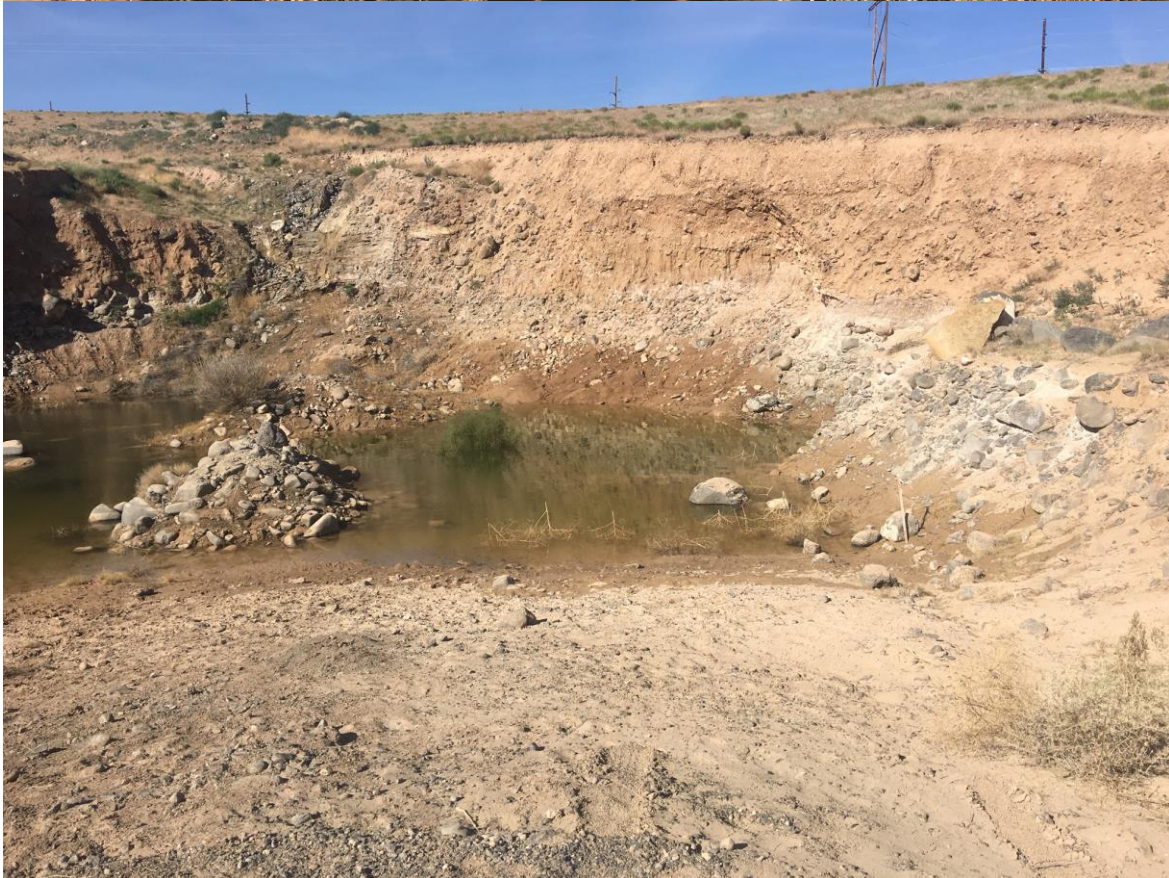
No mining related activity was observed at the site. No water was flowing at the site and the trenches were dry. The pond was down another 1.5 feet. The crack did not appear to increase. CDOT had their drone out at the site assessing the area. I informed John David with CDOT yesterday afternoon about the crack that developed above I-70 and he was going to send his geologist up top to assess and characterize the potential safety hazard. LJW drove through this morning and said CDOT still had a large presence on the interstate and that the eastbound traffic is still restricted to one lane.

7-18-19 Measurements of crack and pit/pond

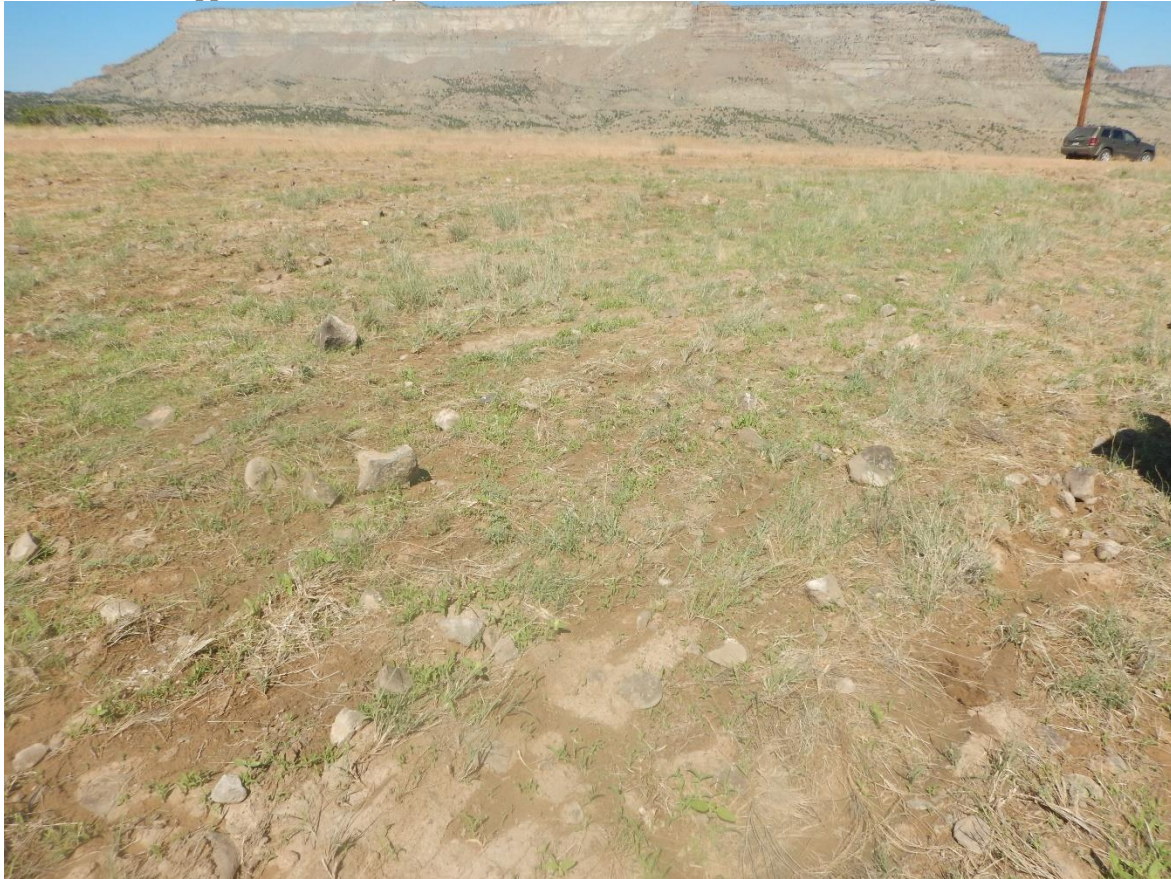
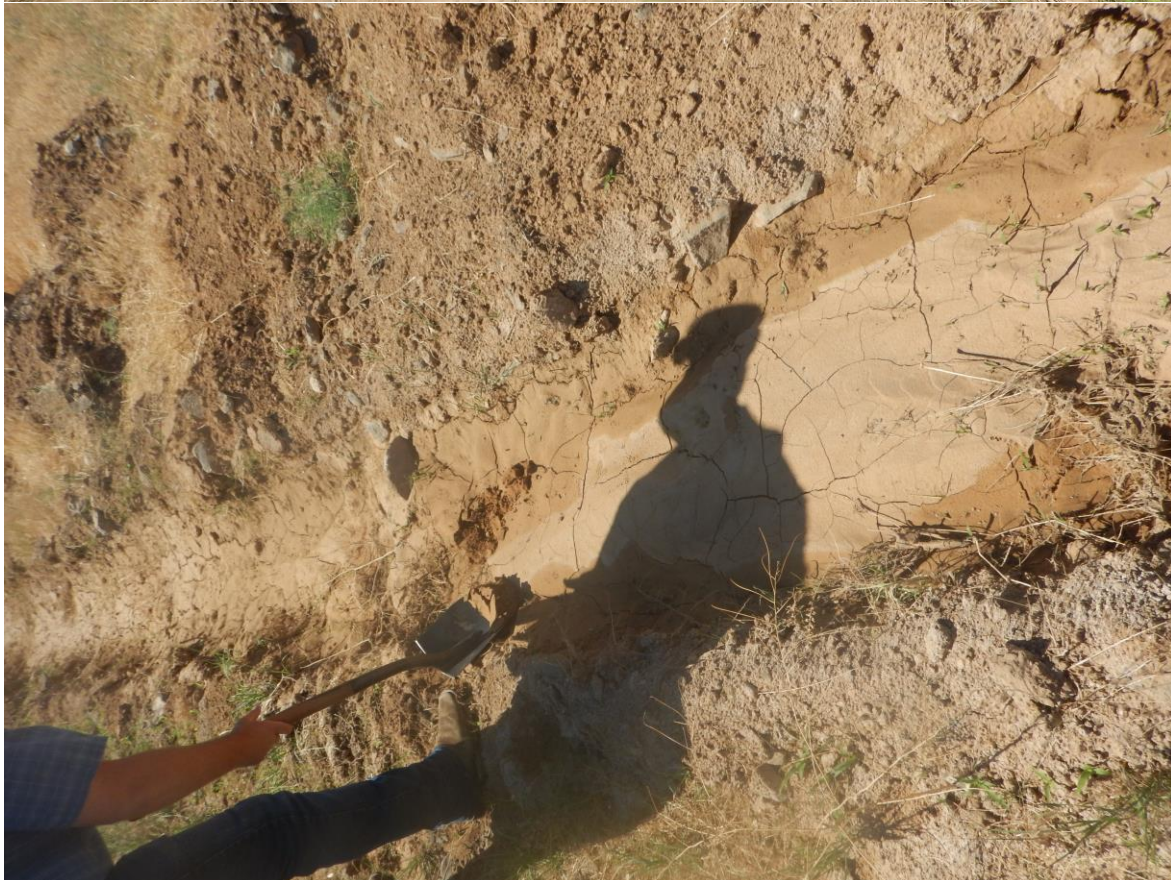
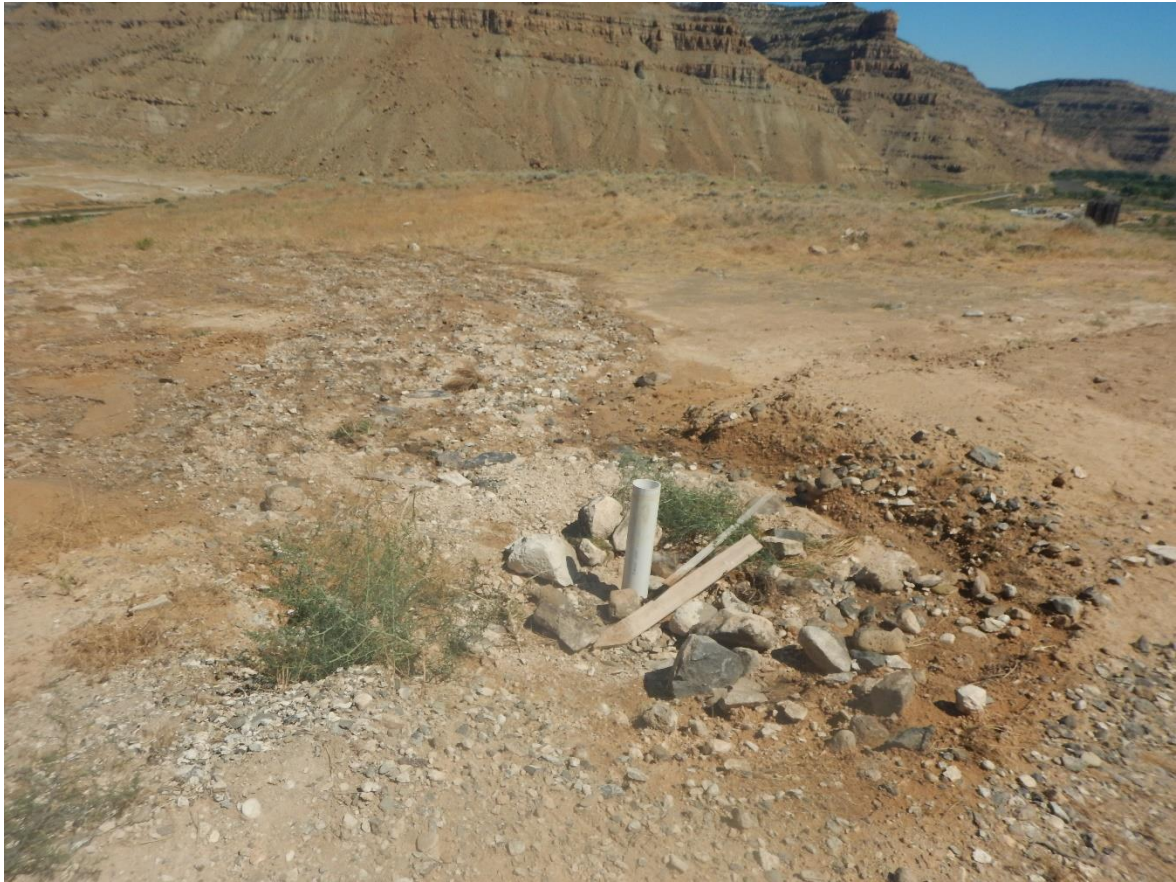
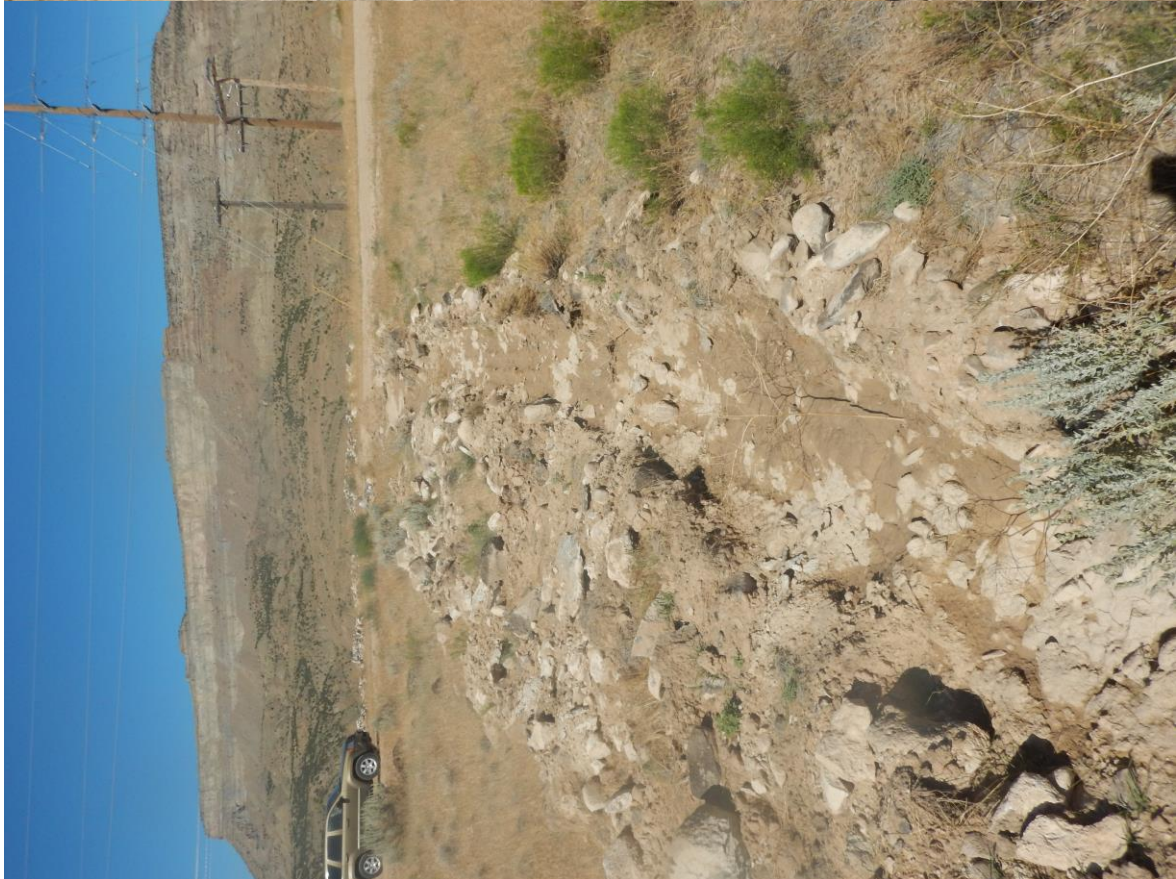
There was evidence of recent water in several of the ditches inside and outside of the permit area. Near the risers the soil was still moist at or near the surface level despite 90F temperatures. The southernmost ditch flowed enough to overflow the ditch the entire length and flooded the field to the north up to the next ditch. Other ditches in the middle of the line were completely dry. This weekend the site received some rain fall that resulted in rain splattered soils that were crusted. Note that according to the USGS Cameo Colorado River station there was no measureable rainfall over the previous weekend. There was a distinct difference between the soils that had been completely dried and those within the ditch that had no patter marks and were still saturated.

The last riser was not present and only an open pipe with static water remained. The area to the north and northwest of this riser was saturated and had evidence of erosion. The water did not completely infiltrate into the soil, rather the water flowed on the surface and went off the edge towards I-70.

7-22-19 Upper field recently flooded, ditch soils still wet, erosion on missing riser head #1

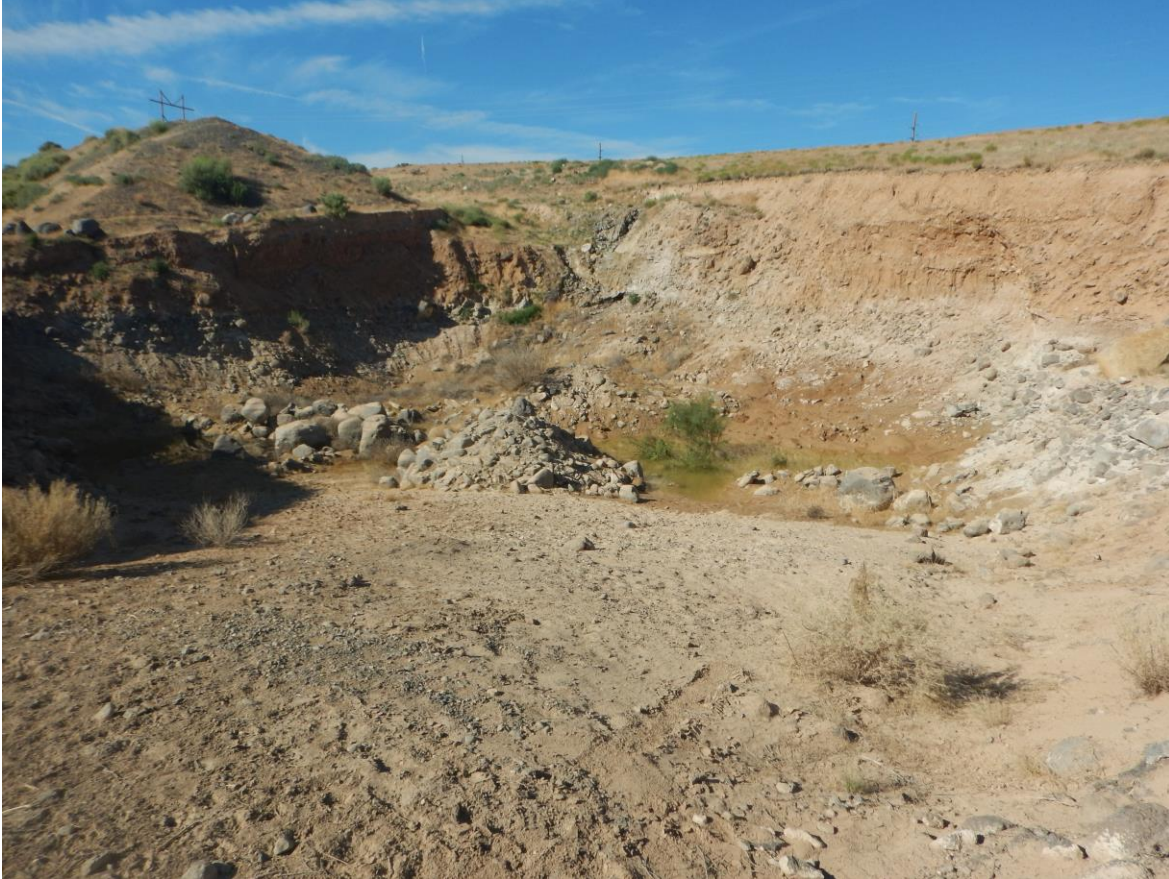
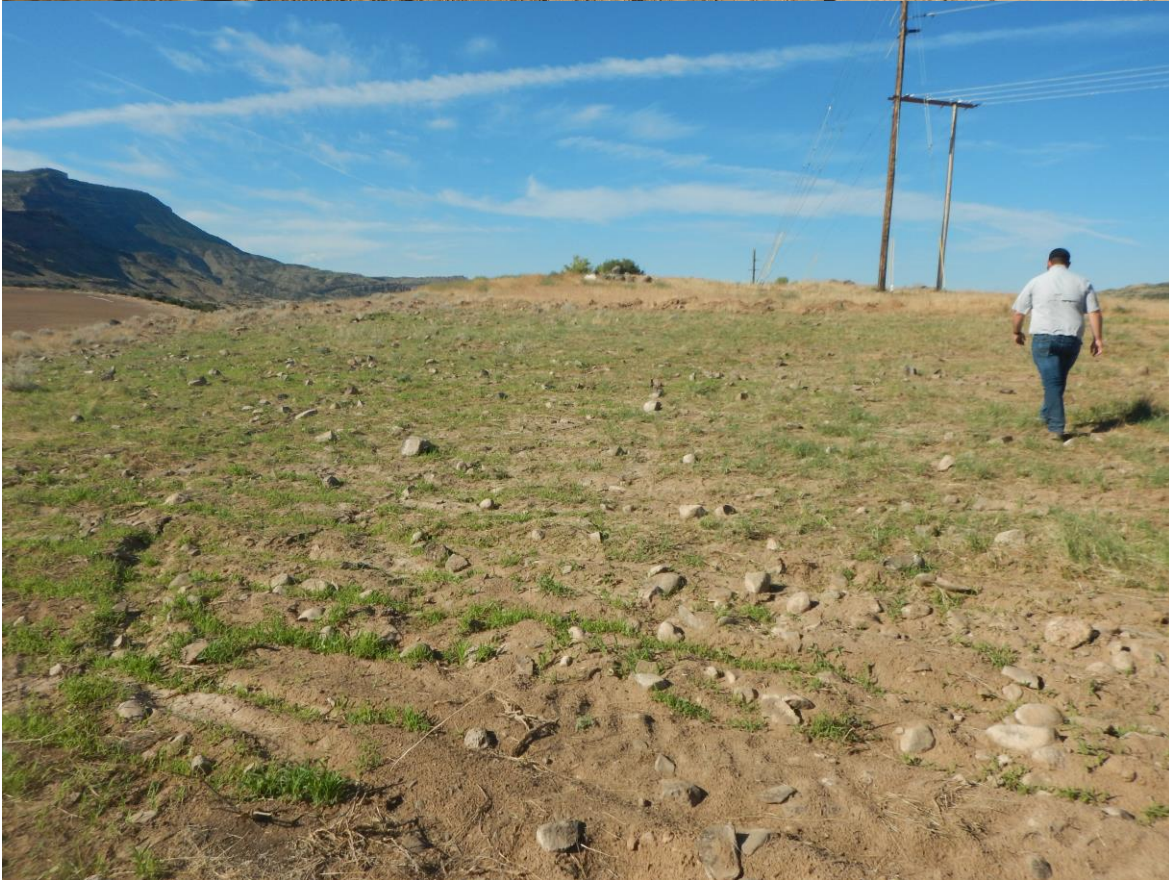
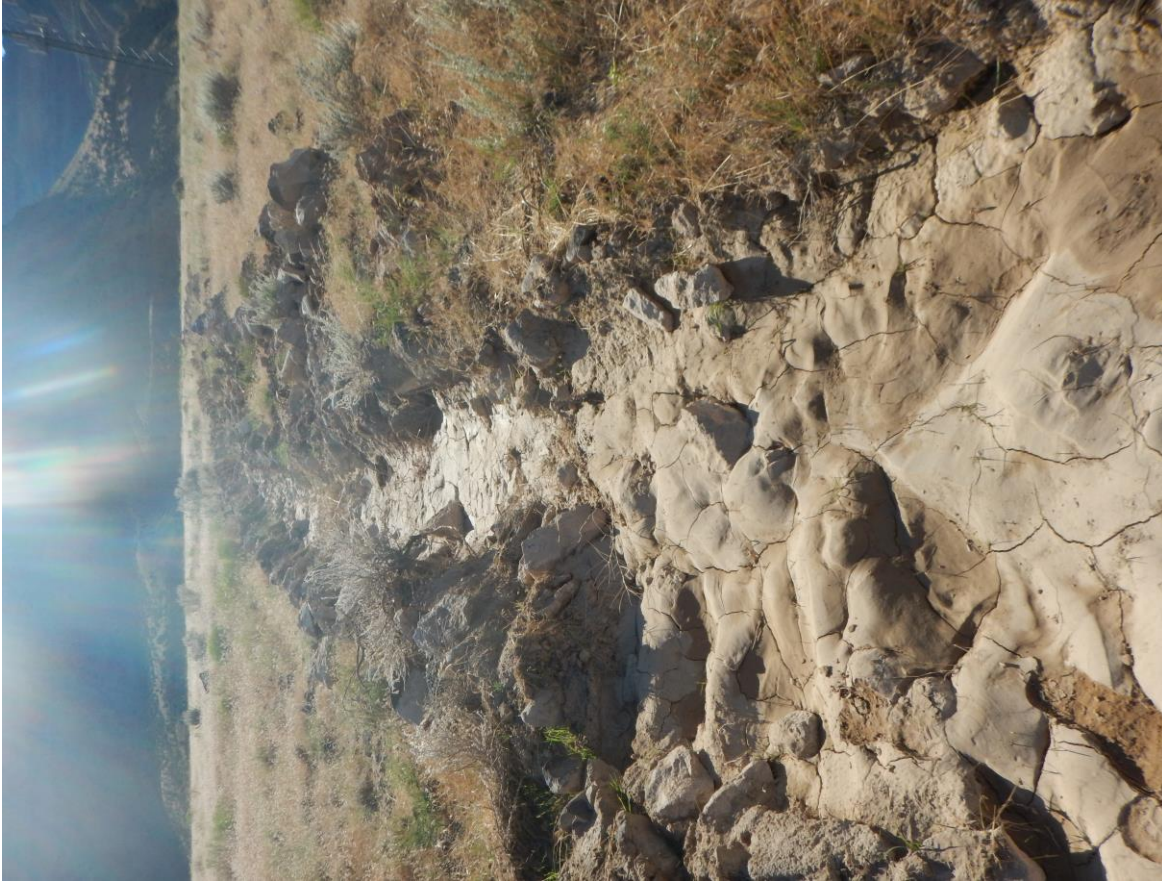
Mr. Fontanari has replaced the removed riser #1 as he indicated yesterday so that the pipe was no longer open. He also installed a riser head #2 on the pipe that was previously capped. In the area adjacent to riser #1 where the water drained and flowed NW off the side of the hill was still very wet. DRMS anticipated the soils to be much drier as it was 103F yesterday and today's is breezy and 88F. It's unclear if additional water was discharged. The other ditches are in the process of drying out, there is no evidence of additional water being discharged recently. The soils were moist and patchy, likely by tomorrow the surface will be completely dry and only damp several inches below the surface. The upper/southern ditches where water recently flowed were much drier. Soils in the field were completely dried out. The northwest pit/pond is continuing to drop. DRMS estimated the water is down approximately 3 ft. today in the western pit/pond as compared to yesterday's inspection. The stake was moved to the current water level to measure the progress tomorrow.

7-23-19 Pit/pond significantly dewatered, field beginning to dry, ditches with some wetness
