MINERALS PROGRAM INSPECTION REPORT

MINE NAME: Von Doose Mine	MINE/PROSPECTING ID#: M-2019-031	MINERAL: Silver	COUNTY: Ouray
INSPECTION TYPE: Preoperation Inspection	INSPECTOR(S): Lucas J. West	INSP. DATE: August 1, 2019	INSP. TIME: 10:00
OPERATOR: Atlas Mining & Reclamation, LLC	OPERATOR REPRESENTATIVE: Eli Doose, Mike Thompson	TYPE OF OPERATION: 110(1) - Hard Rock Limited Impact	
REASON FOR INSPECTION: Preoperation Inspection	BOND CALCULATION TYPE: None	BOND AMOUNT: No Bond Held	
DATE OF COMPLAINT: NA	POST INSP. CONTACTS: None	JOINT INSP. AGENCY: None	
WEATHER: Cloudy	INSPECTOR'S SIGNATURE:

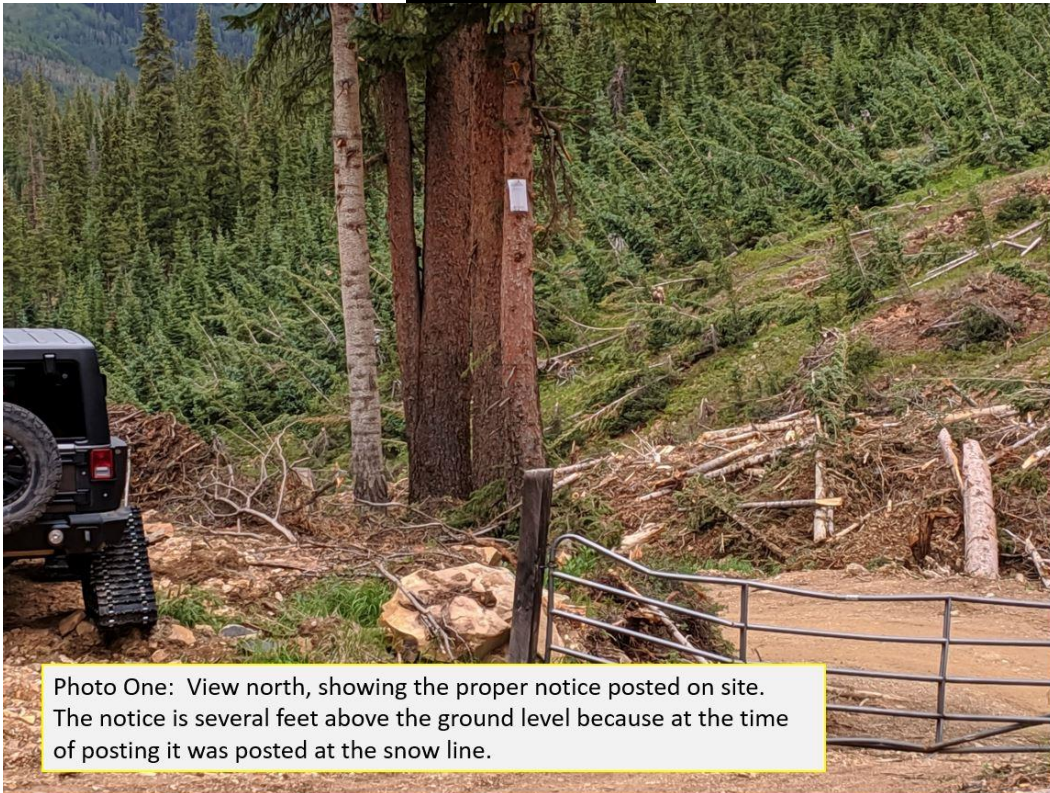
The Proper notice marker as required by Rule 1.6.2(1)(b) was observed and can be seen in Photo One. The notice was posted several feet above ground level because at the time of posting that was the snow line. The gate where the access road meets Ouray County Road 20 was secured. On site discussions focused mainly on the Lower Affected Area as the Applicant has expressed they may remove the proposed Upper Affected Area from the application completely. The area of the laydown yard was observed and can be seen in Photos Two and Three. The area is well vegetated and was stable at the time of the inspection. Discussions detailed the amount of earthwork and grading that would need to be conducted and that all final slopes steeper than a 2H: 1V would require a factor of safety calculation. The access road leading from the proposed laydown yard to the portal area was stable and in good condition. The road would be reworked as part of the mining operation and can be seen in Photo Four. The area where the portal and waste rock are to be constructed were stable at the time of the inspection. The portal area can be seen in Photo Five.

Photo One: View north, showing the proper notice posted on site. The notice is several feet above the ground level because at the time of posting it was posted at the snow line.

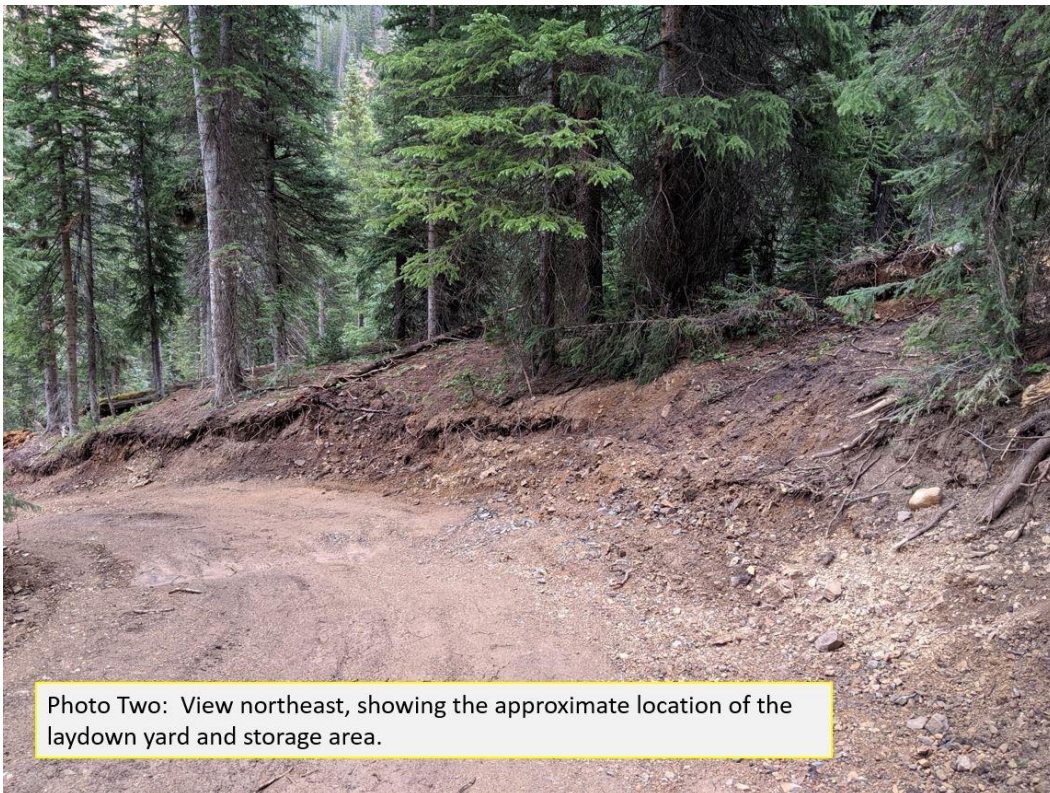
Photo Two: View northeast, showing the approximate location of the laydown yard and storage area.
