MINERALS PROGRAM INSPECTION REPORT
PHONE: (303) 866-3567

| MINE NAME: Western Slope Flagstone Quarry No. 2 | MINE/PROSPECTING ID#: M-1996-076 | MINERAL: Gravel | COUNTY: Mesa |
| INSPECTION TYPE: Monitoring | INSPECTOR(S): Amy C. Yeldell (ACY), Lucas J. West (LJW), G. Russ Means (GRM) | INSP. DATE: July 24, 2019 to August 5, 2019 | INSP. TIME: Various |

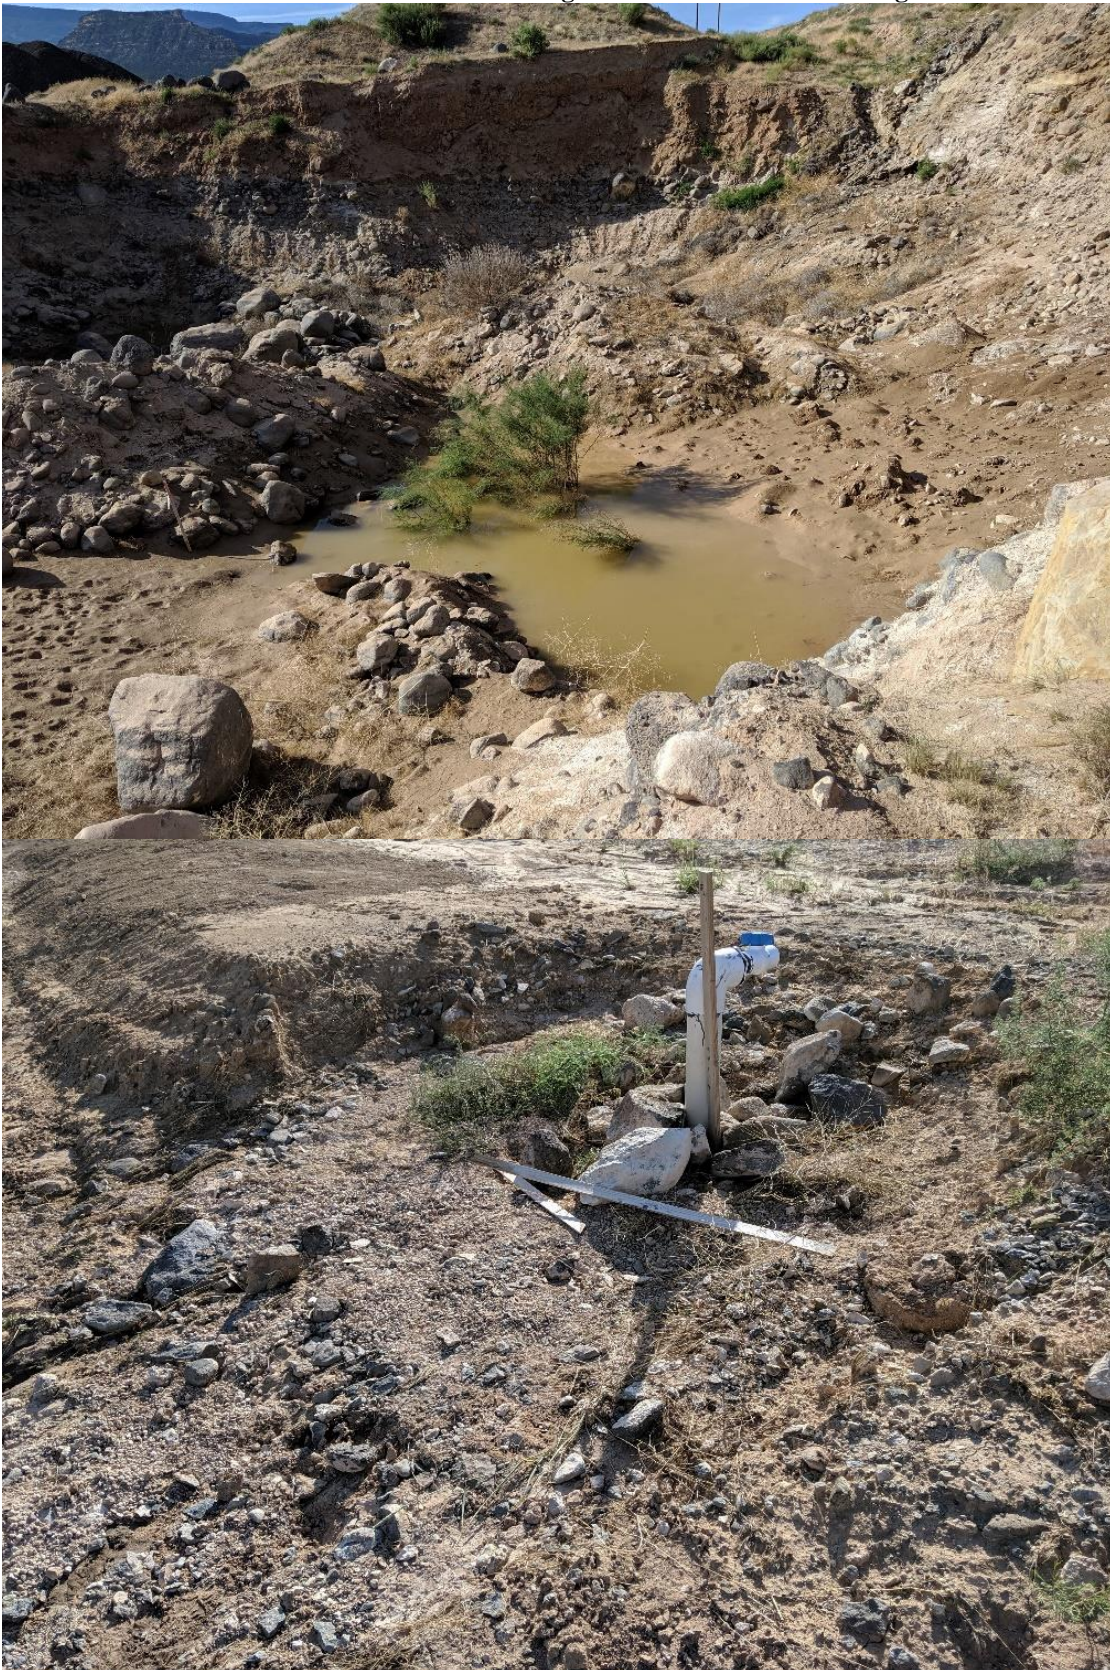
July 24, 2019

This was an additional monitoring inspection conducted by Lucas West of the Division. No Operator representative was present during the inspection. The condition of the site remains unchanged from the previous inspection. All risers and land application ditches were dry and no evidence of new water application was observed. The flow marks surrounding the Number One riser remain unchanged. The water level in the west pond/pit continues to recede. The water level has dropped another two feet since the previous inspection. No new problems were noted during this inspection.

West Pit Pond with minor amounts of water remaining and flow marks surrounding the Number One Riser

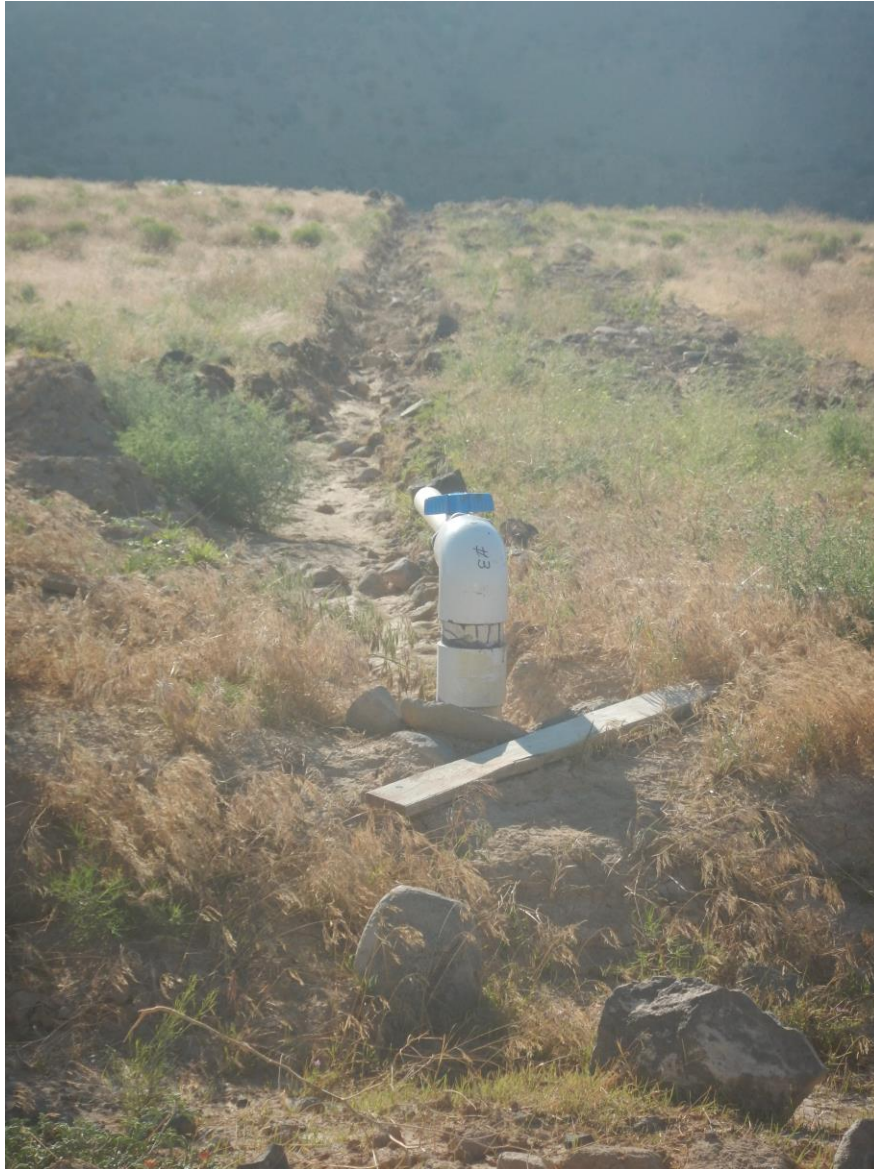
July 29, 2019

The Cease and Desist sign was still present on the mine sign posted at the haul road entrance. The west pond/pit remains dewatered. Soils in the pit/pond appear to remain saturated (darkened) however no seepage was observed on the rock portions of the highwall. CDOT conducted additional rock fall mitigation/blasting of the hillside above I-70 on 7-25-19 (previous Thursday). The Division did not observe any additional cracking or other surface disturbance impacts. The area surrounding riser #1 (which recently leaked) was completely dry. All other risers and ditches appeared to be off and dry. Recent rain over the weekend throughout the Grand Valley has left the soils rain spattered but crusted.

Pit dry with darkened soils, no seepage, Risers off and ditches dry

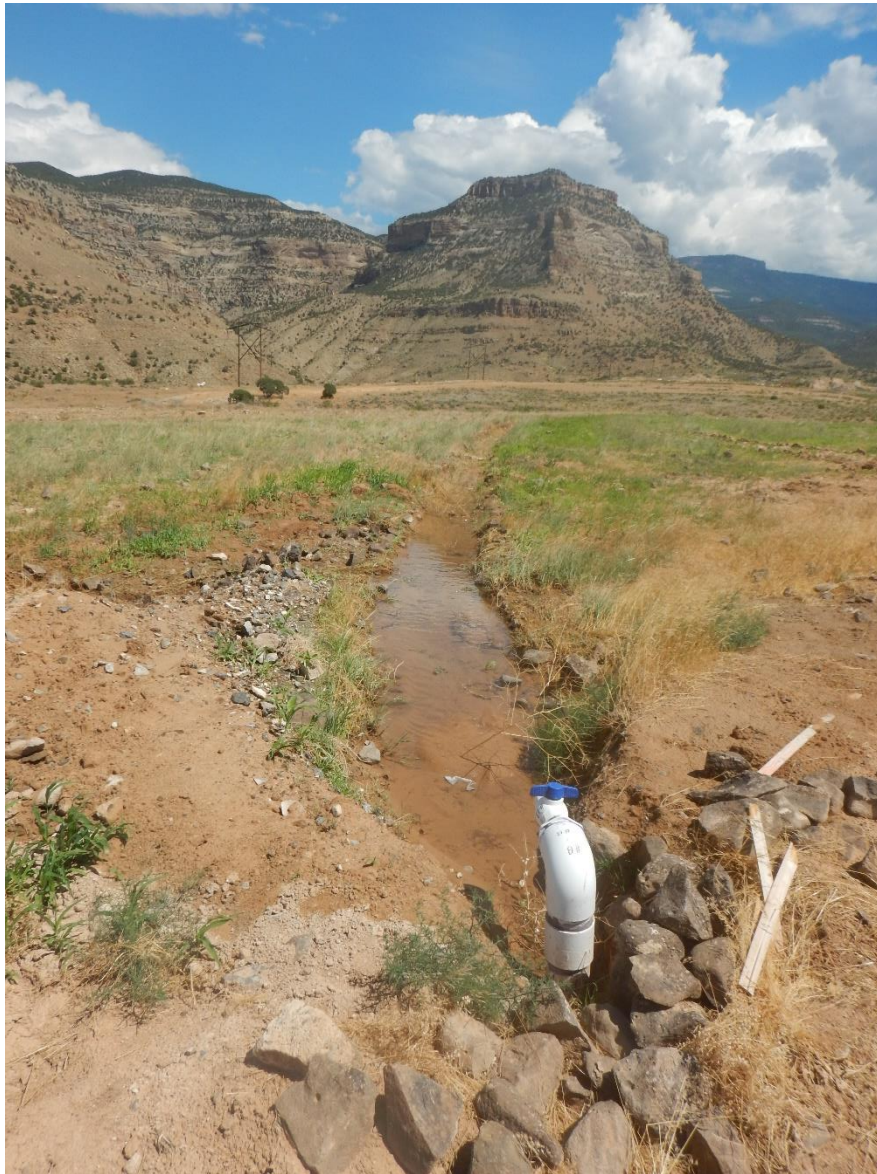
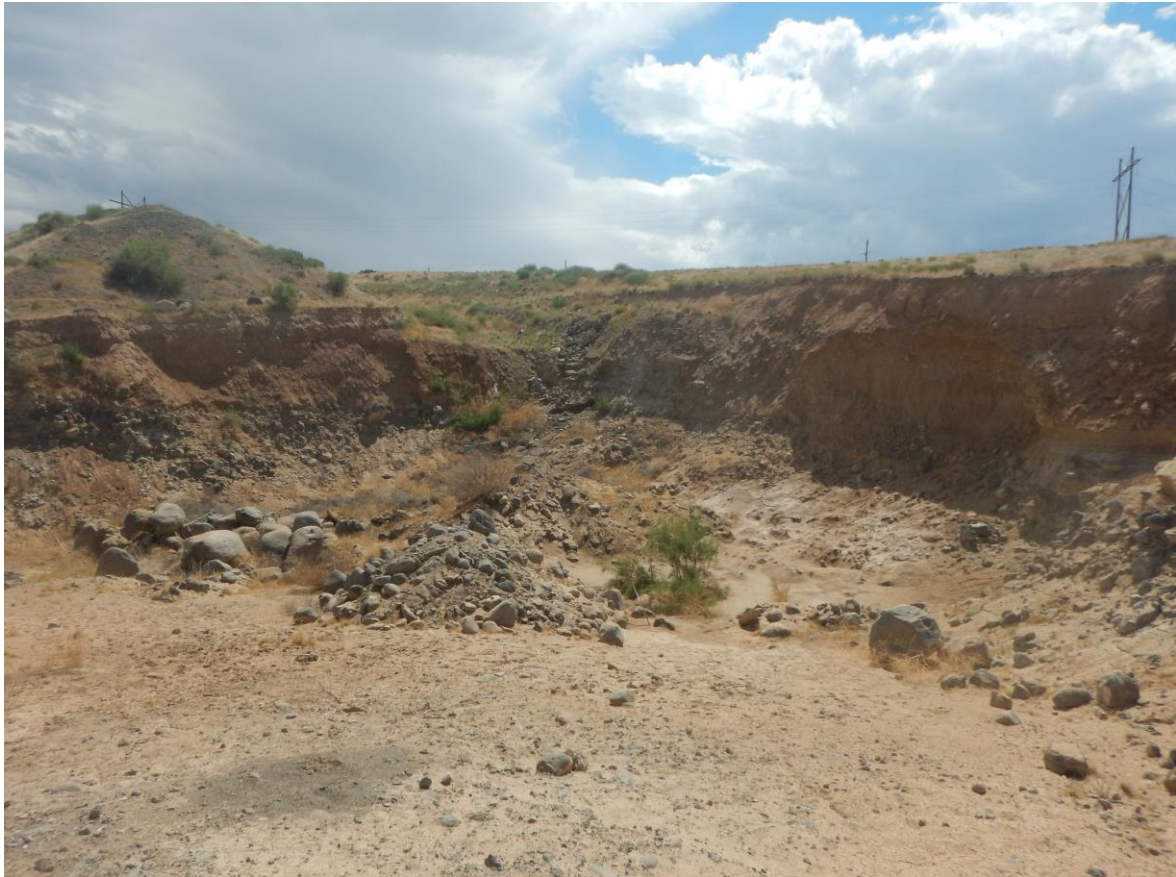
This was an additional monitoring inspection as well as a site debrief for GRM who was in town. The upper ditches (#12-14) were recently watered. Some of the ditches still had standing water present. A crop has begun to germinate, these areas are believed to be outside of the permit boundary. The lower ditches (#1-11) were all dry. The water line remains pressurized. Several of the sink holes previously observed have since been filled in. The both pits/ponds remain dry.

July 31, 2019
Standing water in #13, dry pit

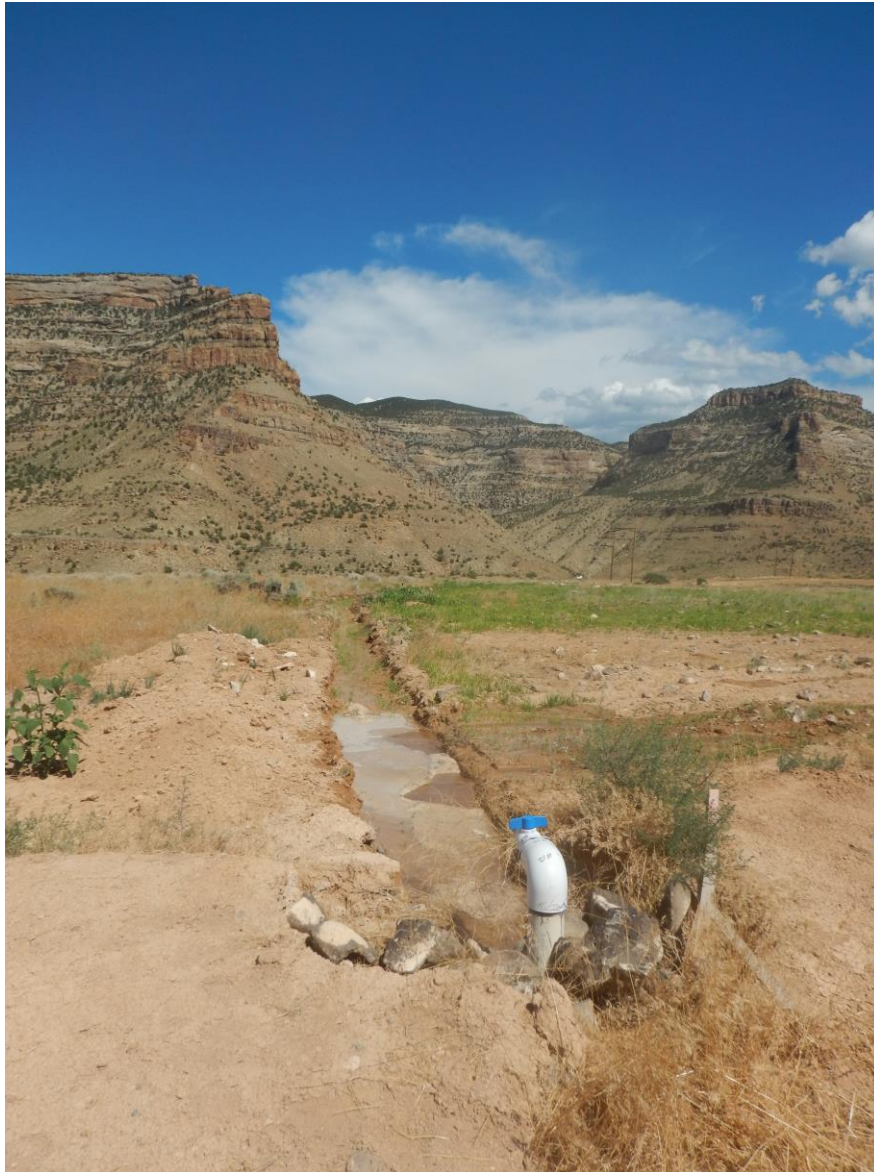
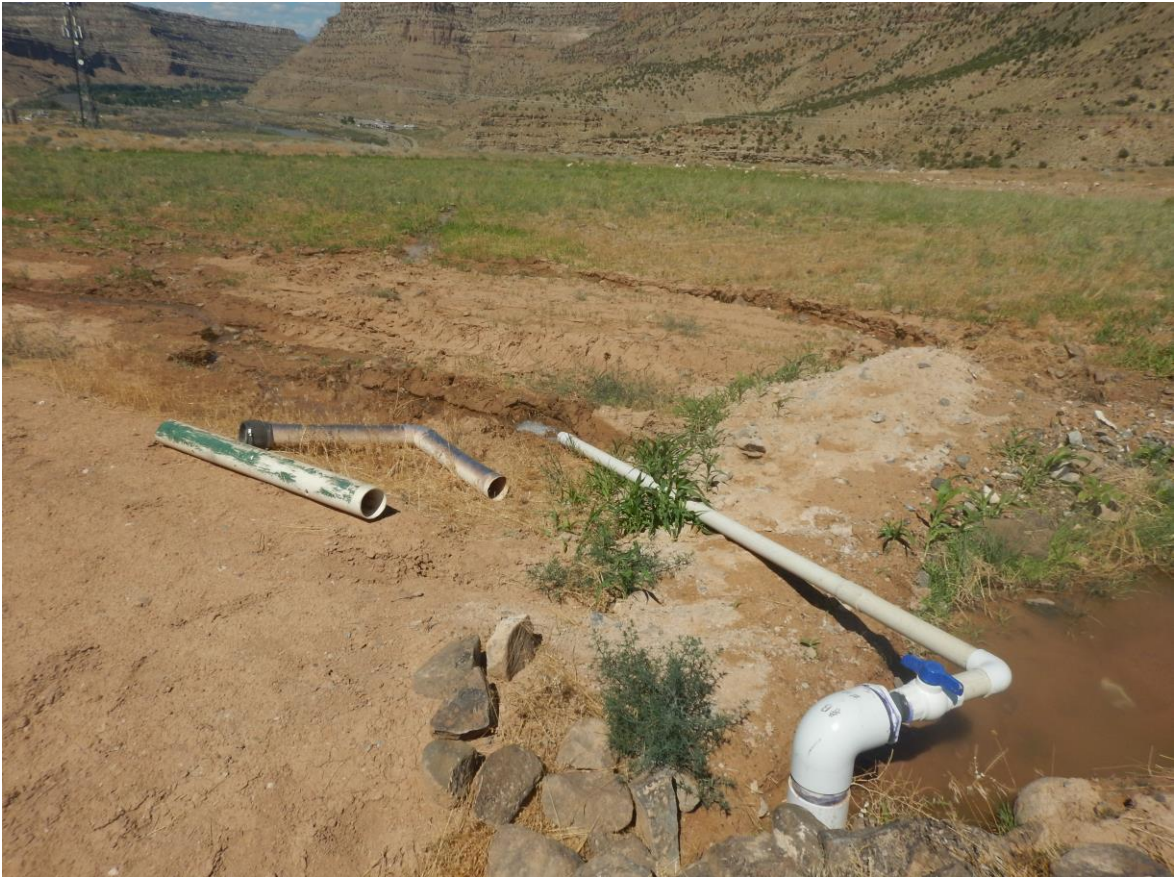
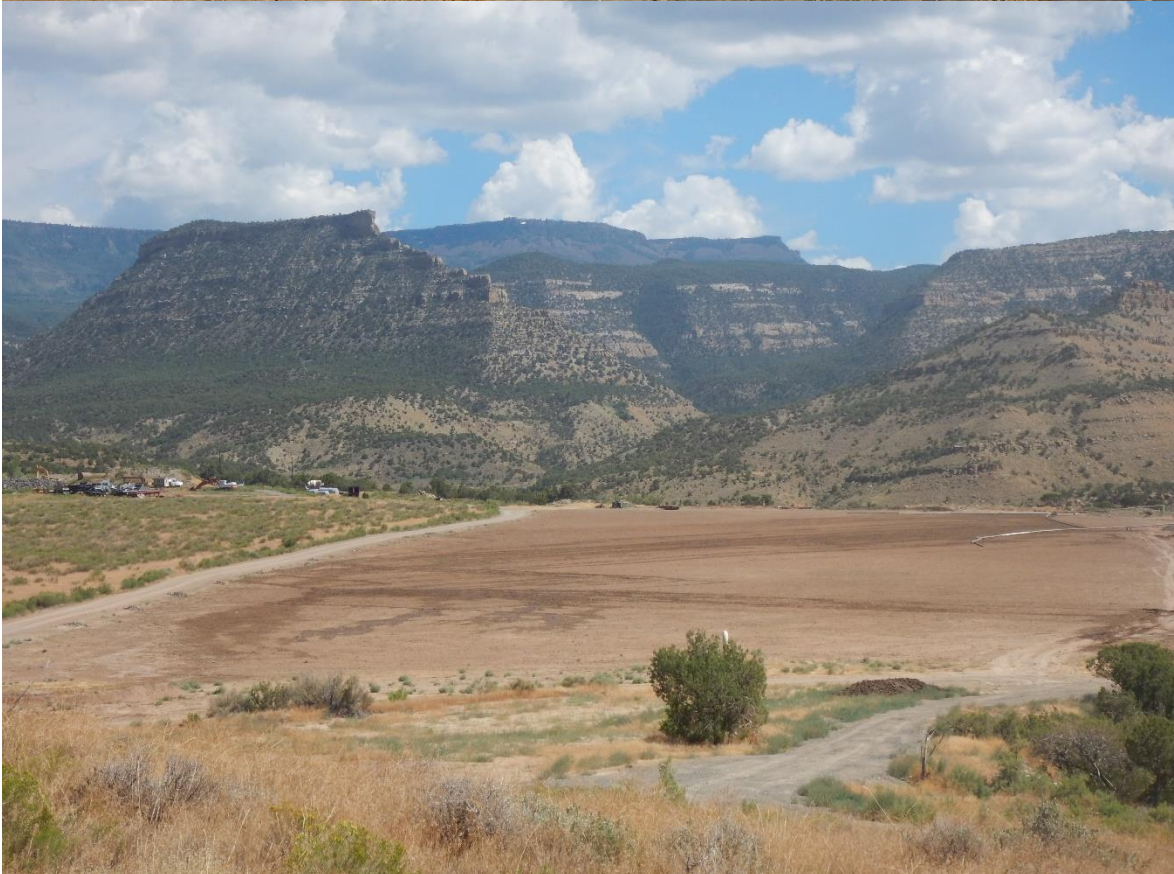
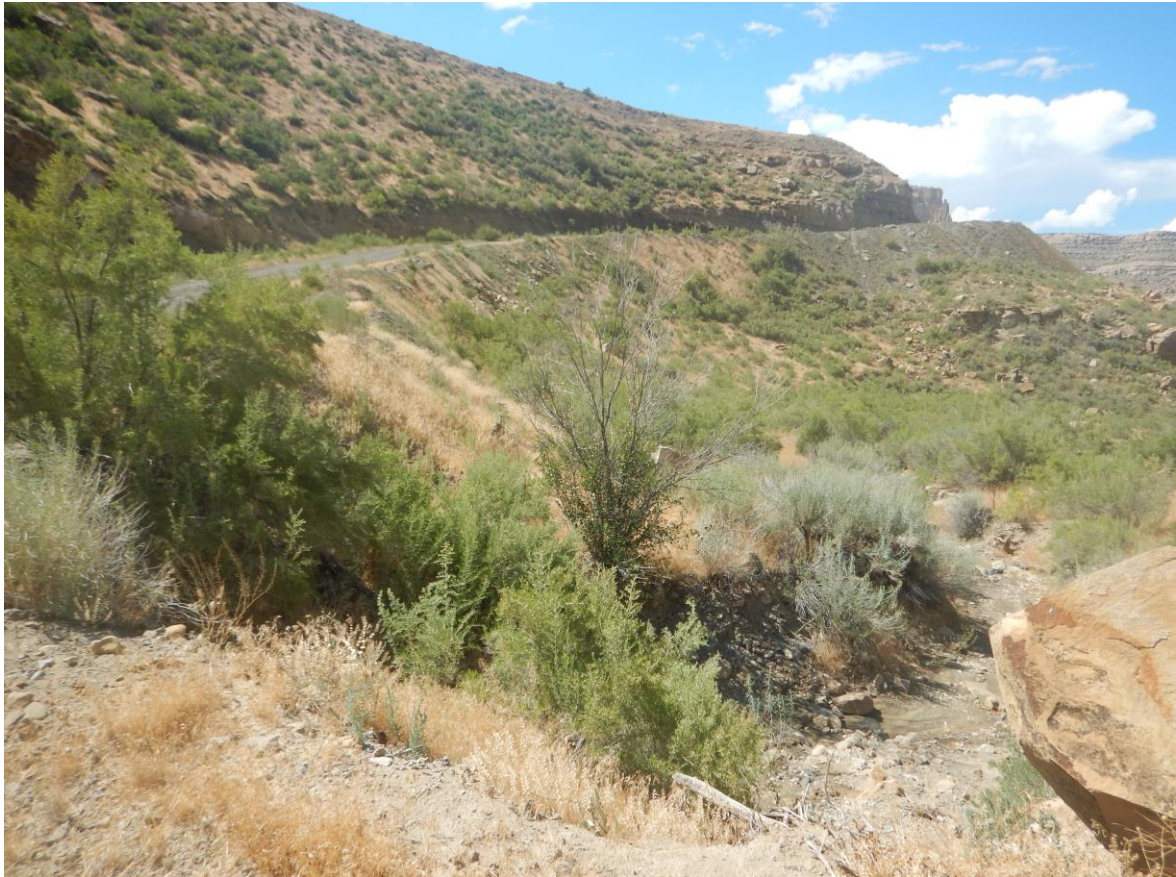
August 2, 2019

Riser/ditches #1-11 were all off and dry. Riser #12 was off, the ditch itself was wet from receiving water from the up gradient ditches. Excessive run-off was contained within ditch #12 and did not continue to flow further north (downhill). Risers #13 and #14 were both on and directing water via an elbow (90°) to the north outside of the excavated ditch channel. Ditch #13 was saturated from receiving water from riser #14. Ditch #14 was only wet for the first 20 feet or so, all water exited the ditch and flowed north. Both pits/ponds remain dry.

The field within the Middle Mine Area (Phases 15 & 16) is continuing to be cultivated. Rocks have been removed and the field has been cross ripped. Water was being applied from risers located outside of the permit boundary on the western side. The water was observed flowing through the ripper channels into the mine permit area.

Previously in the AM Tonya Hammond (Snowcap) called the Division to inform us that there was new run-off from an area within the mine permit boundary. The Division was unable to locate where on-top of the mesa the water was coming from. While leaving the site via the haul road, the first culvert at the bottom of the ephemeral drainage (within mine permit boundary) was saturated indicating recent water. Mrs. Hammond had indicated on the phone that during her morning inspection water was flowing through this culvert. By the next culvert (700 LF downstream) water had completely infiltrated and the drainage was dry.

#12 receiving water up gradient, #13 with elbow directing water down gradient, Middle Mine Area field with water being applied, bottom haul road culvert wet

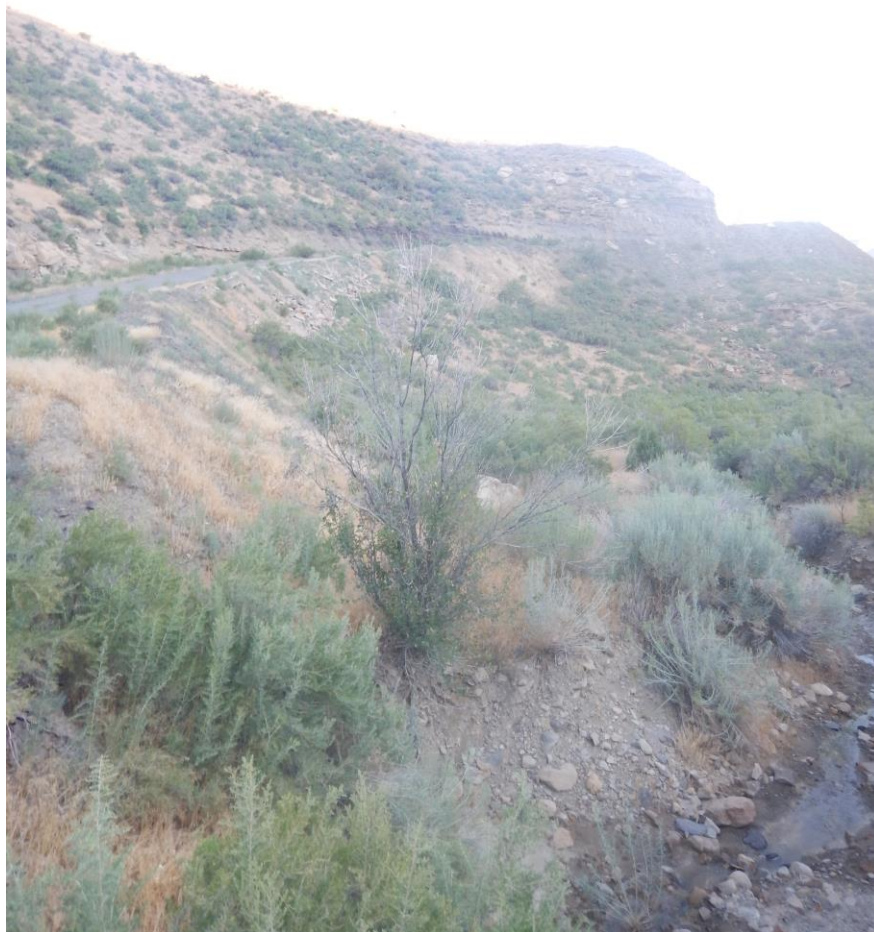
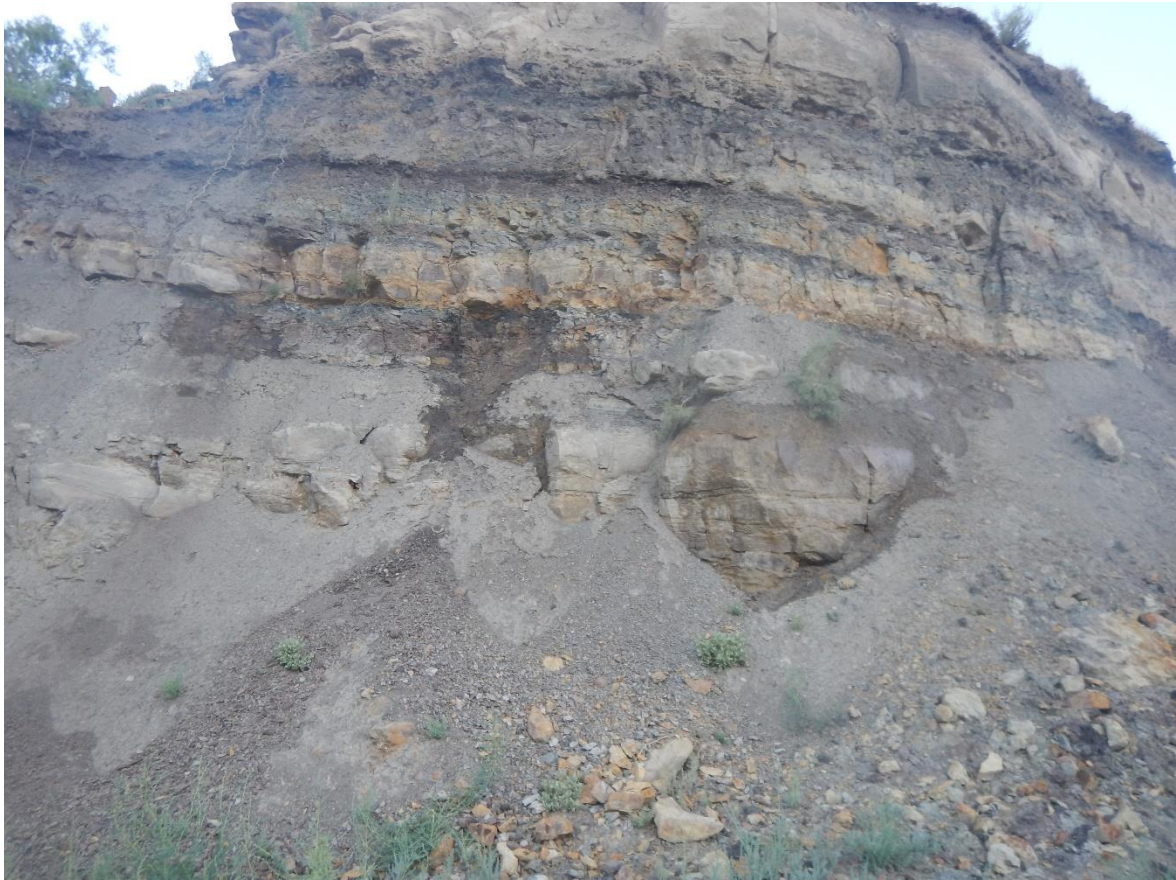
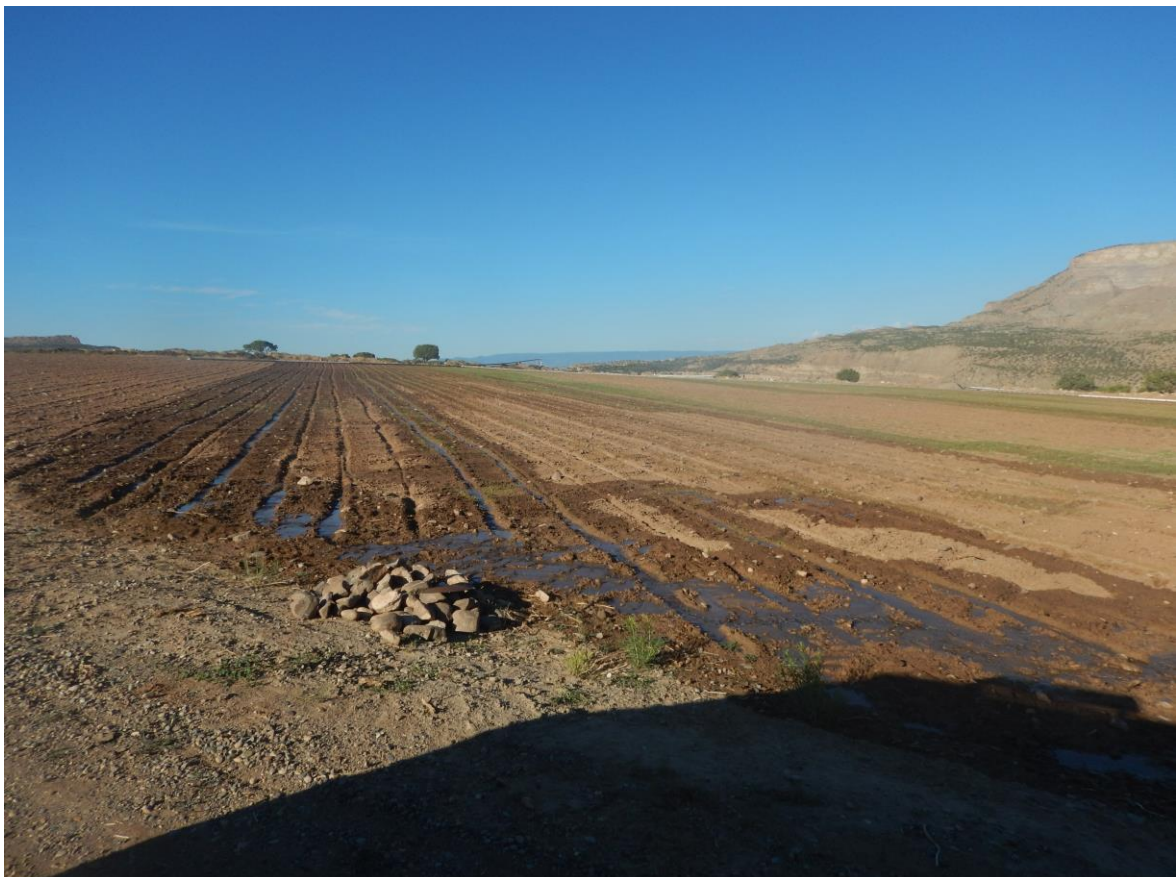
August 5, 2019

The Division accessed the site via the haul road. The upper most culvert had water flowing through it. Like the day before water infiltrated within the ephemeral drainage before it reached the second culvert. The surrounding soils were dry and crusted leading staff to believe the water in the drainage was not the result of a stormwater event. Near the top of the access road on the northeast corner, water was observed seeping out of the hillside. Once on top both pits/ponds appeared to be dry. The soils within the west pond continue to have a wet sheen due to the heavy clays, no additional seepage from the rock wall in the southwest corner of the pit was observed.

Water was being applied to the Middle Mine Area field. Water was crossing a road outside of the permit boundary on the north end of the field but no roads within the mine permit area were being impacted by excess water run-off. The field has begun to germinate.

Risers #1-9 and #11 were off and ditches dry. Riser #10 was leaking and approximately the first 6 feet of the ditch is wet with standing water. Riser #12 was off but the ditch was wet from receiving up gradient water. Risers #13-14 were both off but the ditches and field were saturated.

As Division staff was leaving the site I (ACY) encountered Tonya Hammond (Snowcap). Still unable to find the water source she indicated on Friday, the Division had Mrs. Hammond show me the source. There is an additional buried water line along the northeastern edge of the Middle Mine Area. The area has volunteered with Alyssum and other noxious weeds making the contoured berm hard to see. No ditches have been excavated from this water line, just vertical capped risers. One of the risers was missing its cap and water was flowing out, and down the hillside into the ephemeral drainage that leads to the bottom haul road culvert (see map). The Division estimates that the cap has been off since at least Friday (8-2-19) when water was first observed in the drainage. After the inspection, the Division notified DWR. Mrs. Hammond also sent a video taken on Friday of the water's path.

**Bottom haul road culvert flowing, haul road hillside seepage, cultivated field germinating with applied water, east water line
leaking riser**
