MINERALS PROGRAM INSPECTION REPORT
PHONE: (303) 866-3567

MINE NAME: Reynolds Pit	MINE/PROSPECTING ID#: M-2006-028	MINERAL: Sand and gravel	COUNTY: Delta
INSPECTION TYPE: Monitoring	INSPECTOR(S): Stephanie J. Mitchell	INSP. DATE: July 17, 2019	INSP. TIME: 09:45
OPERATOR: Cornerstone Materials LLC	OPERATOR REPRESENTATIVE: Zane Luttrell	TYPE OF OPERATION: 112c - Construction Regular Operation	
REASON FOR INSPECTION: Citizen Complaint	BOND CALCULATION TYPE: Complete Bond	BOND AMOUNT: \$74,440.52	
DATE OF COMPLAINT: NA	POST INSP. CONTACTS: None	JOINT INSP. AGENCY: None	
WEATHER: Clear	INSPECTOR'S SIGNATURE:

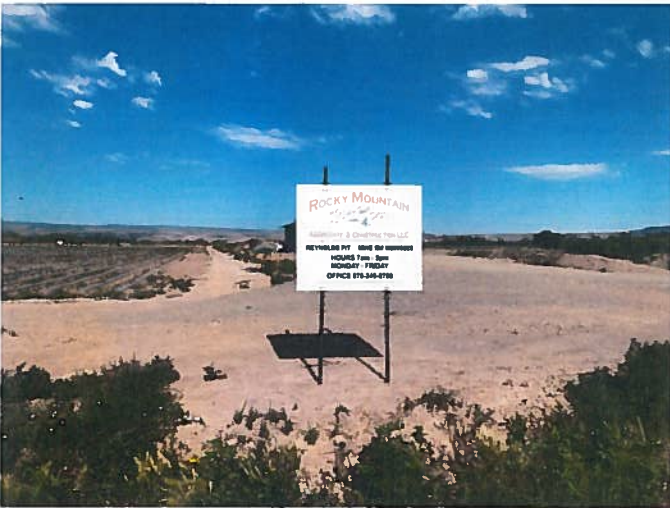
The Mine Identification sign was at the entrance to the mine site in compliance per Rule 3.1.12 (2). Previously it was posted on the Scalehouse. It is noted that the Operators other Company (Rocky Mountain Aggregates) is listed as the Operator. The Division encourages the Operator to change the name to Cornerstone Materials LLC on the sign. The permit boundaries were delineated by fencing and roads, except for the northern portion, where it daylight to the recently released Fedler pit.

Mine ID

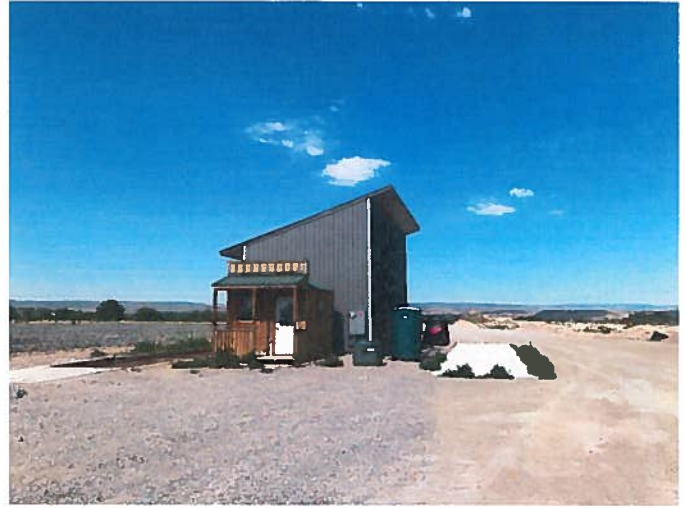
Scale House and Storage facility- water

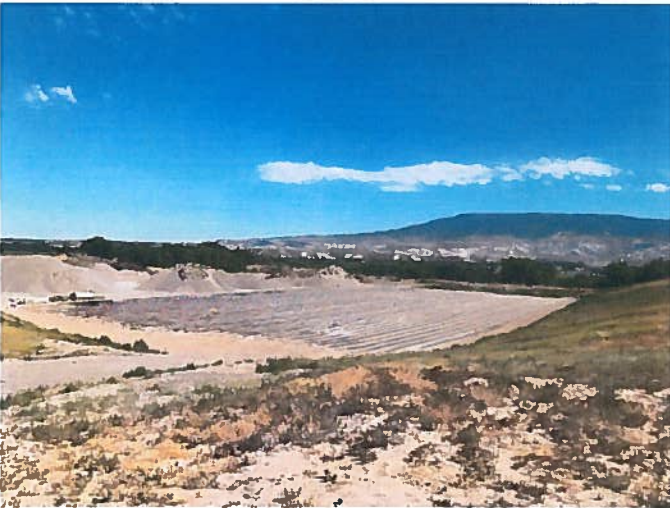
Overall Site w hemp fields

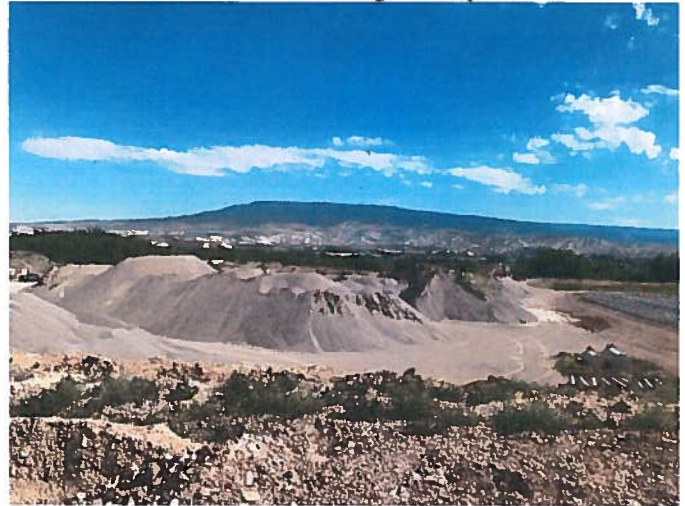
Material Stockpiles

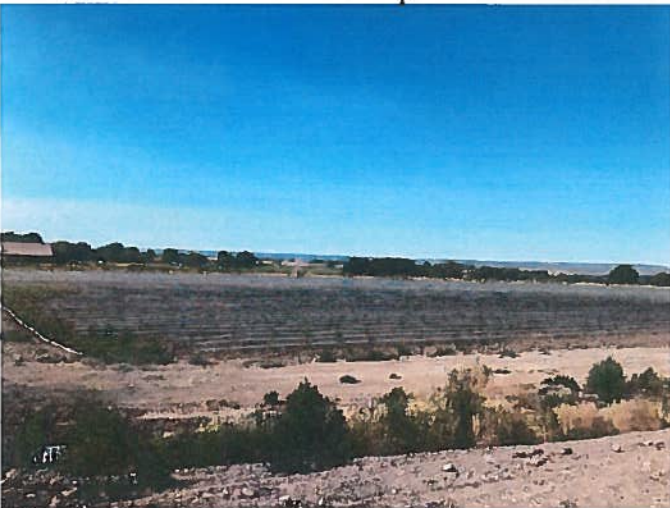
Hemp Fields

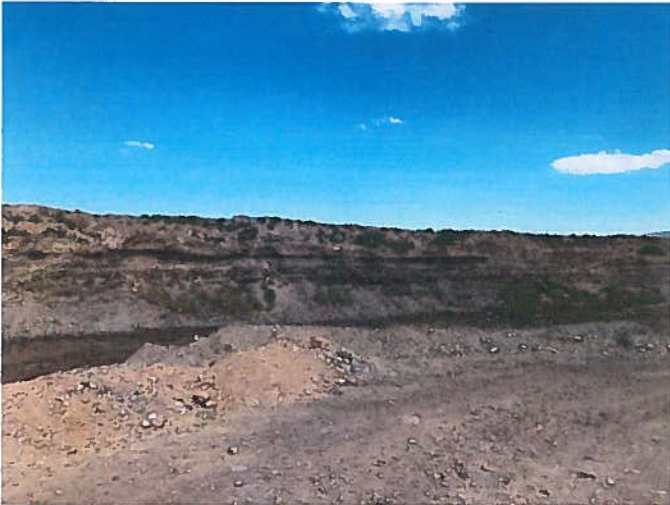
Irrigation tail waters is filling the northern portion of the disturbance. The operator was currently backfilling the pit to reduce water impounding on site. The highwall is around 15-20 feet in height and appears to be stable. Fencing is not required near the highwall for it is on private land and is not a requirement in the mining plan.

Active Highwall- does not require fencing

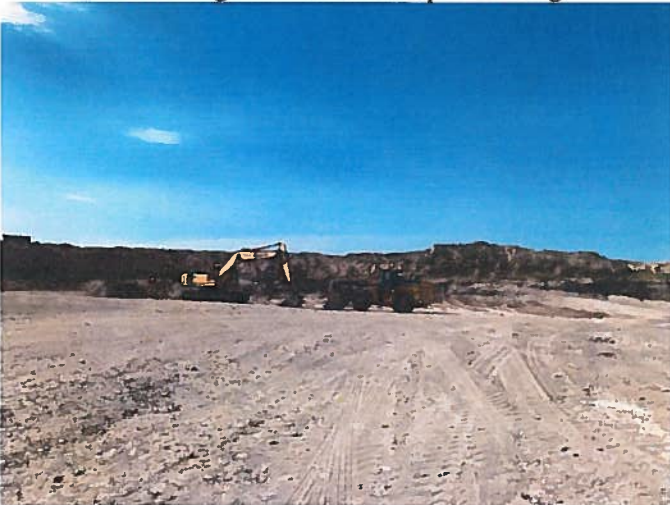
Loader and Excavator on site

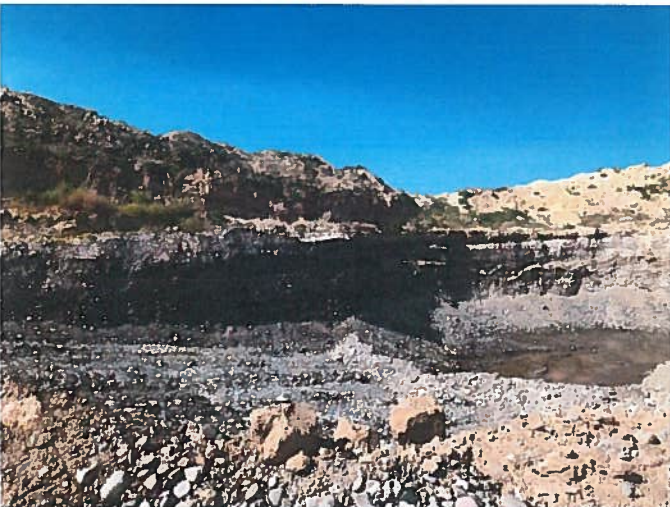
Irrigation tails impounded
