**MINERALS PROGRAM INSPECTION REPORT**  
**PHONE: (303) 866-3567**

<b>MINE NAME:</b> St Jude Mine	<b>MINE/PROSPECTING ID#:</b> M-1978-039-HR	<b>MINERAL:</b> Uranium and vanadium	<b>COUNTY:</b> San Miguel
<b>INSPECTION TYPE:</b> Monitoring	<b>INSPECTOR(S):</b> Lucas J. West	<b>INSP. DATE:</b> August 5, 2019	<b>INSP. TIME:</b> 10:25
<b>OPERATOR:</b> Pinon Ridge Mining LLC	<b>OPERATOR REPRESENTATIVE:</b> George Glasier, Michael Rutter	<b>TYPE OF OPERATION:</b> 110d - Designated Limited Impact	
<b>REASON FOR INSPECTION:</b> Normal I&E Program	<b>BOND CALCULATION TYPE:</b> None	<b>BOND AMOUNT:</b> \$61,021.00	
<b>DATE OF COMPLAINT:</b> NA	<b>POST INSP. CONTACTS:</b> None	<b>JOINT INSP. AGENCY:</b> None	
<b>WEATHER:</b> Clear	<b>INSPECTOR'S SIGNATURE:</b>

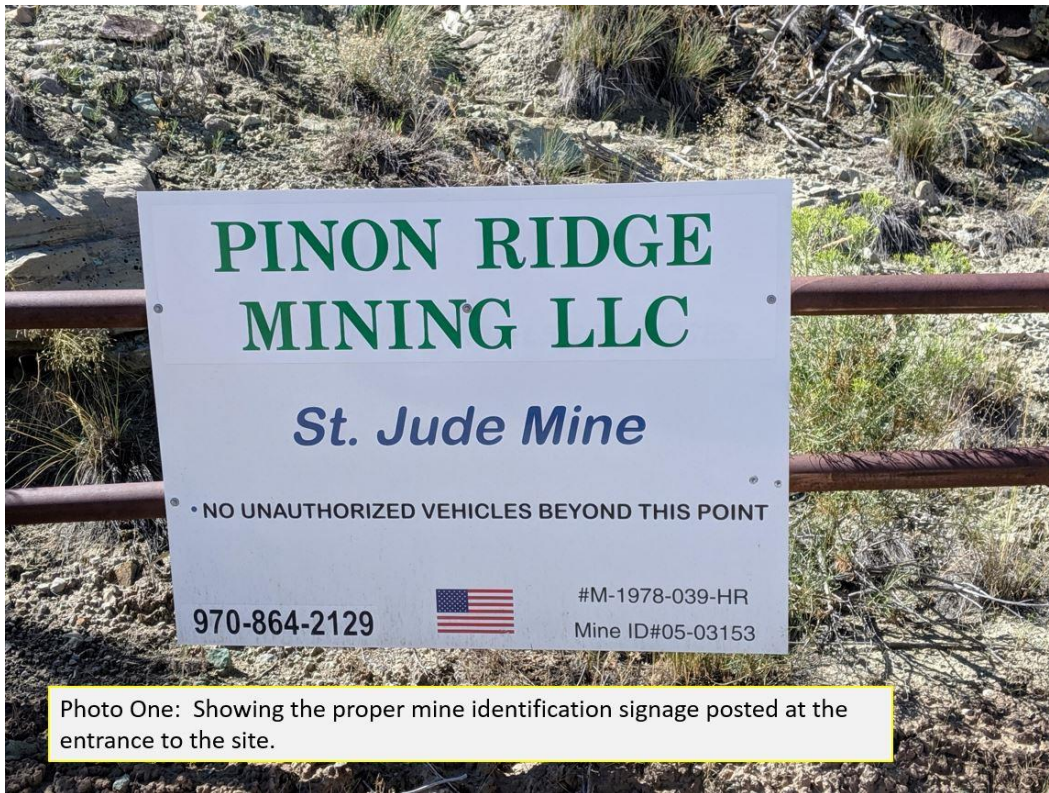
As seen in Photo One, the permit ID sign was observed at the entrance to the site. The permit boundary markers were also observed. All disturbances are contained within the permitted areas. The remote vent shaft sites were not inspected at this time. Various mining related equipment and vehicles were on site at the time of the inspection. The diversion ditches and storm water control devices appear to be functioning as designed and no significant erosion was observed throughout the site. The main work area, adjacent to the portal and shops, appeared to be stable and in good condition. The earthen backfill used to secure the portal has been removed, the gates have been opened and the mine has been ventilated. The portal structure is in good condition and required only minor repairs. The portal located on site can be seen in Photo Two. A tank of Mag Chloride is located adjacent to the portal to be used in road maintenance throughout the sites.

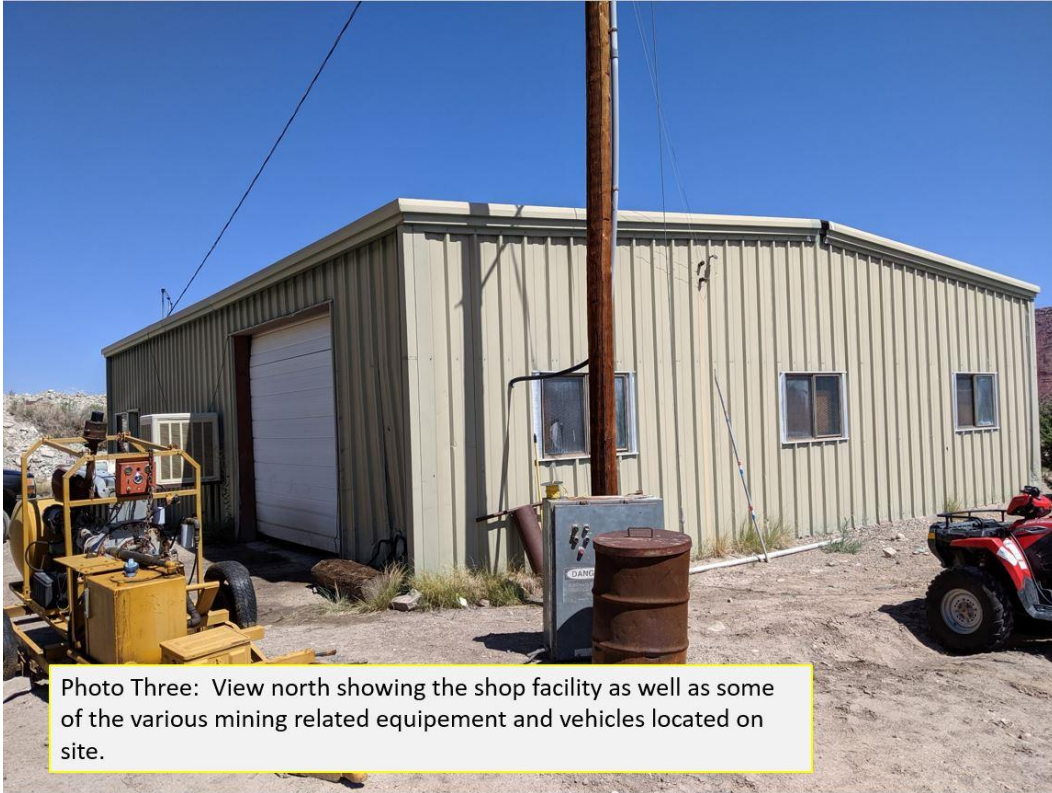
The shop facility has been repaired and is in full use. The interior and exterior of the shop are in good condition. The shop facility can be seen in Photo Three. No fuel storage containers were observed on site. Various other debris was observed on site however it was stored in an orderly fashion and was not a concern at this time. The waste rock dump storage area was observed, and appears to be stable and in good condition.
