**MINERALS PROGRAM INSPECTION REPORT**  
**PHONE: (303) 866-3567**

<b>MINE NAME:</b> St Jude Mine	<b>MINE/PROSPECTING ID#:</b> M-1978-039-HR	<b>MINERAL:</b> Uranium and vanadium	<b>COUNTY:</b> San Miguel
<b>INSPECTION TYPE:</b> Monitoring	<b>INSPECTOR(S):</b> Lucas J. West	<b>INSP. DATE:</b> August 5, 2019	<b>INSP. TIME:</b> 10:25
<b>OPERATOR:</b> Pinon Ridge Mining LLC	<b>OPERATOR REPRESENTATIVE:</b> George Glasier, Michael Rutter	<b>TYPE OF OPERATION:</b> 110d - Designated Limited Impact	
<b>REASON FOR INSPECTION:</b> Normal I&E Program	<b>BOND CALCULATION TYPE:</b> None	<b>BOND AMOUNT:</b> \$61,021.00	
<b>DATE OF COMPLAINT:</b> NA	<b>POST INSP. CONTACTS:</b> None	<b>JOINT INSP. AGENCY:</b> None	
<b>WEATHER:</b> Clear	<b>INSPECTOR'S SIGNATURE:</b>

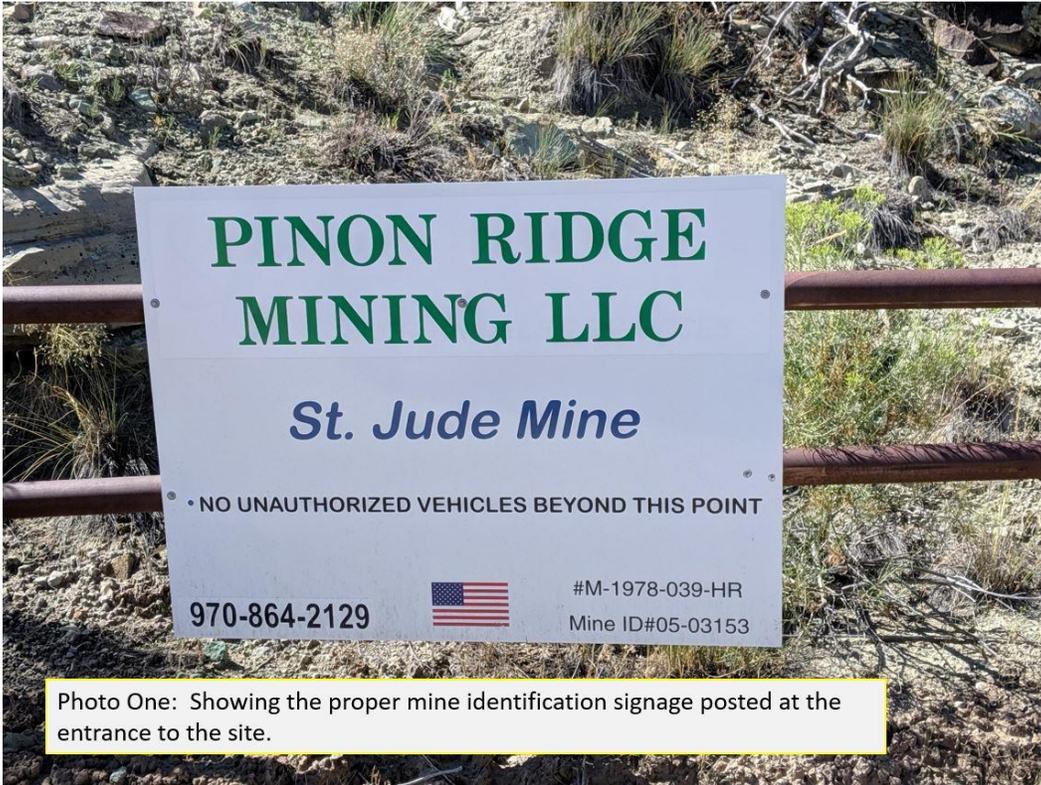
As seen in Photo One, the permit ID sign was observed at the entrance to the site. The permit boundary markers were also observed. All disturbances are contained within the permitted areas. The remote vent shaft sites were not inspected at this time. Various mining related equipment and vehicles were on site at the time of the inspection. The diversion ditches and storm water control devices appear to be functioning as designed and no significant erosion was observed throughout the site. The main work area, adjacent to the portal and shops, appeared to be stable and in good condition. The earthen backfill used to secure the portal has been removed, the gates have been opened and the mine has been ventilated. The portal structure is in good condition and required only minor repairs. The portal located on site can be seen in Photo Two. A tank of Mag Chloride is located adjacent to the portal to be used in road maintenance throughout the sites.

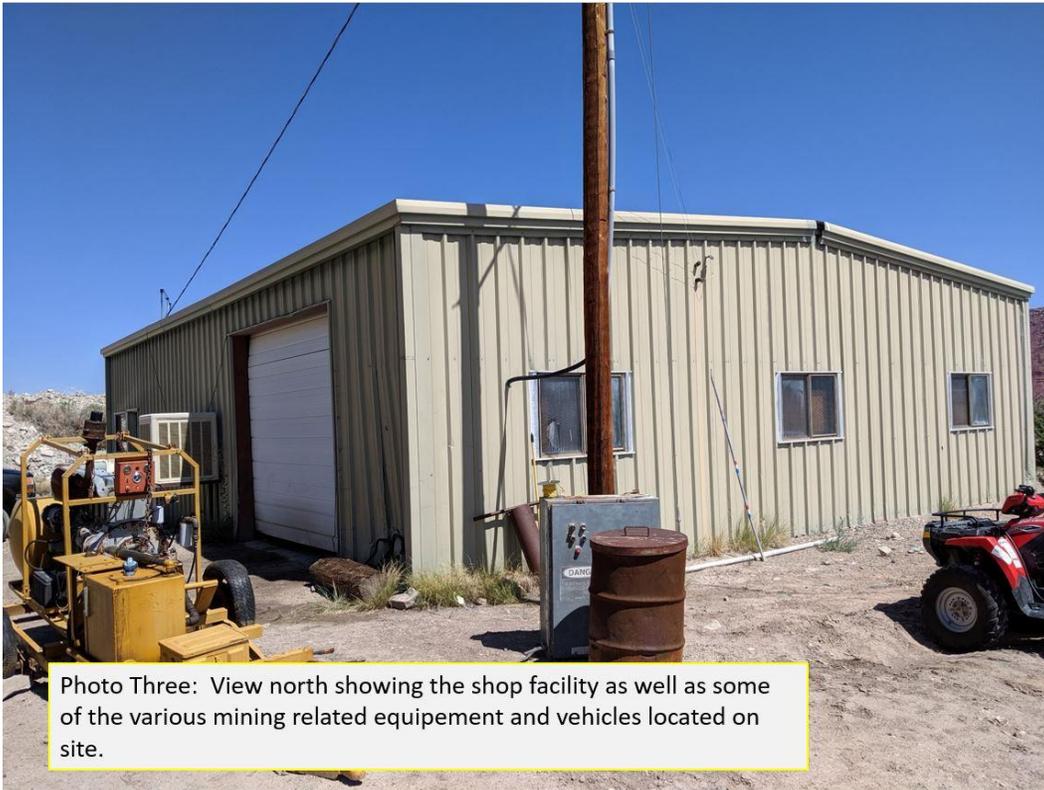
The shop facility has been repaired and is in full use. The interior and exterior of the shop are in good condition. The shop facility can be seen in Photo Three. No fuel storage containers were observed on site. Various other debris was observed on site however it was stored in an orderly fashion and was not a concern at this time. The waste rock dump storage area was observed, and appears to be stable and in good condition.

Photo Three: View north showing the shop facility as well as some of the various mining related equipment and vehicles located on site.
