**COLORADO**Division of Reclamation,
Mining and Safety

MINERALS PROGRAM INSPECTION REPORT**PHONE: (303) 866-3567**

MINE NAME: Sunday Mine	MINE/PROSPECTING ID#: M-1977-285	MINERAL: Uranium and vanadium	COUNTY: San Miguel
INSPECTION TYPE: Monitoring	INSPECTOR(S): Lucas J. West	INSP. DATE: August 5, 2019	INSP. TIME: 11:47
OPERATOR: Pinon Ridge Mining LLC	OPERATOR REPRESENTATIVE: George Glasier, Michael Rutter	TYPE OF OPERATION: 112d-2 - Designated Mining Operation	
REASON FOR INSPECTION: Normal I&E Program	BOND CALCULATION TYPE: None	BOND AMOUNT: \$330,242.00	
DATE OF COMPLAINT: NA	POST INSP. CONTACTS: None	JOINT INSP. AGENCY: None	
WEATHER: Clear	INSPECTOR'S SIGNATURE:

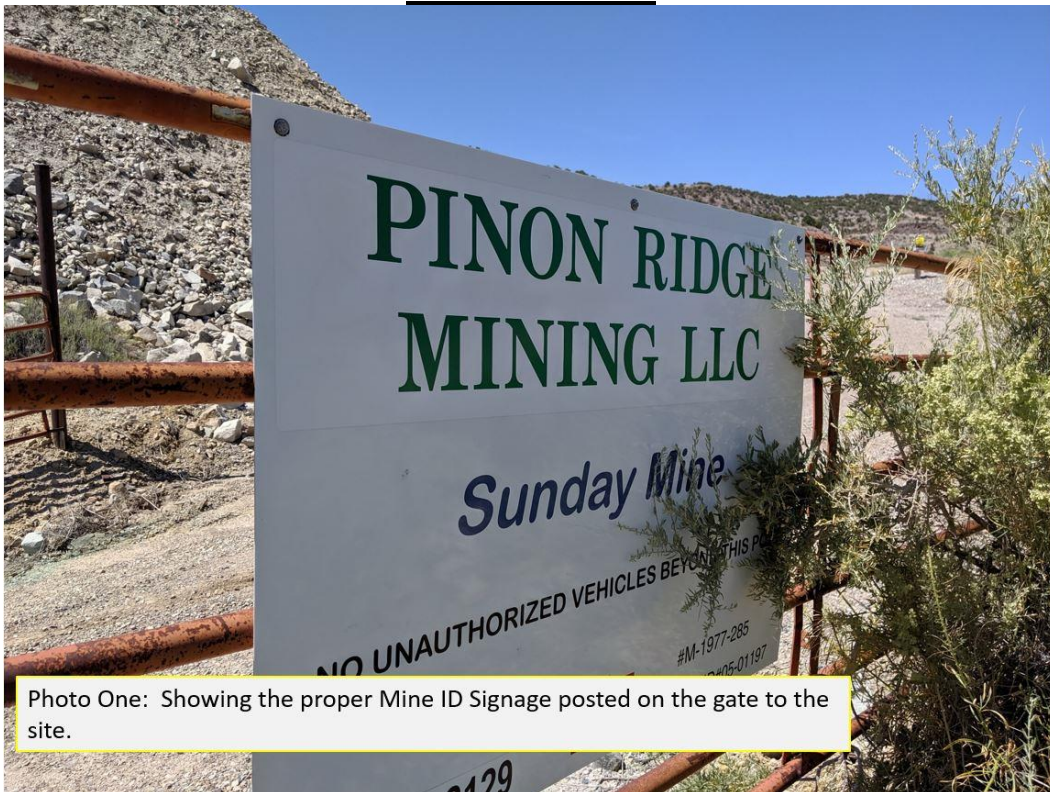
As seen in Photo One, the permit ID sign was observed at the entrance to the site. The permit boundary markers were also observed. All storm water control devices are in good condition and appear to be functioning as designed at the time of the inspection. All diversion ditches appear to be functioning as designed and no significant erosion was observed throughout of the site. The waste rock dumps and out slopes of all constructed faces were observed and appear to be stable. The portal has been opened and the earthen plug has been removed. The portal is currently being used as source of ventilation only and can be seen in Photo Two. All work facilities were secure and seemed to be in good condition during the time of the inspection. Vent shaft S-2, located to the Northwest of the shop facilities is covered with a steel grate and has been secured. All loadouts, roads and pad areas that exist on site were observed and in good condition.

Photo One: Showing the proper Mine ID Signage posted on the gate to the site.

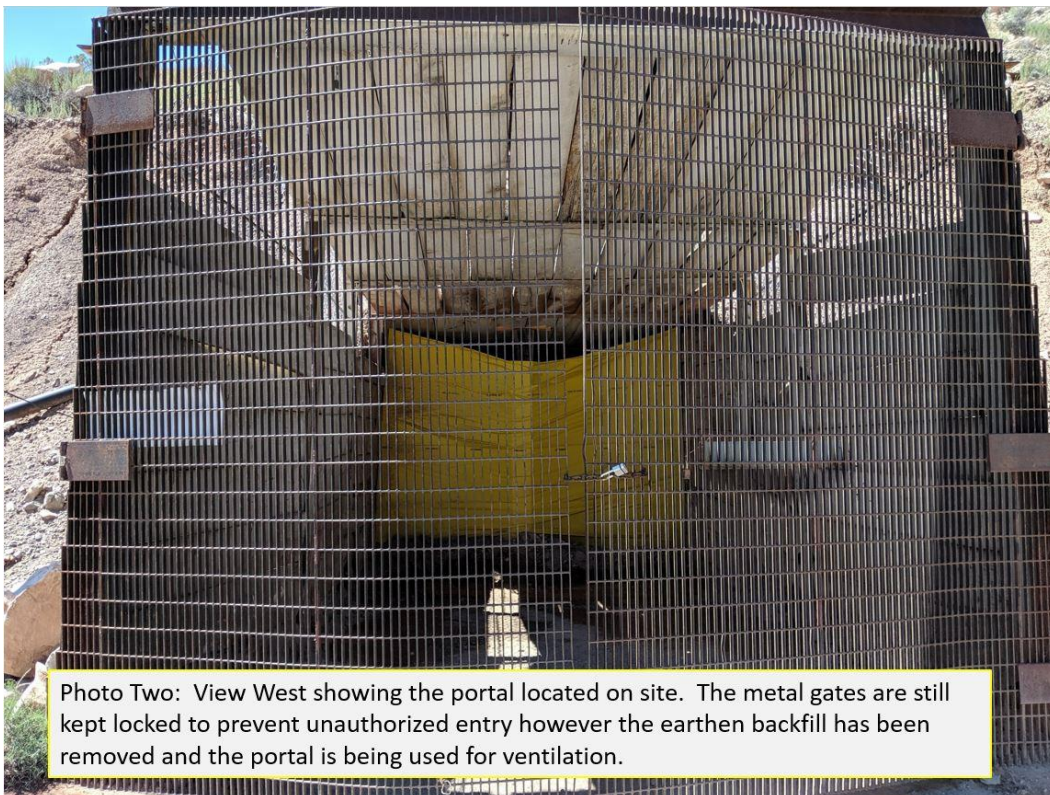
Photo Two: View West showing the portal located on site. The metal gates are still kept locked to prevent unauthorized entry however the earthen backfill has been removed and the portal is being used for ventilation.
