MINERALS PROGRAM INSPECTION REPORT
PHONE: (303) 866-3567

MINE NAME: West Sunday	MINE/PROSPECTING ID#: M-1981-021	MINERAL: Uranium and vanadium	COUNTY: San Miguel
INSPECTION TYPE: Monitoring	INSPECTOR(S): Lucas J. West	INSP. DATE: August 5, 2019	INSP. TIME: 12:32
OPERATOR: Pinon Ridge Mining LLC	OPERATOR REPRESENTATIVE: None	TYPE OF OPERATION: 112d-3 - Designated Mining Operation	
REASON FOR INSPECTION: Normal I&E Program	BOND CALCULATION TYPE: None	BOND AMOUNT: \$85,036.00	
DATE OF COMPLAINT: NA	POST INSP. CONTACTS: None	JOINT INSP. AGENCY: None	
WEATHER: Clear	INSPECTOR'S SIGNATURE:

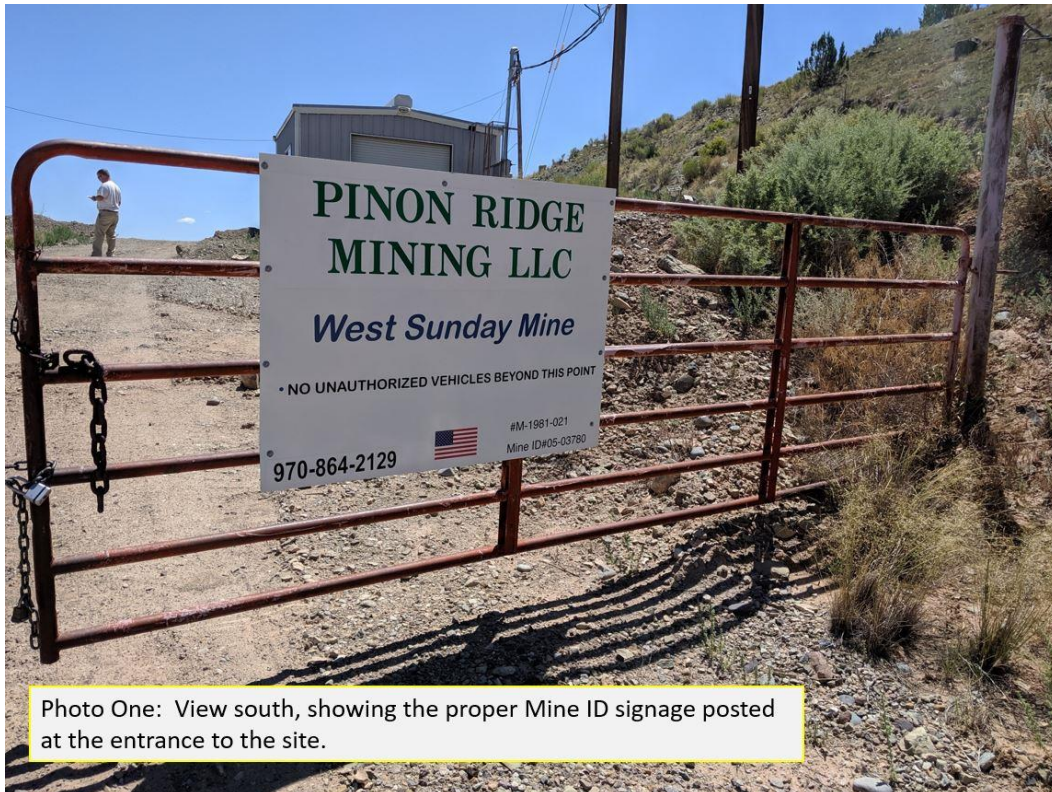
As seen in Photo One, the permit ID sign was observed at the entrance to the site. The permit boundary markers were also observed. The remote vent shaft sites were not inspected at this time. Evidence that the diversion ditches and storm water control devices are functioning as designed was observed and no significant erosion was observed throughout the site.

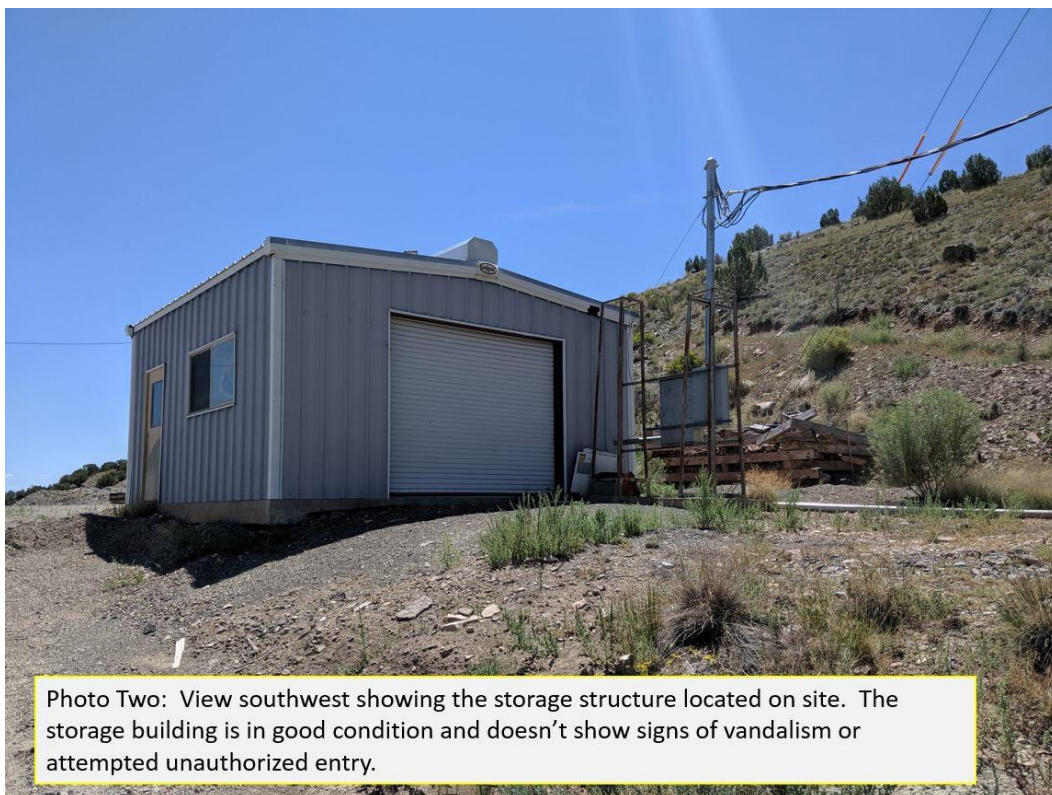
All work and shop appeared to be in good condition as seen in Photos Two and Three. The shop and storage facility in Photo Two was discovered to be unsecure, with the bay door opened. According to the operator there appeared to be no signs of theft or damage to the structure. The office facility was secured, and no signs of attempted unauthorized entry were noted on that facility. The portal located on site has been opened to be used as ventilation for the underground workings of the entire Sunday Complex. The earthen backfill material has been removed but the gates remain locked to prevent unauthorized entry. The portal with its locked gates can be seen in Photo Four. Two fuel storage containers were observed on site but were empty and appear to have not been utilized in some time. Various other debris was observed on site however it was stored in an orderly fashion and was not a concern at this time. The main pad and work area was in good condition, evidence of weed management during the growing season was observed. The whole site exhibits positive drainage and no erosional issues were observed at this time. Some areas around the perimeter of the pad area have begun to revegetate themselves with volunteer species.
