MINERALS PROGRAM INSPECTION REPORT
PHONE: (303) 866-3567

MINE NAME: Blue Mesa Project	MINE/PROSPECTING ID#: P-2018-009	MINERAL: Uranium and vanadium	COUNTY: Montrose
INSPECTION TYPE: Surety Release Inspection	INSPECTOR(S): Dustin M. Czaplá	INSP. DATE: August 13, 2019	INSP. TIME: 10:00
OPERATOR: Hubbard Trucking, Inc.	OPERATOR REPRESENTATIVE: None	TYPE OF OPERATION: MP - Mineral Prospecting	
REASON FOR INSPECTION: Surety Release Requested	BOND CALCULATION TYPE: None	BOND AMOUNT: \$18,658.58	
DATE OF COMPLAINT: NA	POST INSP. CONTACTS: None	JOINT INSP. AGENCY: None	
WEATHER: Clear	INSPECTOR'S SIGNATURE:

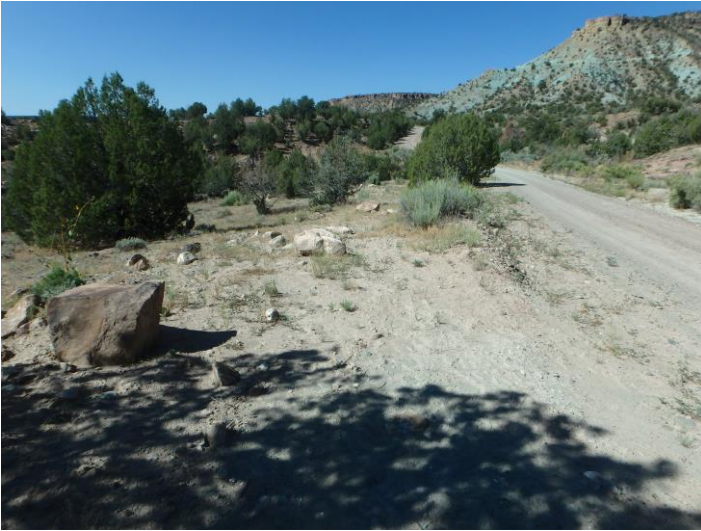
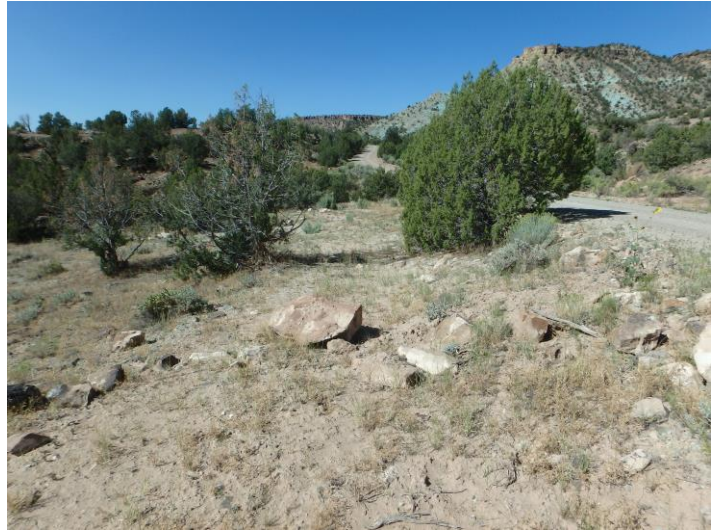
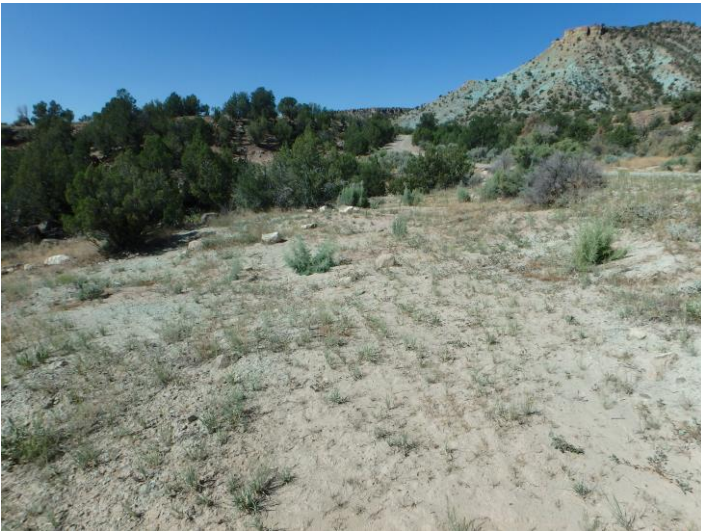
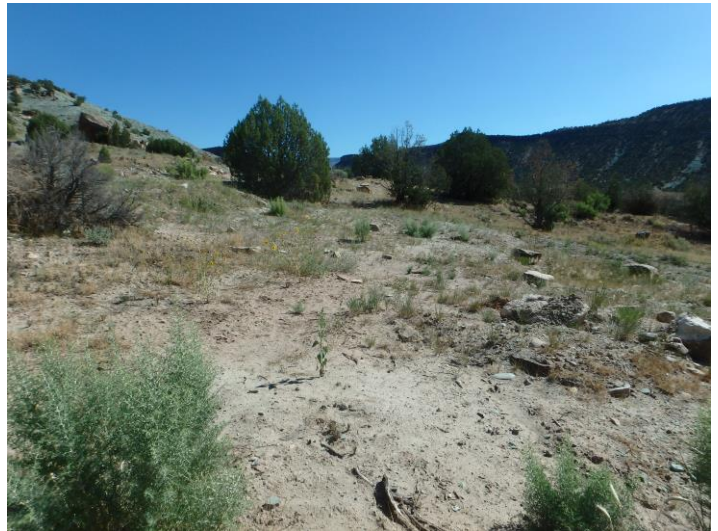
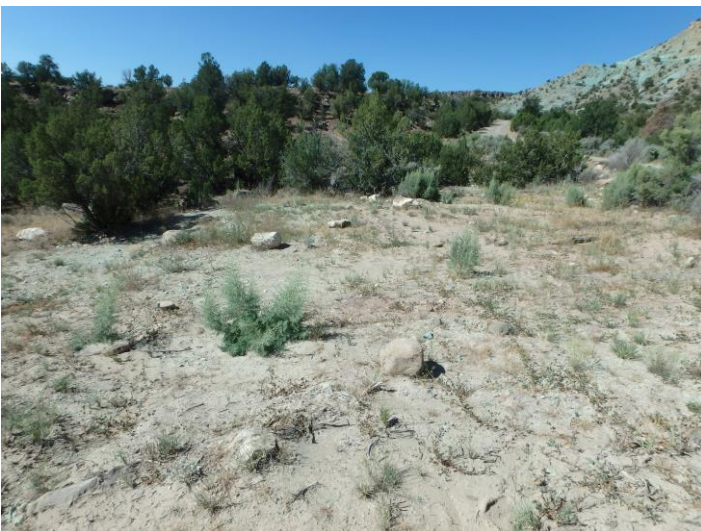
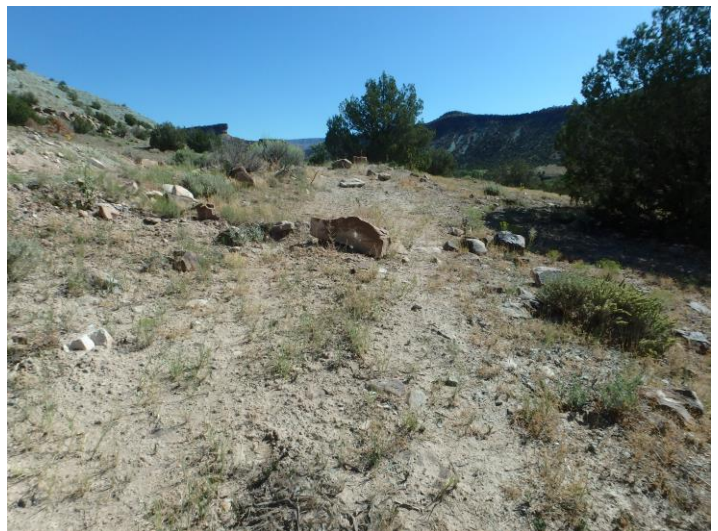
PHOTOGRAPHS

This was a surety-release inspection. The Division received a request for release from further reclamation responsibility from the operator on July 25, 2019. The operator drilled only one of the holes authorized under the NOI. The drill location is located approximately seventeen miles south of Gateway and accessed from O14 Road. This inspection confirmed that reclamation is adequate. The bore hole has been backfilled, the site regraded and seeded. Vegetation is well established. The drill location is nearly indiscernible from the surrounding area.
