**MINERALS PROGRAM INSPECTION REPORT**  
**PHONE: (303) 866-3567**

<b>MINE NAME:</b> Canyon Sand & Gravel	<b>MINE/PROSPECTING ID#:</b> M-1988-057	<b>MINERAL:</b> Sand and gravel	<b>COUNTY:</b> Archuleta
<b>INSPECTION TYPE:</b> Monitoring	<b>INSPECTOR(S):</b> Lucas J. West	<b>INSP. DATE:</b> August 6, 2019	<b>INSP. TIME:</b> 13:15
<b>OPERATOR:</b> Canyon Sand & Gravel	<b>OPERATOR REPRESENTATIVE:</b> None	<b>TYPE OF OPERATION:</b> 110c - Construction Limited Impact	
<b>REASON FOR INSPECTION:</b> Normal I&E Program	<b>BOND CALCULATION TYPE:</b> Complete Bond	<b>BOND AMOUNT:</b> \$1,974.00	
<b>DATE OF COMPLAINT:</b> NA	<b>POST INSP. CONTACTS:</b> None	<b>JOINT INSP. AGENCY:</b> None	
<b>WEATHER:</b> Clear	<b>INSPECTOR'S SIGNATURE:</b>

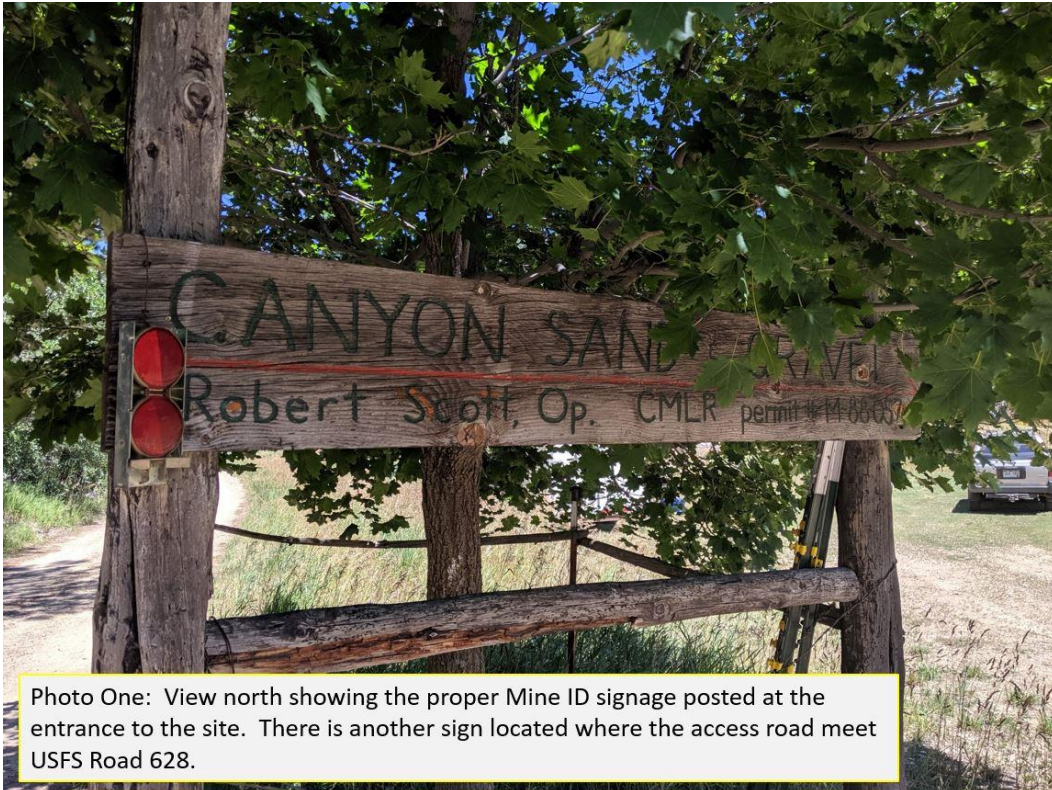
The proper mine identification signage was posted at the entrance to the site and can be seen in Photo One. The mining related equipment located on site consisted of a front end loader, crusher and conveyors. The equipment appears to be functional and in good condition and can be seen in Photos Two and Three. Several above ground storage tanks were observed on site and verified to be empty. The Division would like to remind the operator that when the tanks contain fuel they must have secondary containment sufficient to hold the contents of the tank plus 10%.

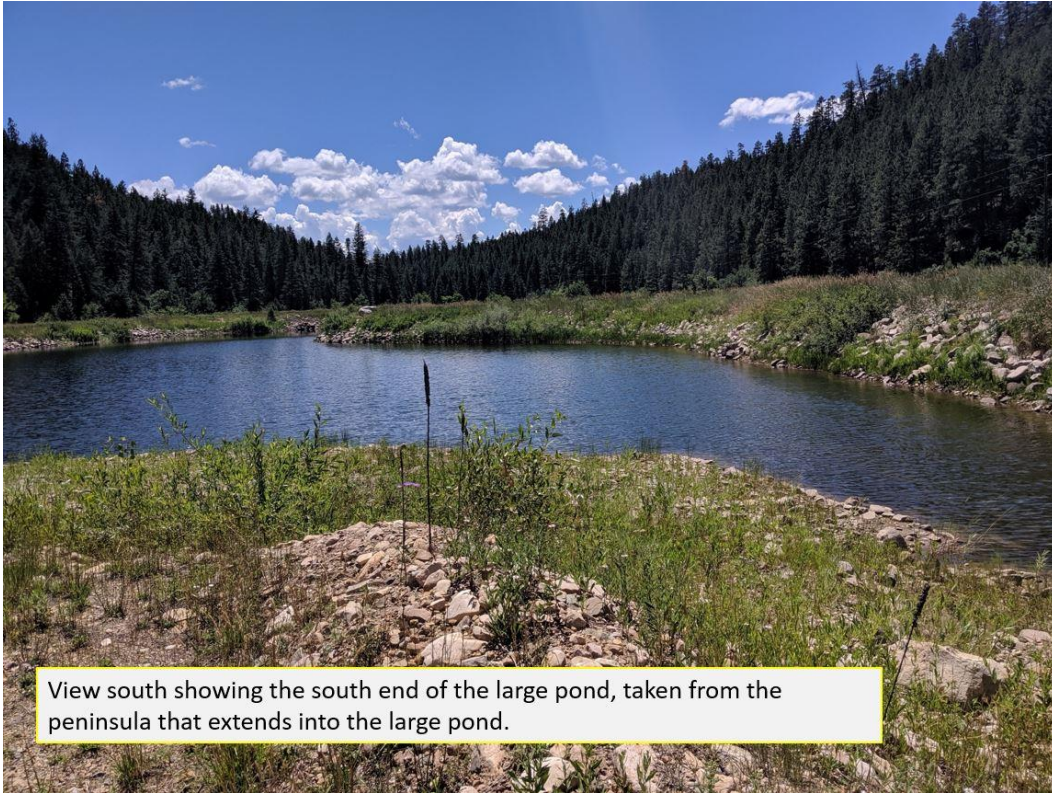
View south showing the south end of the large pond, taken from the peninsula that extends into the large pond.

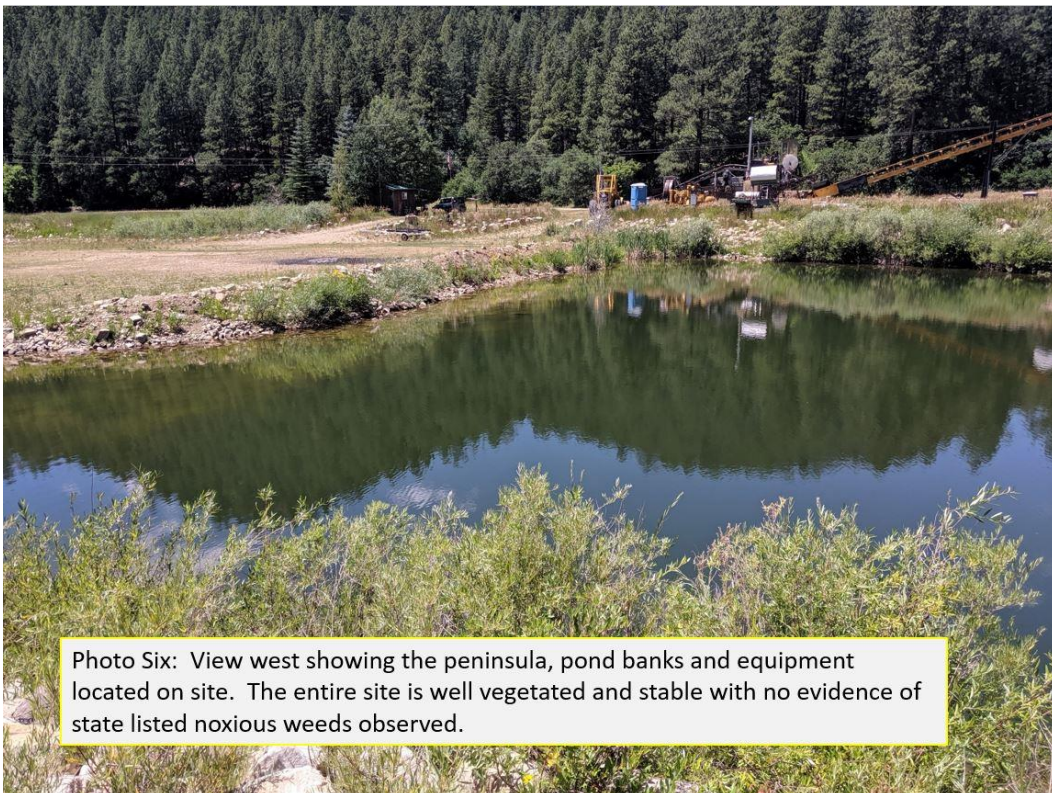
Photo Six: View west showing the peninsula, pond banks and equipment located on site. The entire site is well vegetated and stable with no evidence of state listed noxious weeds observed.

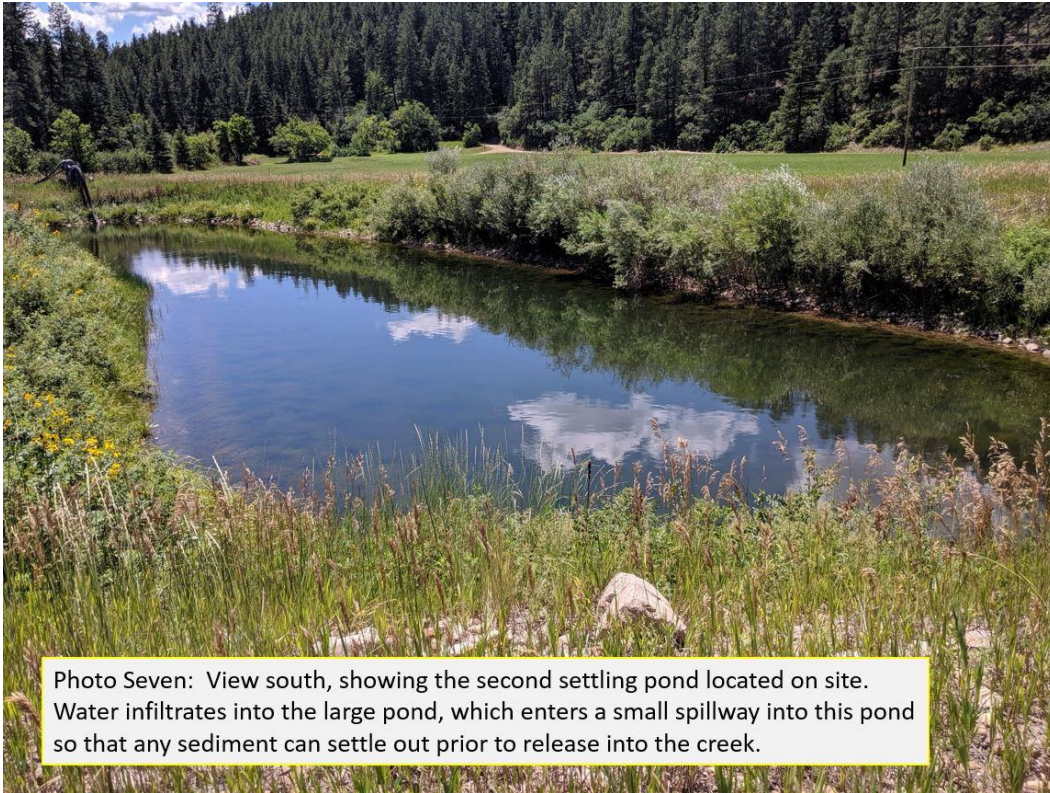
The mining activity has been conducted to create a large pond with a smaller settling pond immediately adjacent. The large pond contains a large peninsula extending into its center. The larger pond can be seen in Photos Four through Six while the smaller can be seen in Photo Seven. The Peninsula appears to be stable and in good condition. All of the pond banks are relaxed to an approximately 3H: 1V or shallower configuration and are well vegetated. No evidence of erosion, settling or slumping was noted on any portion of the pond banks. The North end of the large pond contains a large rock structure complete with fire pit. The construction of the structure appears to be a dry stack configuration of large well placed boulders. The structure is in good condition and appears to be functioning as designed at the time of the inspection. Along the west bank of the river is a large dyke that separates the affected lands from Devils Creek. The dyke is stable and shows no signs of erosion or degradation. Throughout the site no state listed noxious weeds were observed and evidence of chemical treatment of nuisance species was observed.
