MINERALS PROGRAM INSPECTION REPORT
PHONE: (303) 866-3567

MINE NAME: Brenner Pit #2	MINE/PROSPECTING ID#: M-2013-014	MINERAL: Sand, gravel, clay	COUNTY: Kit Carson
INSPECTION TYPE: Monitoring	INSPECTOR(S): Elliott R. Russell	INSP. DATE: June 13, 2019	INSP. TIME: 07:50
OPERATOR: Kit Carson County	OPERATOR REPRESENTATIVE: Dave Hornung	TYPE OF OPERATION: 110c - Construction Limited Impact	
REASON FOR INSPECTION: Normal I&E Program	BOND CALCULATION TYPE: None	BOND AMOUNT: NA	
DATE OF COMPLAINT: NA	POST INSP. CONTACTS: None	JOINT INSP. AGENCY: None	
WEATHER: Clear	INSPECTOR'S SIGNATURE:

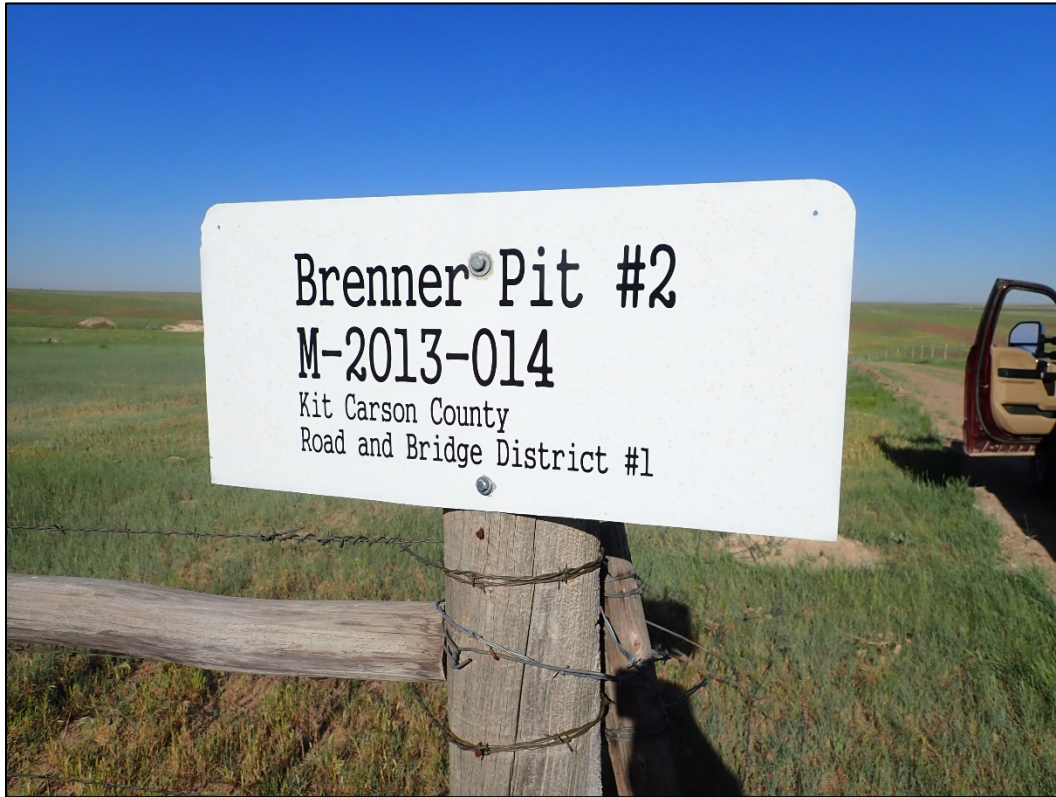
Signs and Markers: The permit sign was properly posted and boundary markers delineated the permit boundary.

Photo 1. Mine identification sign; looking west.

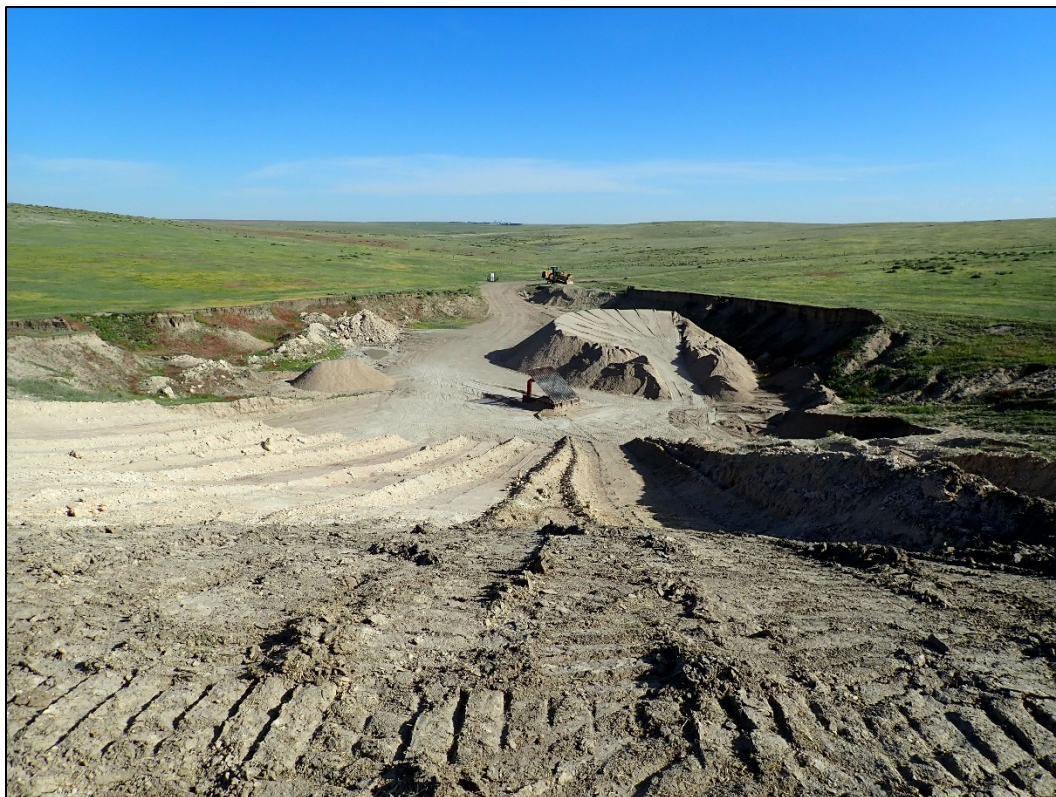
The site consists of a single hill side excavation which slightly daylight to the north and has a mining face on the south. Several stockpiles of material were located on the pit floor. Topsoil had been stripped and stockpiled in various locations around the site including south of the southern mining face.

Photo 2. Site overview; looking north.

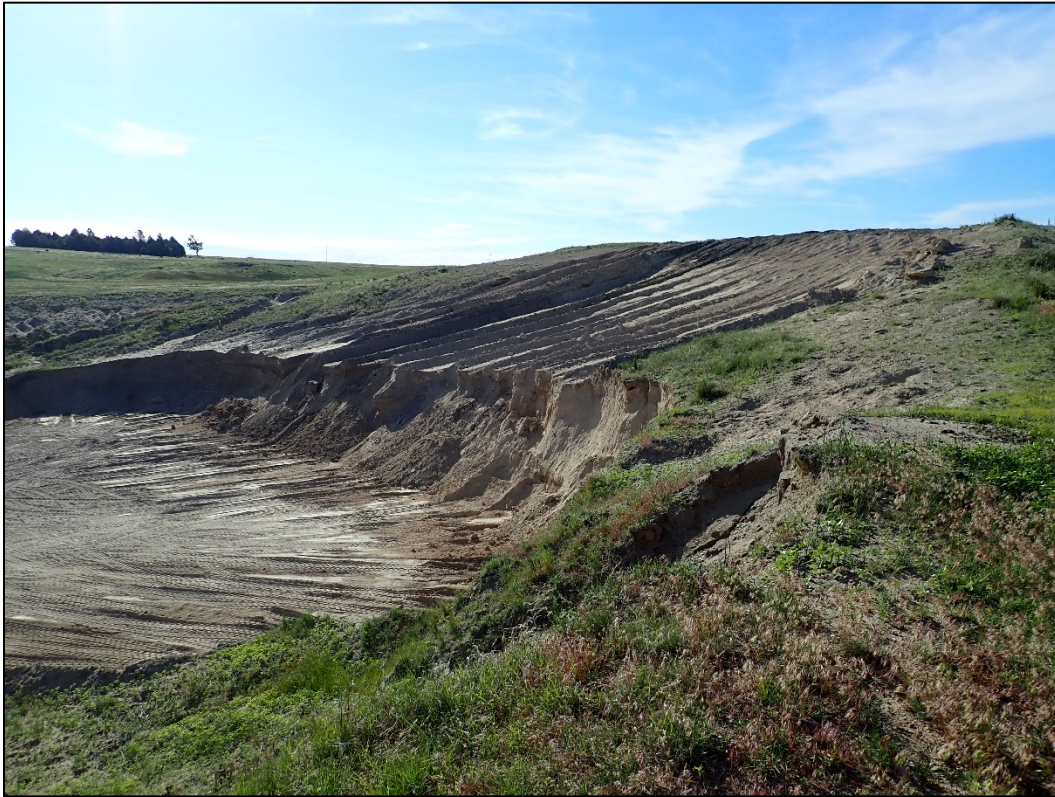
Photo 3. Mining face on the south side of the pit; looking southeast.

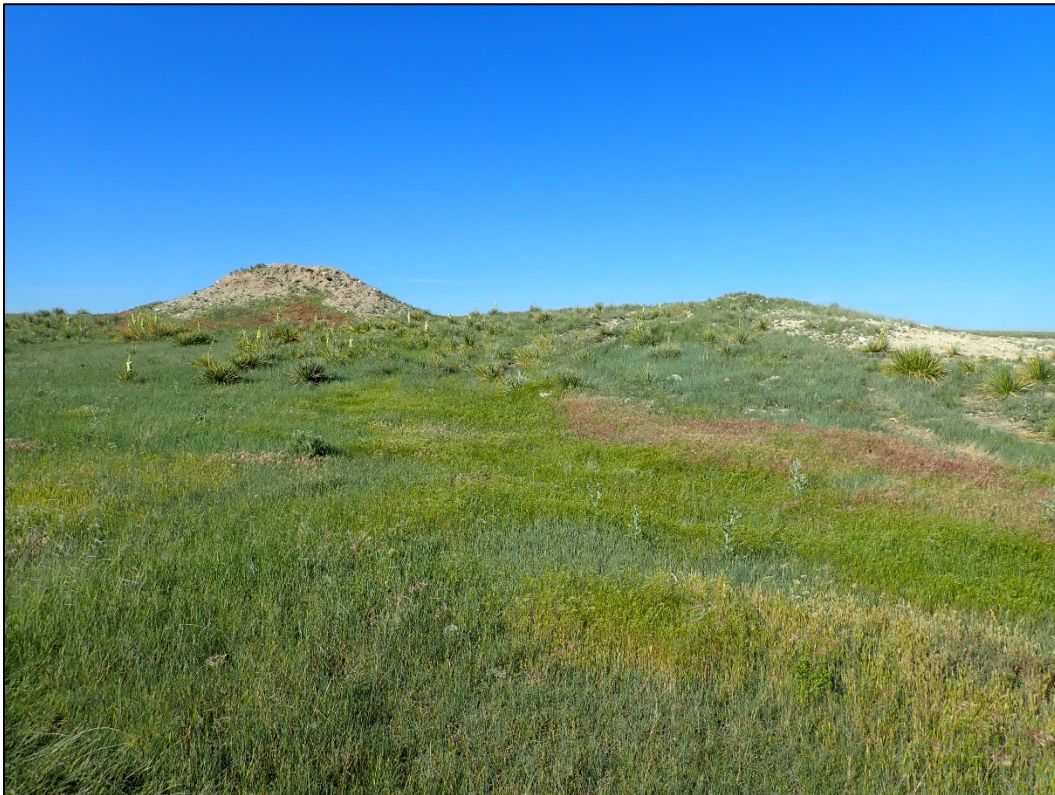
Photo 4. Topsoil stockpile south of the southern mining face; looking southwest.

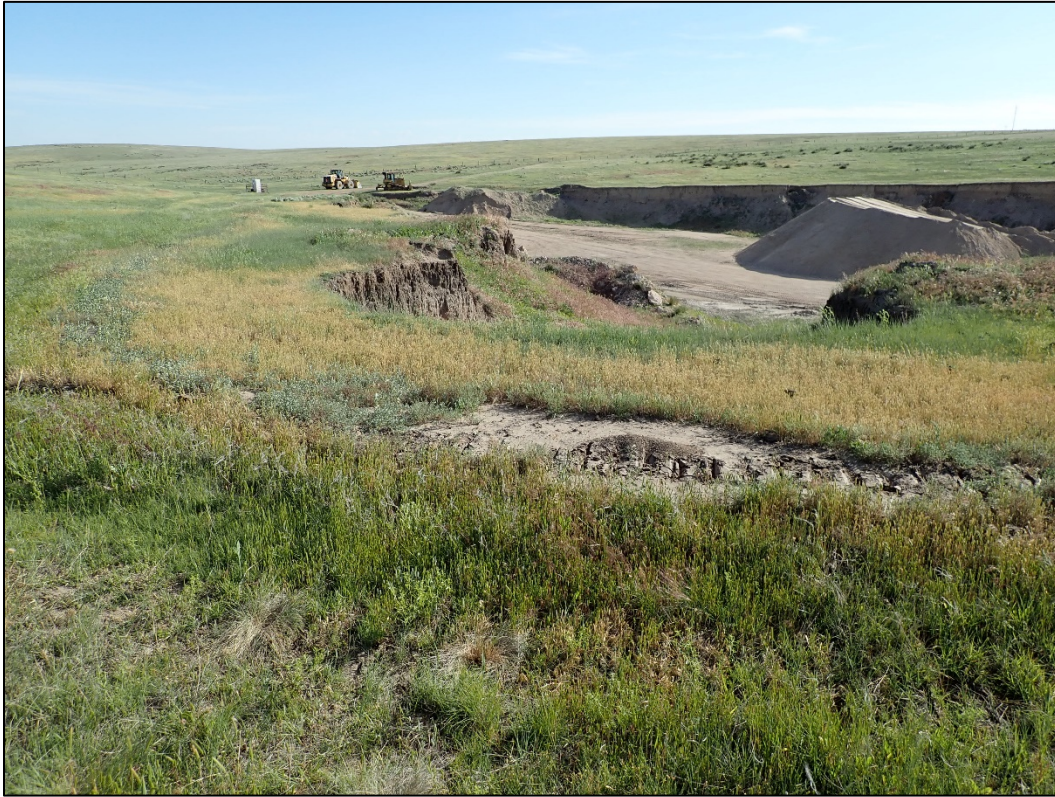
Sediment Control: The Operator should monitor the head cut erosional feature which has developed along the west/southwest side of the pit. Storm water appears to flow down a drainage swale to the west of the site and, with time, the small berm which directs water around the pit has deteriorated which now causes flows to enter the excavation. This head cut, if left unchecked, could advance off-site to the west which would be a violation of C.R.S 34-32.5-116(4)(i) and (j). The Division recommends the Operator backfill/slope the vertical face of the head cut and/or reestablish the storm water control berm.

Photo 5. Head cut erosional feature along west/southwest side of the pit; looking northeast.
