MINERALS PROGRAM INSPECTION REPORT

MINE NAME: Brenner Pit	MINE/PROSPECTING ID#: M-1982-079	MINERAL: Sand and gravel	COUNTY: Kit Carson
INSPECTION TYPE: Monitoring	INSPECTOR(S): Elliott R. Russell	INSP. DATE: June 13, 2019	INSP. TIME: 08:20
OPERATOR: Kit Carson County	OPERATOR REPRESENTATIVE: Dave Hornung	TYPE OF OPERATION: 110c - Construction Limited Impact	
REASON FOR INSPECTION: Normal I&E Program	BOND CALCULATION TYPE: None	BOND AMOUNT: No Bond Held	
DATE OF COMPLAINT: NA	POST INSP. CONTACTS: None	JOINT INSP. AGENCY: None	
WEATHER: Clear	INSPECTOR'S SIGNATURE:

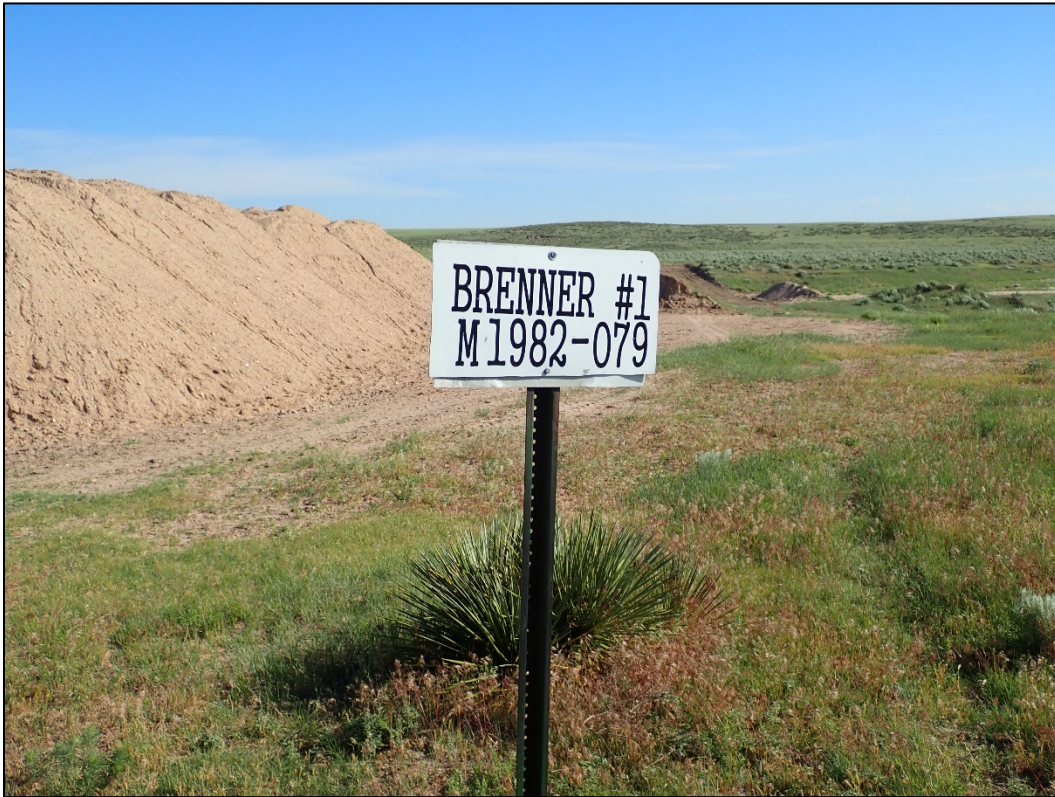
Signs and Markers: The permit sign was properly posted and boundary markers delineated the permit boundary.

Photo 1. Mine identification sign; looking north.

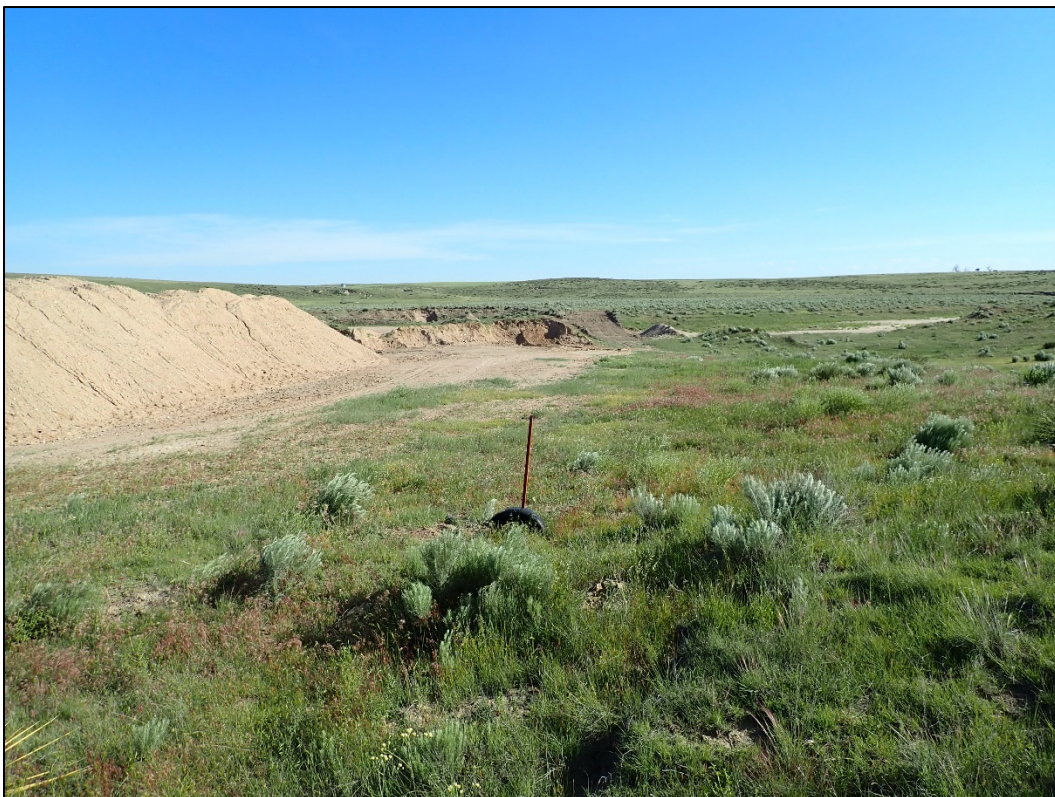
Photo 2. Southeast boundary marker and product stockpile; looking north.

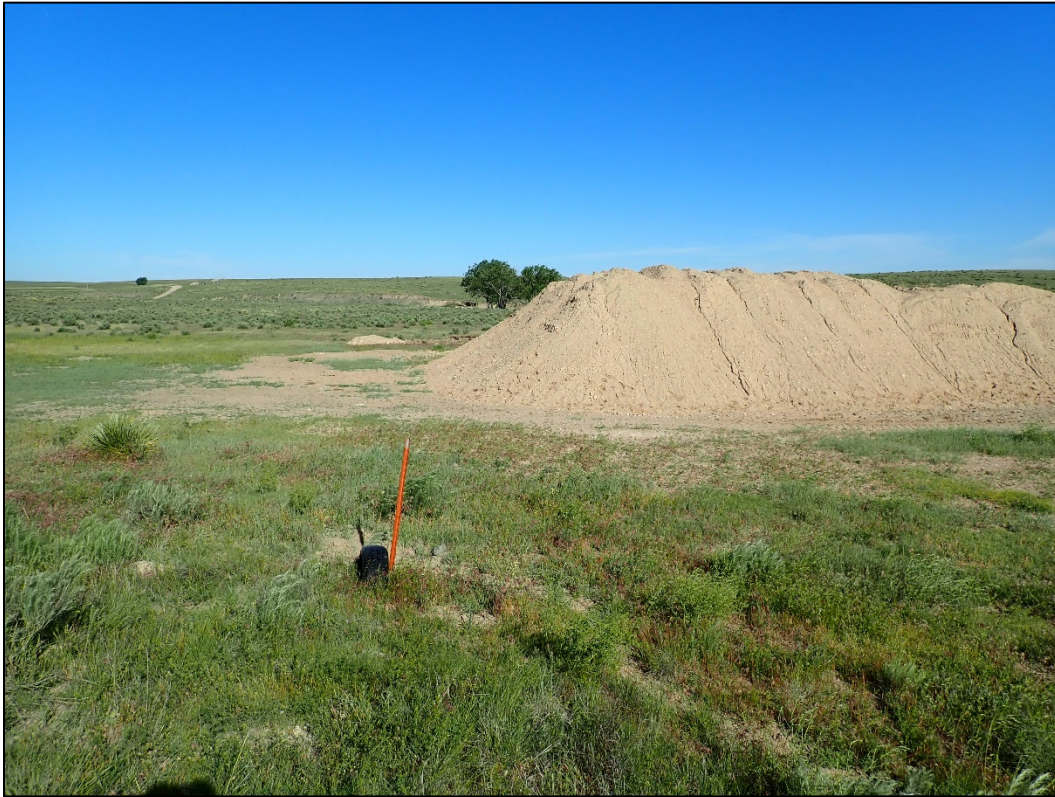
Photo 3. Southeast boundary marker and product stockpile; looking west.

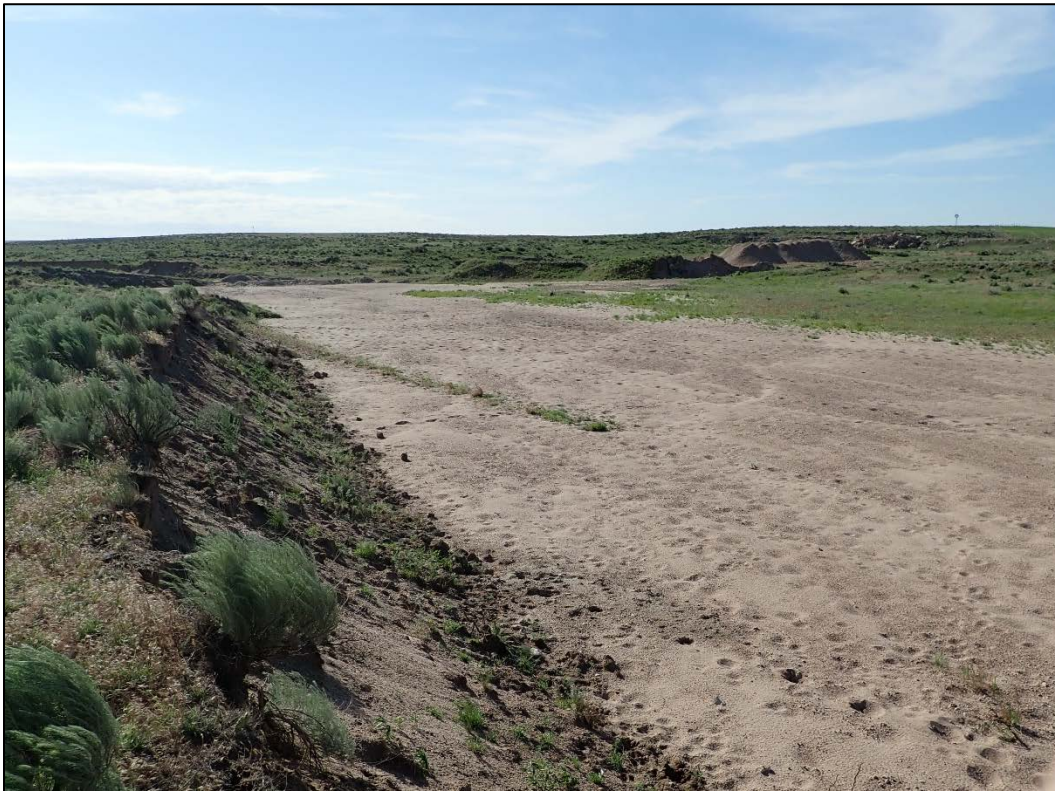
Photo 4. Bonny Creek within the permit boundary; looking southeast and downstream.

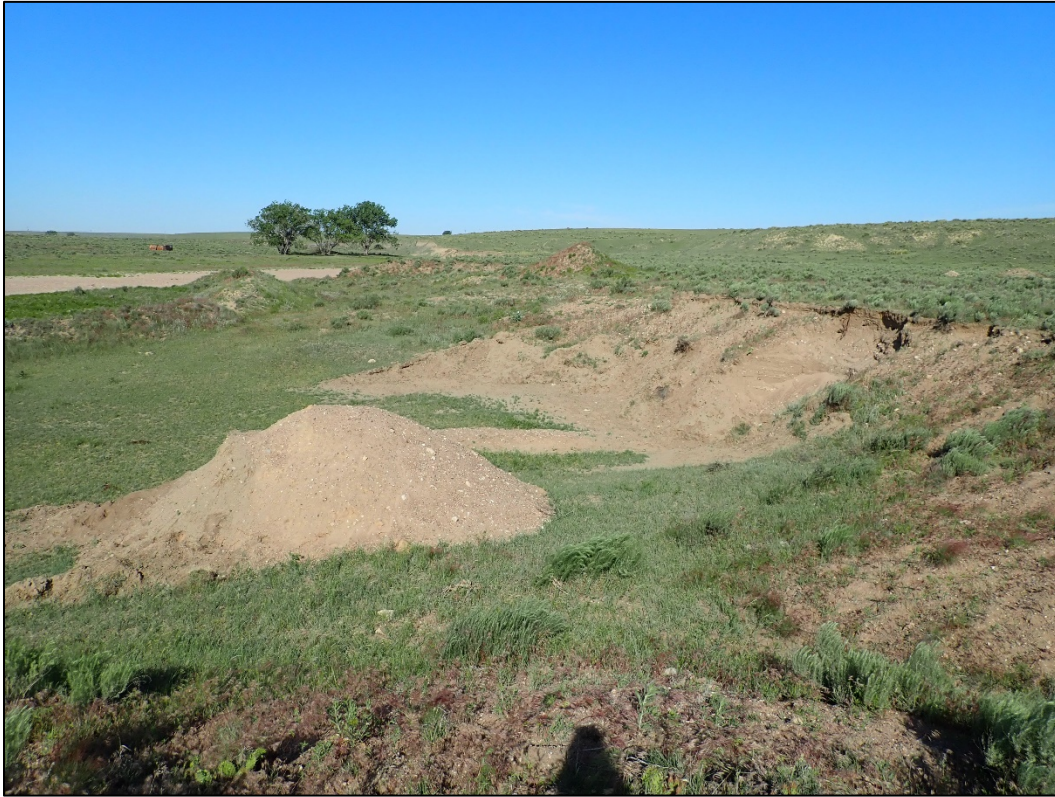
Photo 5. Excavated area on the north of the creek channel; looking west.
