MINERALS PROGRAM INSPECTION REPORT PHONE: (303) 866-3567

MINE NAME:		MINE/PROSPECTING ID#:	MINERAL:	COUNTY:		
Smith Pit		M-2006-049	Sand and gravel	Kit Carson		
INSPECTION TYPE:		INSPECTOR(S):	INSP. DATE:	INSP. TIME:		
Monitoring		Elliott R. Russell	June 13, 2019	09:00		
OPERATOR:		OPERATOR REPRESENTATIVE:	TYPE OF OPERATION:			
Kit Carson County		Dave Hornung	110c - Construction Limited Impact			
REASON FOR INSPECTION:		BOND CALCULATION TYPE:	BOND AMOUNT:			
Normal I&E Program		None	NA			
DATE OF COMPLAINT:		POST INSP. CONTACTS:	JOINT INSP. AGENCY:			
NA		None	None			
WEATHER:	INSPECTOR'S SIGNATURE:		SIGNATURE DAT	E:		
Clear	At Pmill		August 23, 2019

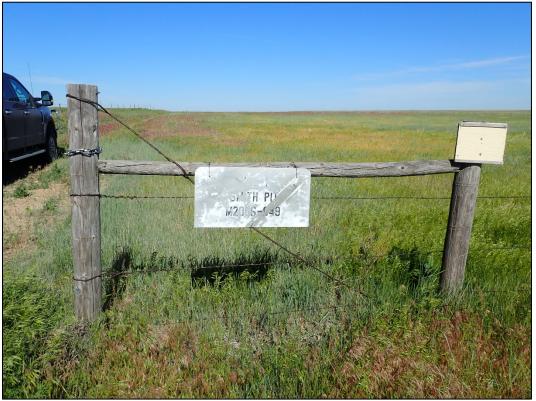
The mine identification sign was faded and illegible during the inspection. This was discussed with the Operator and a compliance problem would be cited requiring a new sign to be posted at the entrance to the site as required by Rule 3.1.12(1). The Operator promptly replaced the sign after the inspection and emailed a photograph to the Division on June 13, 2019. This problem has been resolved.

Signs and Markers: The permit sign faded and needs to be replaced. Boundary markers delineated the permit boundary.

Photo 1. Faded mine identification sign; looking east.

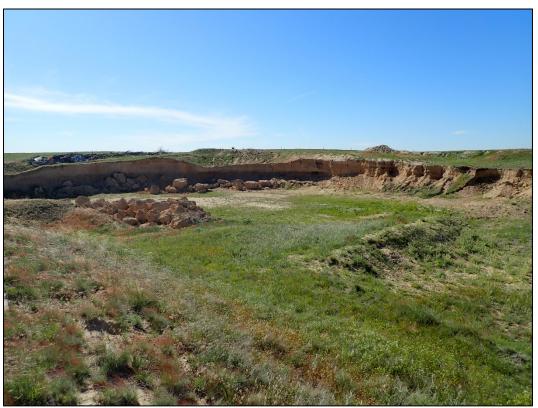
Photo 2. Site overview; looking southeast.

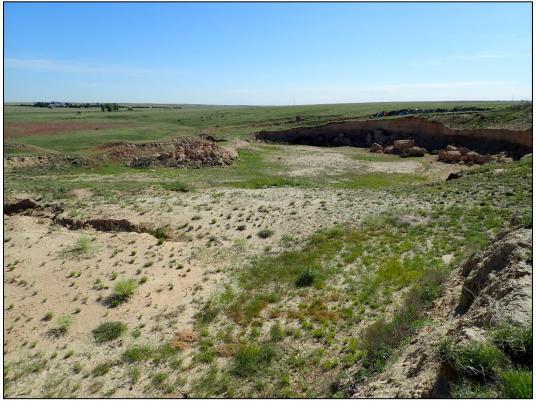
Photo 3. Site overview; looking northeast.

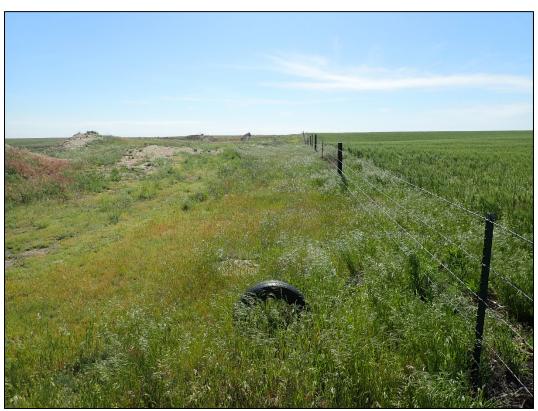
Photo 4. Southwest boundary marker; looking east.

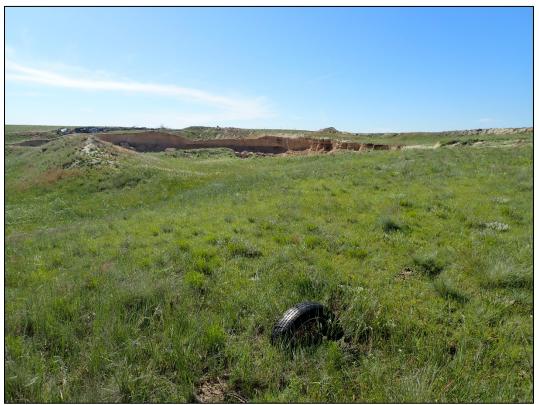
Photo 5. Northwest boundary marker; looking southeast.
