**MINERALS PROGRAM INSPECTION REPORT**  
**PHONE: (303) 866-3567**

<b>MINE NAME:</b> Triangle One Pit	<b>MINE/PROSPECTING ID#:</b> M-1980-228	<b>MINERAL:</b> Sand and gravel	<b>COUNTY:</b> Archuleta
<b>INSPECTION TYPE:</b> Monitoring	<b>INSPECTOR(S):</b> Lucas J. West	<b>INSP. DATE:</b> August 6, 2019	<b>INSP. TIME:</b> 14:25
<b>OPERATOR:</b> Oldcastle SW Group, Inc. dba Four Corners M	<b>OPERATOR REPRESENTATIVE:</b> Matt Carnahan	<b>TYPE OF OPERATION:</b> 112c - Construction Regular Operation	
<b>REASON FOR INSPECTION:</b> Normal I&E Program	<b>BOND CALCULATION TYPE:</b> None	<b>BOND AMOUNT:</b> \$19,504.00	
<b>DATE OF COMPLAINT:</b> NA	<b>POST INSP. CONTACTS:</b> None	<b>JOINT INSP. AGENCY:</b> None	
<b>WEATHER:</b> Clear	<b>INSPECTOR'S SIGNATURE:</b>

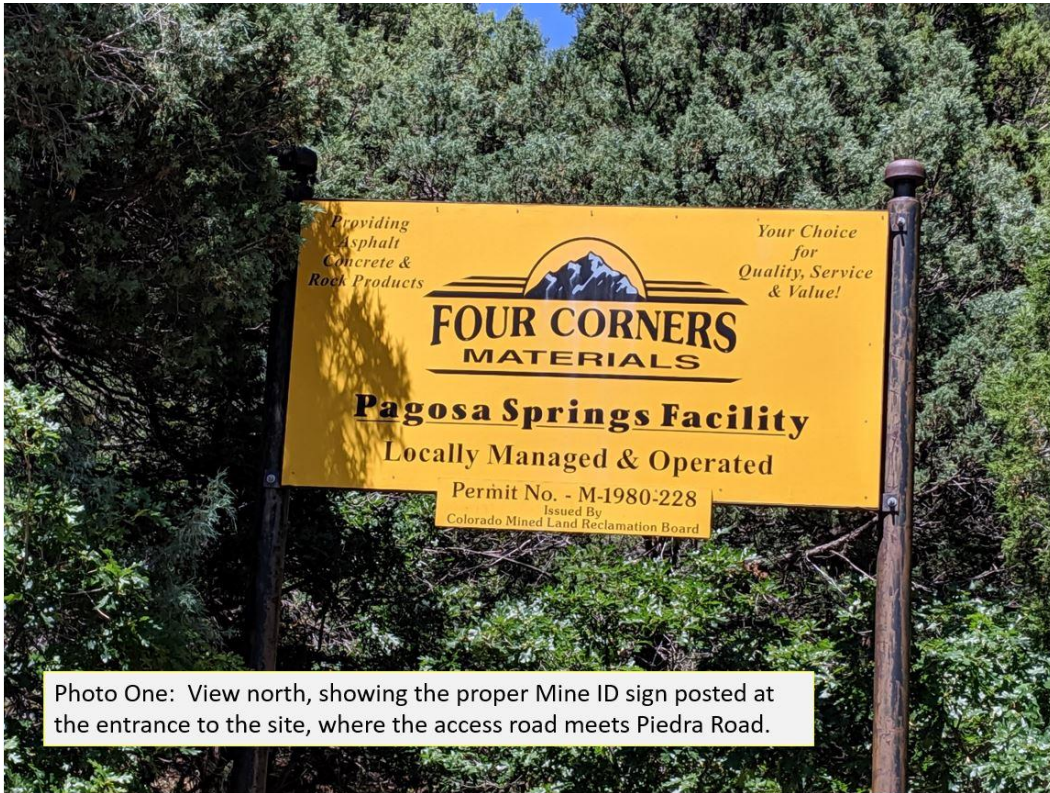
Proper mine identification signage is posted at the entrance to the site, shown in Photo One. The permit boundaries were clearly marked with signs and berms around the perimeter of the site. The site was not active during the time of the inspection. Active mining operations have not taken place at the site since the late 1990's. The site has become a processing facility and plant location for materials that have been mined at other permitted sites in accordance with the approved reclamation plan. Photo Two shows the processing facilities in good condition. Materials used in processing are imported and most of the reserves have been used. Photo Three shows an example of the remaining stockpiles on site. All stockpiles appear to be stable and are in good condition. All fuel storage located on site is kept within proper secondary containment devices. Storm water control devices were observed, and appear to be functioning as designed. The sediment ponds located on site are in good condition and are stabilized with vegetation. The pit floor exhibits positive drainage and no erosional issues were noted during the time of the inspection.

Photo One: View north, showing the proper Mine ID sign posted at the entrance to the site, where the access road meets Piedra Road.

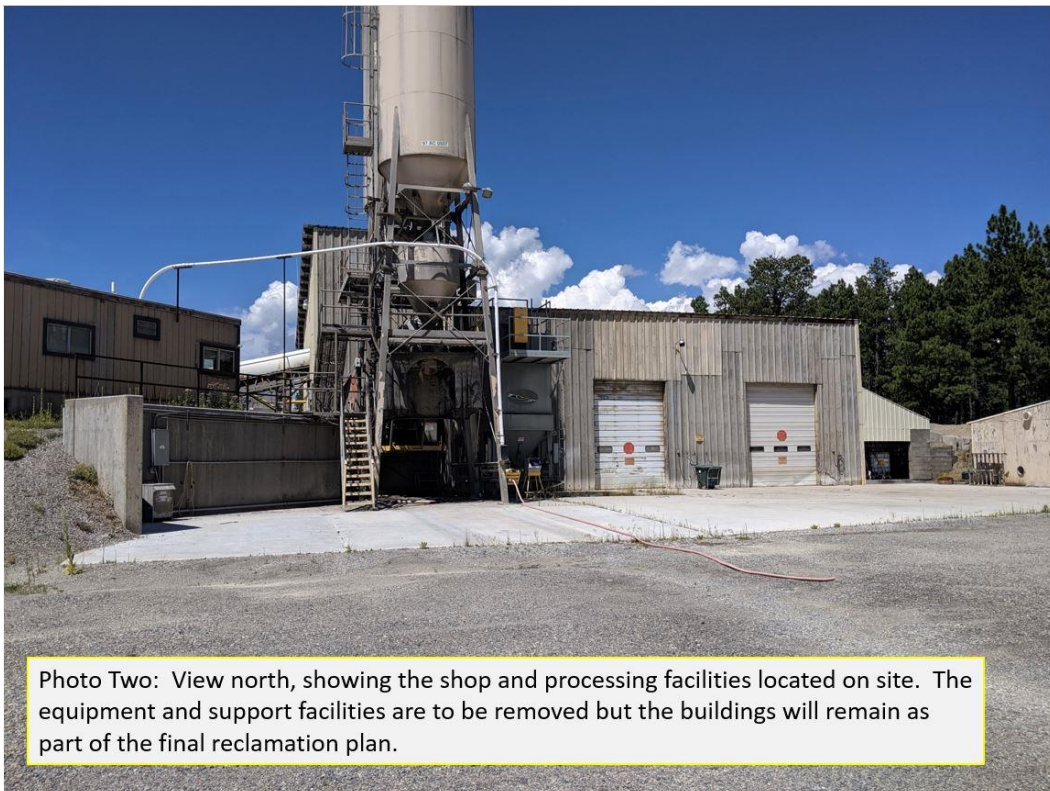
Photo Two: View north, showing the shop and processing facilities located on site. The equipment and support facilities are to be removed but the buildings will remain as part of the final reclamation plan.
