**COLORADO**Division of Reclamation,
Mining and Safety

MINERALS PROGRAM INSPECTION REPORT**PHONE: (303) 866-3567**

MINE NAME: Climax Mine	MINE/PROSPECTING ID#: M-1977-493	MINERAL: Molybdenum	COUNTY: Summit
INSPECTION TYPE: Monitoring	INSPECTOR(S): Lucas J. West	INSP. DATE: August 14, 2019	INSP. TIME: 09:45
OPERATOR: Climax Molybdenum Company	OPERATOR REPRESENTATIVE: Dianna Kelts	TYPE OF OPERATION: 112d-3 - Designated Mining Operation	
REASON FOR INSPECTION: Normal I&E Program	BOND CALCULATION TYPE: None	BOND AMOUNT: \$91,011,850.00	
DATE OF COMPLAINT: NA	POST INSP. CONTACTS: None	JOINT INSP. AGENCY: None	
WEATHER: Clear	INSPECTOR'S SIGNATURE:

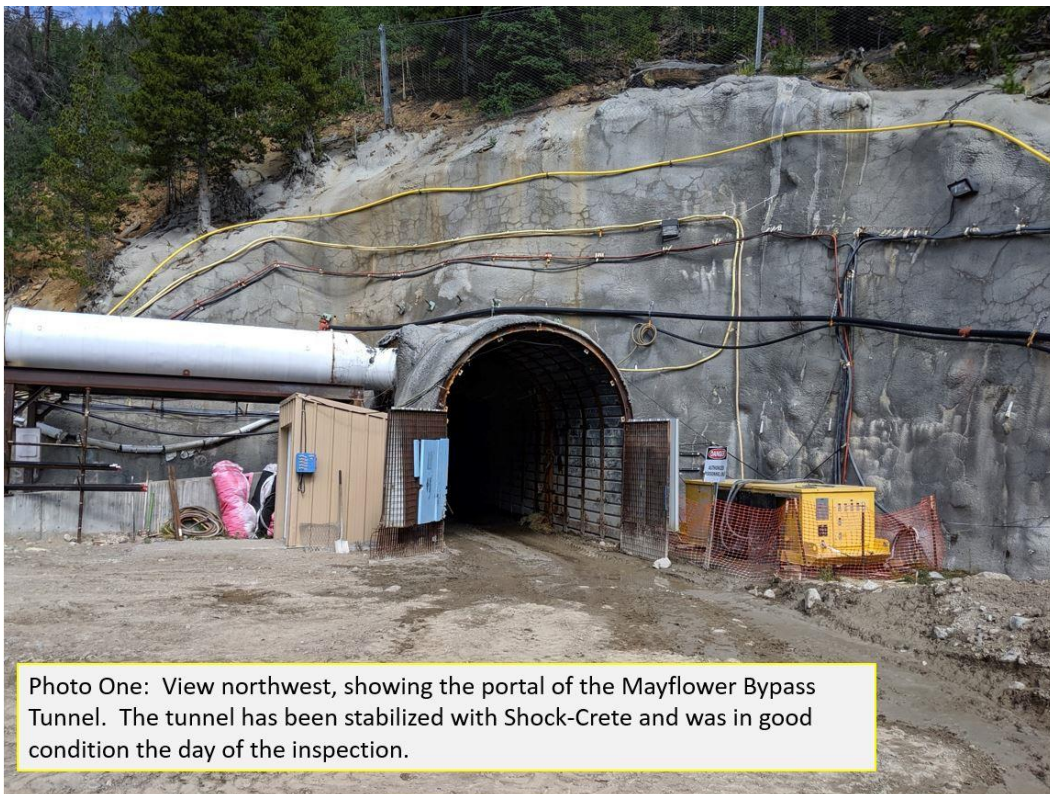
Mayflower Bypass Tunnel: The portal and work area for the Mayflower Bypass Tunnel were observed. Active tunneling is taking place by slowly advancing the underground tunnel. The operator provided details that current progress is slow because of the proximity of the new tunnel to historic underground workings. The portal, which can be seen in Photo One, is in good condition and has been stabilized with Shock-Crete around its mouth. The work area surrounding the portal is in excellent condition. All equipment and materials are being stored in a neat and orderly fashion. The work areas can be seen in Photos Two and Three. The upper reaches of 10 mile creek pass adjacent to the work area and is protected by series of silt fences and berms. The protection measures were in good condition and functioning as designed the day of the inspection. All fuel and hazardous materials being used in the area are being stored within proper secondary containment structures.

Photo One: View northwest, showing the portal of the Mayflower Bypass Tunnel. The tunnel has been stabilized with Shock-Crete and was in good condition the day of the inspection.

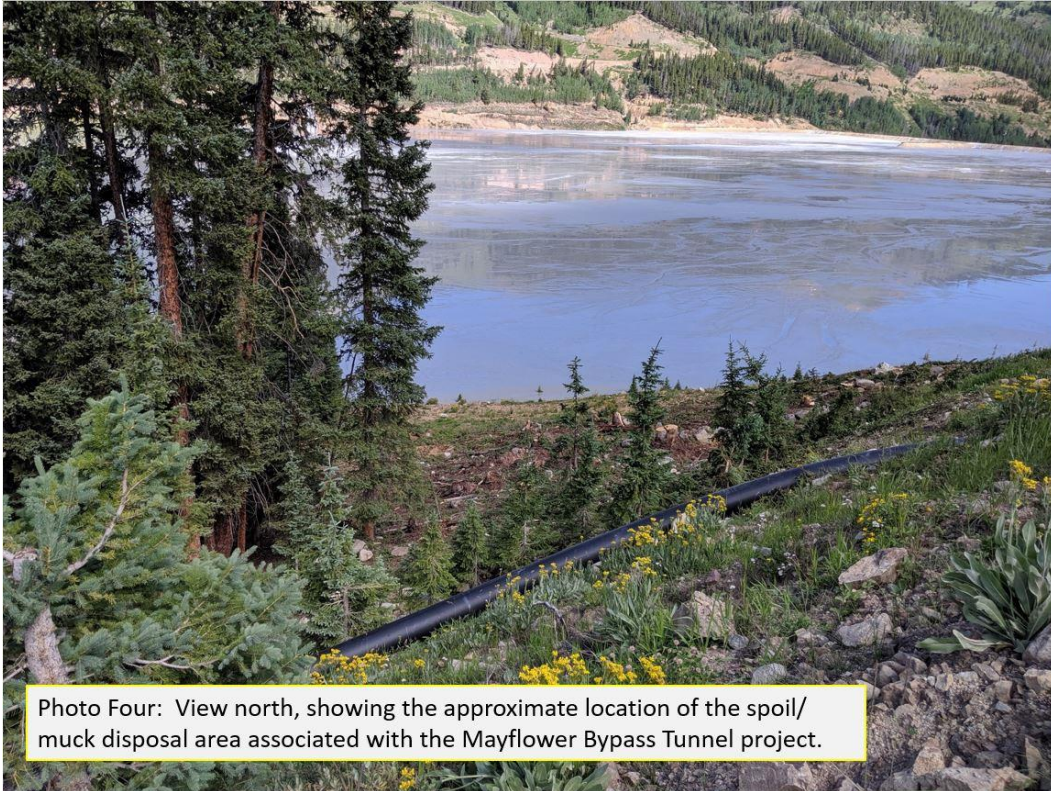
The muck storage area for the Mayflower Bypass Tunnel as approved through Technical Revision 30 has not yet been constructed. The proposed location of the storage area exists within the footprint of the Mayflower Tailings Storage Facility (TSF) and therefore protected by its associated Environmental Protection Facilities. The location of the storage area will be along the south/east side of the Mayflower TSF near the North Cut Out of the Tailings Delivery Line. The approximate area can be seen in Photo Four.

Photo Four: View north, showing the approximate location of the spoil/muck disposal area associated with the Mayflower Bypass Tunnel project.

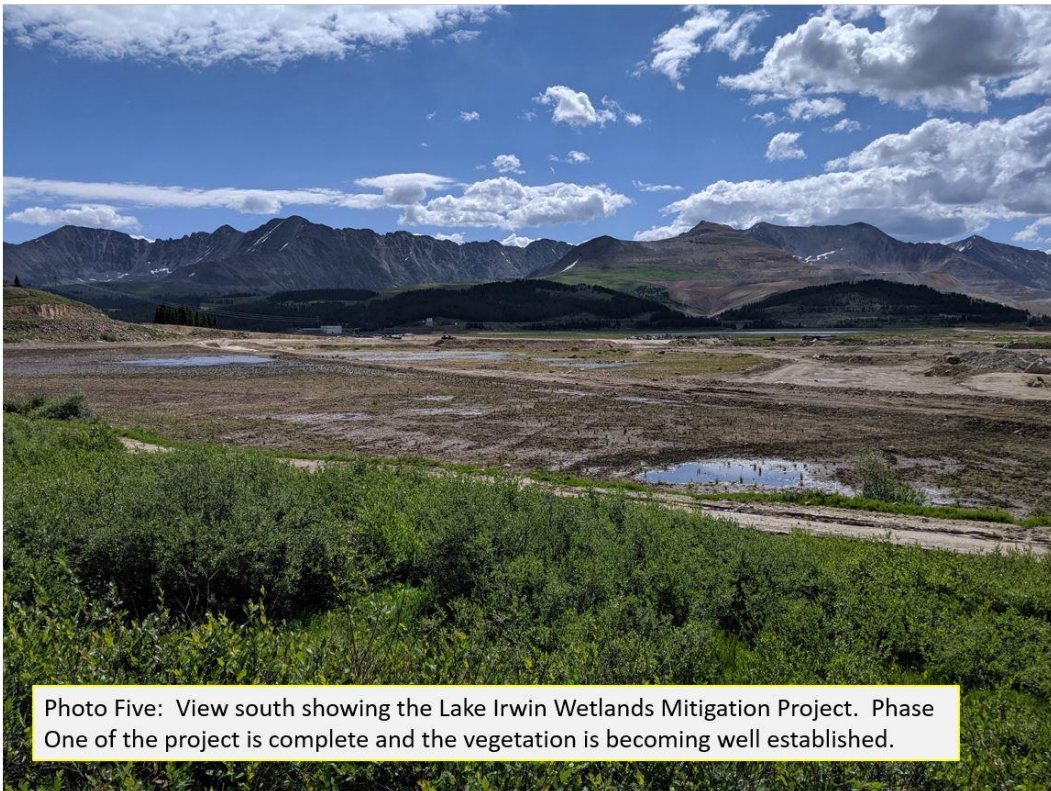
Lake Irwin Wetlands Mitigation Project: Phase One of the Lake Irwin project has been officially deemed complete. Minor maintenance of the area is required and the vegetation is becoming well established. Phase One can be seen in Photo Five. Phase Two of the project is scheduled to commence next year.

Photo Five: View south showing the Lake Irwin Wetlands Mitigation Project. Phase One of the project is complete and the vegetation is becoming well established.

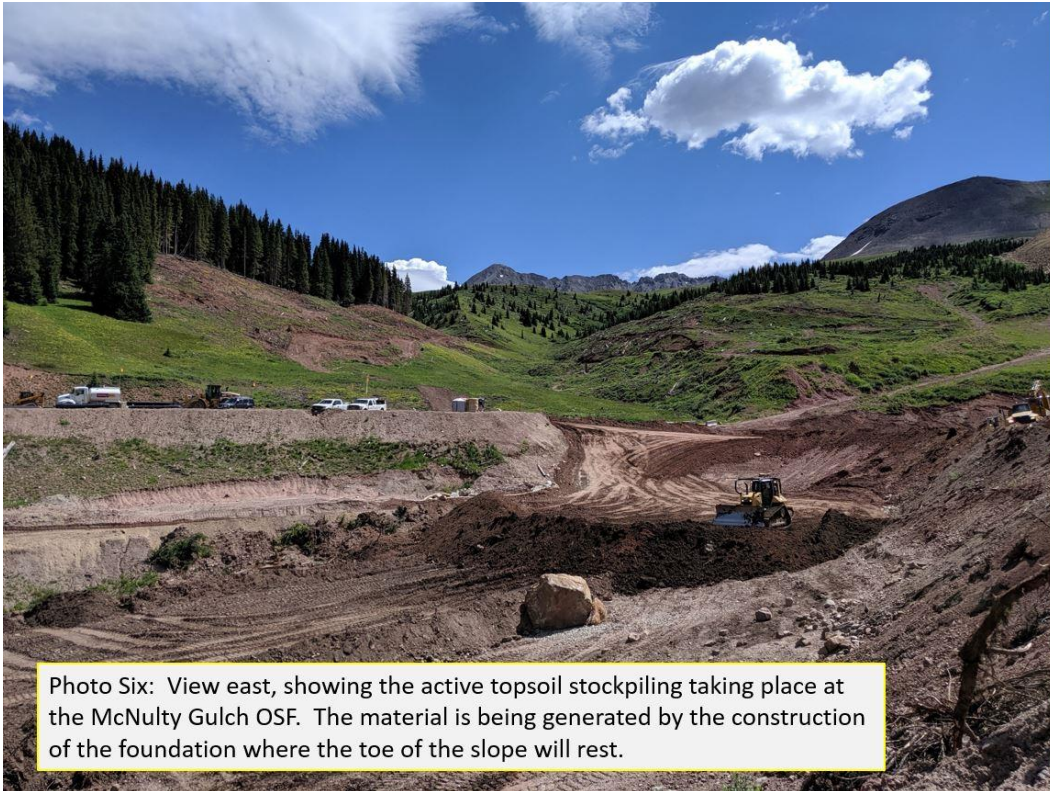
McNulty Gulch OSF: Construction of the McNulty OSF was being conducted during the inspection and can be seen in Photos Six through Eight. The valley drains under the topsoil stockpile areas have been completed, and active topsoil stockpiling was being conducted. The topsoil is being generated from the area that is being graded and prepared for construction of the toe of the facility. Concurrent with topsoil stockpiling material is being placed in 2 foot lifts and compacted in compliance with the approved plan. This will create the foundation for which the facility will be built. All construction materials were actively being monitored by personnel who were also conducting quality checks and quality assurance measurements. Area 2 West has

Photo Six: View east, showing the active topsoil stockpiling taking place at the McNulty Gulch OSF. The material is being generated by the construction of the foundation where the toe of the slope will rest.

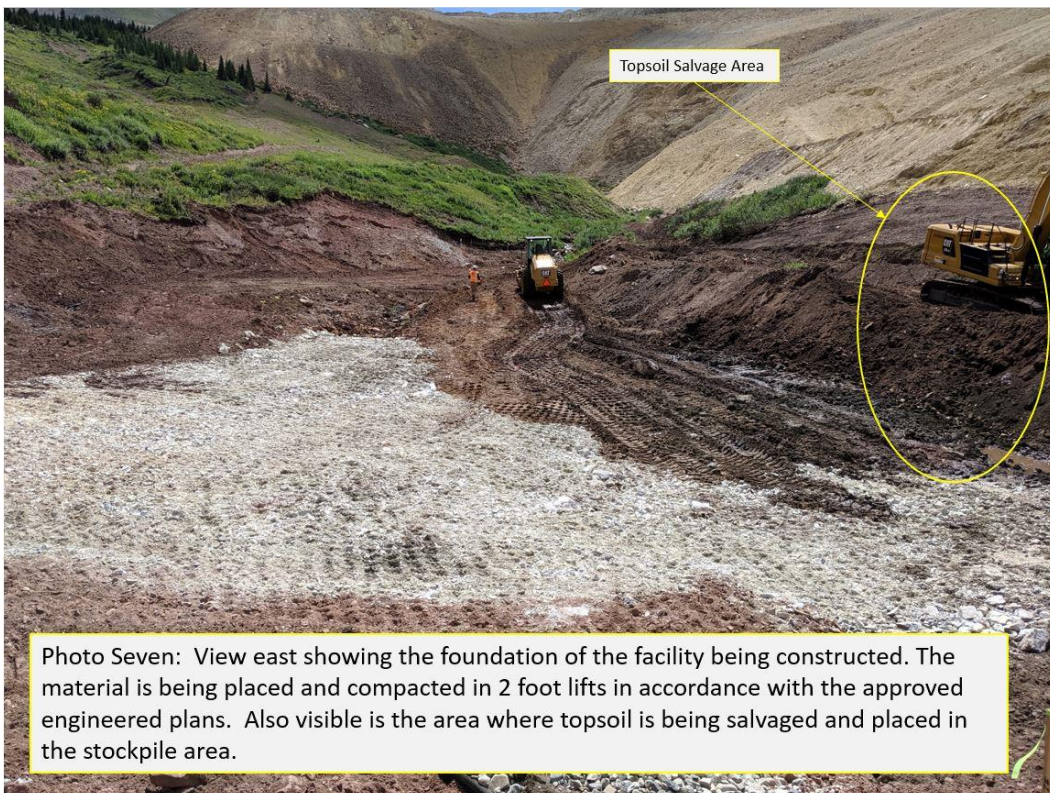
Photo Seven: View east showing the foundation of the facility being constructed. The material is being placed and compacted in 2 foot lifts in accordance with the approved engineered plans. Also visible is the area where topsoil is being salvaged and placed in the stockpile area.

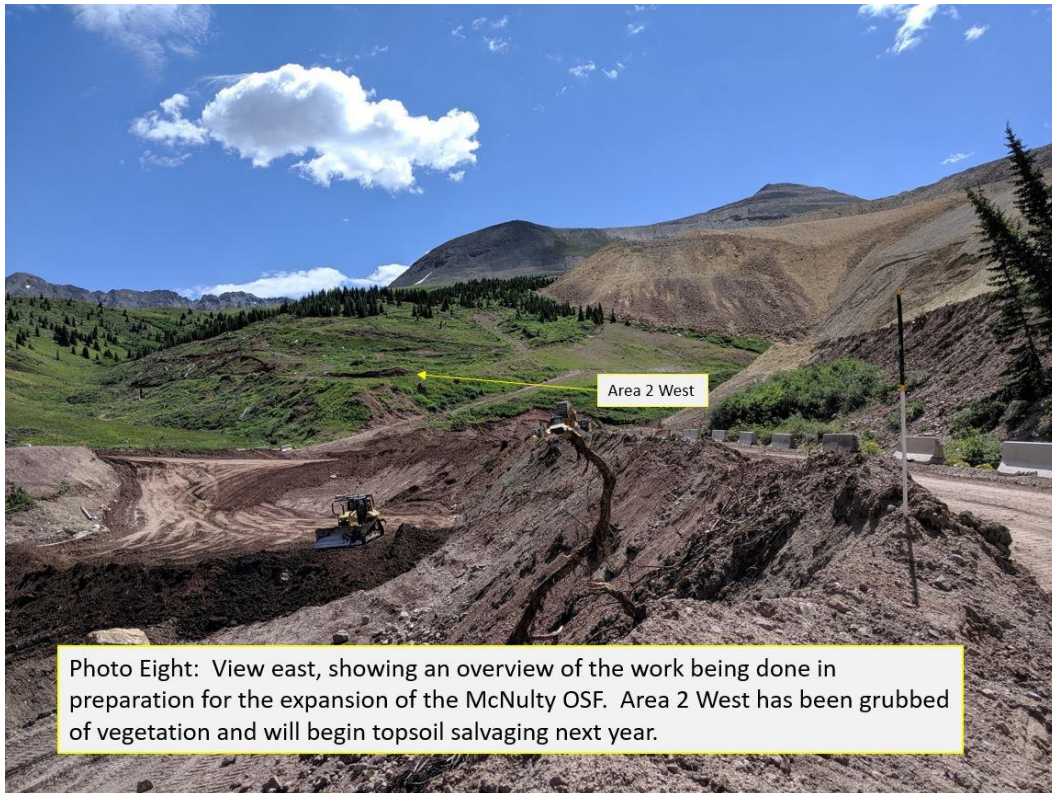
been cleared of major vegetation and stockpile salvaging will take place next summer.

Photo Eight: View east, showing an overview of the work being done in preparation for the expansion of the McNulty OSF. Area 2 West has been grubbed of vegetation and will begin topsoil salvaging next year.
